***Federal Railroad Administration
Office of Railroad Safety
Accident Analysis Branch***

***Accident Investigation Report
HQ-2015-1061
Technical Report***

***CSX Transportation
Maryville, TN
July 1, 2015***

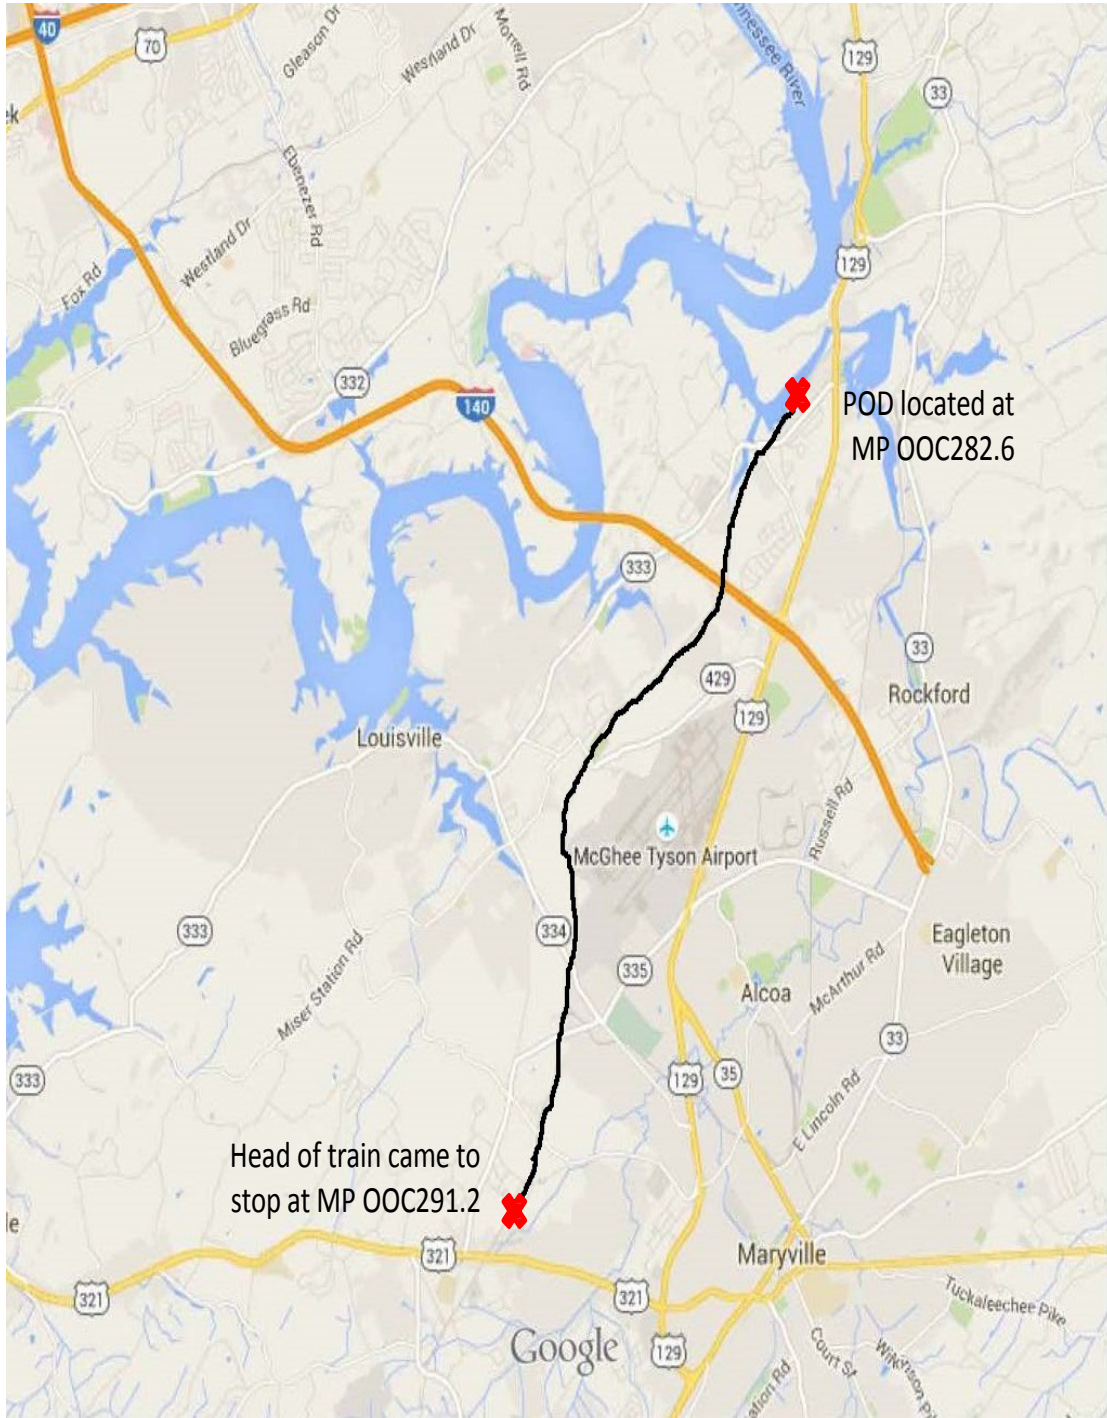
Lewall Rd Overpass MP OOC291.2

July 1, 2015 11:45pm
CSX S54101 Traveling southward
2 locomotives 57 cars
Trailing tons 5803
Head end came to stop at MP OOC291.2
