**Federal Railroad
Administration**

Measurement of Wheel Load Environment of a Standard 3-piece Truck

9. SPONSORING/MONITORING AGENCY NAME(S) AND ADDRESS(ES) U.S. Department of Transportation Federal Railroad Administration Office of Research, Development and Technology 1200 New Jersey Avenue, SE Washington, DC 20590			10. SPONSORING/MONITORING AGENCY REPORT NUMBER DOT/FRA/ORD-17/25

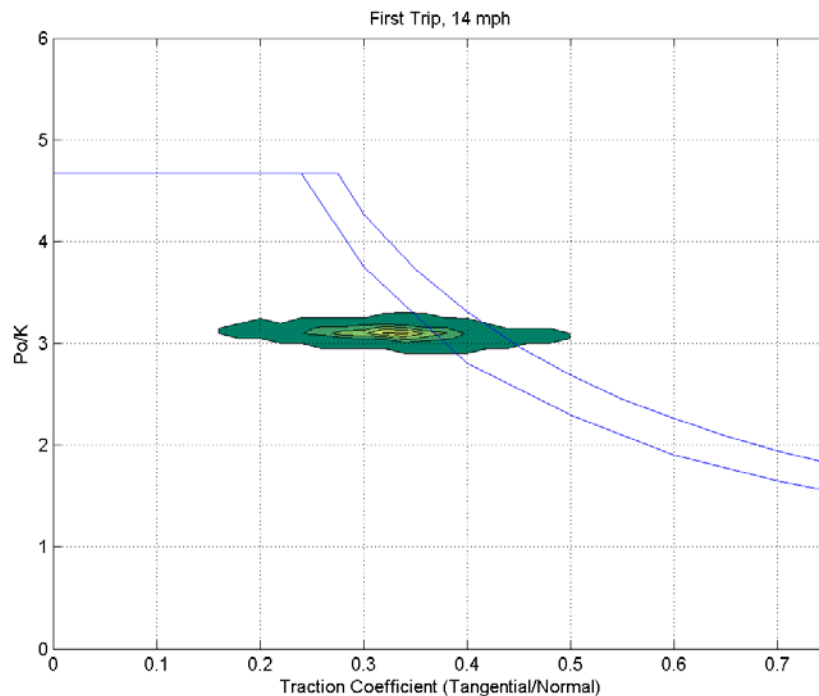
Figure 13. Shakedown Data at a 4.1-Degree Curve, First Trip, 3.5-inches Superelevation Excess

On the first trip, the train was traveling at 14 mph through this curve, resulting in an underbalance condition with 3.5 inches of superelevation excess. On the second trip, the train was traveling much faster at 28 mph. The train speed of the second trip resulted in a much less severe underbalance condition with 1.75 inches of superelevation excess. Figure 13 shows a contour plot of the shakedown conditions during the first trip when the shakedown limit was exceeded for a significant distance. Figure 14 shows a contour plot from the same curve during the second trip when the shakedown limit was only exceeded for a brief distance.

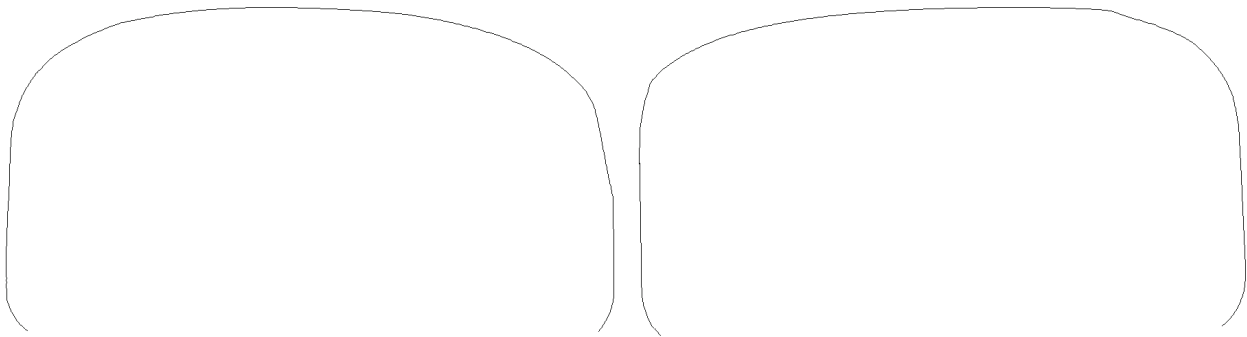
Figure 16. Curve A Rail Profiles: High Rail on the Left, Low Rail on the Right

Curve A is a 4.2-degree curve with 4.3 inches of superelevation. Figure 15 shows the condition of the low rail with relatively mild RCF cracks. Figure 16 shows the transverse profiles of the high and low rails, both installed in 2009. Minimal residual lubricant was found at this site. Figure 17 shows that the shakedown limit was not exceeded in this curve during the first trip. Figure 18 shows that minimal distance was traveled above the shakedown limit during the second trip.

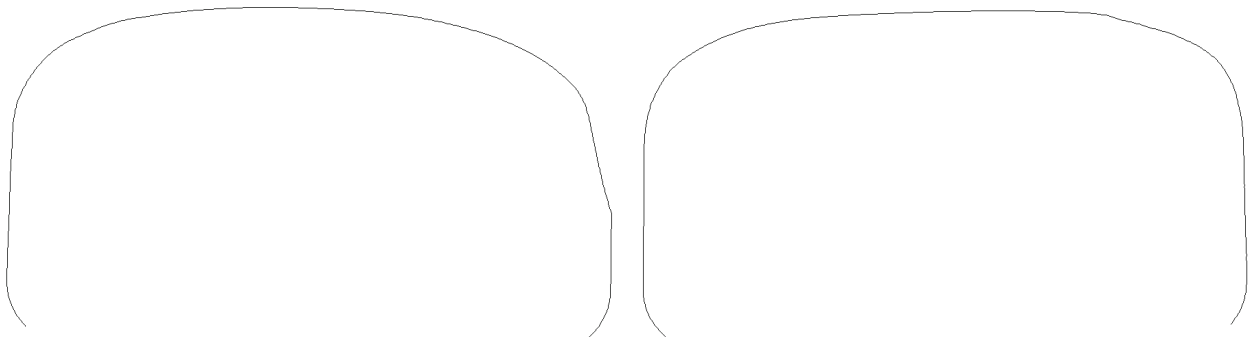
Figure 20. Curve B Rail Profiles: High Rail on the Left, Low Rail on the Right

Curve B is a 6.46-degree curve with 3.9 inches of superelevation. Curve B is also rank ordered site 14, as Figures 8 and 9 show. Figure 19 shows the condition of the low rail with relatively severe RCF cracks and spalls. Figure 20 shows the transverse profiles of the high and low rails, both installed in 2009. Rail at this site was extremely dry with metal wear flakes visible in the ballast. Figures 21 and 22 show that the shakedown limit was exceeded in this curve during the first and second trips, respectively.

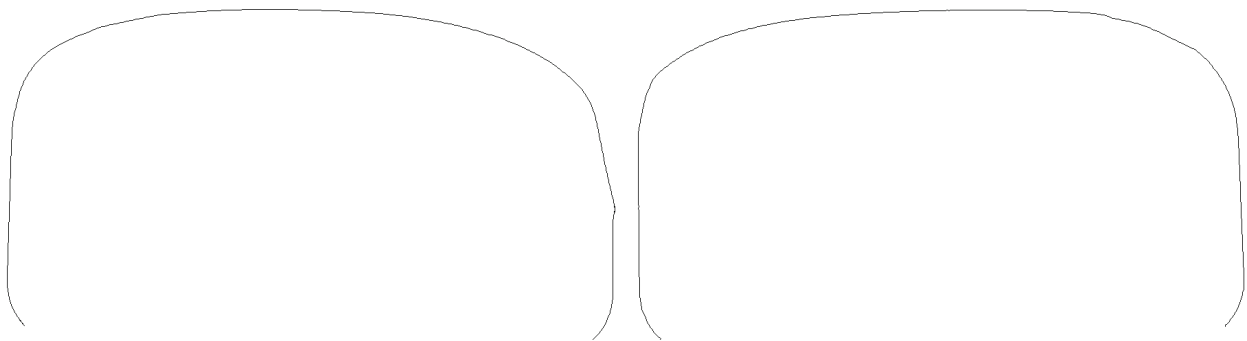
Figure 24. Curve C Rail Profiles: High Rail on the Left, Low Rail on the Right

Curve C is a 4.12-degree curve with 4.3 inches of superelevation. Figure 23 shows the condition of the low rail with moderate RCF cracks and tiny spalls. Figure 24 shows the transverse profiles of the high and low rails, both installed in 2009. Rail at this site was extremely dry with metal wear flakes visible in the ballast. Figures 25 and 26 show that the shakedown limit was exceeded in this curve during the first and second trips, respectively.

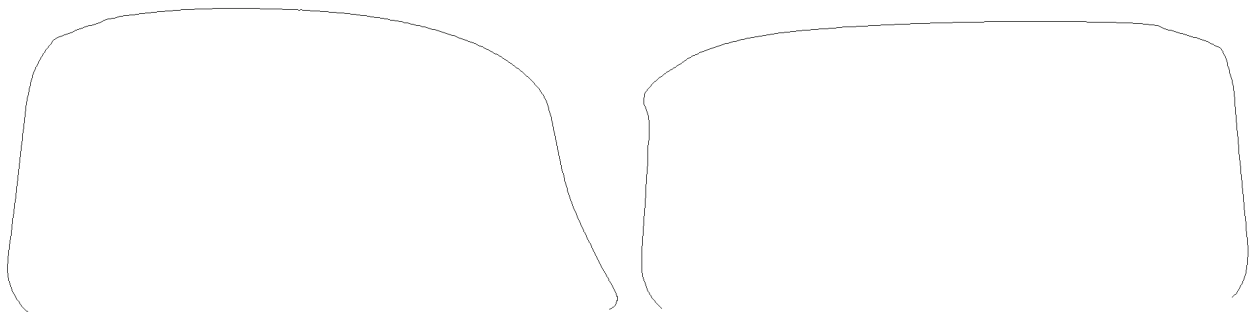
Figure 28. Curve D Rail Profiles: High Rail on the Left, Low Rail on the Right

Curve D is a 4.04-degree curve with 3.5 inches of superelevation. Curve D is also rank ordered site 1, as Figures 8 and 9 show. Figure 27 shows the condition of the low rail with relatively severe RCF cracks and spalls. Figure 28 shows the transverse profiles of the high and low rails, both installed in 2004. Rail at this site was extremely dry with metal wear flakes visible in the ballast. Figures 29 and 30 show that the shakedown limit was exceeded in this curve during the first and second trips, respectively.

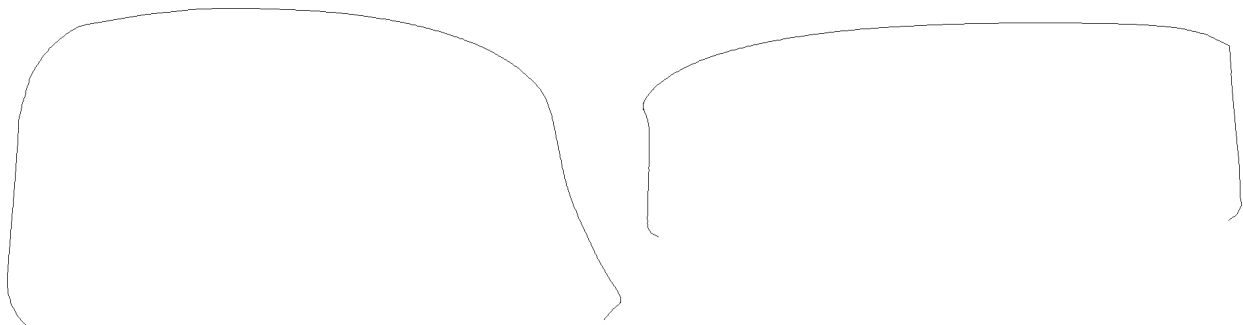
Figure 32. Curve E Rail Profiles: High Rail on the Left, Low Rail on the Right

Curve E is a 4.12-degree curve with 3.5 inches of superelevation. Figure 31 shows the condition of the low rail with moderate RCF cracks and small spalls. Figure 32 shows the transverse profiles of the high rail (installed in 2004) and low rail (installed in 1994). Rail at this site was extremely dry with metal wear flakes visible in the ballast. Figure 33 shows that the shakedown limit was exceeded only briefly in this curve during the first trip. Figure 34 shows that the shakedown limit was not exceeded during the second trip.

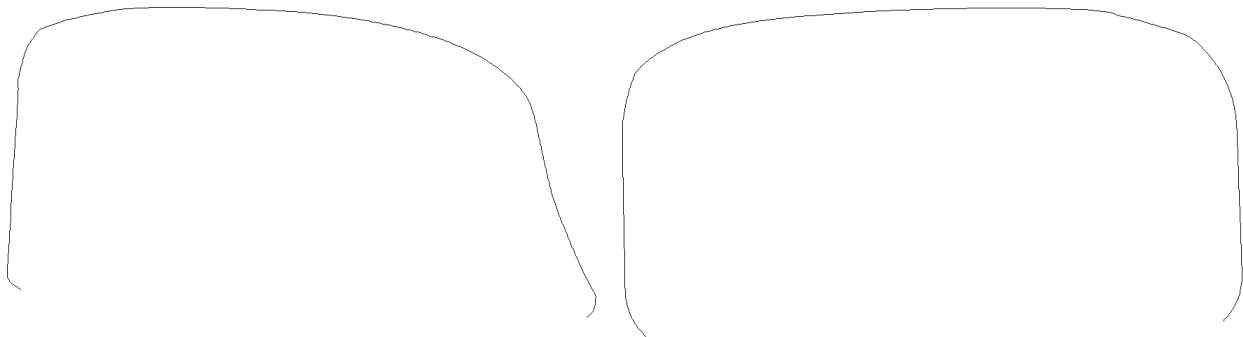
Figure 36. Curve F Rail Profiles: High Rail on the Left, Low Rail on the Right

Curve F is a 4.25-degree curve with 5 inches of superelevation. Figure 35 shows the condition of the low rail with relatively severe RCF cracks and small spalls. Unmatched dye penetrant and developer caused dye bleed-out, as Figure 35 shows. Figure 36 shows the transverse profiles of the high rail (installed in 2001) and low rail (installed in 2007). Rail at this site was extremely dry with metal wear flakes visible in the ballast. Figure 37 shows that the shakedown limit was not exceeded in this curve during the first trip. No data was available from this curve during the second trip.

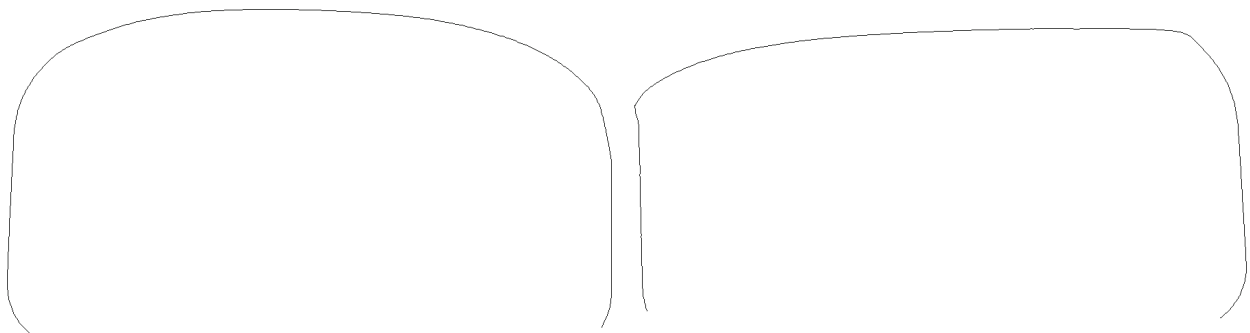
Figure 39. Curve G Rail Profiles: High Rail on the Left, Low Rail on the Right

Curve G is a 4.02-degree curve with 5 inches of superelevation. Curve G is also rank ordered site 20, as Figures 8 and 9 show. Figure 38 shows the condition of the low rail with relatively severe RCF cracks and small spalls. Unmatched dye penetrant and developer caused dye bleed-out, as Figure 38 shows. Figure 39 shows the transverse profiles of the high rail (installed in 2008) and low rail (installed in 2006). Rail at this site was extremely dry with metal wear flakes visible in the ballast. Figures 40 and 41 show that the shakedown limit was exceeded in this curve during the first trip and second trips, respectively.
