**Federal Railroad  
Administration**

## **Slab Track at Facility for Accelerated Service Testing: Performance and Serviceability**

Office of Research,  
Development  
and Technology  
Washington, DC 20590

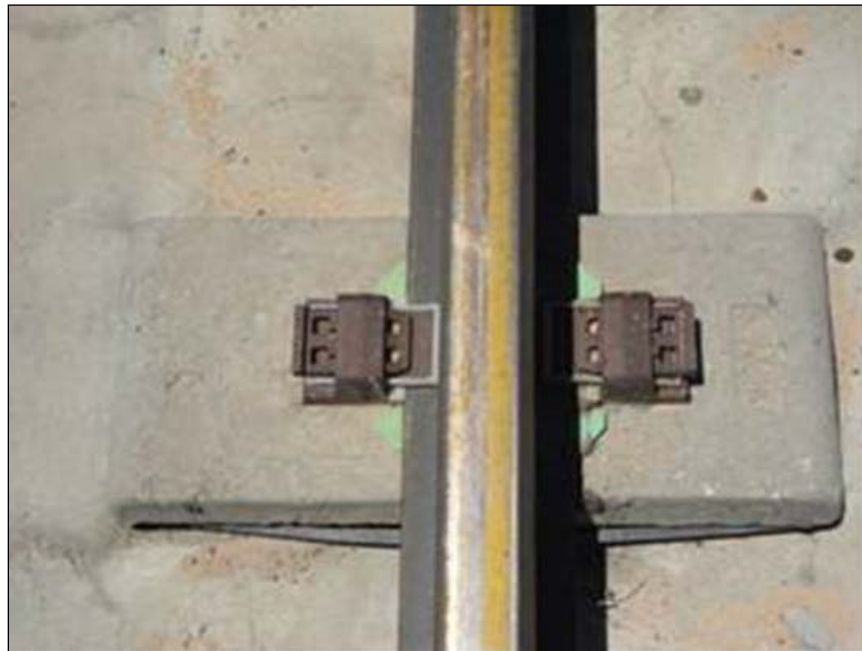
**Figure 13. Typical IDBT Fastener Installation**

The IDBT system consists of a concrete block that has the rail fastener base cast into the top of the block. The fastener is resilient and clips into the base using a plastic insulator on top of the rail base and a polymer pad under the rail base to isolate the rail electrically for signal circuit continuity. Figure 13 displays a top view of a typical IDBT fastener installation.

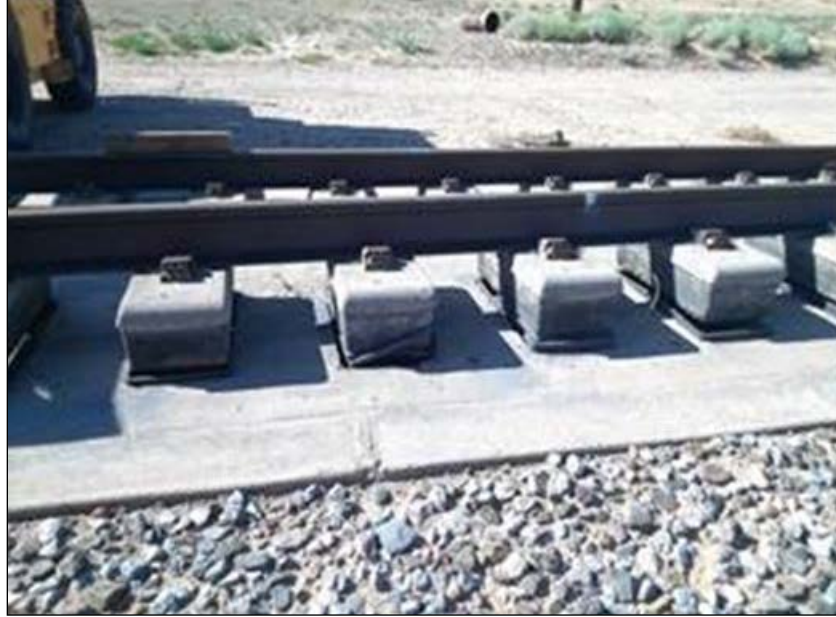
**Figure 14. Concrete Boots for the IDBT Fastening System**

The entire concrete block assembly fits into a rubber boot (with resilient pad in the bottom) and the block and boot assembly is placed into a void cast into the concrete slab. The design assumes that the concrete block will fit in the void, which will restrict its movement and help in the function of maintaining track geometry integrity. The rubber boot also functions as additional electrical insulation for signal circuit continuity in case an issue develops with the clip and insulator. Figure 14 is a photograph taken during demolition of the slab that shows the general concept of the blocks.

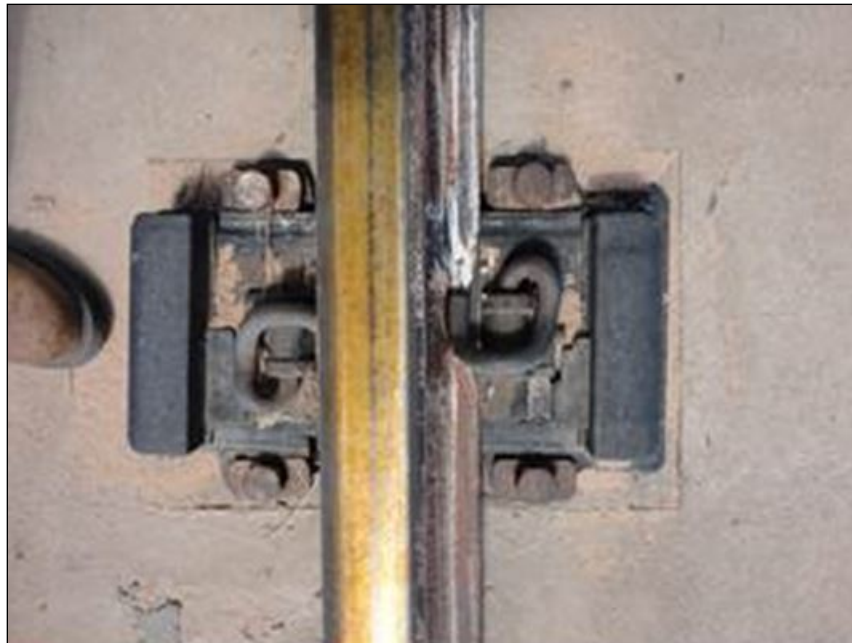
**Figure 19. Typical DFST Fastener Installation**

The DFST fastener is a self-contained unit that is bolted to the concrete slab with four anchor bolts. The bolts require a threaded anchor insert cast into the slab. The entire plate with bolts constitutes the fastening assembly. The plate with bolts and inserts are cast into the slab during the casting of the concrete. The bolts develop hold-down force through special serrated washers mated to anchor slots on the base plate. The plate uses a standard spring clip on each side to hold the rail to the plate. The unit is insulated for signal continuity. Figure 19 shows a top view of a typical installation.

Bolt tension on the anchor bolts is a critical factor in fastener performance. If the bolt is not working to engage the other mechanisms of the fastener, the bolt itself must provide all the resistance against movement including bearing against any movement. This will result in a failure of the anchor bolts. The plate needs to be solidly in place to prevent gage spread. The bolt tension adds greatly to increase the amount of lateral force necessary to shift the plate (and the rail) laterally. Bolt tension and bolt condition in general has declined over time. At the time of the demolition of the slab track, program maintenance to address essentially all plates could have been planned. A detailed inventory of loose or missing bolts was undertaken before the rail was removed for demolition. Table 1 provides the results of the bolt tension inventory.
