**RESEARCH RESULTS**  
FRA OFFICE OF RAILROAD POLICY & DEVELOPMENT

RR 18-03 | February 2018

## FULL-SCALE SHELL IMPACT TEST OF A DOT-117 TANK CAR

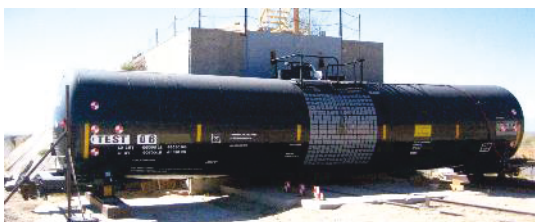
Figure 1. Pre-test Photo of DOT-117

On September 28, 2016, the Federal Railroad Administration (FRA) conducted a full-scale shell impact test of a DOT-117A100W (DOT-117) tank car at the Transportation Technology Center (TTC) in Pueblo, CO. The shell of the car was struck at the mid-length by a 297,000 pound ram car, which was equipped with a 12-inch by 12-inch impactor. Figure 1 shows the tank car in its pre-test position against the TTC impact wall.

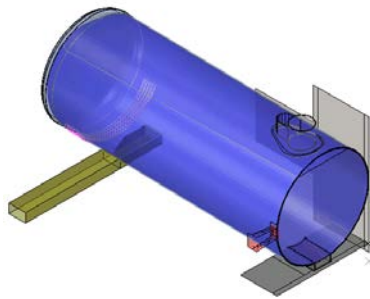
Figure 3. Half-symmetric DOT-117 FEA Model

An FEA-based simulation was also performed in conjunction with the test. A schematic of the FEA model is shown in Figure 3. This model used symmetry (half-length) in order to simplify and speed-up the simulations. This model featured explicit modeling of the water and simplified modeling of the air within the tank.

phase of the lading. The jacket was modeled using shell elements. The tank was also modeled using shell elements, except in the vicinity of the impact. The impact zone was modeled using solid elements, with elastic-plastic and ductile failure material properties defined. This combination of element type and properties would allow the team to simulate a puncture of the tank, the jacket, or both.
