FULL-SCALE SHELL IMPACT TEST OF A DOT-111 TANK CAR

On October 30, 2018, the Federal Railroad Administration (FRA) conducted a full-scale shell impact test of a DOT-111A100W (DOT-111) tank car meeting voluntary industry standard CPC-1232 at the Transportation Technology Center (TTC) in Pueblo, CO. The shell of the car was struck at its mid-length by a 297,000-pound ram car equipped with a 12-inch by 12-inch impactor. [Figure 1](#) shows the tank car in its pre-test position against the impact wall at TTC.

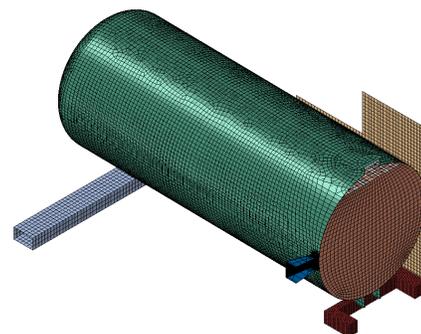
Figure 3. Half-symmetric DOT-111 FE Model

FEA was performed in conjunction with the test. A schematic of the FE model is shown in [Figure 3](#). This model used symmetry (half-length) to simplify and speed-up the simulations. This model featured detailed modeling of the water and simplified modeling of the air within the tank. The water was modeled using a Lagrangian mesh with an equation-of-state (EOS) material behavior and the air was modeled as an ideal gas using a pneumatic cavity. The tank was modeled using shell elements, except in the impact zone. The impact zone was modeled using solid elements, with elastic-plastic and ductile failure material properties defined. This combination of element type and properties would allow puncture of the tank car to be modeled while minimizing the model's run-time.
