**Federal Railroad
Administration**

Crippling Load Test of Budd Pioneer Car 244, Test 3

1. AGENCY USE ONLY (Leave blank)		2. REPORT DATE April 2013	3. REPORT TYPE AND DATES COVERED Technical Report	
4. TITLE AND SUBTITLE Crippling Load Test of Budd Pioneer Car 244, Test 3			5. FUNDING NUMBERS DTRF53-00-C-00012 Task Order 235

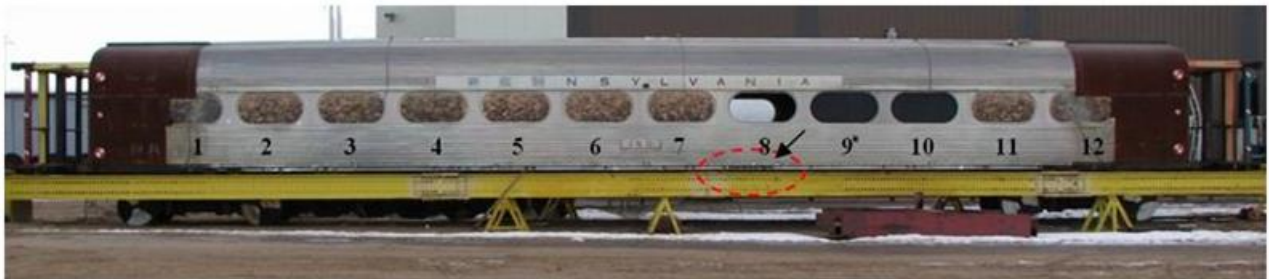
Figure 7. Location of the Steel Patch below Window 8 on Car 244

After Test 1, two fatigue cracks were discovered in the right side sill where brackets had been welded to support undercar equipment (Figure 4). A steel patch (Figure 5) was welded over the cracks to keep the sill side in line during compression for Test 2. Another patch was welded over the left sill to preserve car structural symmetry (Figure 6). Figure 7 and Figure 8 show the locations of the steel patches relative to the car windows. Test 2 was conducted in January 2011. It had the same setup and procedures as Test 1. No significant permanent compression of the car structure occurred after the two tests. Therefore, Car 244 was determined to be suitable for Test 3, the crippling load test.

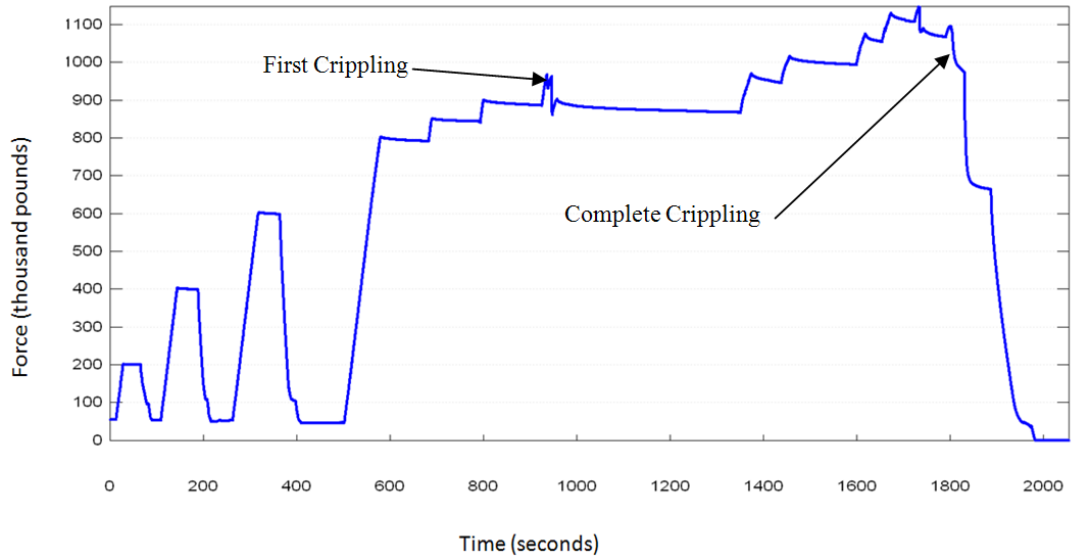
Figure 9. Load History for Shakedown Test (Car 248)

Figure 9 shows the load history during the shakedown test. The car first crippled at approximately 963,000 lb. The maximum total load applied by the four actuators in the shakedown test was approximately 1,148,000 lb. That load completely crippled the car. Figure 10 through 12 show crippling on Car 248. The crippling on Car 248 occurred between cross-members 4 and 5 in the vicinity of window 8. Unlike Car 244, Car 248 had no side-sill patches below window 8.

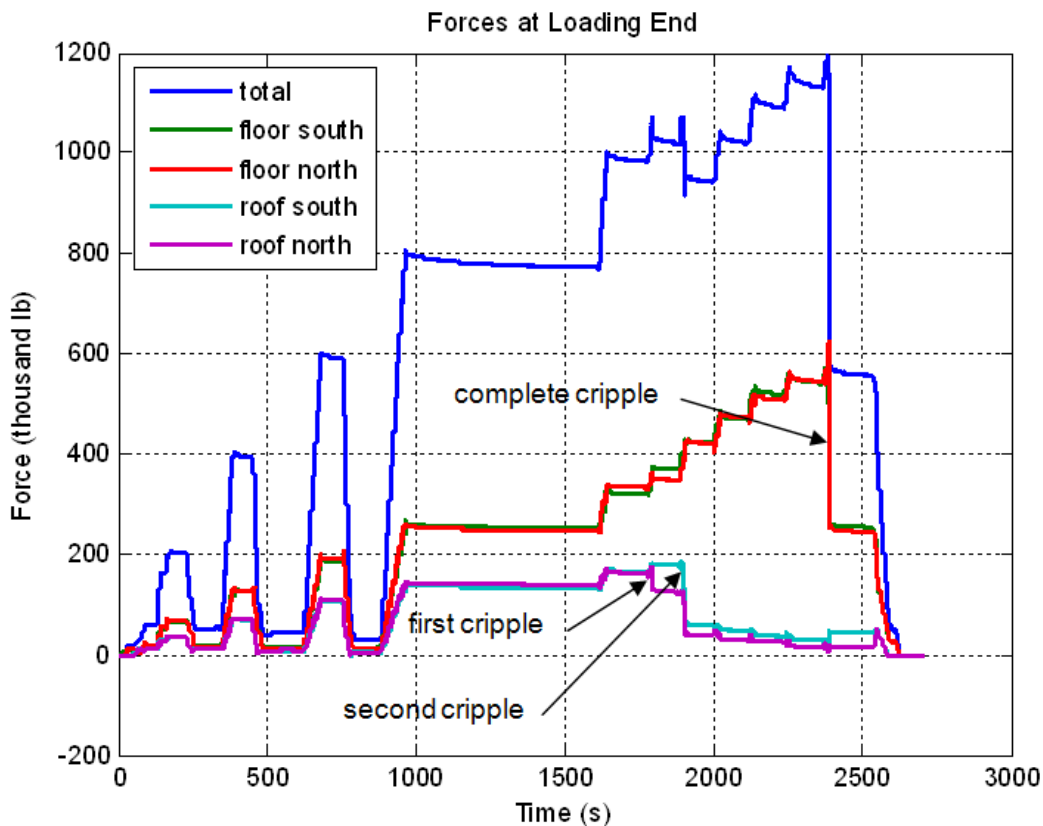
Figure 26. Load History for Test 3 (Car 244)

Figure 26 shows the load history for Test 3. It includes the total applied load and each of the four individual actuator loads. Intermediate loading cycles of 200,000, 400,000, and 600,000 lb and the dwell at 800,000 lb were applied in accordance with the test plan [5]. The north side of the car is the left side when viewed from B-end to A-end. The north side roof of Car 244 initially crippld at approximately 1,070,000 lb between cross-members 1 and 2, followed shortly by crippling of the south side roof. The center sill (floor level) failed at approximately 1,200,000 lb between the loading end and cross-member 1.

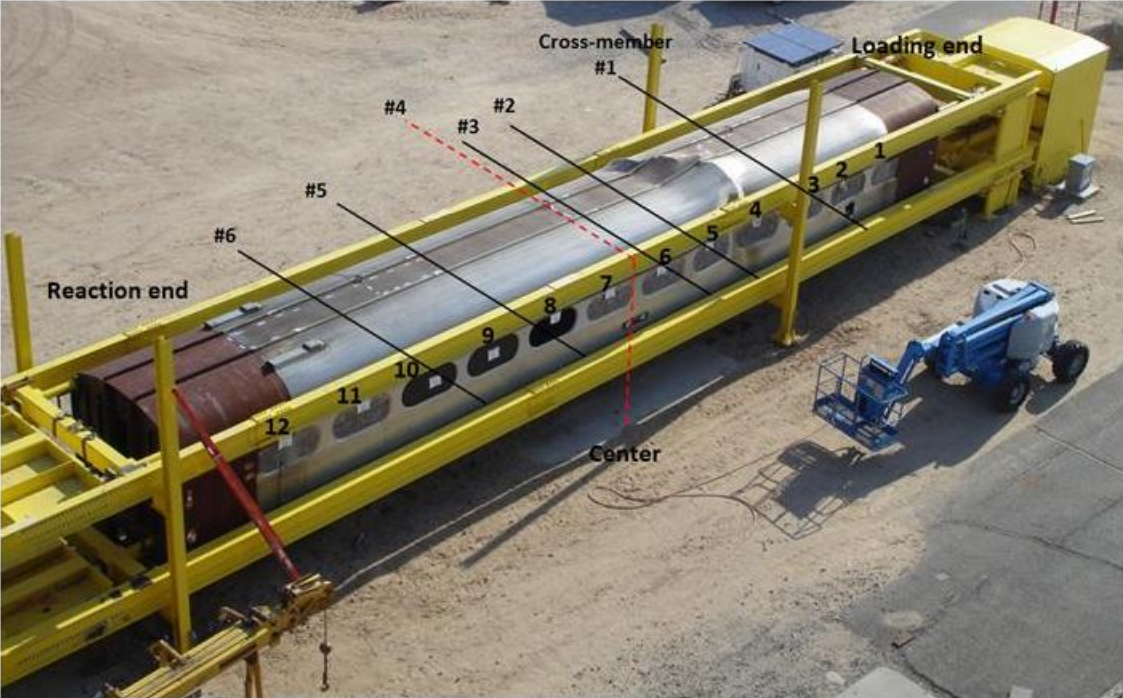
Figure 27. Car 244 after Test 3

Figure 27 through Figure 35 show various damage locations after crippling. Figure 36 shows the relative locations of all crippling that occurred under Car 244.

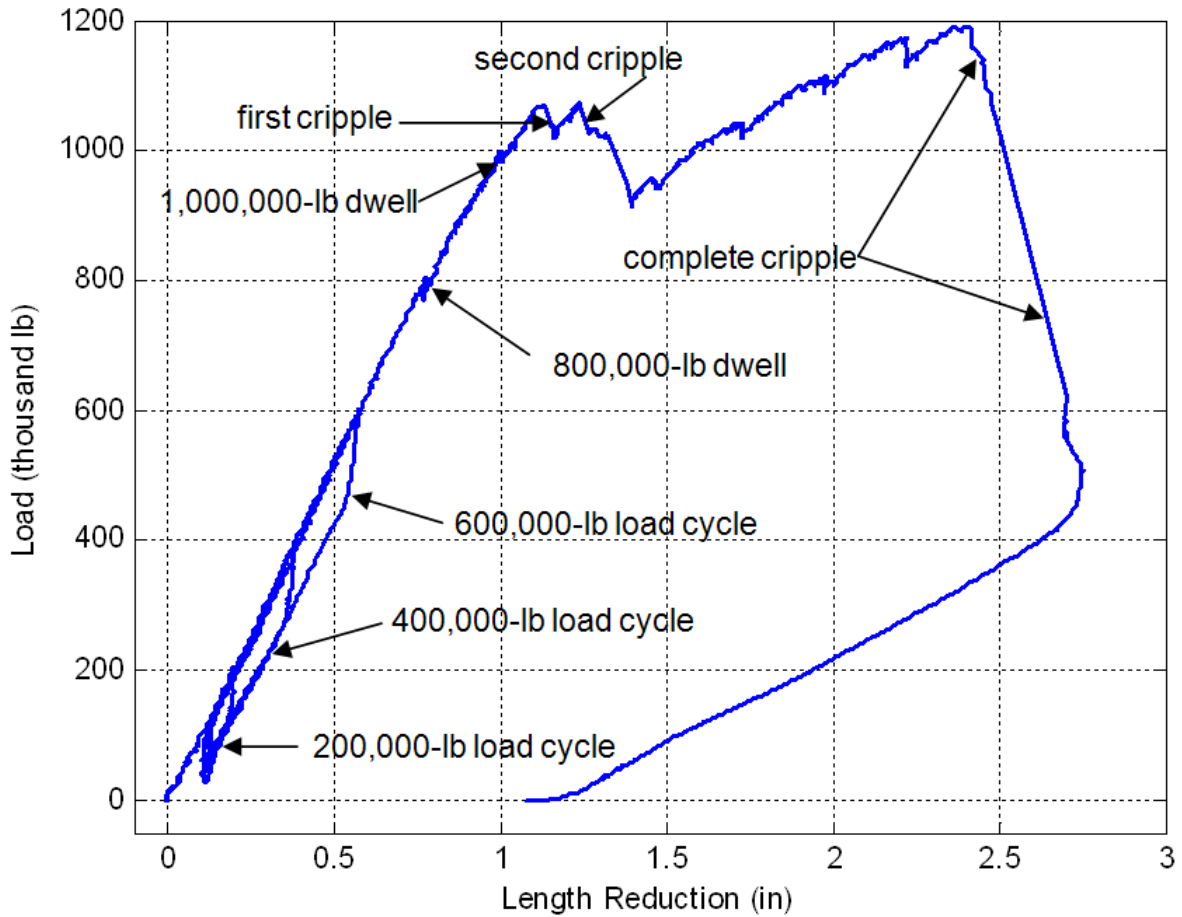
Figure 37. Load-Deflection Curve

Figure 37 shows the load-deflection history for Test 3 on Car 244, including the 200,000-, 400,000-, and 600,000-pound load cycles, the dwell at 800,000 lb, and the crippling. The first crippling at the roof level occurred at approximately 1,070,000 lb. The complete crippling, including the center sill and side sills, occurred at approximately 1,200,000 lb.

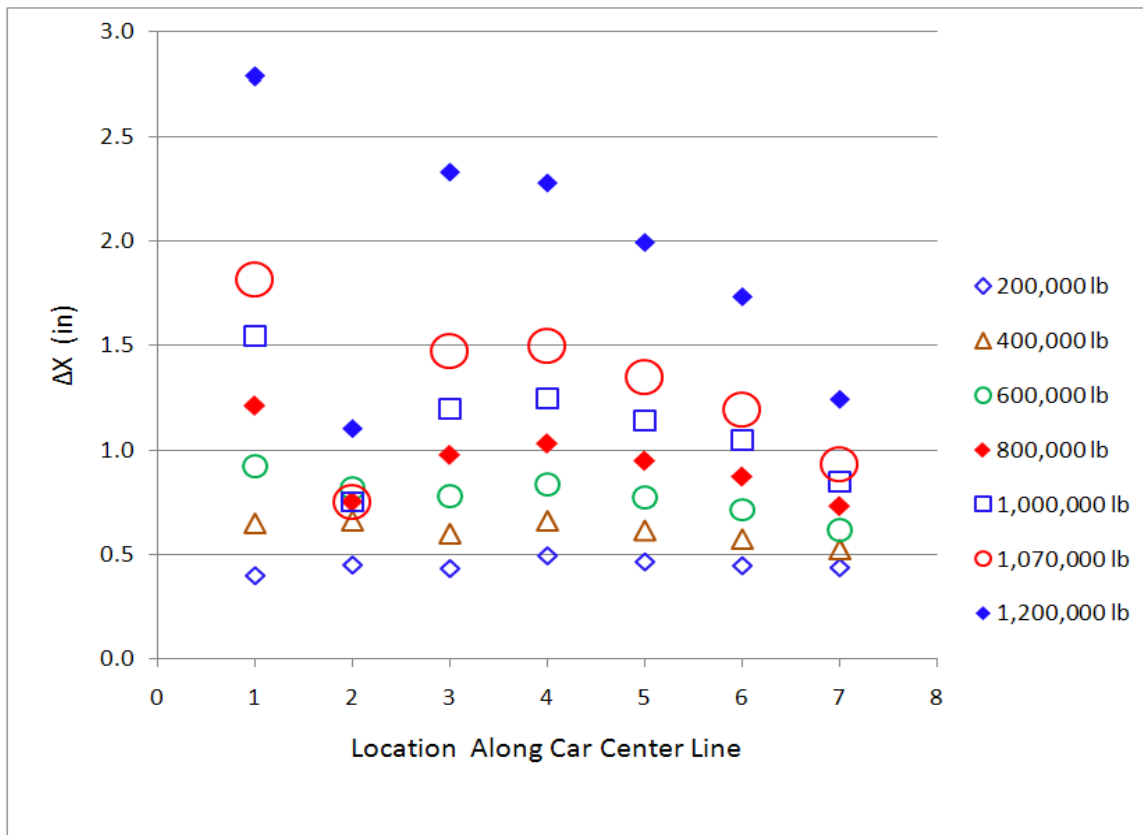
Figure 38. Compressive Displacement along Car Center Line

Figure 38 shows longitudinal movement of several locations on the center sill relative to the ground. The cross-sections where the measuring string potentiometers were located beneath the car are shown in Figure 19. Location 1 is at the loading end, and location 7 is at the reaction end. The center sill at location 2 stopped moving longitudinally relative to the ground at 800,000 lb, whereas the other locations along the center sill continued to move at higher loads. This indicates that under compressive loads Car 244 crippled in close proximity to location 2. Had these measurements been displayed in real time during the test, they could have provided an indication of the major crippling location even before the 800,000-pound load level was reached. The crippling location shown by the test data in Figure 38 contains the physical damage shown in Figure 33 and Figure 34.
