NAR Case Studies

Paul Nony, Ph.D.

CENTER FOR TOXICOLOGY
AND ENVIRONMENTAL HEALTH, LLC

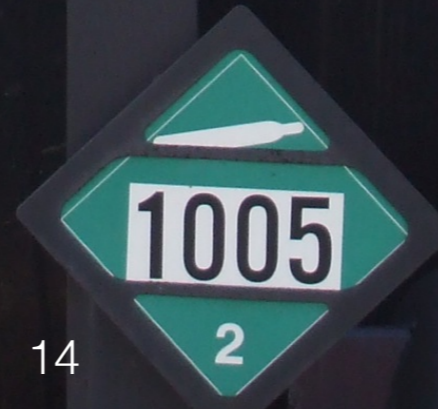
- An anhydrous ammonia rail car experienced a release from the top of the car during transit
- The car was isolated at the El Paso rail yard and inspected
- Ammonia was detected leaking from a valve on top of the car

- The source of the leak was determined to be a valve that was not closed completely
- The valve was closed and the tank car was shipped down the road after the stopped leak was confirmed
