Brunswick Layover Environmental Assessment (EA)

**Appendix G: MaineDEP TMDL Assessment Summary: Unnamed Tributary
to the Androscoggin (near River Rd.)**

TMDL Assessment Summary

Unnamed Tributary to the Androscoggin (near River Rd.)

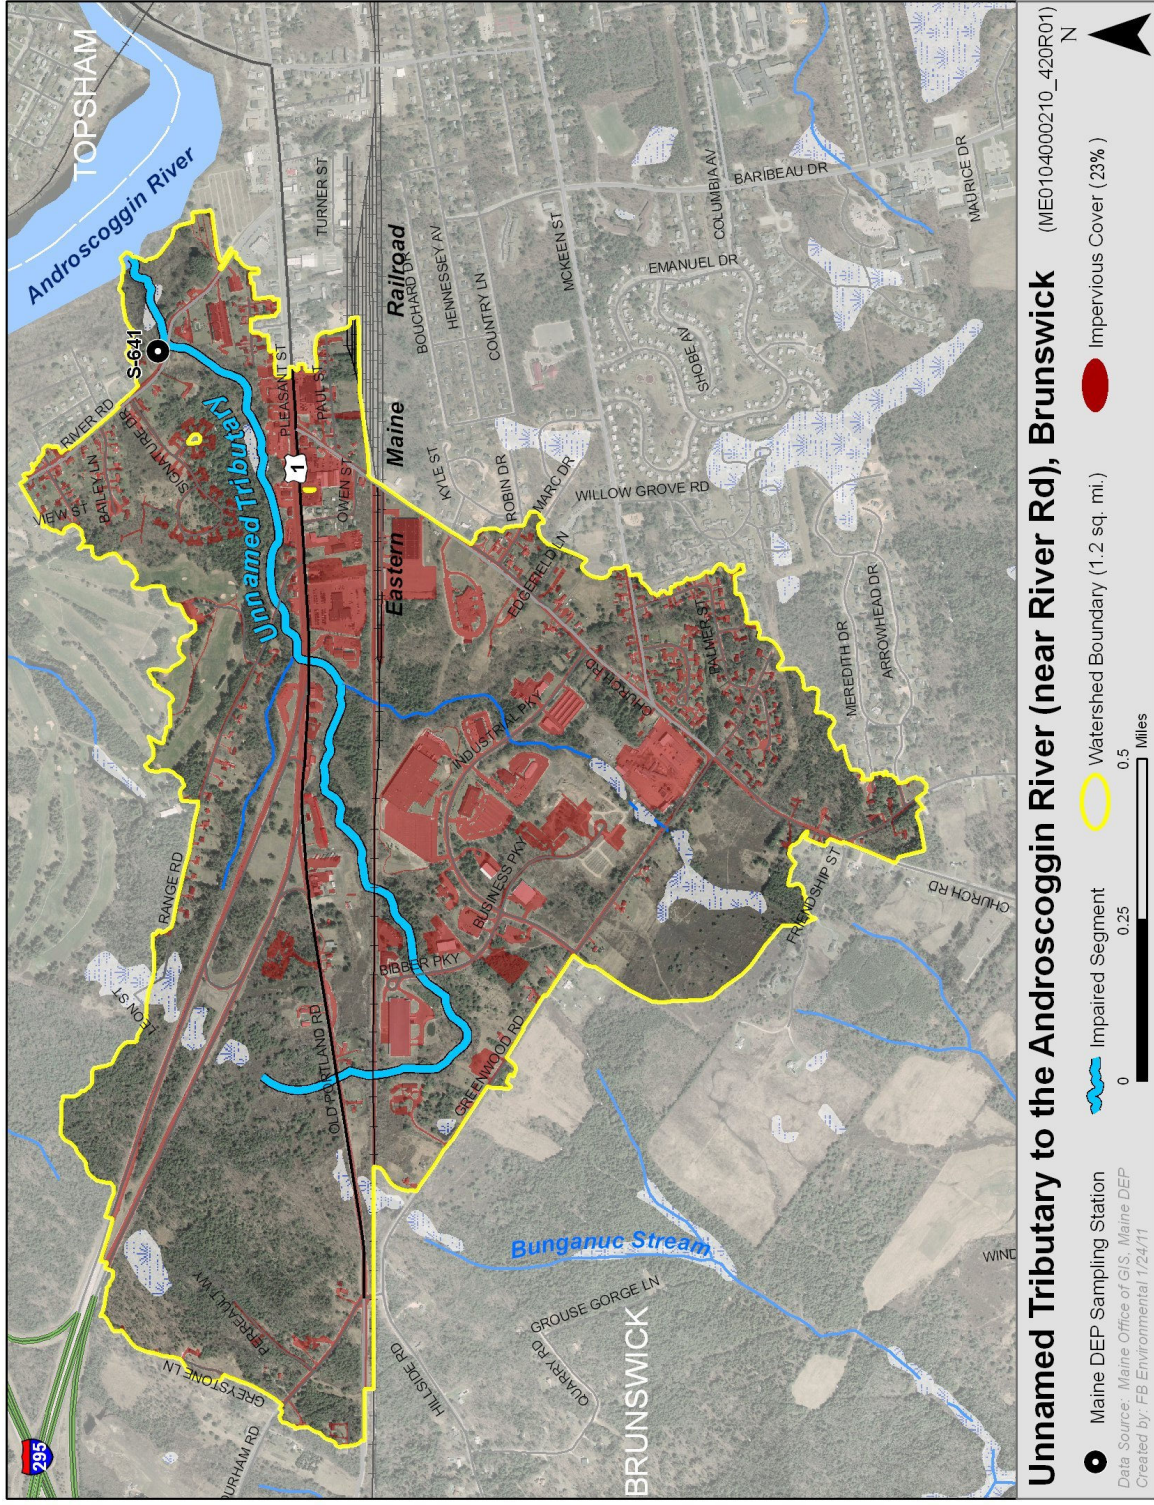
Figure 1: Map of Unnamed Tributary to the Androscoggin River (near River Road) watershed impervious cover.

Unnamed Tributary's impairment is not caused by a single pollutant, %IC is used for this TMDL to represent the mix of pollutants and other impacts associated with excessive stormwater runoff. The Unnamed Tributary watershed has an impervious surface area of **23%** (Figure 1). DEP has found that in order to support Class B aquatic life use, the Unnamed Tributary watershed may require the

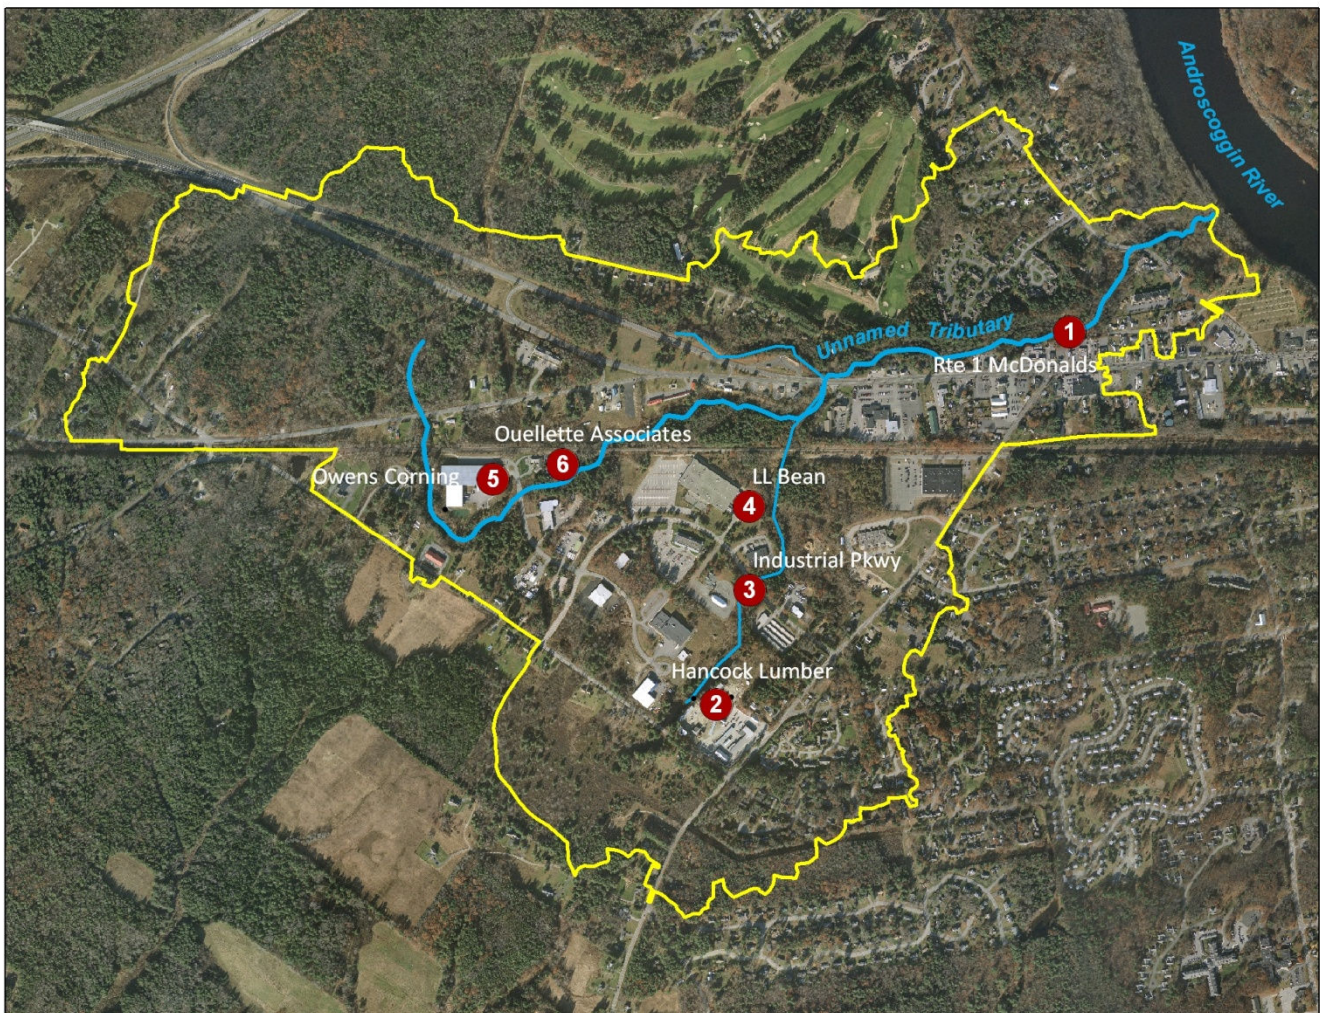
Figure 4: Locations of potential stormwater mitigation sites in the Unnamed Tributary watershed.

Locations of the potential stormwater mitigation sites identified during the reconnaissance survey are shown in Figure 4 below.

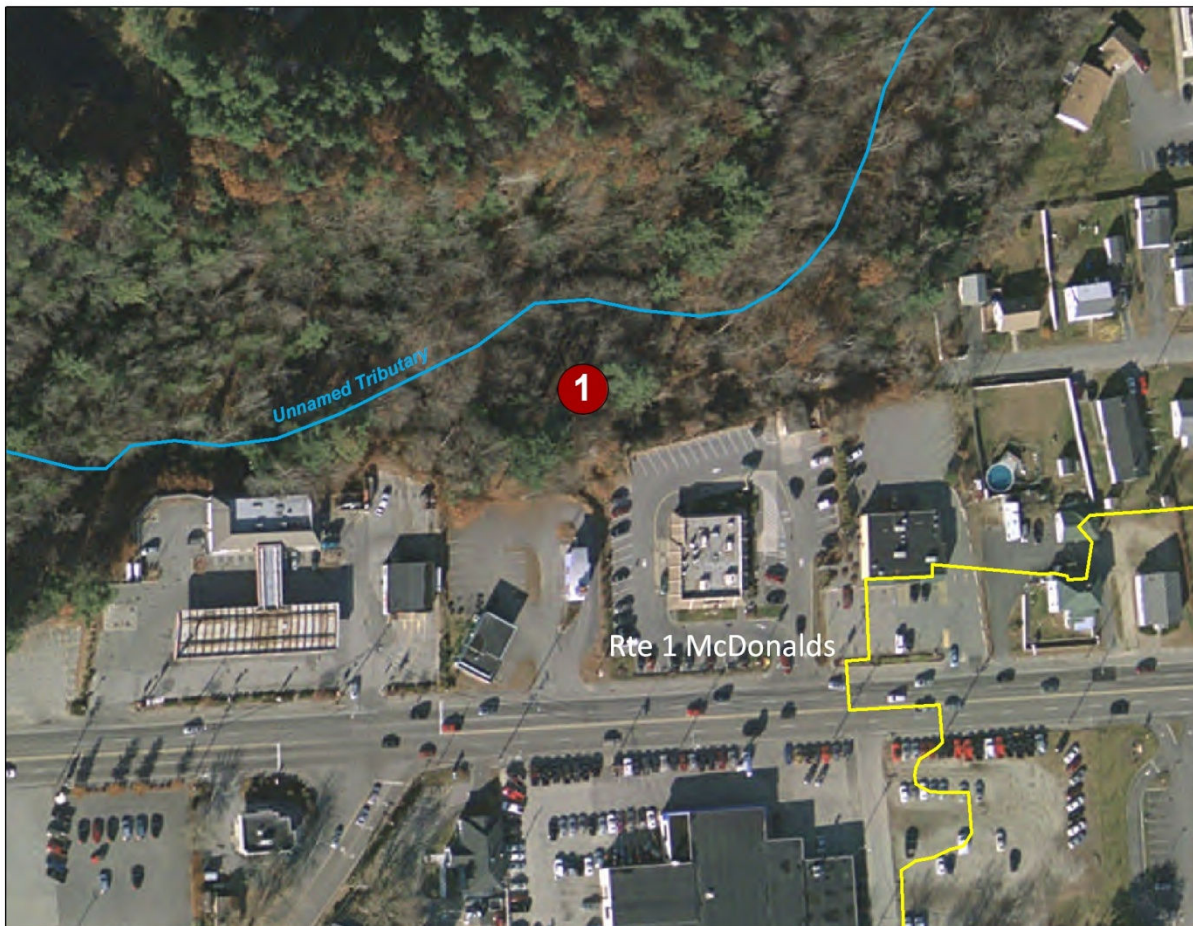
Figure 5: Location of potential stormwater mitigation Site 1 behind McDonalds on Rte 1.

Site 1 is located behind the McDonalds building on Route 1. In this reach, the Unnamed Tributary flows parallel to Route 1. A steep slope behind the businesses along Route 1 leads down to the stream. At Site 1, two large culverts, stacked one above the other, emerge from the steep bank behind the McDonalds building. These culverts appear to be linked to a storm catchment that drains a portion of Route 1 and some of the nearby businesses. Where the culverts emerge from the embankment, slope failure and erosion has resulted in large amounts of soil entering the stream. At the time of the reconnaissance visit, heavily sediment-laden water was flowing under the culverts and directly to the stream in addition to stormwater flowing out of the culverts. Approximately 50 feet to the east of the culverts, a concrete sluiceway appears to drain the McDonald's parking lot. Runoff from the lot flows down the outfall and into the stream untreated.

Along this stream reach, similar steep slopes with embankment erosion were noted behind other businesses as well, in addition to trash and yard waste debris. Thus, this entire reach of river should be evaluated for potential mitigative BMP implementation. Several types of invasive species also grow thickly along the banks, including Japanese knotweed, Japanese barberry, multiflora rose, and bittersweet.

- 1. Retrofit Reconnaissance Inventory (RRI).** An RRI survey of the commercial businesses draining to the outlet at this site would support characterization and reduction of excessive stormwater flow volumes reaching the stream from this location. This type of survey includes a rapid field assessment of potential stormwater storage and on-site retrofit sites in the area. Retrofits provide stormwater treatment in locations where practices previously did not exist or were ineffective, and include modification to existing stormwater practices or construction of new practices. Typical sites that may be investigated for possible retrofitting include culverts, storm drain outfalls, highway rights-of-way, open spaces, parking lots, and existing detention ponds.

- 2. Rock rip-rap and native vegetation.** Stabilizing bare soil on the steep slopes surrounding the culverts at Site 6 with stone rip-rap and native vegetation would help to reduce impacts to water quality at the site. Riprap is a permanent, erosion-resistant ground cover constructed of large, loose, angular or rounded stone. Its purpose is protecting the soil surface from the erosive forces of concentrated runoff; to slow the velocity of concentrated runoff while enhancing the potential for infiltration; and to stabilize steep slopes. It should be used in combination with native vegetation plantings to shade the stone and protect against increasing stream temperature.

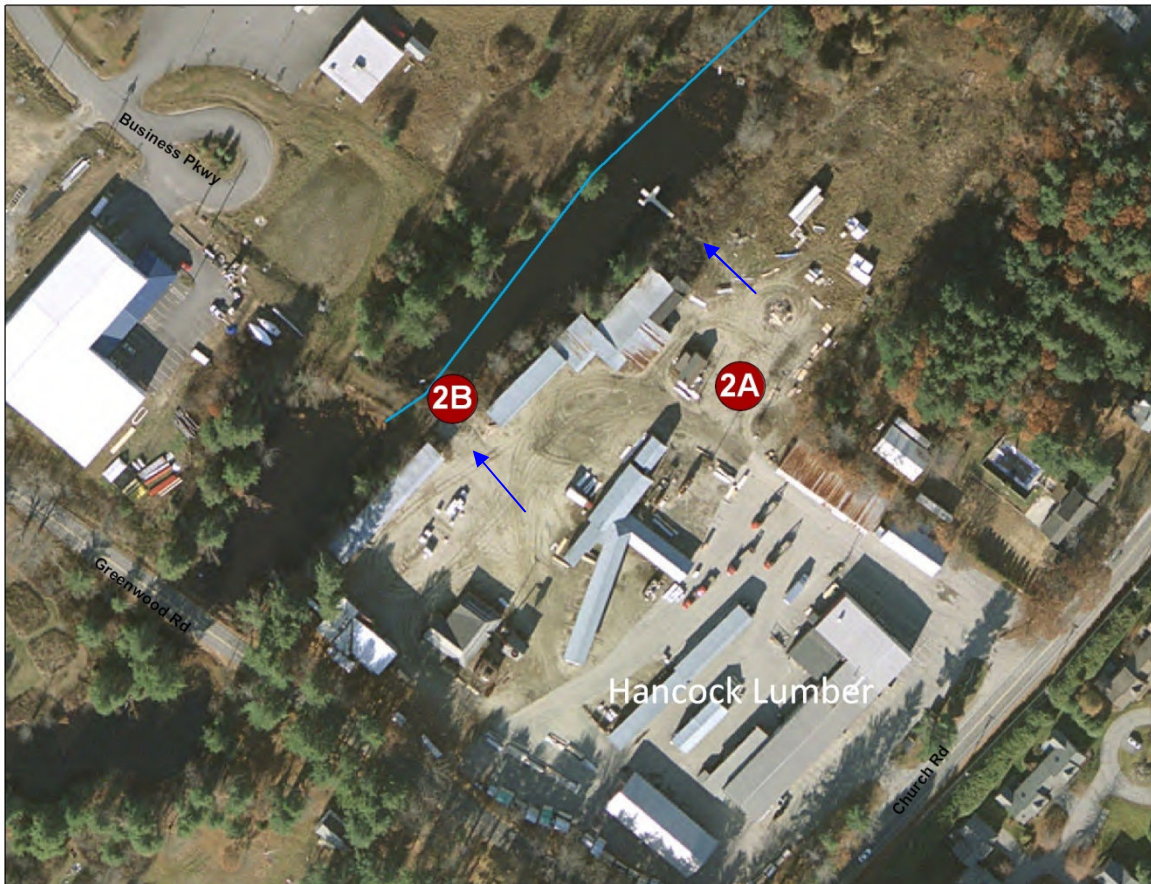
Figure 6: Location of potential stormwater mitigation Site 2 at Hancock Lumber off Church Rd. Blue arrows indicate direction of direct flow to stream.

Site 2 is located at the Hancock Lumber property off of Church Road (Figure 6). The property is situated adjacent to the headwaters of the small stream that flows into the Unnamed Tributary, and consists of a main building and paved parking area in front and a large unpaved lot with several small outbuildings in back.

- **Site 2A:** On the northeastern side of the property, a large portion of the unpaved lot drains into a storm drain which outlets into the nearby stream. Because the soil around the drain is not stabilized, sediment and debris flow freely into the drain and the stream. Nearby, overland flow from the portions of the unpaved lot drains directly to the stream, which has little to no vegetated buffer to help filter sediment.
- **Site 2B:** On the northwestern side of the property, overland flow from the unpaved lot and roof runoff drains directly to the stream. Large pieces of trash were also noted in the stream nearby.

4. **Redirect flow.** Stormwater flowing directly from roofs and unpaved parking lots should be redirected and hydrologically disconnected from the stream. This could be accomplished by regraded to direct stormwater flow away from the stream to a grassed swale or infiltration gallery.

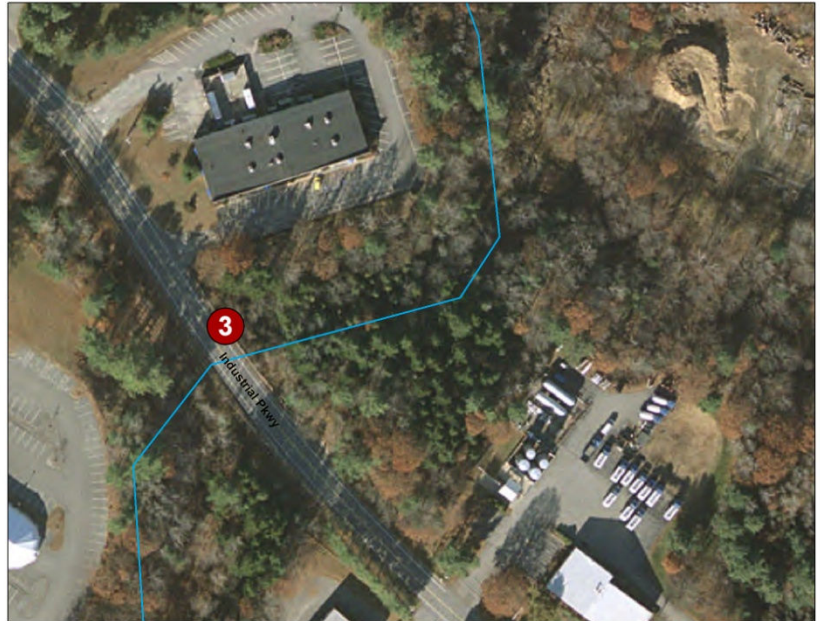
Figure 7: Location of potential stormwater mitigation Site 3 near 4 Industrial Parkway.

Site 3 is located on Industrial Parkway, just south of the property at 4 Industrial Parkway (Figure 7). As shown in the photographs below, a curb cut leads to a ~15 foot long metal half-culvert at this site. Runoff from the roadway and adjacent commercial building flows down the culvert and directly to a stream. The invasive Japanese knotweed was also noted at the site.

1. Rock rip-rap and native vegetation. Replacing the metal culvert at Site 3 with a channel of rock rip-rap interspersed with native vegetation would help to slow water flow and filter sediments. Riprap is a permanent, erosion-resistant ground cover constructed of large, loose, angular or rounded stone. Its purpose is protecting the soil surface from the erosive forces of concentrated runoff; to slow the velocity of concentrated runoff while enhancing the potential for infiltration; and to stabilize steep slopes. It should be used in combination with native vegetation plantings to shade the stone and protect against increasing stream temperature.

2. Plunge pool. A plunge pool at the channel outlet would allow the dissipation of energy filtration of sediment before water enters the stream.

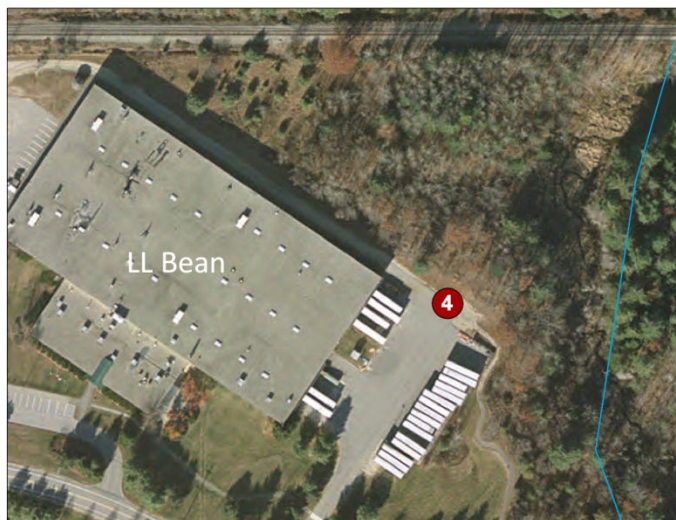
Figure 8: Location of potential stormwater mitigation Site 4 at LL Bean off Industrial Pkwy.

Site 4 is located at the LL Bean warehouse off Industrial Parkway in the central part of the watershed (Figure 8). The property is located adjacent to a small stream that flows into the Unnamed Tributary (Figure 8). Although much of the stormwater runoff from this property is directed to a stormwater detention pond, the existing treatment does not capture all of the stormwater on the property. Specifically, some of the stormwater drains to the northeast corner of the property. Here, stormwater flows across an area of bare soil and down an eroding channel that leads directly to the stream. Additionally, an uncovered dumpster was noted at the northeast corner of the building. Runoff from the dumpster was noticed nearby.

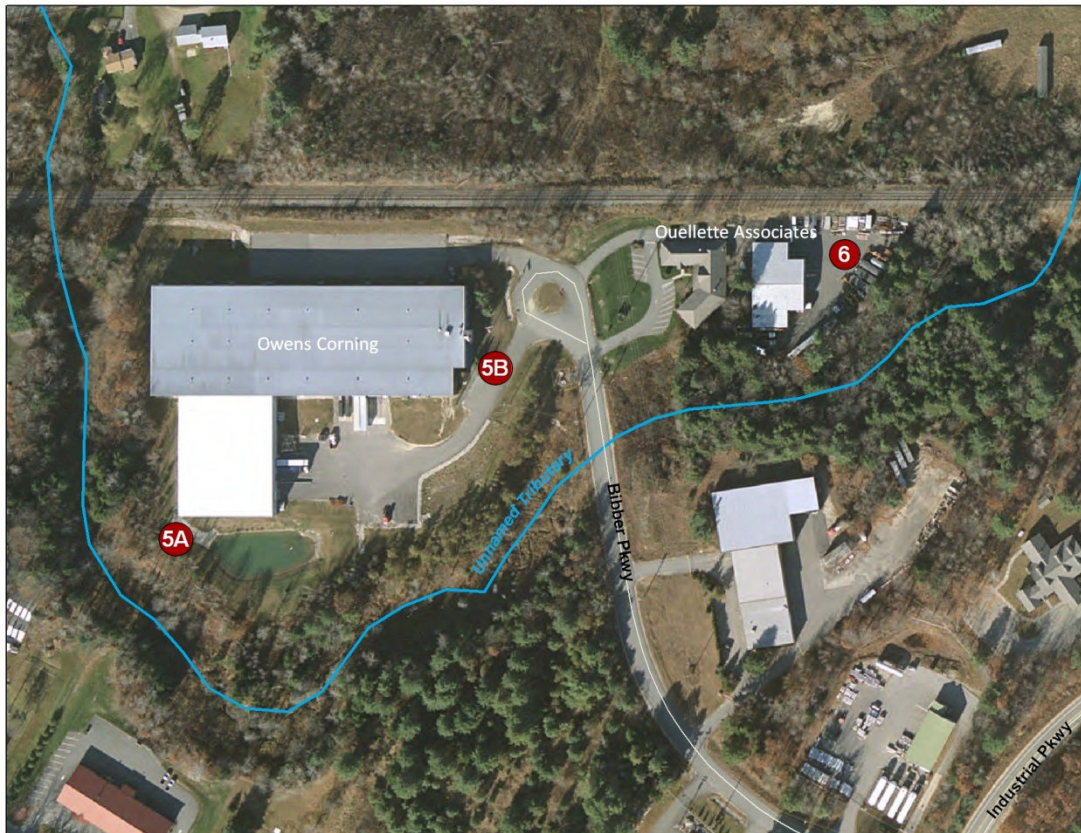
Figure 9: Locations of potential stormwater mitigation Sites 5A, 5B and 6 off of Bibber Parkway.

At Site 5, the Unnamed Tributary flows around the Owens Corning building off of Bibber Parkway (Figure 9). During rainstorms, large amounts of rainwater flow off the roof and pavement at the Owens Corning property. Most of this stormwater runoff is directed to treatment systems such as a large stormwater detention pond and rock-lined ditches. However, two locations on the property were noted as having either inadequate or non-existent stormwater treatment in place.

- **Site 5A:** On the back side of the Owen’s Corning building, a large volume of water flows off the roof during rain storms. A rock lined swale on the back side of the building directs some of the flow to a stormwater detention pond. However, during the reconnaissance visit, it was noted that instead of being filtered through the rock swale, some of the rainwater pools nearby, creating an erosive channel that flows into the woods above the stream rather than flowing into the detention basin. This problem seems to be due to inadequate maintenance of the treatment system.

- **Site 5B:** On the front side of the building, flow from a building drainage pipe has created an eroding channel that flows down the driveway and eventually into a grass-lined ditch that is also eroding. Water from this ditch then flows past the Bibber Parkway pump station, and sediment-laden water flows directly to the stream.

Infiltration systems in particular should be inspected several times in the first year of operation and at least annually thereafter. Conduct the inspections after large storms to check for surface ponding near the inlet that may indicate clogging (e.g. Site 5A).

4. **Redirect flow.** Stormwater flowing directly from roofs and parking lots should be redirected and hydrologically disconnected from the stream. This could be accomplished by regraded to direct stormwater flow away from the stream to a grassed swale, infiltration gallery or rain garden.
