U.S. Department of  
Transportation  
**Federal Railroad  
Administration**

## Alternative Occupied Volume Integrity (OVI) Tests and Analyses

1. AGENCY USE ONLY (Leave blank)		2. REPORT DATE October 2013		3. REPORT TYPE AND DATES COVERED	
4. TITLE AND SUBTITLE Alternative Occupied Volume Integrity (OVI) Testing and Analyses				5. FUNDING NUMBERS RR28A1/JG343 RR28A2/JL649 RR28A2/KL649

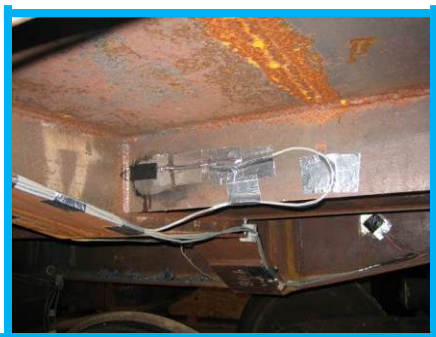
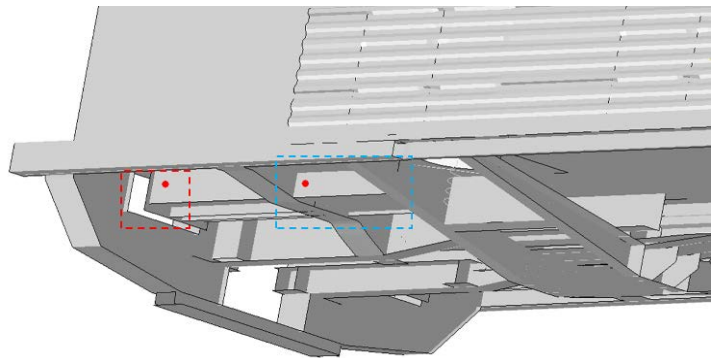
**Figure 38. Strain Gages at Floor-Level Energy Absorber Support**

At the floor-level, two strain gages were added to each of the four energy absorber supports, for a total of eight floor-level strain gages. The first location instrumented at each support is on the longitudinal channel supporting the lateral face where the load was applied. The second location instrumented with a strain gage at each floor-level support was on the longitudinal channel inboard of the first lateral member of the car. The strain gages at a floor-level energy absorber support are shown in Figure 38.

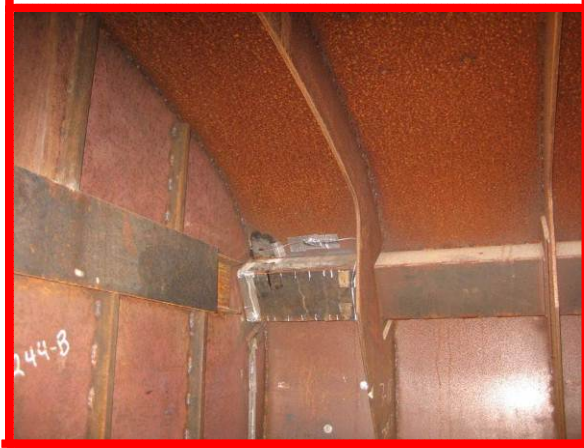
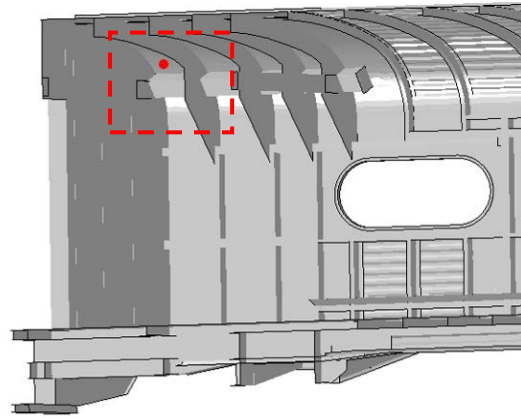
**Figure 39. Strain Gage at Roof-Level Energy Absorber Support**

Strain gages were also placed at the roof energy absorber support location. The roof support consists of a longitudinal tube that passes through the bulkhead of the car and is attached to the roof structure within the occupant volume of the car. One additional strain gage was placed on the interior of the car's roof just inboard of the bulkhead at each roof loading or restraint location. A typical location is shown in Figure 39.

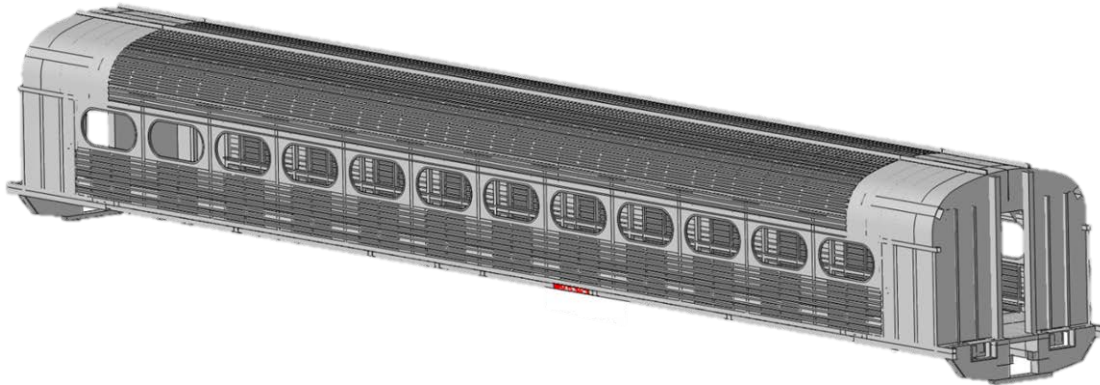
**Figure 40. FE Model Used in Crippling Analysis**

The FE model for the 800-kip buff strength test was used as a starting point for the crippling model. Because the endframes and CEM components were removed from the Pioneer cars prior to the crippling tests, these structures were removed from the FE model as well. The section thickness and plastic stress-strain behavior assigned to the center sill and the plastic stress-strain behavior assigned to the side sills were adjusted to reflect the properties used in the original Pioneer car FE model. Additionally, because the lateral-vertical symmetry used in the 800-kip model could suppress a potential lateral buckling mode in the crippling model, the existing structure was mirrored to create a full-car model. The full-car model contained a total of 381,700 elements. This model is shown in Figure 40.

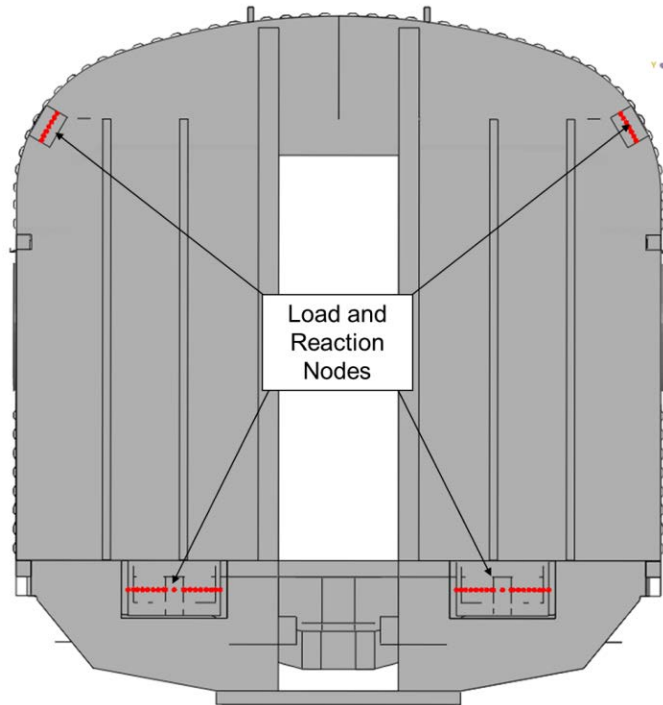
**Figure 41. Load and Reaction Nodes, Crippling test FE Model**

a single row of nodes at each load area was selected, each load application or restraint location was free to rotate as a result of this boundary condition. At the rear end of the car, corresponding rows of nodes were selected at each restraint location and were restricted from longitudinal motion. The nodes to which the boundary condition was applied are shown in Figure 41 for one end of the FE model.

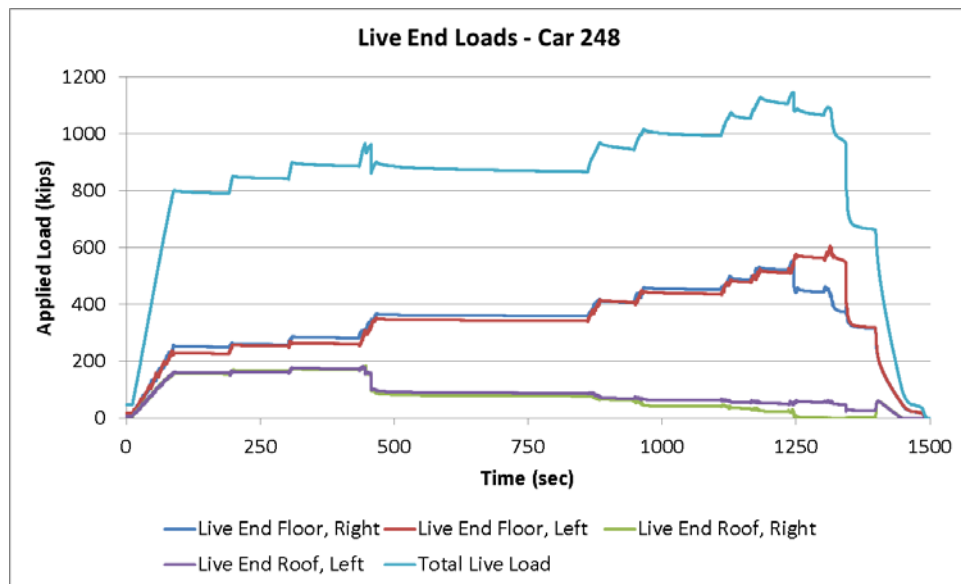
**Figure 42. Live End Loads versus Time, Car 248 Crippling Test**

The limited-instrumentation shakedown test of car 248 was performed at TTC on June 15, 2011. An initial longitudinal load was used to settle the car within the test frame. The car was then loaded in 200-kip increments, with a return to a nominal load of approximately 20 kips between increments. Once a load of 800 kips was reached, the load was not actively removed between loading increments. The load was paused at 800 kips to permit the data recorded up to that point to be reviewed. Loading increased beyond 800 kips until the roof buckled, at which point the test was paused to permit inspection of the data collected and photographs of the car to be taken. Loading then resumed until crippling was reached. The load versus time data from the four live end load cells are plotted in Figure 42 for the final load increment, from the nominal load to 800 kips, and then up to crippling. This figure also includes the sum of the four load cell measurements plotted against time.

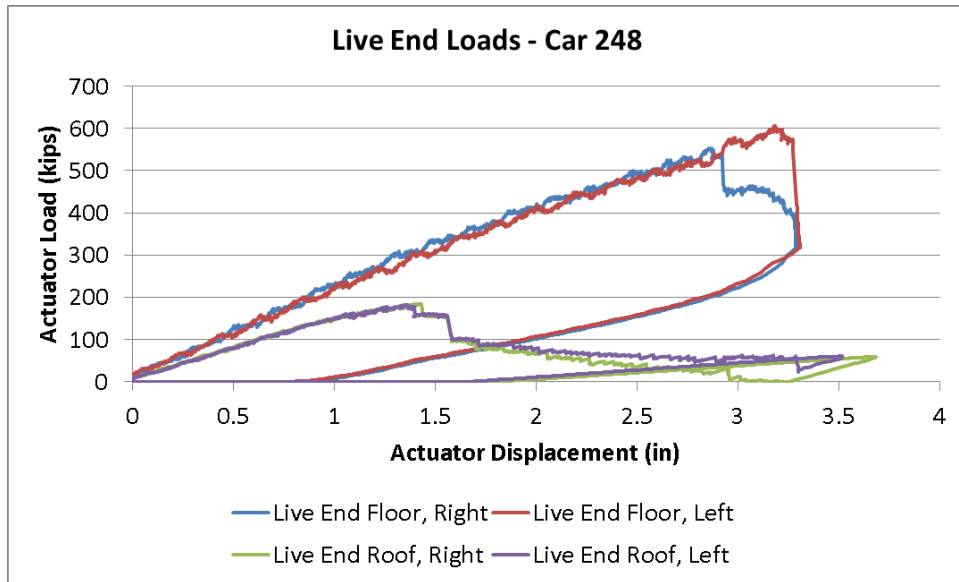
**Figure 43. Live End Loads and Displacements, Car 248**

The load from each individual load cell is plotted against the corresponding actuator displacement in Figure 43 for the load cells at the live end of the car. As seen in this figure, the two load cells at the roof recorded very similar load-displacement characteristics. The roof's stiffness was approximately the same for both the left and right sides, and both sides reached nearly identical peak loads. The right load cell recorded a peak load of 185 kips, and the left load cell recorded a peak load of 183 kips.

At the floor-level, both load cells recorded similar load-displacement characteristics. There is a larger variance in peak load between the floor-level load cells than was seen at the roof-level. The right load cell recorded a peak load of 554 kips, and the left recorded a peak load of 607 kips. The left side load begins to decrease at a smaller displacement than the load on the right side. This behavior may be an indication of the left side sill crippling before the right side sill. Because of the limited instrumentation employed in the test of Car 248, additional information on the progression of damage to the carbody is not available.

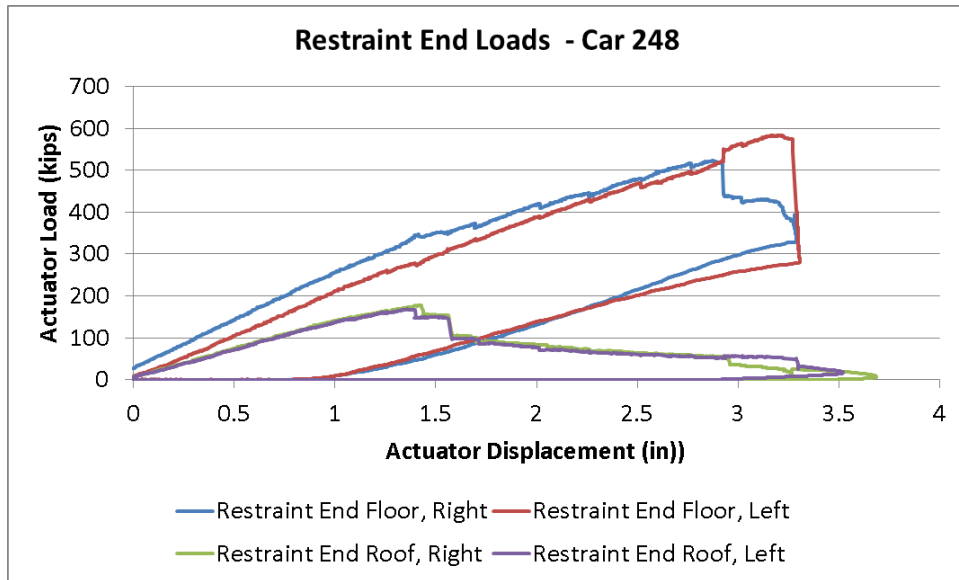
**Figure 44. Restraint End Loads and Displacements, Car 248**

The loads in the individual load cells at the restraint end of the car are plotted in Figure 44 against the displacement of the corresponding actuator on the live end. The roof-level data are nearly identical for the left- and right-side load cells, as it was at the front end of the car. At the floor-level, the left and right side data have more variance than at the front end. The left-side load cell records a higher load at zero displacement than the load cell at the right. However, even with this offset taken into account, the right side load does not reach the same level as the left side load at the floor.

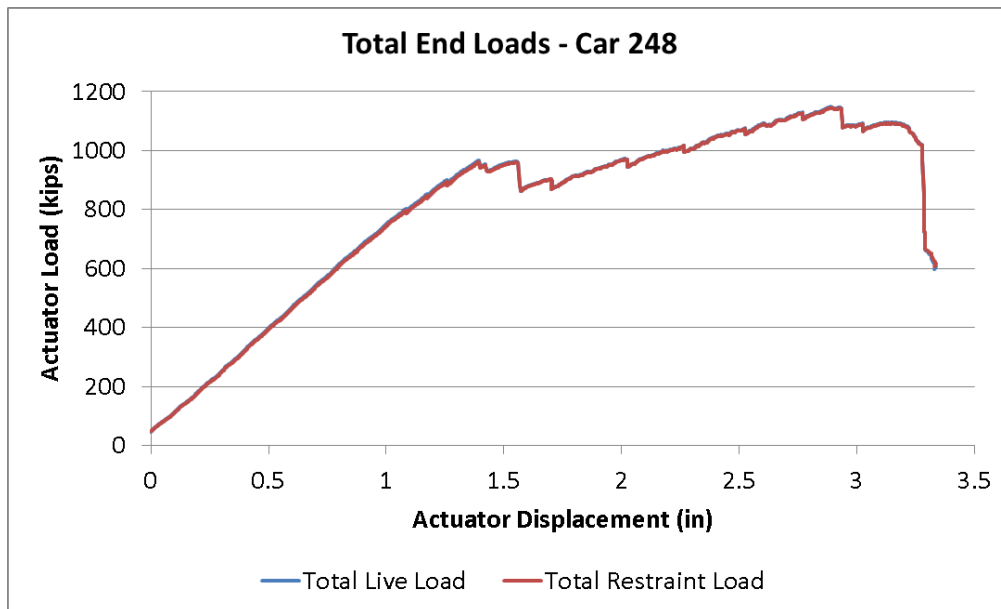
**Figure 45. Total End Loads for Car 248 Shakedown Test**

The total applied load and total restraining load are obtained by summing the four load cell measurements at each respective end of the car. The total applied load and total restraint load are plotted against the average live end actuator displacement in Figure 45. These two values are in excellent agreement with each other. This indicates that the test is being conducted in a quasi-static manner, free from dynamic effects, and that the full load applied to the front end of the car is exiting the structure through the rear restraints. The load does not appear to be exiting the car through any uninstrumented locations or “short-circuits” in the load path.

The load-displacement response is approximately linear to above 800 kips. At a total load of approximately 950 kips, the roof structure begins to buckle and the total load decreases. Because

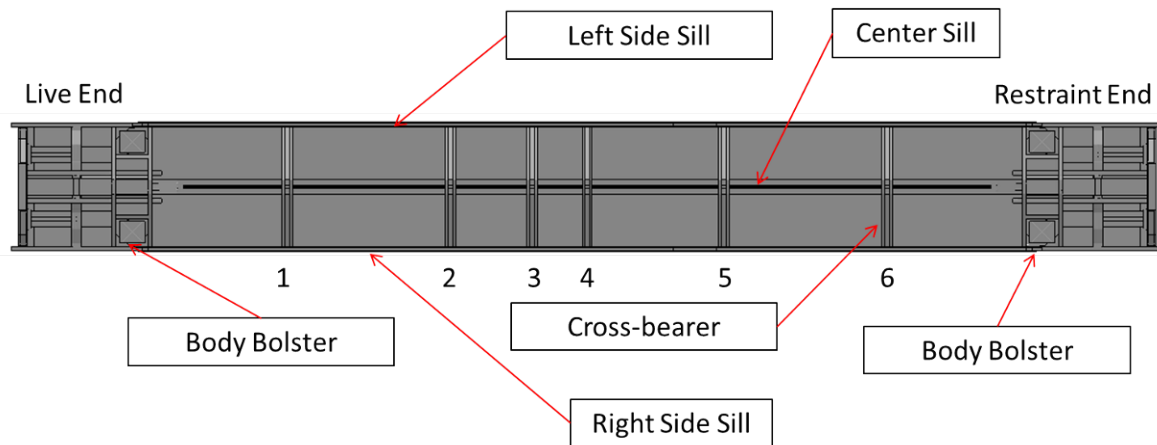
**Figure 46. Annotated Underframe for Pioneer Cars**

The underframe of the car consists of three major longitudinal structural members: the center sill and the left and right side sills. These three members are attached by two types of lateral members: the body bolsters and cross-bearers. The body bolsters are located at the ends of the occupied volume and attach the trucks to the car body. A total of six cross-bearers are located at irregular intervals between the two bolsters. An underframe view of Pioneer 248, taken from the FE model of the car, is shown in Figure 46 with these structural members indicated.

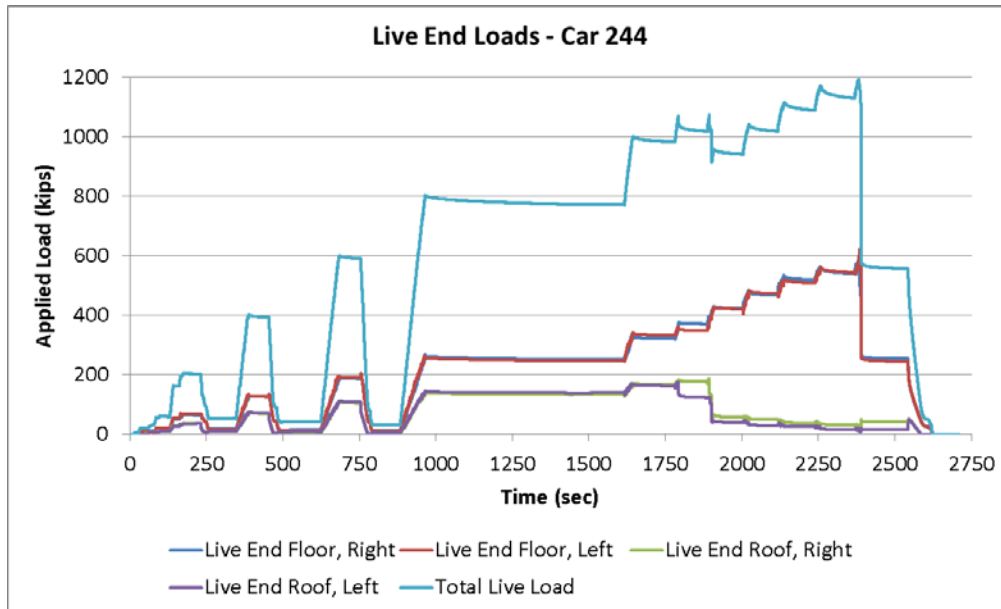
**Figure 54. Live End Loads, Car 244 Crippling Test**

The loading procedures used in the test of Car 244 were similar to the procedures used on Car 248. In both tests, the car was secured within the frame by a small longitudinal load. The car was then loaded in 200-kip increments, with a return to a nominal load of approximately 20 kips between increments. Once a load of 800 kips was reached, the load was not actively reduced between increments. The actuators were pushed forward in 0.25-inch increments and then paused to allow the structure to settle. This approach was followed until crippling occurred. The individual live end loads and the total live end load are plotted against time in Figure 54 for the full sequence of loads.

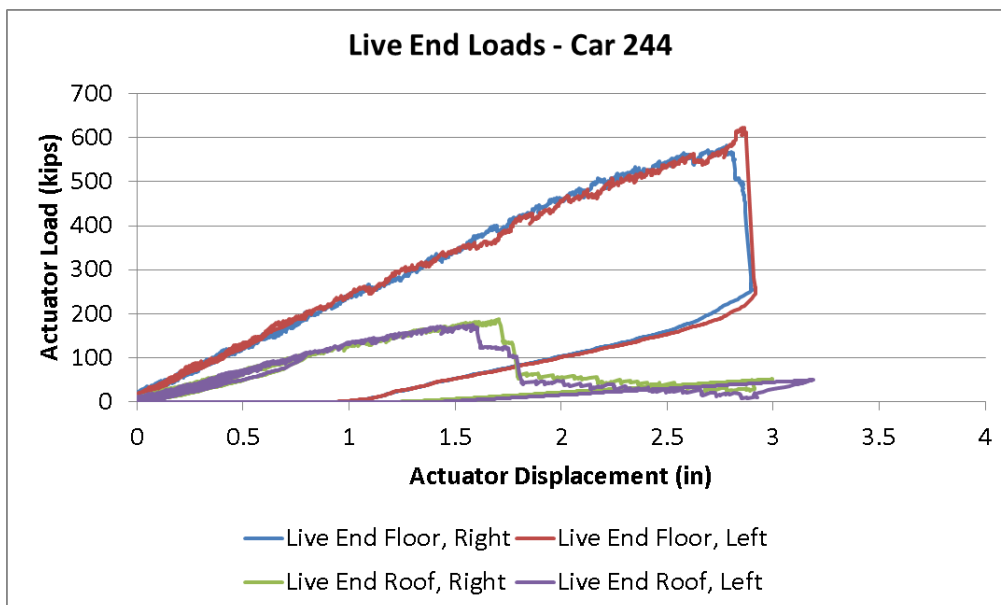
**Figure 55. Live End Loads and Displacements (Car 244 Crippling Test)**

The loads measured by each of the four live end load cells are plotted against the displacement of each hydraulic actuator in Figure 55. The load cell names and locations for the test of Car 244 are the same as were used for Car 248, as shown in Table 7. Both of the floor-level load cells recorded approximately the same load-displacement characteristic, with the left-side load cell measuring a slightly higher peak load than the right-side. The two roof load cells also recorded very similar load levels. The right load cell measured a slightly higher peak load than the left.

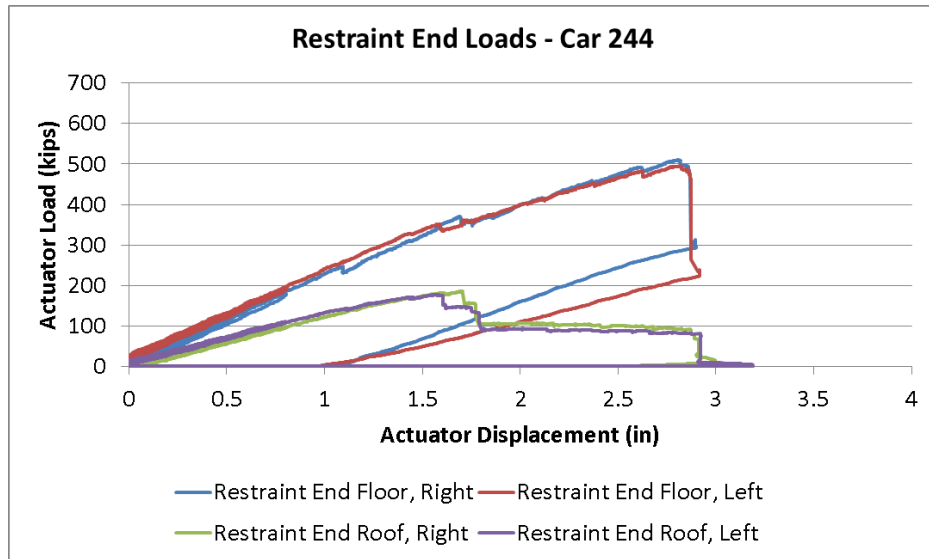
**Figure 56. Restraint End Loads and Displacements (Car 244 Crippling Test)**

The load at each restraint location is plotted against actuator displacement for the corresponding location on the live end for the four restraint end load cells in Figure 56. At both the floor and roof restraint locations, the left and right side loads are roughly equal. Comparing the loads at a

given displacement between the restraint end (Figure 56) and the live end (Figure 55), it is apparent that some portion of the load that is introduced to the car through the floor at the live end is being reacted through the roof at the restraint end of the car. The peak load in each floor location on the live end is approximately 600 kips, while the peak load in each floor location on the restraint end is slightly greater than 500 kips.

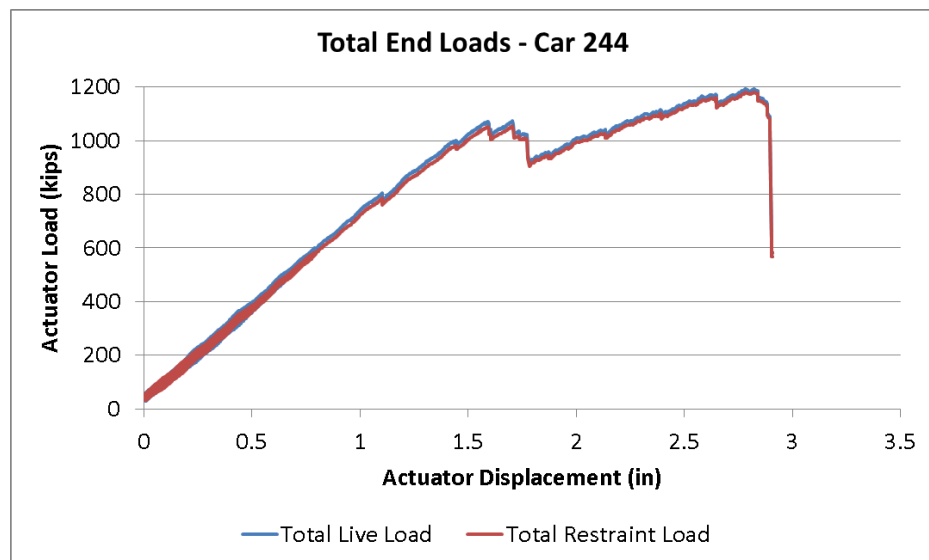
**Figure 57. Total End Loads for Car 244 Crippling Test**

In Figure 57, the total applied load on the live end of the car and the total reaction load from the restraint end of the car are plotted against the average displacement of the actuators on the live end. The live end and restraint end loads are approximately equal throughout the entire test. This verifies that the test is being run in a quasi-static manner, free from dynamic effects. Additionally, this result indicates that the longitudinal load is entering and exiting the car through the load cells without experiencing losses through any noninstrumented load paths.

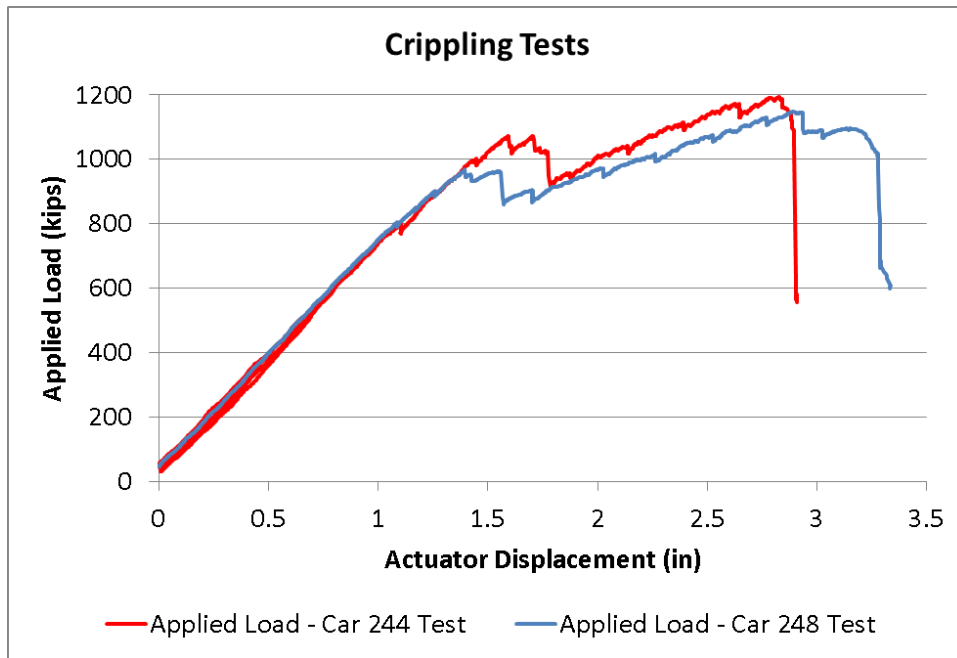
**Figure 58. Load-Displacement Behavior for Car 248 and Car 244**

The results from the crippling test of Car 244 are similar to the results from Car 248. The live end load versus actuator displacement from each car is plotted in Figure 58. In both cars, the roof structure buckles at a load of approximately 1 million pounds. In Car 248, the actual buckling load is slightly below 1 million pounds and in Car 244 this load is slightly above 1 million pounds. Because the underframe structure has not been compromised at the roof buckling load in either car, as the displacement continues to increase, the load is able to increase as well. Car 248 had a crippling load of 1.15 million pounds and Car 244 had a crippling load of more than 1.19 million pounds.

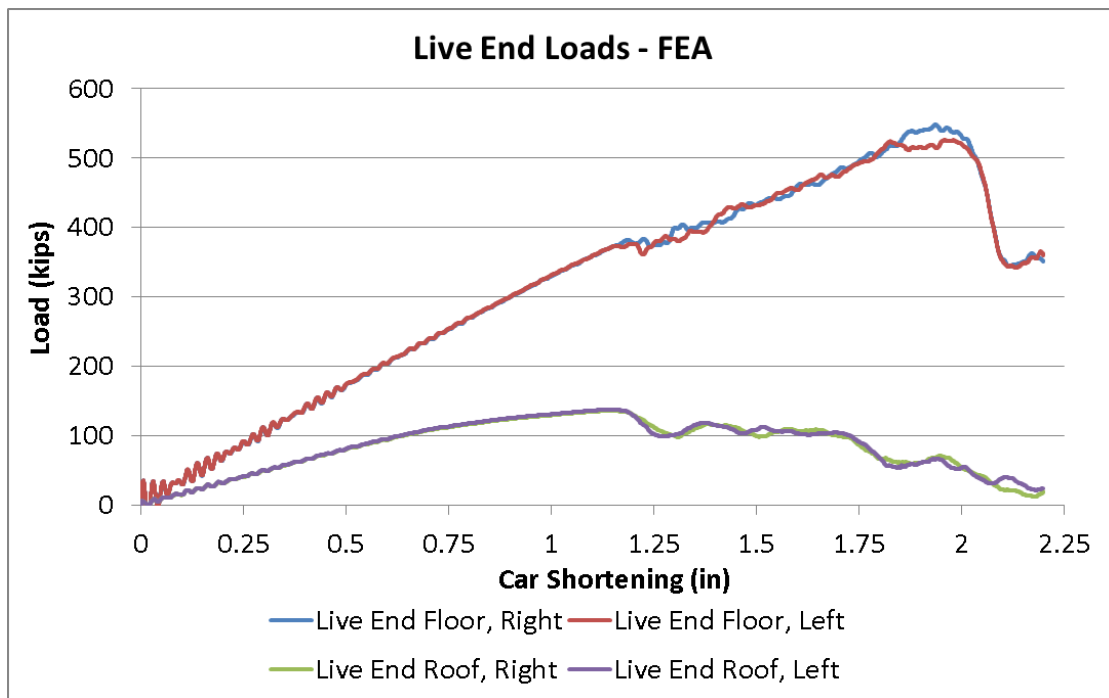
**Figure 67. Live End Loads by Location (Crippling FEA)**

Load versus displacement data were obtained independently for each loaded location on the live end of the car in the crippling analysis. Figure 67 shows the load-displacement behavior calculated by the FE analysis for each of the four live end load locations. In this figure, the horizontal axis represents the total shortening of the car.

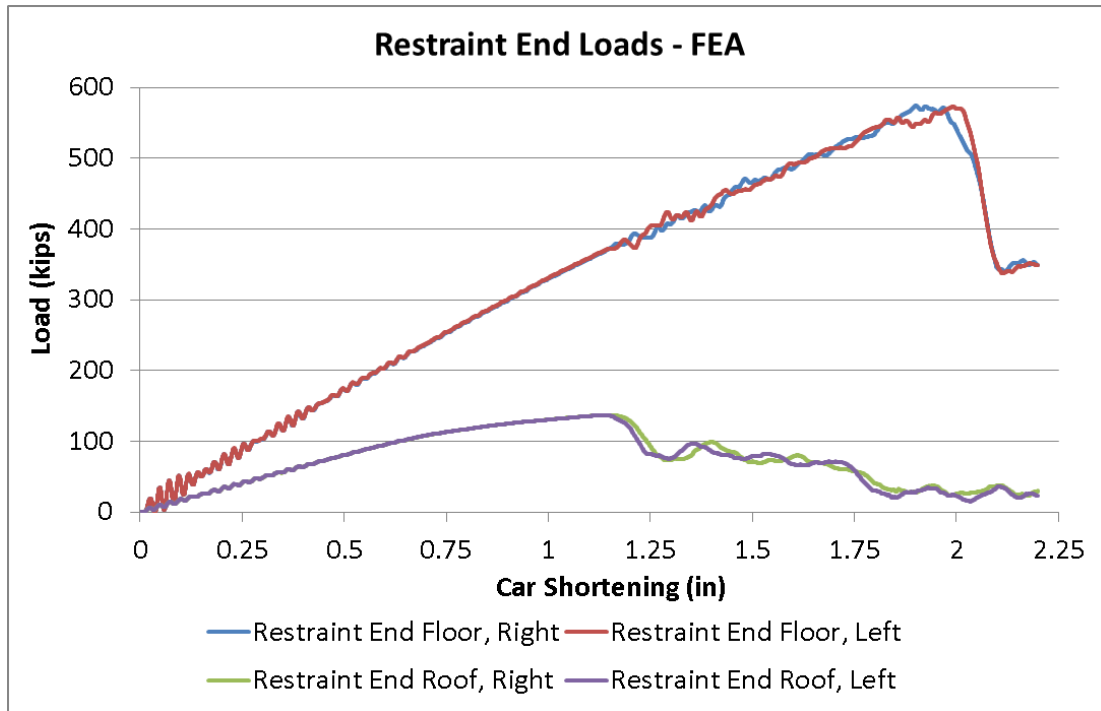
**Figure 68. Restraint End Loads by Location (Crippling FEA)**

A corresponding set of load versus displacement characteristics were generated for the restraint end of the car. These four characteristics are shown in Figure 68. Figure 67 and Figure 68 indicate that the load being reacted and the load being introduced into the car at the corresponding live end location are approximately the same. These results show the same qualitative behavior as was seen in the crippling tests of Cars 248 and 244.

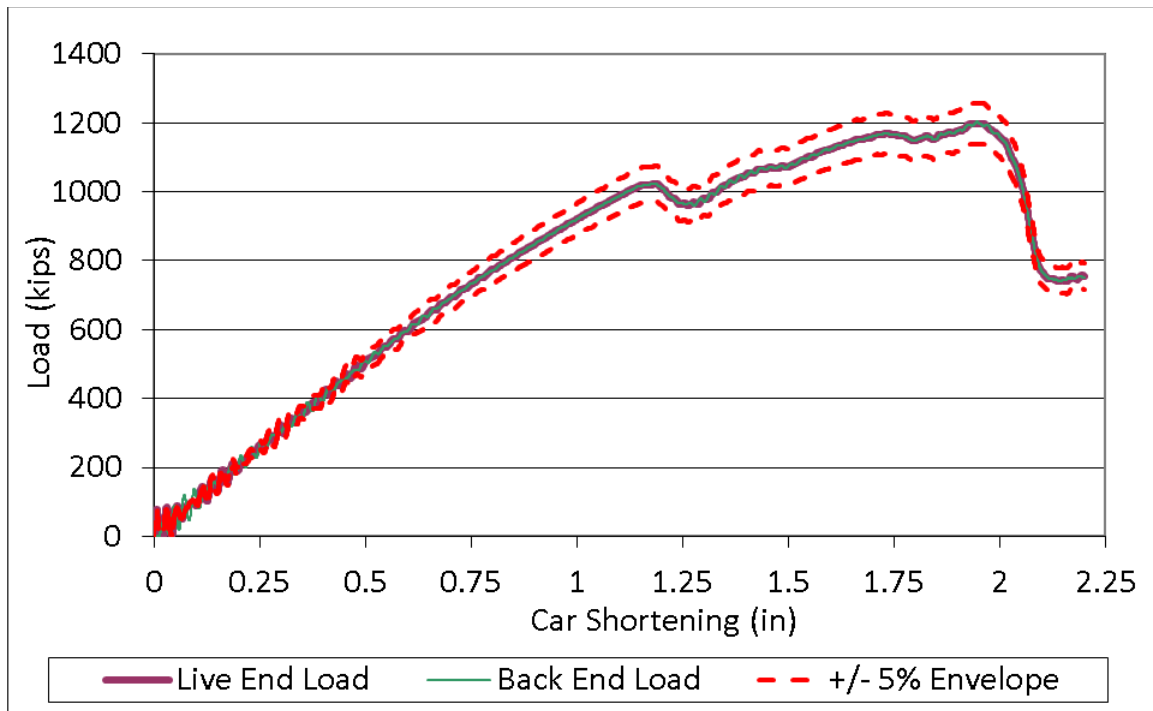
**Figure 69. Live Load and Reaction Load for Crippling Analysis**

For the purpose of applying the quasi-static condition, the four loads applied to the live end are added together and plotted versus the displacement of the live end. The four loads at the back end are also summed and plotted against the displacement of the live end. Because the restraint

end in the model cannot move, the live end displacement is the same measurement as the shortening of the car. A +/-5 percent envelope on the live end force is plotted alongside the two load-displacement characteristics in Figure 69.

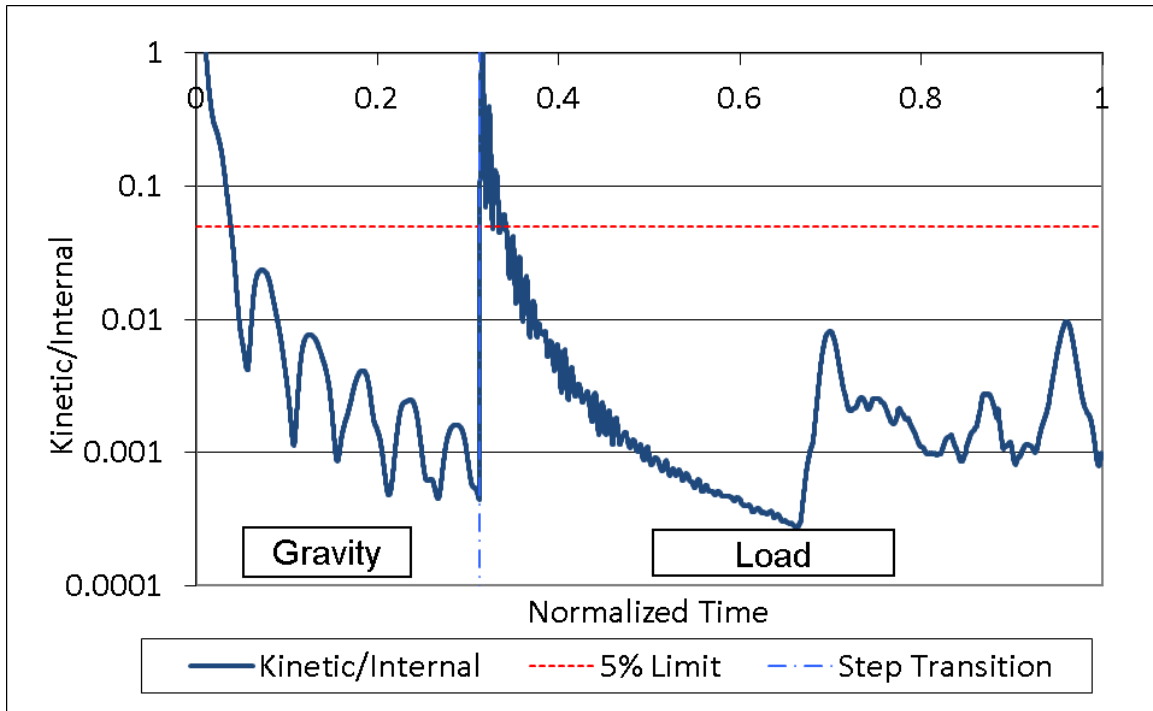
**Figure 70. Ratio of Kinetic Energy to Internal Energy for Crippling Analysis**

The ratio of kinetic energy to internal energy for the crippling simulation is plotted in Figure 70. The simulation consisted of two steps: a gravity step and a compression load step. The transition between the two steps is indicated by a dashed vertical line in this figure. The energy ratio is plotted on a logarithmic scale because this quantity varies over several orders of magnitude during the course of the simulation.

Figure 70 shows that the ratio of kinetic energy to internal energy is well below 5 percent for nearly the entire length of the simulation, except for the initial portion of each step. Based upon either of the ETF criteria, the crippling analysis can be considered quasi-static.

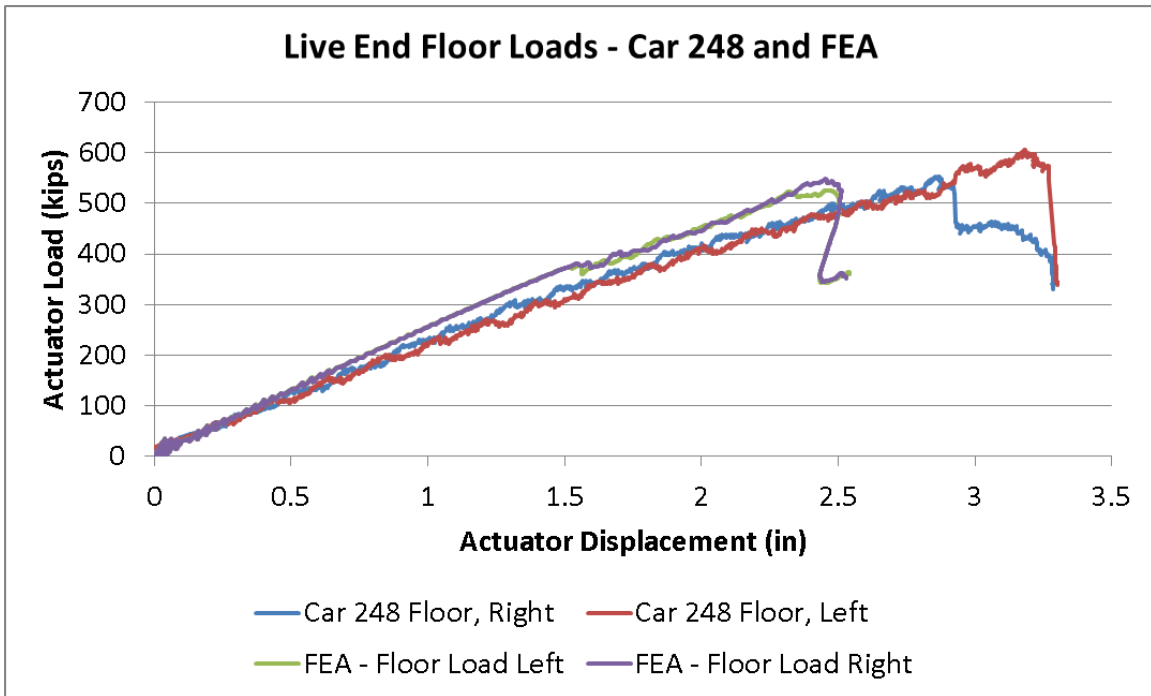
**Figure 71. Live Load at Floor for Test of Car 248 and FE Model**

Figure 71 plots the load in the floor-level energy absorber supports in the test and the loads in the corresponding energy absorber supports in the FE model. There is generally good agreement between the floor-level load data from the test and the floor-level response of the FE model. The FE model is slightly stiffer than Car 248. The load through the left floor energy absorber support in the model reaches a maximum load of 525 kips, and the load on the right floor energy absorber reaches a maximum load of 550 kips.

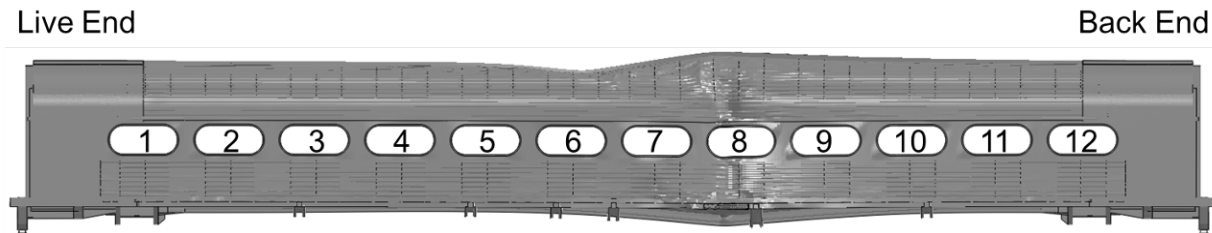
**Figure 78. Deformed Shape of Crippled Car in FEA**

In the FEA results the car first experiences buckling of the roof and sidewall structures. As seen in Figure 78, the roof buckle is a fairly long wavelength buckle, spanning from the sixth window to the eighth window. While buckling initiated at the roof and sidewalls, the underframe continued to carry load until the center sill reached its crippling load. In the FEA, the center sill buckled beneath the eighth window. The center sill also experienced a fairly gradual buckling, as can be seen in Figure 78.

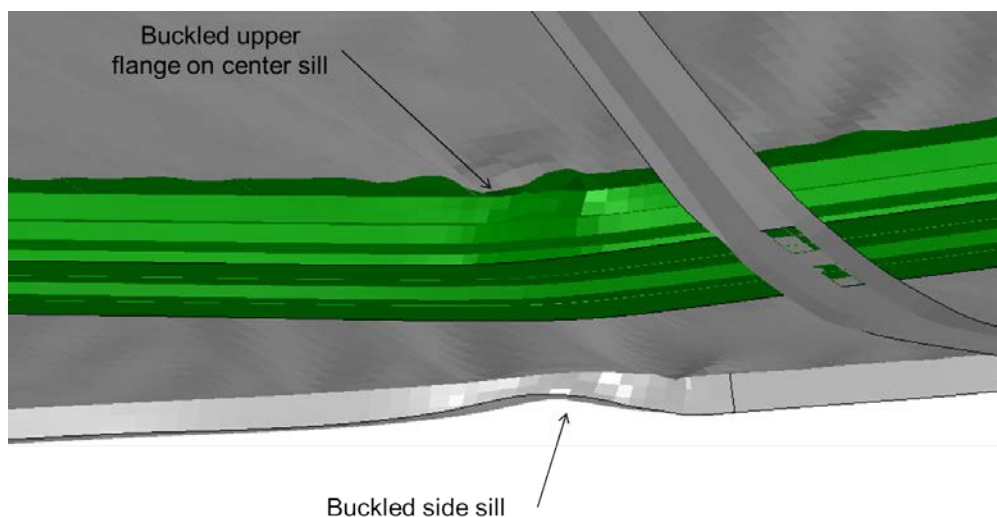
**Figure 79. Detail Showing Buckled Center Sill and Side Sill in FEA**

In the FE model, buckling occurred at both side sills and on the center sill at approximately the same distance from the live end. In the model, each side sill experienced an inward buckling mode of its lower web and flange. The center sill buckled at its upper flange and web. The buckled center sill and one of the two buckled side sills are shown in Figure 79. The center sill has been given a different color from the other members to allow it to stand out in this figure.

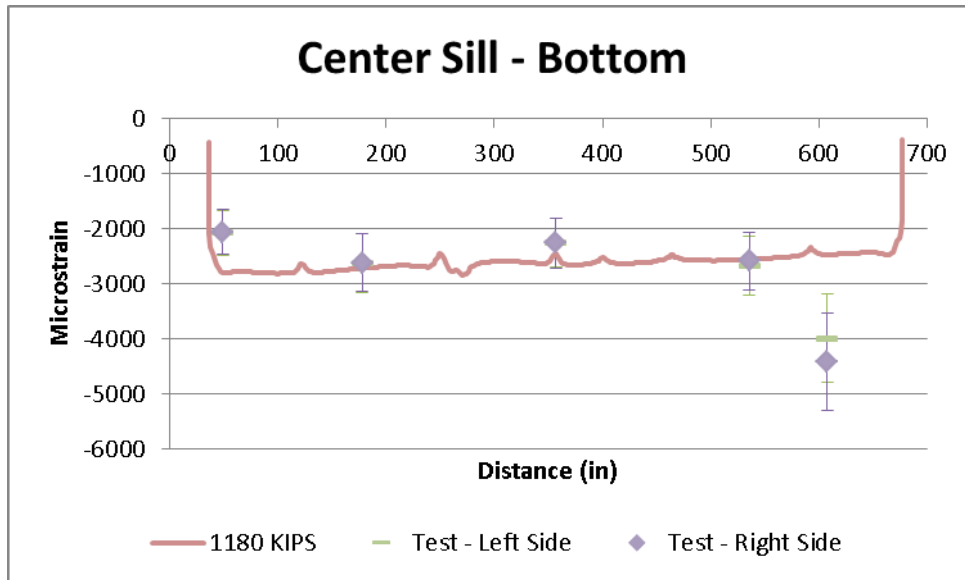
**Figure 86. Longitudinal Strain in Center Sill at 1180 kips, Crippling Test**

A second plot of longitudinal strain versus distance along the center sill for the strain measurements in the bottom half of the web is shown in Figure 85. In this figure the strain measurements are taken at a total applied load of approximately 1.18 million pounds. This load is just prior to crippling in both the test and the model. The test data at 1.18 million pounds are similar in appearance to the test data at a load of 830 kips (Figure 84) with the exception of the measurement location at approximately 600 inches. Because the datum point on this car is at the restraint end, this cross-section is the closest to the live end of the tested car. This set of center sill strain gages happened to be adjacent to an area of the center sill that buckled during the test (Figure 59).

The strain gages adjacent to the buckle indicate a very high level of strain in the center sill at a load just prior to crippling. However, even though the crippling load is a global measurement for the entire car, the strain data in the previous figure indicate that the center sill's buckling is a localized behavior. The center sill remains elastic at the cross-section away from this local buckle even at a load just below the crippling load of 1.2 million pounds.

Figure 86 also contains the strain-distance results calculated from the FE model along the entire length of the center sill for elements in the lower half of the web. Except at the crippling cross-section, the FE results compare favorably with the test data. Because the FE model experienced crippling at a different location than Car 244, there is not a steep change in strain data at the same location as the test car. The FE model's center sill buckled at a location adjacent to a cross-bearer on the restraint end of the car (Figure 78). A small inflection between 200 and 300 inches can be observed in the FE results in Figure 86; this is the location where the incipient buckle will cripple the model.

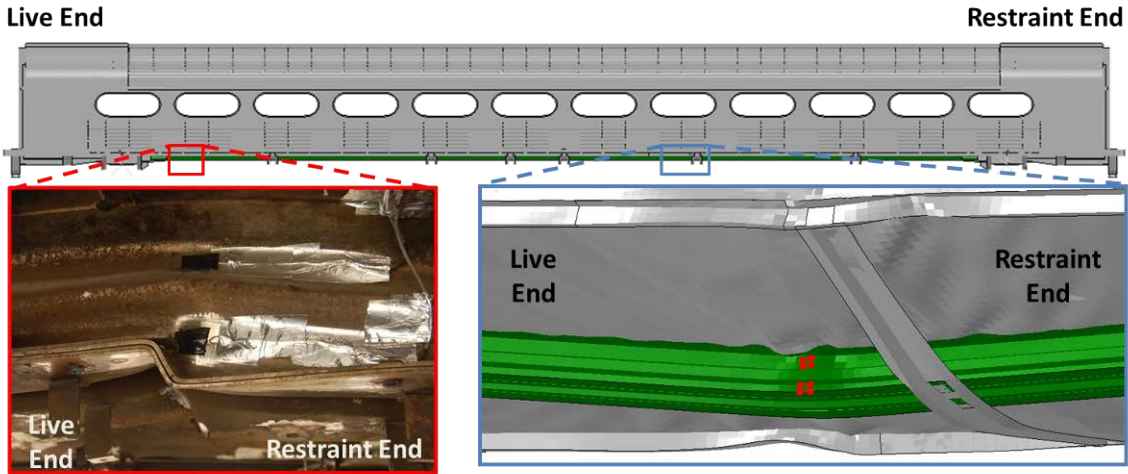
**Figure 87. Crippling Locations for Strain Comparison, FEA (right) and Car 244 (left)**

While the FE model and the tested cars each experienced crippling at different locations, the overall crippling behaviors were very similar. Specifically, the global force-displacement characteristics and the sequences of structural failures were similar for all three results. In order to assess the strain behaviors of Car 244 and the FE model at the location where center sill buckling occurred, data from one location in the test but a different location in the model must be compared. Figure 87 shows an image of the crippled center sill from the FE model and a photograph of one buckled location on the center sill of Car 244. The approximate location of each of these areas of damage is indicated on a profile view of the undeformed car in this figure. Two elements are highlighted in the image of the center sill taken from the FE model, shown at the right in this figure. These two elements correspond to the approximate placement of strain gages on the web of the center sill of Car 244. Two such strain gages can be seen in the left hand side of this figure.

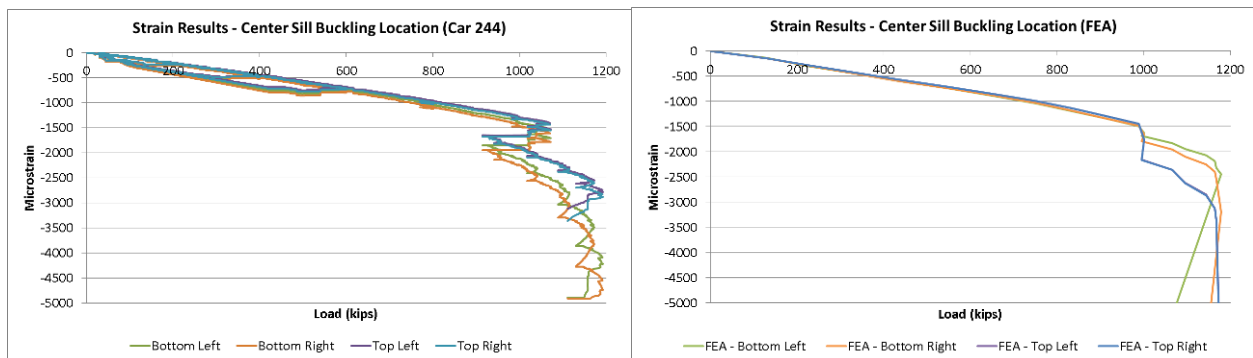
**Figure 88. Strain vs. Load Behavior at Center Sill Buckling Locations, Test (left) and FEA (right)**

The strain versus applied load results from the crippled location on the center sill of Car 244 and the FEA result are plotted in Figure 88. This figure shows the measurements from the four test strain gages on the left; the right shows the calculated strains in the FEA from four elements at the corresponding locations on the center sill at the buckle.

In both the test and the analysis, the strain behaviors are very similar. In both cases, the four strain results overlay one another up to a load of approximately 1 million pounds. The inflection point at approximately 1 million pounds corresponds with buckling of the roof structure. Beyond this load the four strain results begin to diverge in both the test and the FEA. In the test, the two gages at the bottom of the center sill indicate a more rapid change in strain with additional load than do the two at the top. In the FE results, the two locations at the top of the center sill experience greater changes than the two locations at the bottom. Figure 87 shows that the FE results experienced a buckling in the top of the center sill while Car 244's center sill buckled at its bottom. The strain gauges installed on the car during this test had a maximum capacity of +/-3,000 microstrain. Although the gage reports values up to -5,000 microstrain, these results have greatly exceeded the intended range of the strain gage.
