OFFICE OF RESEARCH & DEVELOPMENT

2012 R&D REVIEW

Rail Seat Abrasion

Federal Railroad
Administration

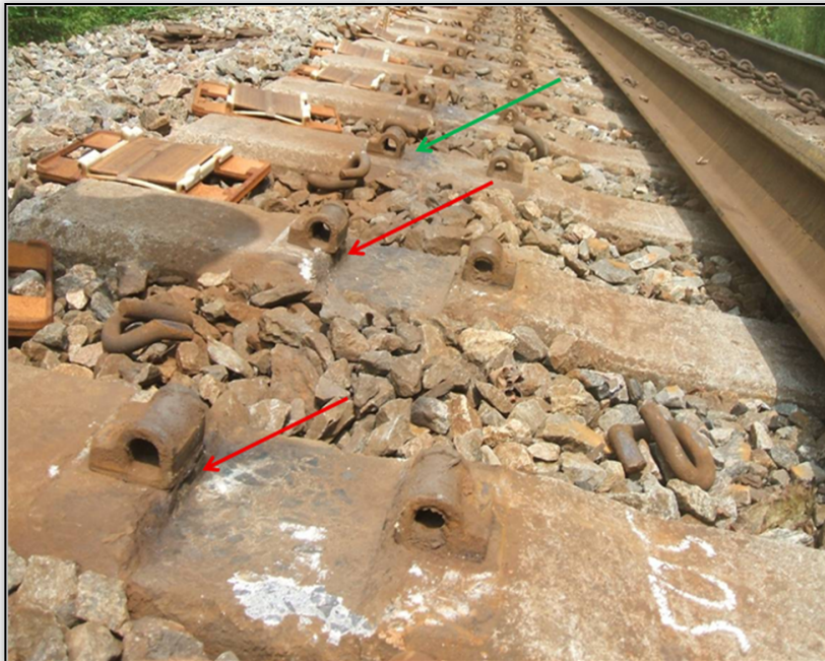
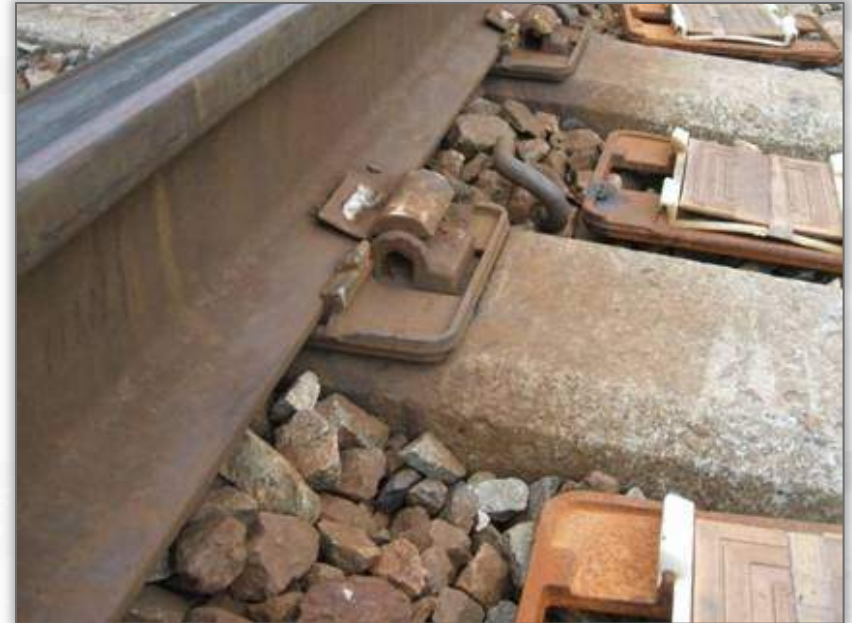
- Field Survey Measurement Approach
 - RSA cannot be measured without removing the rail.

- For this reason measurements were performed during rail replacements and rail seat repairs.

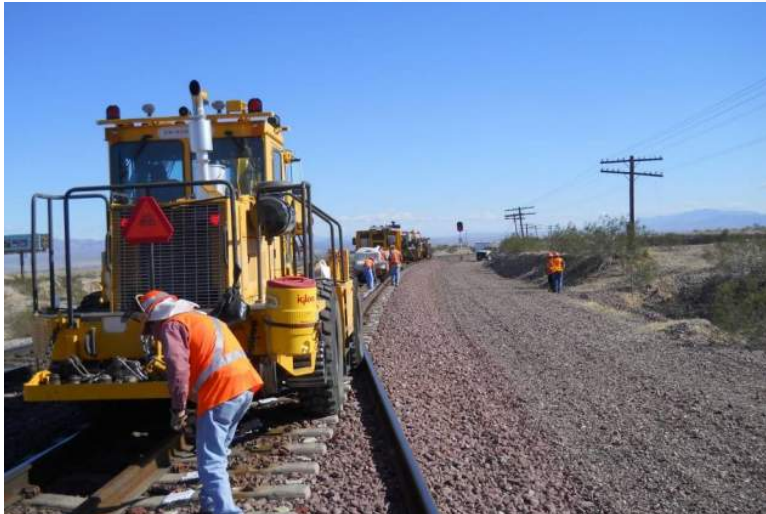
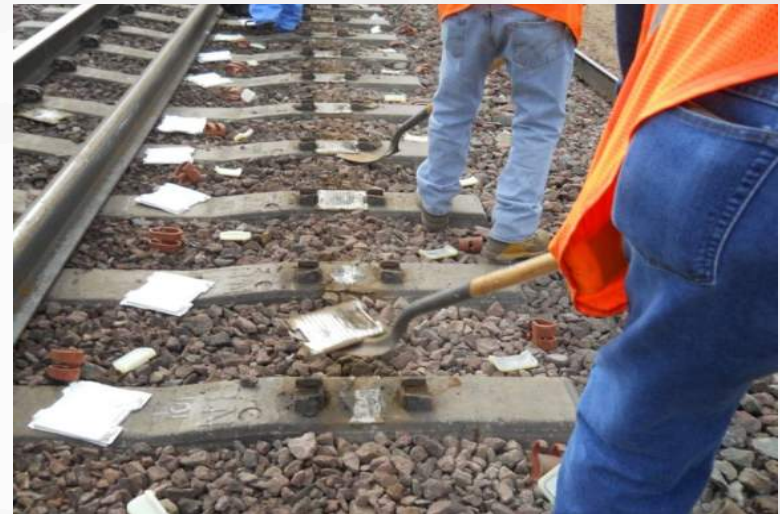
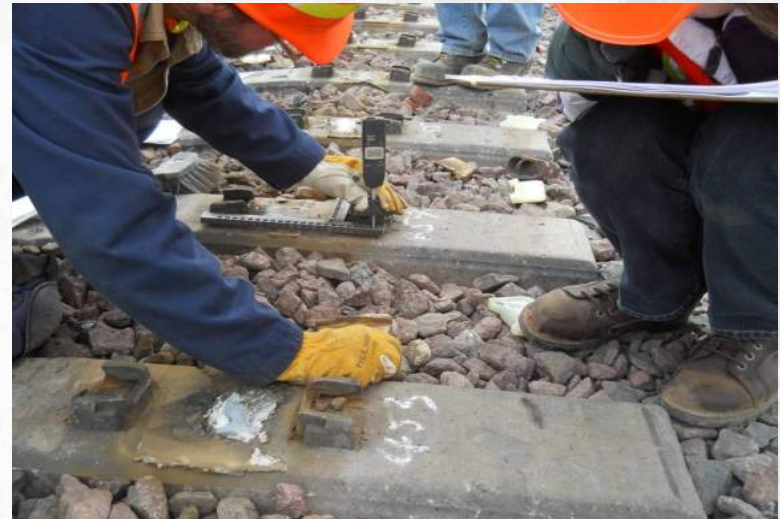
- Rail was declipped, swung out of the way, and railroad personnel cleaned old pads off of the rail seat.
- When this was finished the rail seats could be measured.
- The team replacing pads followed only a short distance behind leaving a limited time for measurements.
