Full-Scale Locomotive Dynamic Crash Testing and Correlations: Locomotive Consist Colliding with Steel Coil Truck at Grade Crossing (Test 3)

1. AGENCY USE ONLY (Leave blank)	2. REPORT DATE September 2011	3. REPORT TYPE AND DATES COVERED Technical Report	
4. TITLE AND SUBTITLE Full-Scale Locomotive Dynamic Crash Testing and Correlations: Locomotive Consist Colliding with Steel Coil Truck at Grade Crossing (Test 3)		5. FUNDING NUMBERS

6. AUTHOR(S) Gopal Samavedam and Kash Kasturi			
7. PERFORMING ORGANIZATION NAME(S) AND ADDRESS(ES) Foster-Miller, Inc. 350 Second Avenue Waltham, MA 02451-1196		8. PERFORMING ORGANIZATION REPORT NUMBER DFRA.010328

9. SPONSORING/MONITORING AGENCY NAME(S) AND ADDRESS(ES) U.S. Department of Transportation Federal Railroad Administration Office of Railroad Policy and Development 1200 New Jersey Avenue, SE Washington, DC 20590		10. SPONSORING/MONITORING AGENCY REPORT NUMBER DOT/FRA/ORD-11/16.I

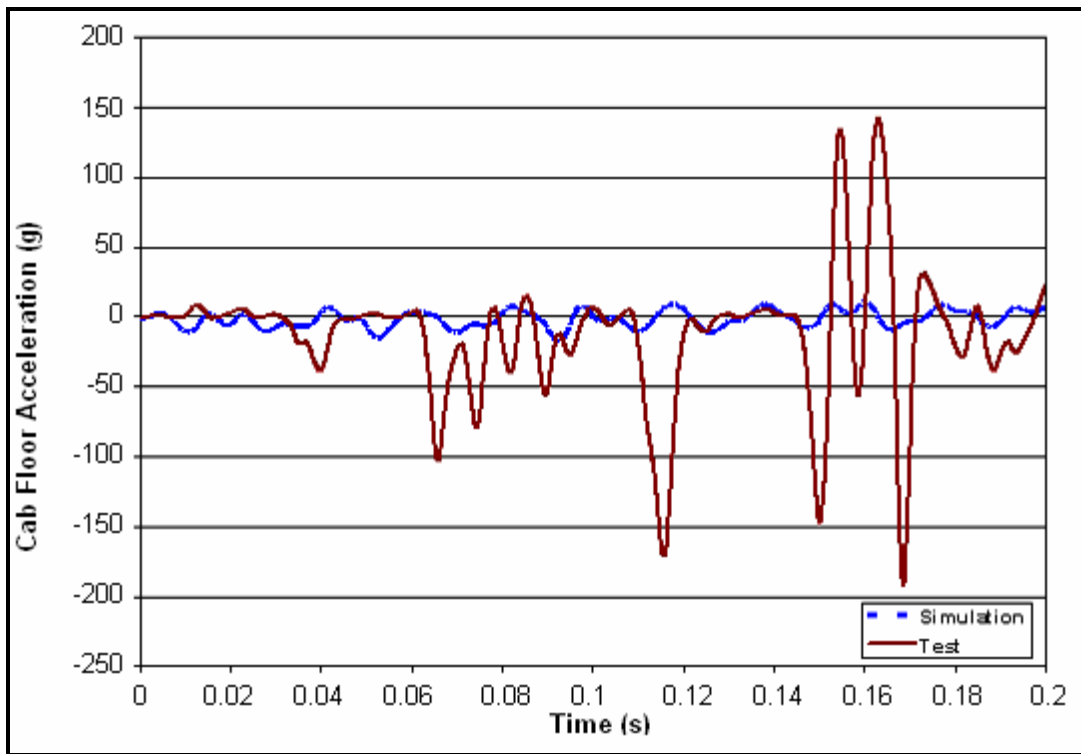
Figure 16. Locomotive Cab Floor Acceleration Filtered at 60 Hz

Simulation accelerations in the locomotive longitudinal direction do not correlate well with the test accelerations. Close examination of the high-speed film data revealed that the coil penetrated the cabin and impacted with the accelerometers. Consequently, the test values are not considered reliable.

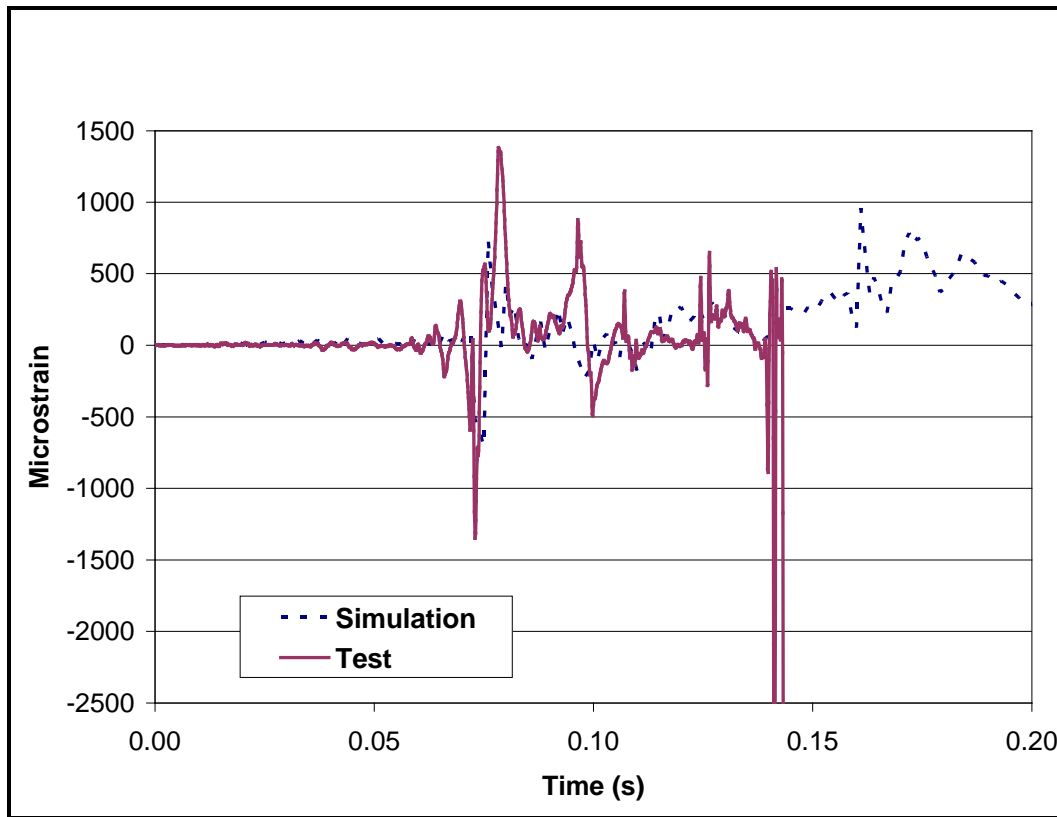
Figure 17. Right Collision Postlongitudinal Strain at Location 3

As shown in Figure 25, simulation results sometimes compare reasonably with test data. A possible reason for disagreement is that the instrumentation was damaged due to the collision. Right collision poststrain correlations at locations 3 (Figure 17) and 10 (Figure 20) confirm the structural failure of the collision post.

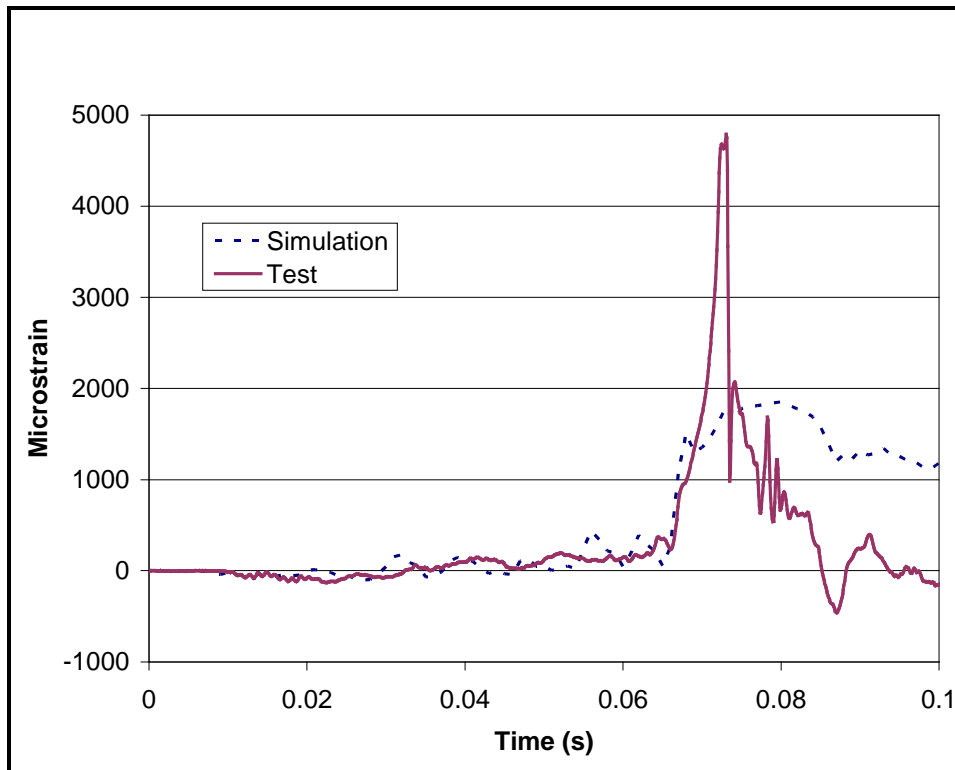
Figure 19. Right Collision Postvertical Strain at Location 8

The test measured maximum strain values on the right post in the vertical leg of the rosette gauge at location 8 (Figure 19). This strain gauge was at the bottom front of the collision post, (see Figure 1). The simulation also predicted the maximum strain occurring at this location.
