Full-Scale Locomotive Dynamic Collision Testing and Correlations: Offset Collisions between a Locomotive and a Covered Hopper Car (Test 4)

Office of Railroad Policy and Development Washington, DC 20590

This report presents the test results and finite element correlations of a full-scale dynamic collision test with rail vehicles as part of the Federal Railroad Administration's research program on improved crashworthiness of locomotive structures. This test involved the 30-mile per hour oblique collision of a locomotive with a stationary covered hopper car fouling the locomotive's right-of-way. The test used an SD70-MAC locomotive.

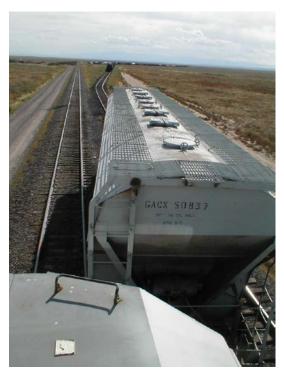
Figure 8. Alignment of Locomotive and Covered Hopper Car at Point of Impact

Figure 8 depicts the alignment of the locomotive and covered hopper car at the point of impact. The covered hopper car sits on a turnout connecting the locomotive's rail path to a parallel track, where it fouls the locomotive's right-of-way by approximately 36 inches (in). Figure 9 shows the engineer's view of the covered hopper car while the locomotive was parked during pretest activities.

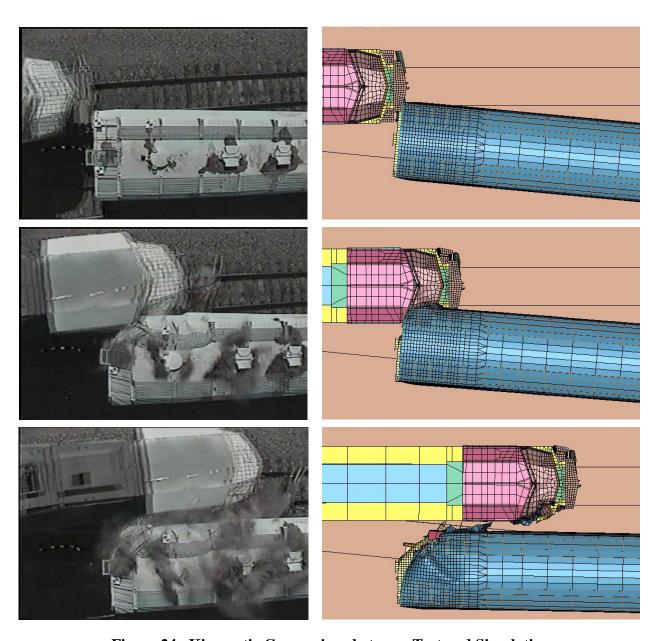
Figure 24. Kinematic Comparison between Test and Simulation

Figure 24 shows the dynamic sequence correlations between the test and the simulation captured at time equals 0.04, 0.225, and 0.64 s. The dynamic sequence as captured from the high-speed video seems to be in reasonable agreement with the simulations from the finite element analysis.

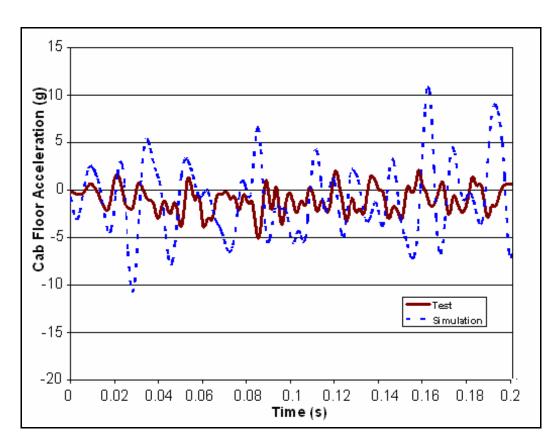
Figure 30. Locomotive Cab Floor Longitudinal Acceleration Filtered at 60 Hz

Figure 30 shows the acceleration correlations between the test vehicles and the finite element simulation. SAE J211 60-hertz filter was used for structural acceleration data. As shown in the figure, the simulation prediction for longitudinal acceleration of the locomotive cab floor varied from the test accelerations. In addition, the results show that the peak longitudinal accelerations for the cab floor were lower than the predicted values.

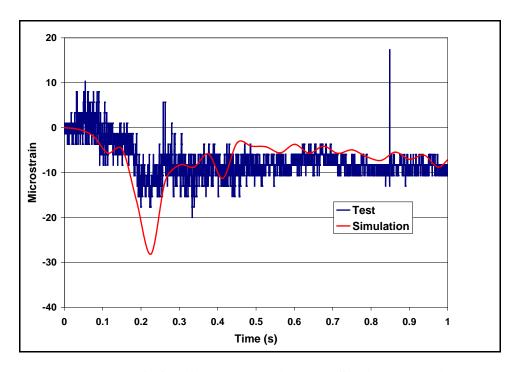
$\ \, \textbf{Figure 31. Left Collision Postlongitudinal Strain at Location 1} \\$

Strain data for collision posts, lead underframe, and the right-hand corner windshield post of the locomotive correlated data between simulation and test. The collision posts and underframe did not suffer any significant damage in the real collision. Simulation results, however, would suggest the occurrence of plastic deformation in the right collision post and surrounding hood structure. The right-hand windshield corner post was torn from the cab in both the test and simulation. Table 4 describes element locations and the identified strains chosen for correlation. Figure 31 through Figure 36 show these strain correlations.

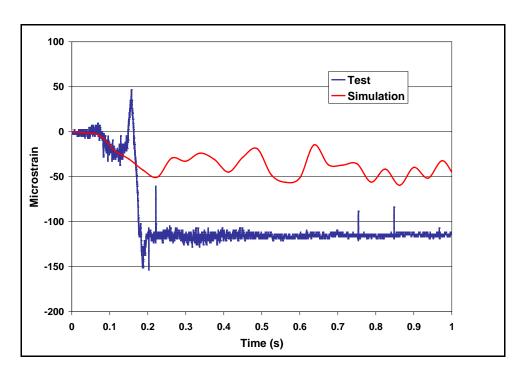
Figure 33. Right Collision Postlongitudinal Strain at Location 1

The above figures show that simulation results are in poor, mixed agreement with the test data on the right collision post for gauge location 1 during the first 0.1 s of the collision locations.
