RR 21-20 | September 2021

MACHINE VISION DATA PRODUCTS FOR THE AUTOMATED TRACK INSPECTION PROGRAM

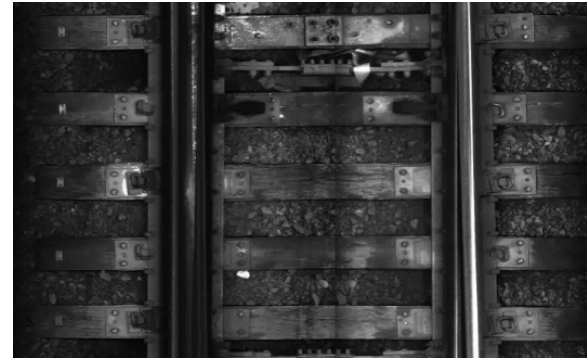
Figure 3 shows an example of the TCIS image extracted around a weak track location (as identified by GRMS). The yellow marks on the side of the image indicate the length of the recorded exception, and the red mark indicates the location of the peak exception value.

Figure 3. Example Exception Report (top) and Example TCIS Image at a GRMS Exception Location (bottom)

The geometry Image Exception Reports present data similar to other reports from FRA's ATIP fleet. The PDF report provides location and magnitude information about the individual exception as well as links to relevant extracted images. Images extracted from TCIS, the Roadbed DVIS, and ROW DVIS are automatically archived for evaluation.

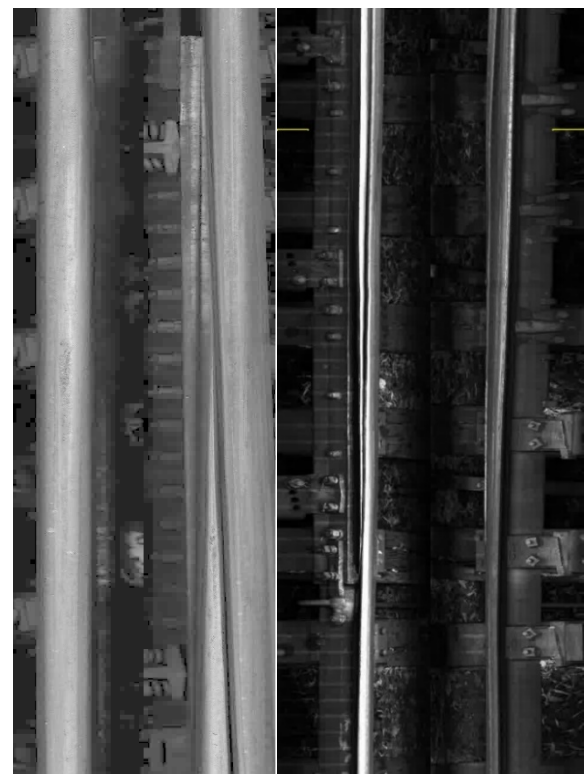
A similar set of images are automatically extracted from various image data products in the vicinity of switches and other user-defined track assets. An Event Report, automatically produced for each survey, details the images extracted from the TCIS, JBIS, RSIS, and both DVIS for these areas. Figure 4 shows examples of extracted images for a switch.

Figure 4. Extracted Images Surrounding a Switch Point from TCIS (top), RSIS (bottom-left), and JBIS (bottom-right)
