U.S. Department
of Transportation
**Federal Railroad
Administration**

Revenue Service Evaluation of a Truck Component Inspection System

1. REPORT DATE (DD-MM-YYYY) 4/22/2020		2. REPORT TYPE Technical Report		3. DATES COVERED (From - To) 09/2015-09/2018	
4. TITLE AND SUBTITLE Revenue Service Evaluation of a Truck Component Inspection System				5a. CONTRACT NUMBER DTFR53-11-D-00008L	
				5b. GRANT NUMBER	
				5c. PROGRAM ELEMENT NUMBER

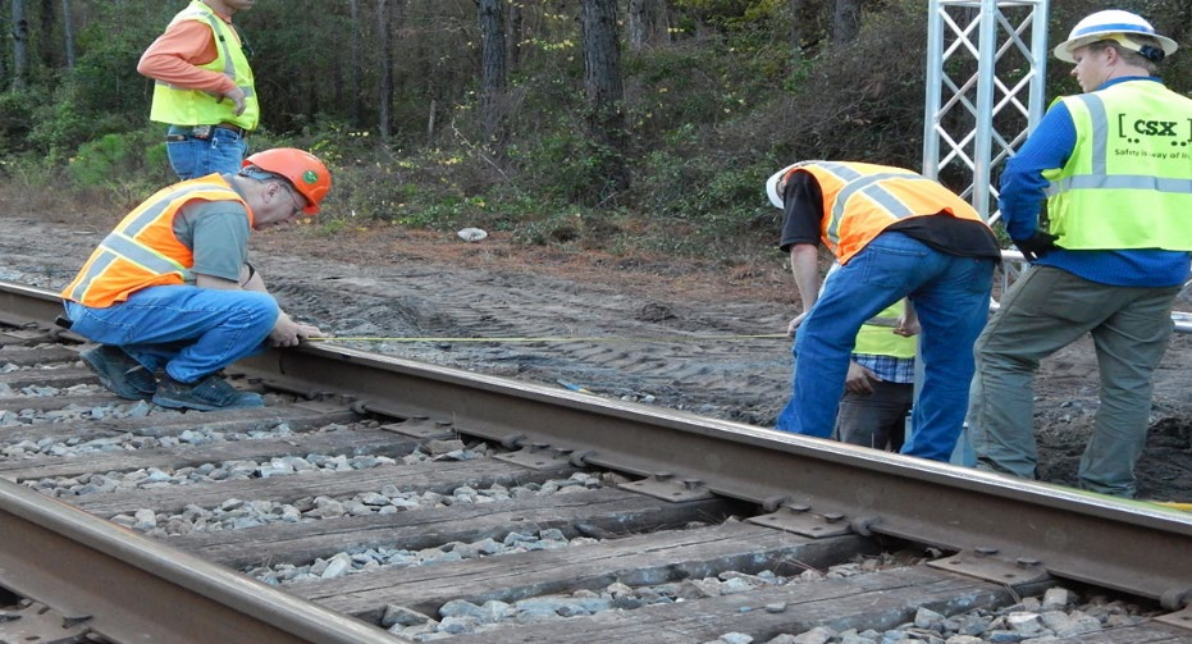
Figure 2. Installation Team Positioning Stanchions

After backfill, the stanchions were positioned for installation on the pylons. Distance to the track must be known precisely so that component sizing is accurate within the images. [Figure 2](#) shows the installation team positioning the stanchions prior to bolting them down.

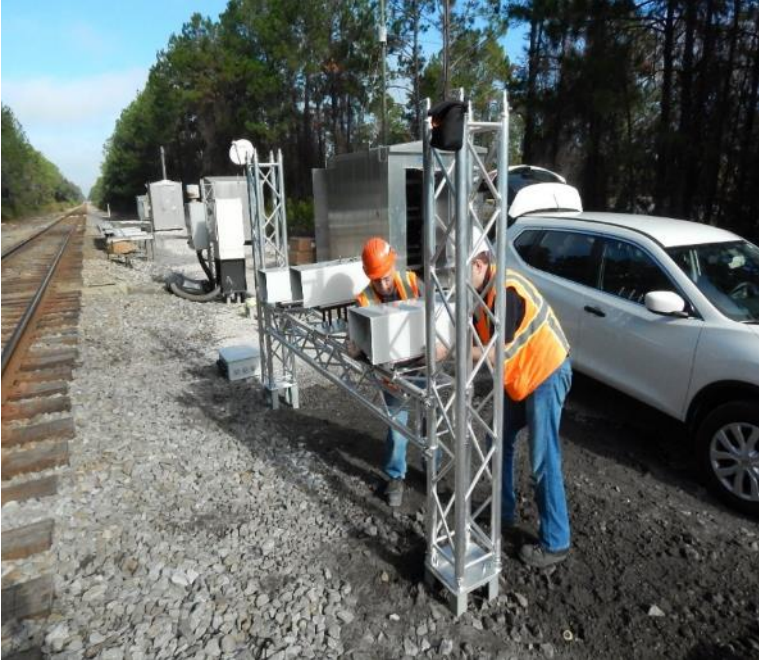
Figure 6. Installation of Axle-level Cameras at Hague Site

Figure 6 shows workers installing the cameras on one side of the track. The control bungalow is visible in the background.

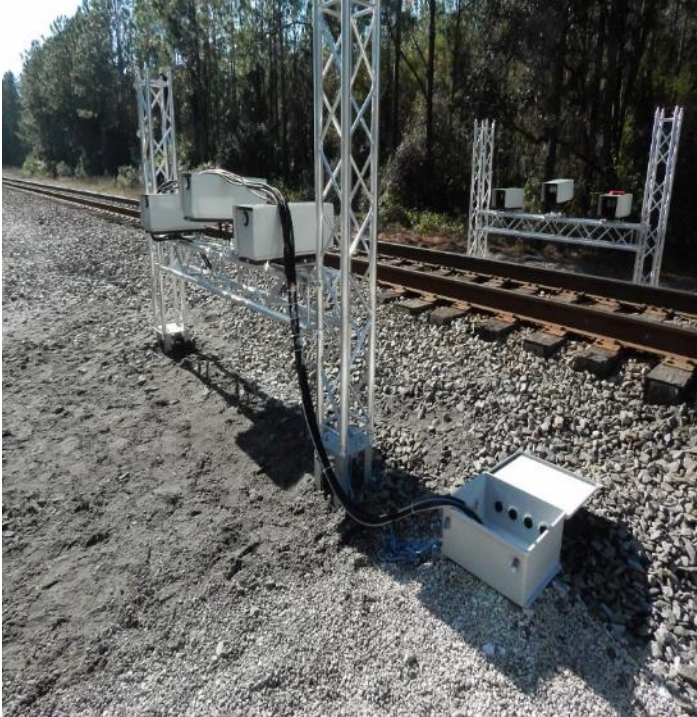
Figure 7. Nearly Completed System Showing All Cameras in Position

Figure 7 shows an image of the nearly completed system, with cameras mounted on both sides of the track.

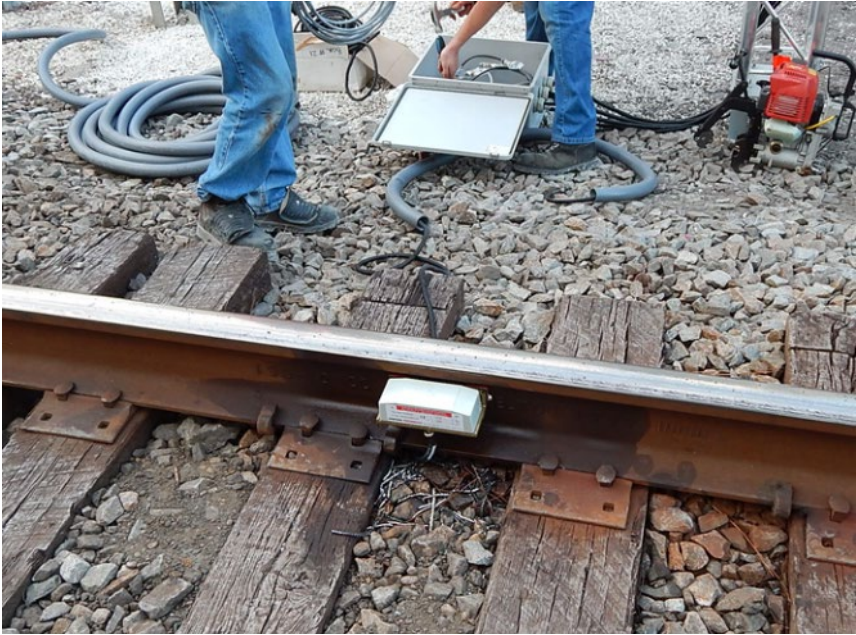
Figure 8. Wheel Sensors Mounted on Each Rail for Precise Triggering of Cameras

Precise triggering of the cameras is required to assure the components are centered in the camera view. Triggering is provided by wheel sensors mounted to the rail. Holes were drilled and the sensors mounted on each rail. [Figure 8](#) shows the sensors mounted to the near rail.
