# FULL-SCALE SHELL IMPACT TEST OF DOT-113 TANK CAR SURROGATE USING LIQUID NITROGEN

## SUMMARY

On July 24, 2021, the Federal Railroad Administration (FRA) conducted a full-scale shell impact test (Test 12) of a surrogate DOT-113 specification tank car at the Transportation Technology Center (TTC) in Pueblo, CO. This test was the third DOT-113 impact test in a planned series of four. A DOT-113 is a double-walled tank car (i.e., tank-within-a-tank) designed to transport authorized cryogenic liquids by rail. The tested “surrogate” tank car was purposefully built for this test with the essential features of a DOT-113 and an outer tank of a slightly thicker steel than required by specification. The tested surrogate did not feature all the equipment required of a DOT-113 tank car (e.g., cabinet, couplers, and trucks) and was approximately 35 percent shorter in length. The shell of the outer tank was struck by a ~297,000-pound ram car equipped with a 12-inch by 12-inch impactor at its mid-height and longitudinally offset ~2.5 feet towards the A-end. This offset impact location was intended to be consistent with the impact location in the previous two DOT-113 impact tests (Tests 10 and 11

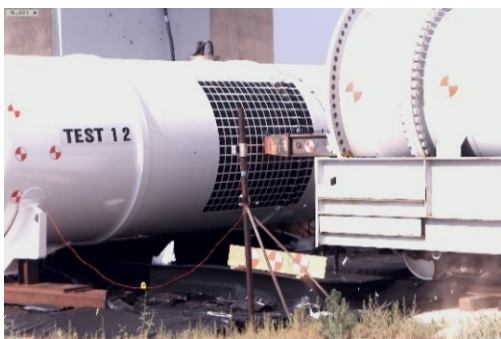
**Figure 1. Pre-impact DOT-113 Surrogate**

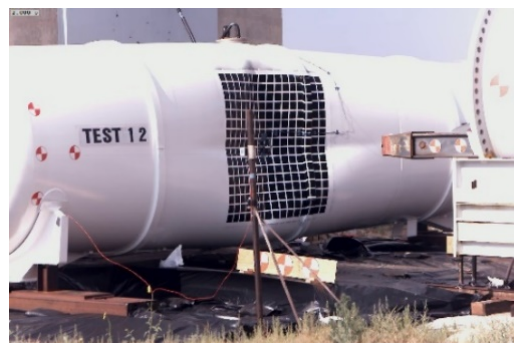
The surrogate resisted the impact without tearing either the inner or the outer tank. The impactor indented the DOT-113 surrogate to a maximum depth of ~59 inches before stopping and rebounding. The impact developed a maximum force of ~1.2 million pounds. [Figure 2](#) shows the outer shell immediately following rebound of the ram car while using a high-speed video frame.

**Figure 2. Post-impact DOT-113 Surrogate**
