# REFURBISHMENT OF RAILROAD CROSSTIES

## A TECHNICAL AND ECONOMIC ANALYSIS

**December 1977**  
**Final Report**

Prepared for  
**U.S. DEPARTMENT OF TRANSPORTATION**  
**FEDERAL RAILROAD ADMINISTRATION**  
**Office of Research and Development**  
**Washington, D.C. 20590**

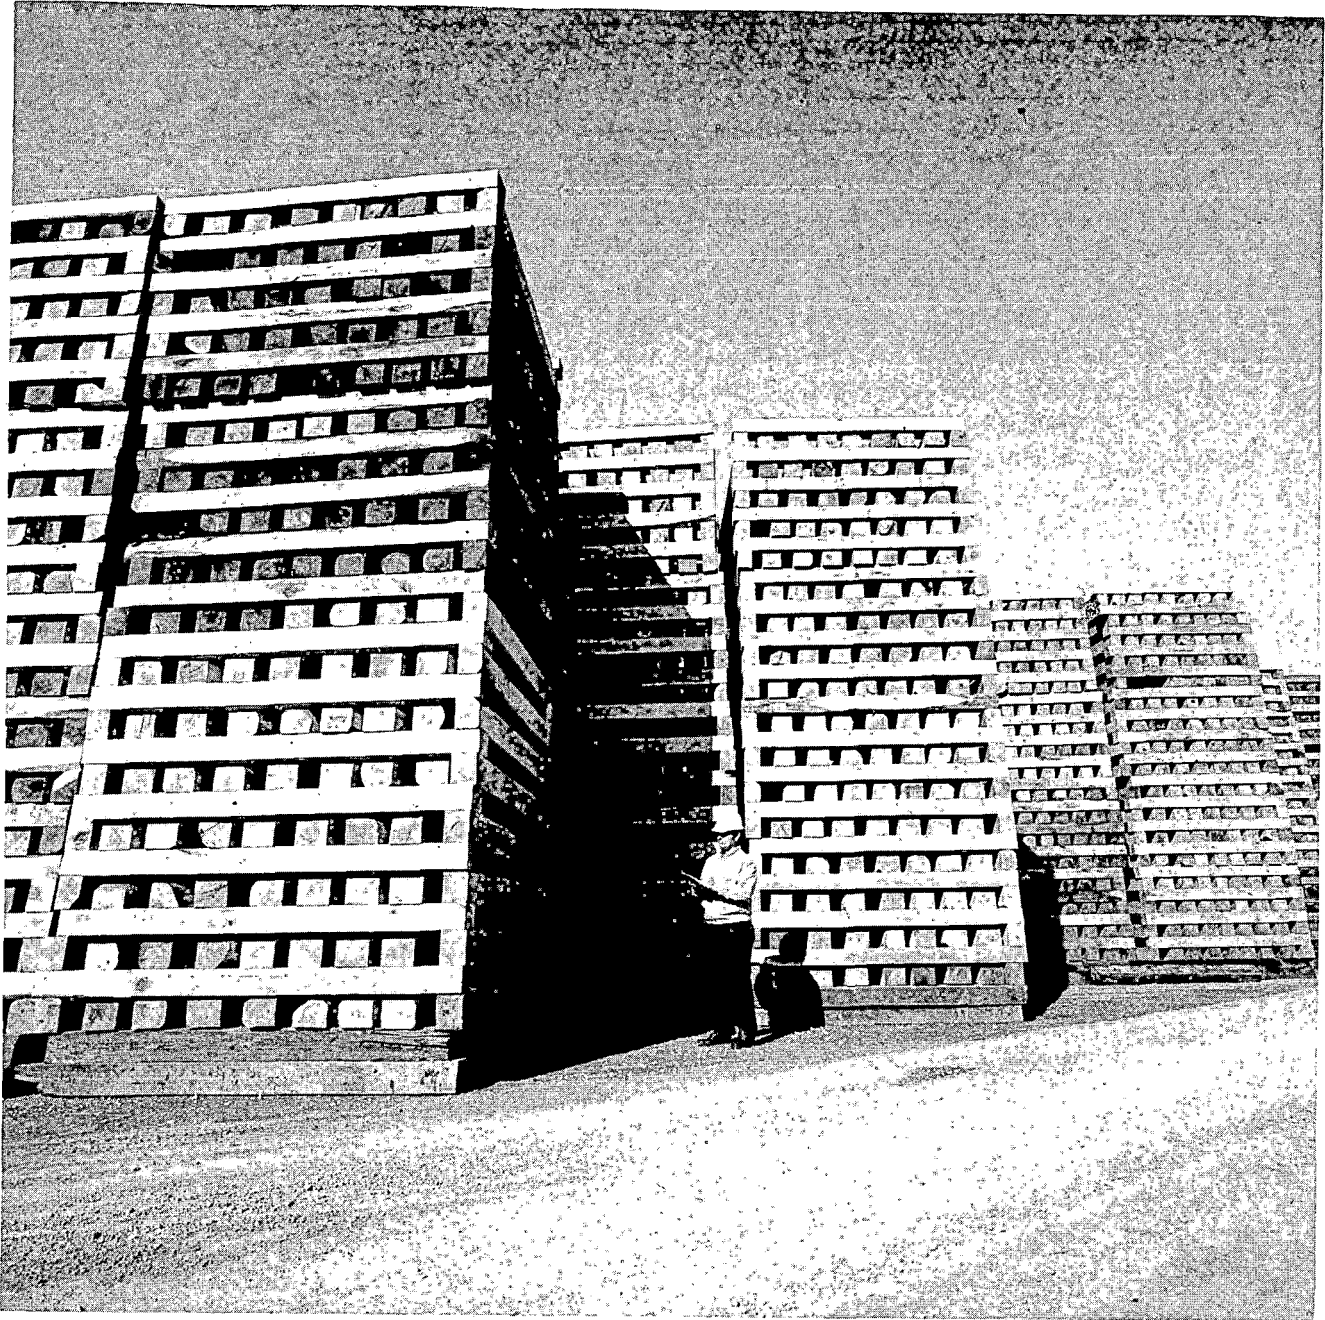
FIGURE 3.2 STOCKPILE OF HARDWOOD LUMBER FOR CROSSTIE USE

From the mill, the ties are taken to the tie concentration yard, where they are inspected and graded, and then to the treating facility, where they are inspected by an agent of the railroad purchasing the ties. An overall view of a large treating facility is shown in Figure 3.1. The pressure treating facilities are shown in the foreground, the lumber stockpiles (Figure 3.2) and processing stations in the background.

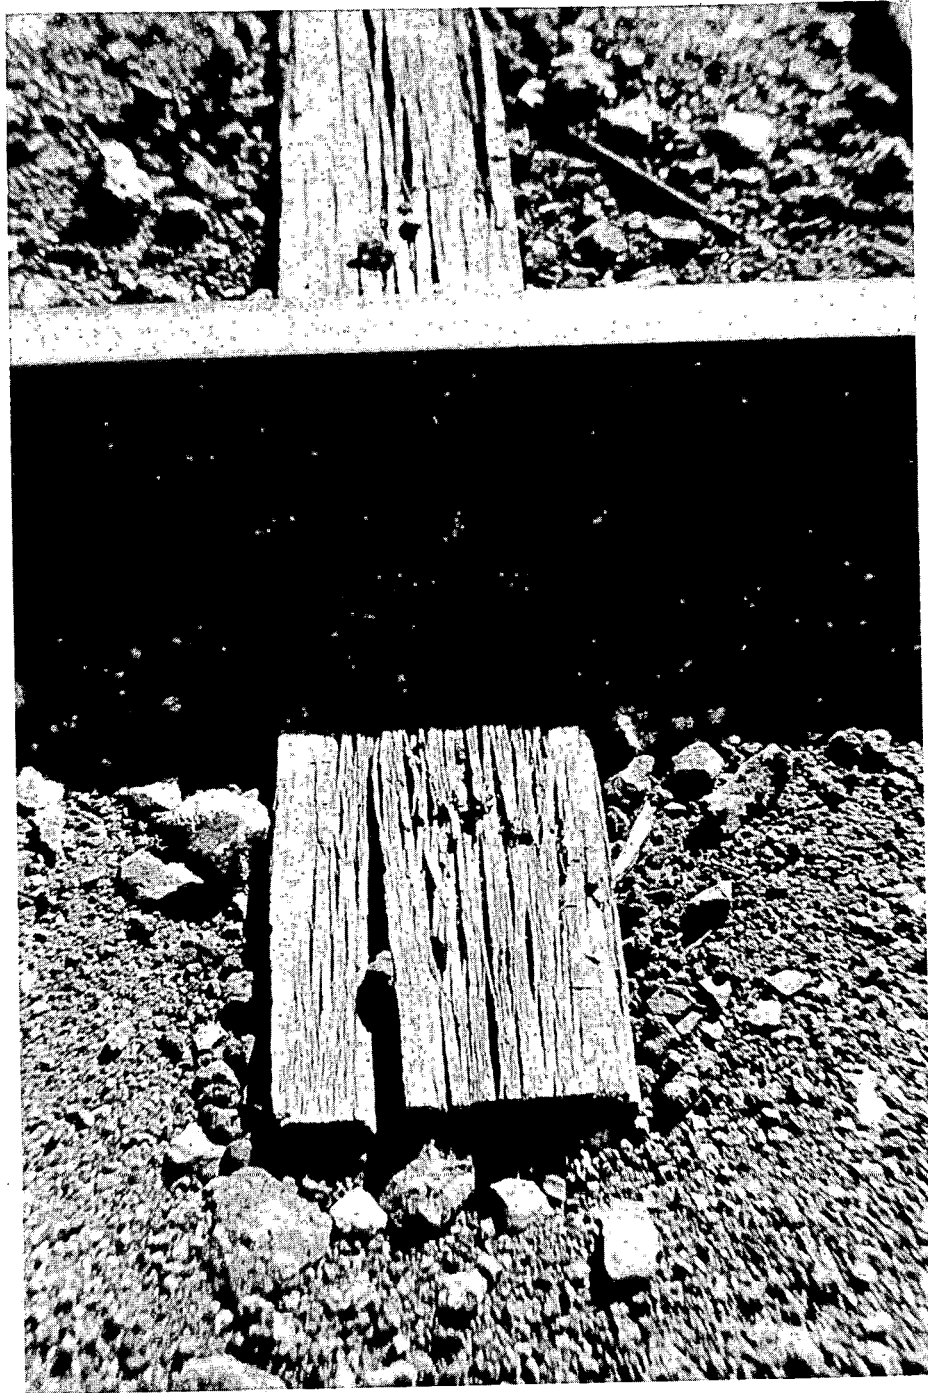
FIGURE 4.5 AN IN-SERVICE TIE EXHIBITING CHECKING AND SPLITTING

This deterioration mode has already been described in Section 2.0. Although checking is not normally a cause for crosstie replacement, it is critical to tie decay because it exposes internal portions of the tie and allows biological attack of untreated wood. Checks may also create large splits when the presence of ballast in a check continually enlarges the check under the movement or vibration of passing trains (see Figure 4.5). The entry of water and the freeze and thaw cycle of the winter will also expand checks or splits, allowing entry of decay fungi, ballast, and other foreign materials.

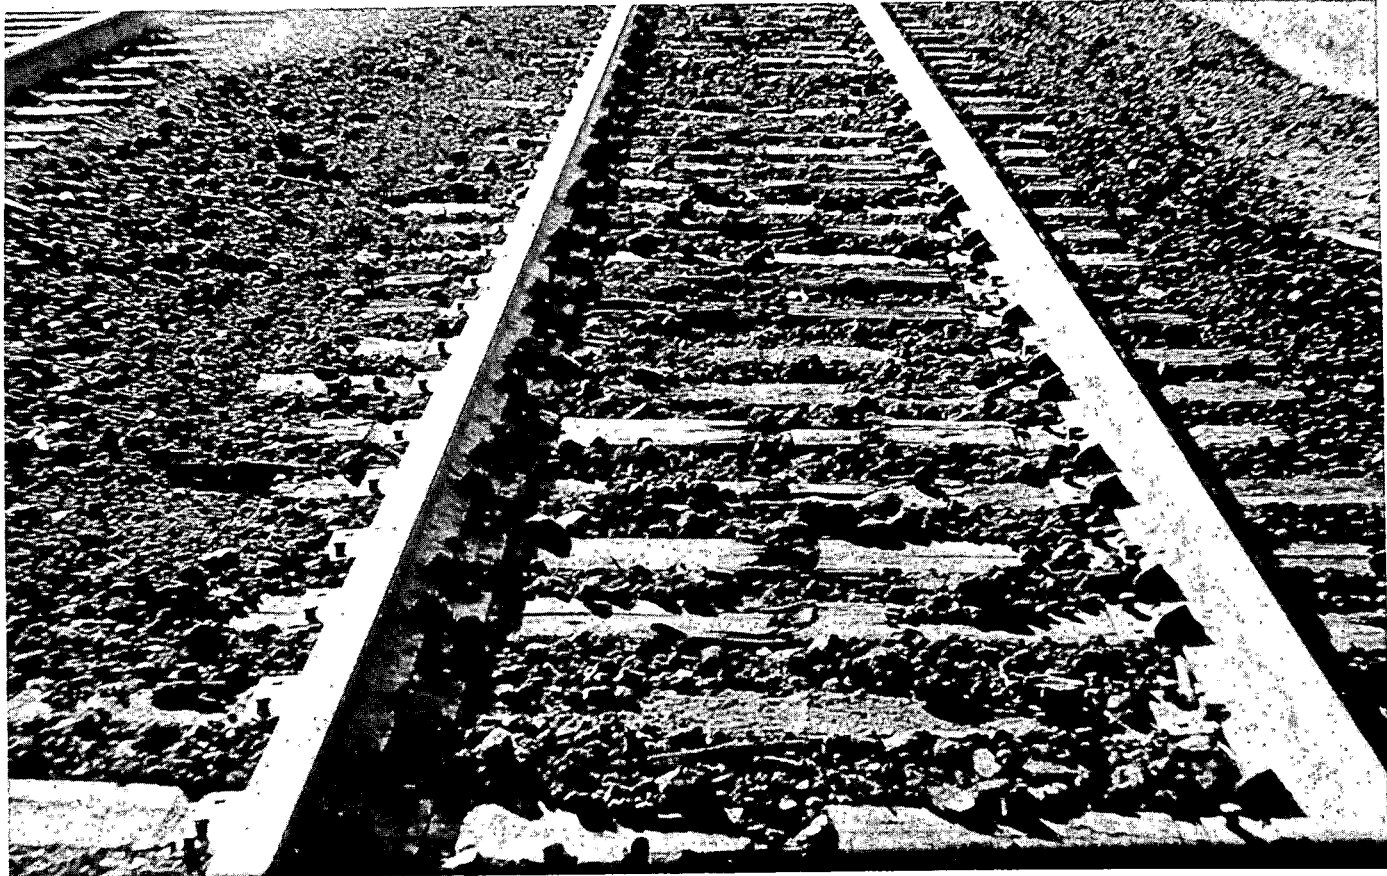
FIGURE 4.6 TIES DAMAGED BY DERAILED BOXCAR

and numerous other problems cause ties to be damaged on their surface or, in some cases, broken through. Figure 4.6 illustrates a case wherein a box car in a long freight train jumped the track and was dragged approximately five miles, with a set of its wheels running along the mid-point of the track. The damage inflicted to the ties is evident. Complete replacement of the damaged section is the only remedy for this type of damage.

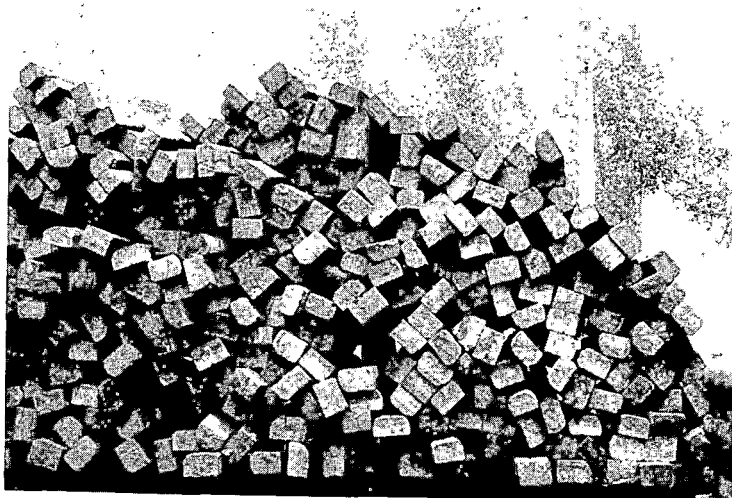
FIGURE 8.4 RECOVERABLE TIES (END VIEW)

Ties are returned to the processing facility on flat cars in the original panel assemblies as shown in Figure 8.1. These panels are disassembled by a rail-mounted mechanized line and the ties sorted into scrap and recoverable tie stockpiles as shown in Figure 8.2. As a close examination of Figure 8.3 and 8.4 reveal, by U.S. standards most of the recoverable ties could be reused with little or no attention other than plugging of the spike holes. The predominant modes of deterioration which are found in these ties are splitting and checking of the tie (12 percent) and mild plate cutting. This would be anticipated considering the length of service the ties have seen, and is consistent with U.S. findings for ties of this age.

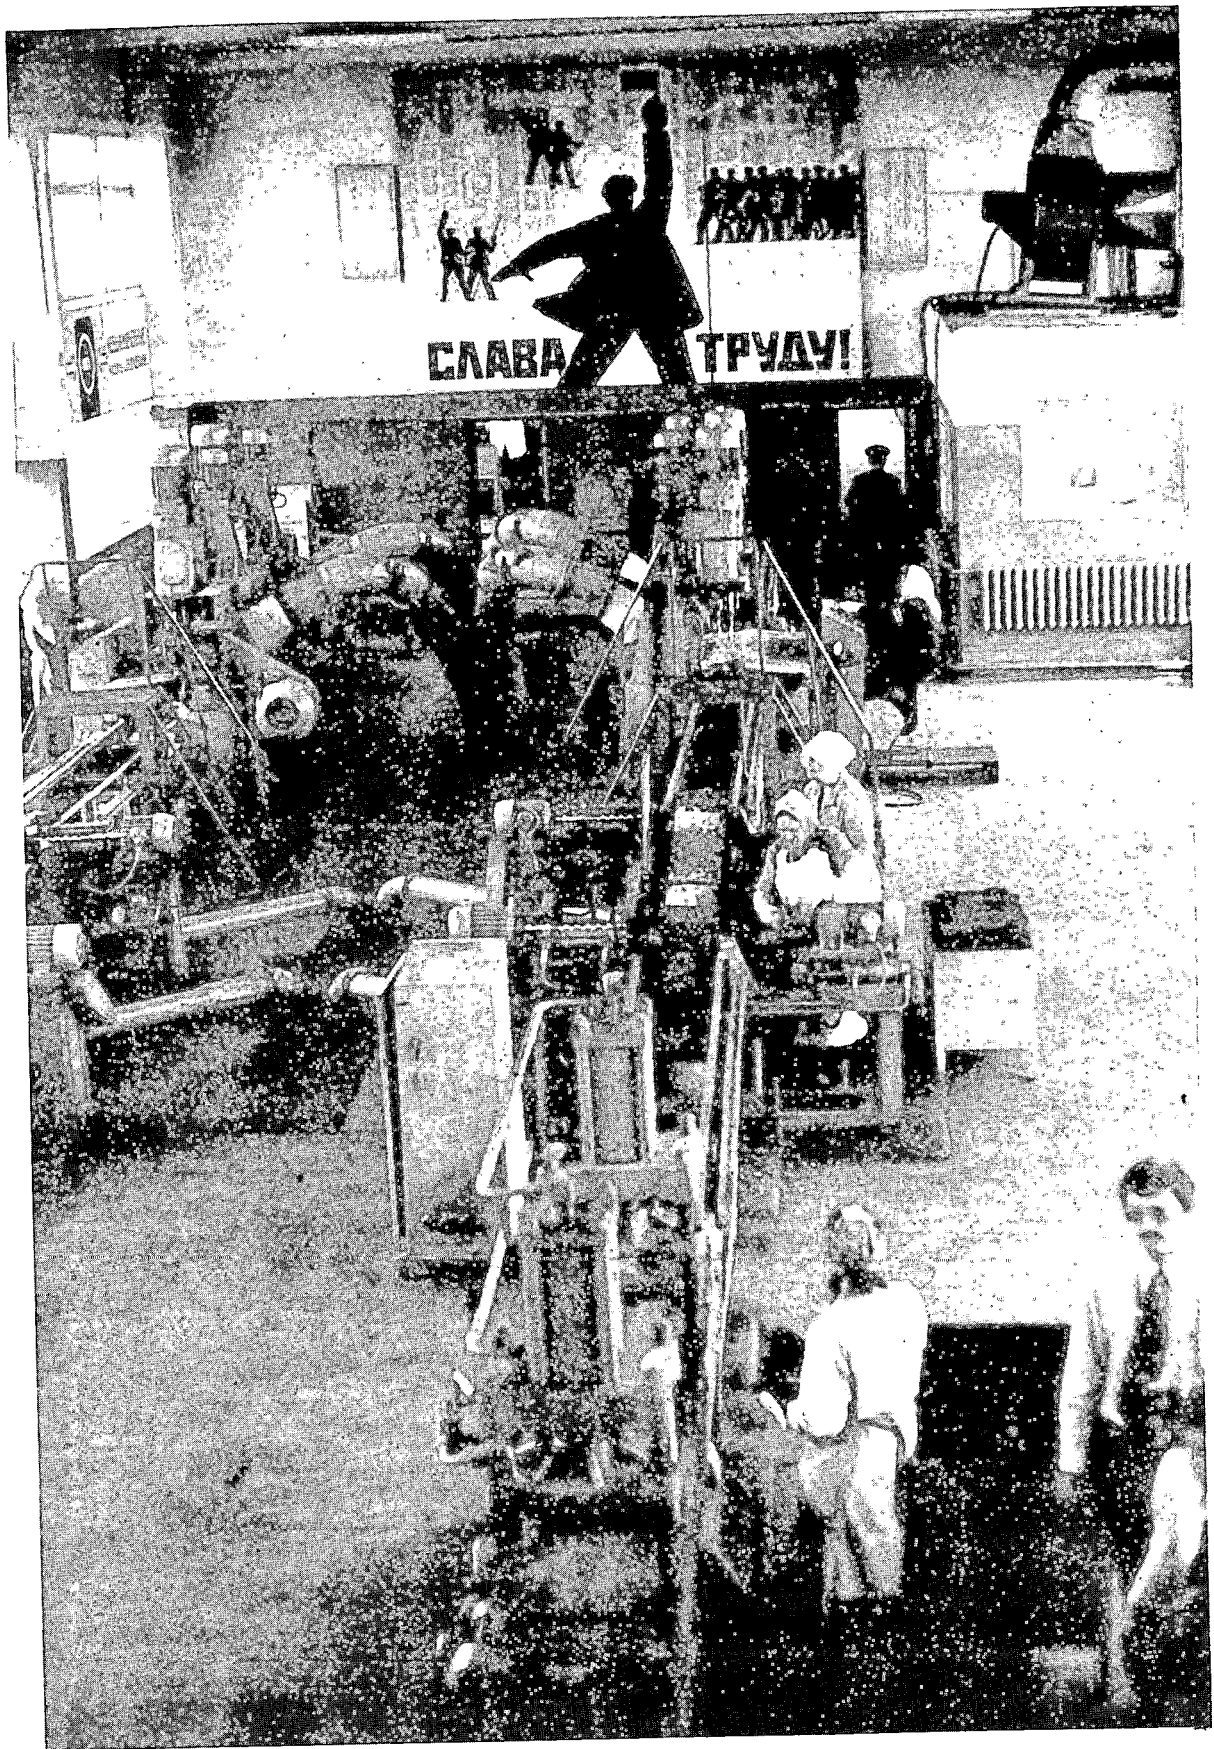
FIGURE 8.6 OVERVIEW OF TYPICAL SOVIET TIE REFURBISHMENT PLANT

A typical Soviet Refurbishment Plant, seen in overview in Figure 8.6, employs double parallel transfer lines with sequential mechanized woodworking operations and requires 16 operators, including foreman and fork lift operators. Ties received for refurbishment are first visually inspected for decay and entrained ballast or fastener parts as they enter the transfer line (Figure 8.7). The ties then flow in two parallel and identical work lines where they are automatically cleaned by pressurized water sprays and wire brushes.

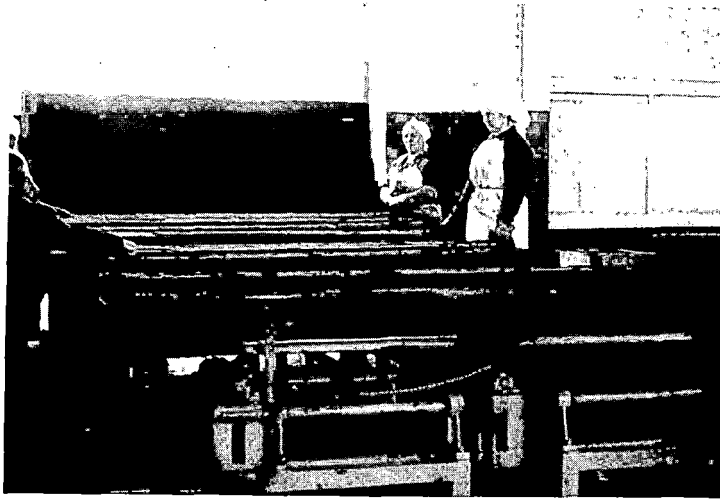
FIGURE 8.7 VISUAL INSPECTION OF TIES ENTERING PLANT
