MEMORANDUM REPORT BRL-MR-3429

**PHYSICAL RESPONSE OF FLAT STEEL
PLATES TO DROP HAMMER IMPACTS**

**William P. Wright
Wayne A. Slack
Willis F. Jackson**

**US ARMY BALLISTIC RESEARCH LABORATORY
ABERDEEN PROVING GROUND, MARYLAND**

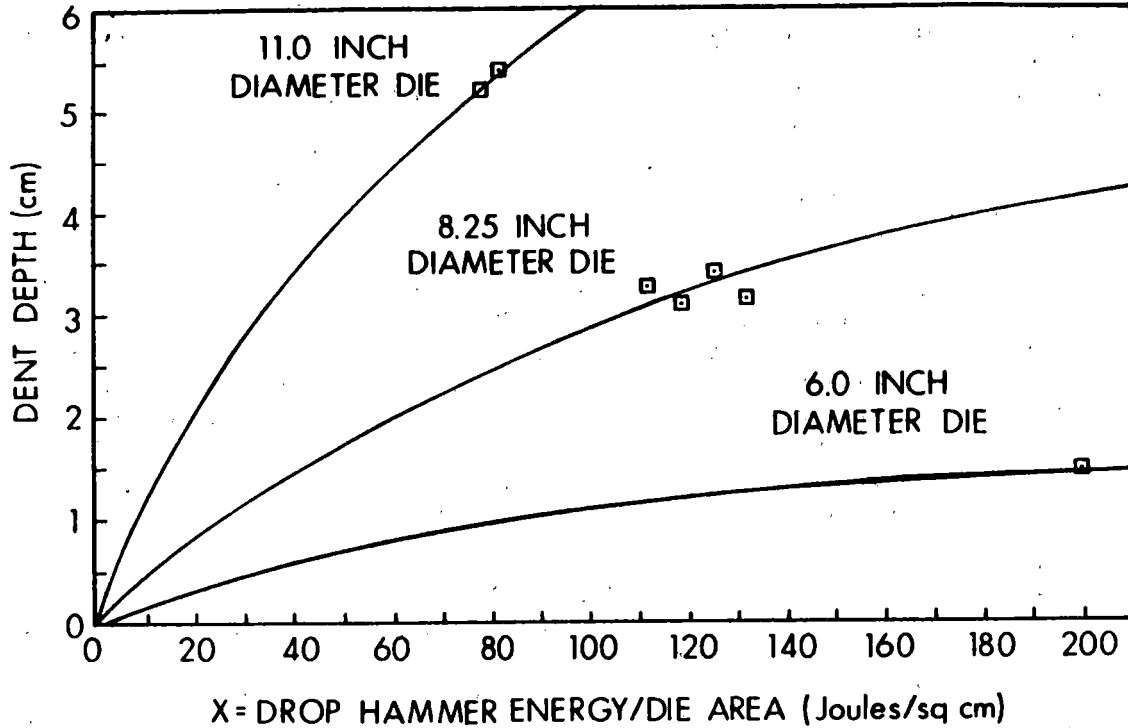
Figure 7: Dent Depth Summary of the 5.5 Inch Flat Top Data

In the remaining tests there were no perforations, thus the dent depths for each were measured. In order to present the dent depth data on one plot, the potential energy of the hammer {hammer height} was divided by the present area of the die. The results are presented in Figure 7. In general, for a specific kinetic energy {potential energy}, the maximum depth of the dents increased as the die diameter was increased. This was attributed to an increase in the bending mode between the edge of the tup and the edge of the die. The curves were drawn merely to assist in visualizing the trend of the data.

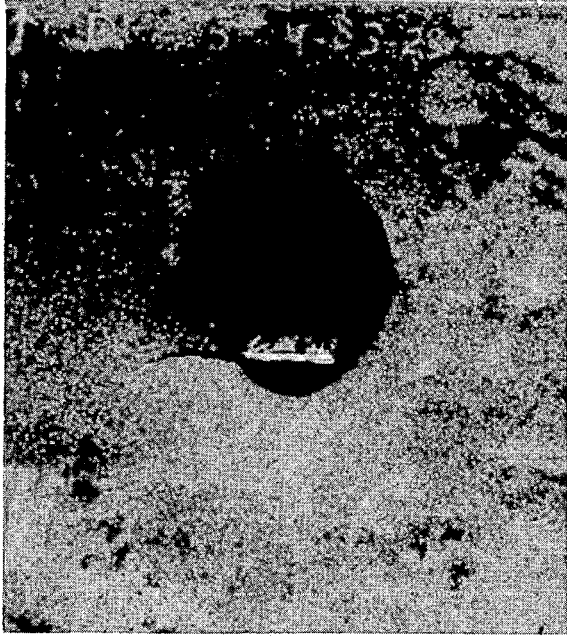
Figure 9: Steel Plate Response to 5.5 Inch Hemispherical Tip in Test Number 25

the plates on Test Numbers 15, 25, 32, and 33. The photographs of the impacted plates are presented in Figures 8 through 11. The impact side and the bottom side of the plate for Test Number 15, where the die diameter was 15.3 cm {6.0 inches} and the hammer height was 178.0 cm {70 inches}, are presented in Figure 8. In that test a punched-out plug was achieved which lodged inside the die. The impact side and the bottom side of the plate for Test Number 25 are presented in Figure 9. The die diameter for this test was 28.0 cm {11.0 inches} and the hammer height was 178.0 cm {70 inches}. The large crack generated probably started on one side of the bulge and propagated circumferentially toward the edges of the bulge. The impact sides and the bottom sides of the plates for Test Number 32 and 33 are presented in Figures 10 and 11 respectively. The die diameter was 35.0 cm {13.75 inches}. The crack in each plate was similar to the one generated in the previous test discussed. For those tests in which die diameters greater than 15.2 cm {6.0 inches} were used, the data indicates that ductile cracks forms rather than shear plugs. The responses of the plates consist of initial crack formation and crack enlargement as the hammer height is increased {more kinetic energy on impact}. The damage mechanism was probably severe thinning of the steel around the sides of the bulge as the tups penetrated and then the thinned metals separated by ductile fracture.

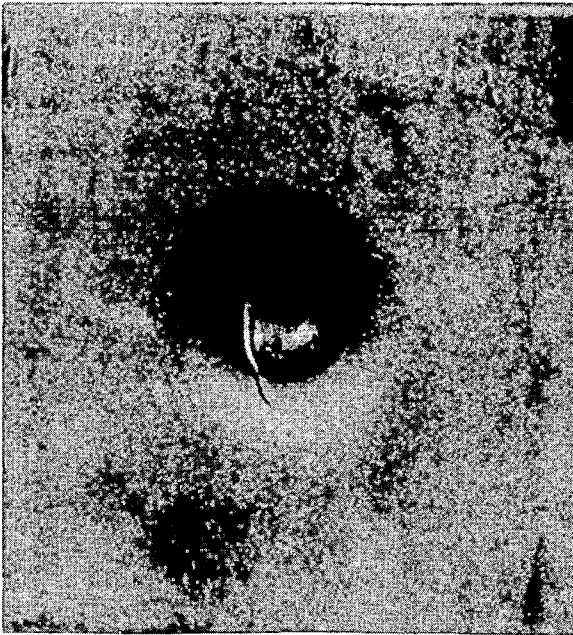
Figure 11: Steel Plate Response to 5.5 Inch Hemispherical Tup in Test Number 33

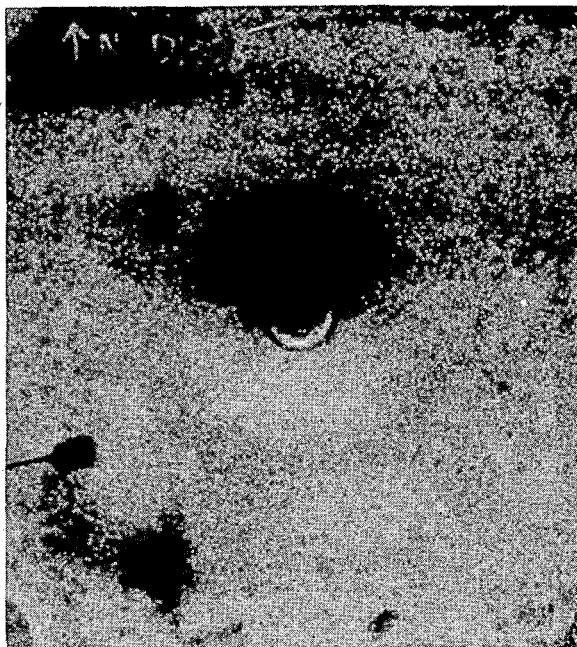
Figure 15: Steel Plate Response to 3.75 Inch Hemispherical Tip in Test Number 40

Figure 15 presents a view of the impact side and the bottom side of a sample impacted plate using the T_{MH} tup. The response of the plate was similar to that obtained for the larger hemispherical tup. Figure 16 presents a sample of the DM measurements for this group of tests which also is similar to the previously discussed group. The dent depth as functions of drop hammer energy/die area {joules/sq. cm} are presented in Figure 17. The trends are similar to the previous group's results but the dent depths are greater as anticipated.

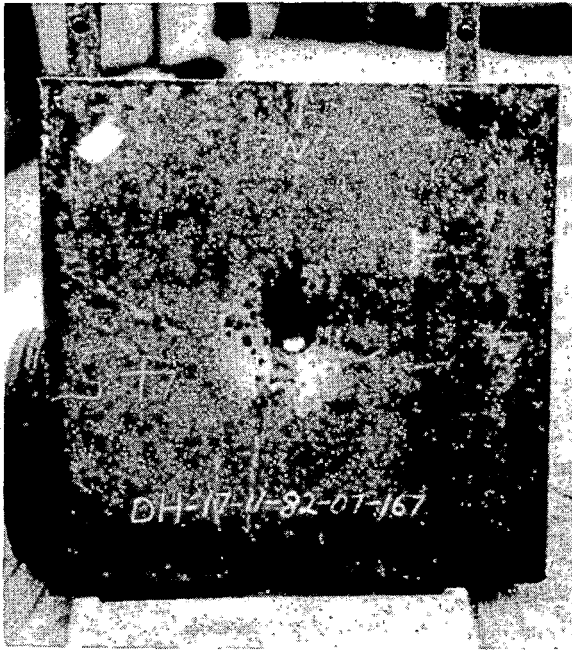
Figure 18: Steel Plate Response to 2.0 Inch Hemispherical Tup in Test Number 55

An example of one of the tests, where a 15.2 cm {6.0 inch} diameter die was used is presented in Figure 18. The imprint of the perimeter of the die is visible in both photographs. Figure 19 presents a sample DM measurement plot for Test Number 61 where a 21.0 cm {8.3 inch} diameter die was used. In general, the plates experienced a great deal of bending due to the relatively large distance between the edge of the die and the tup.

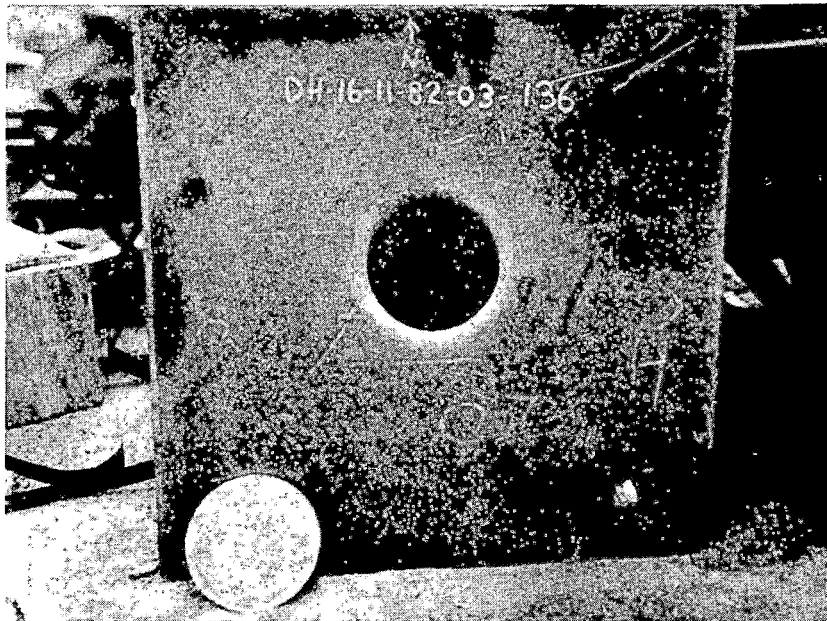
Figure B2: Steel Plate Response to 5.5 Inch Flat Tup in Test Number 2

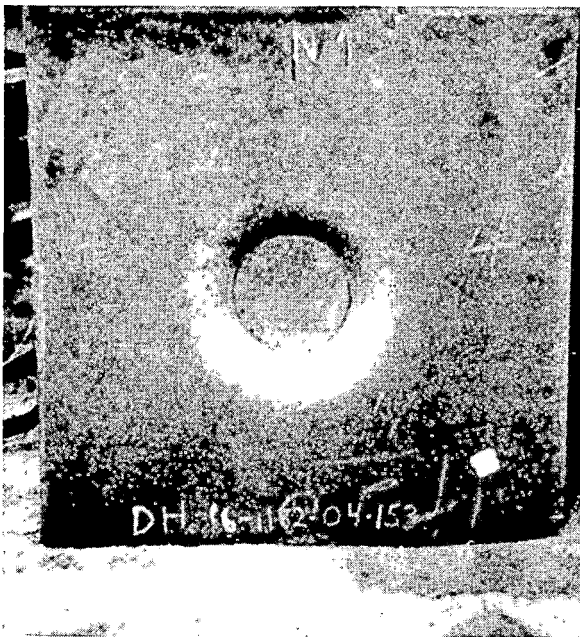
Figure B4: Steel Plate Response to 5.5 Inch Flat Tup in Test Number 4

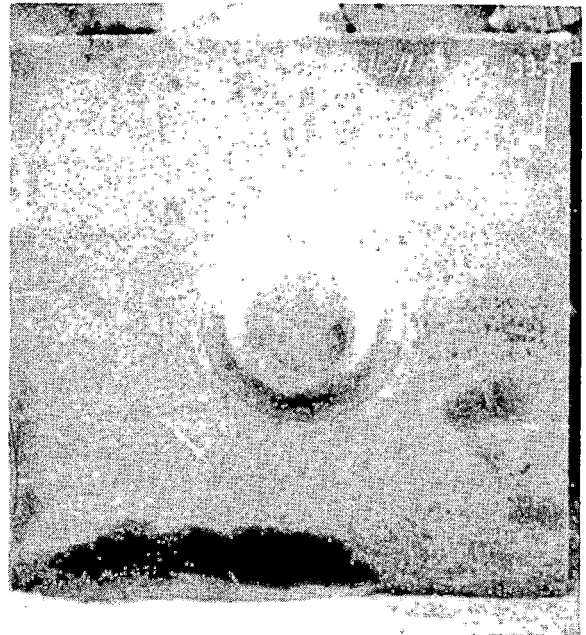
Figure B5: Steel Plate Response to 5.5 Inch Flat Tup in Test Number 5

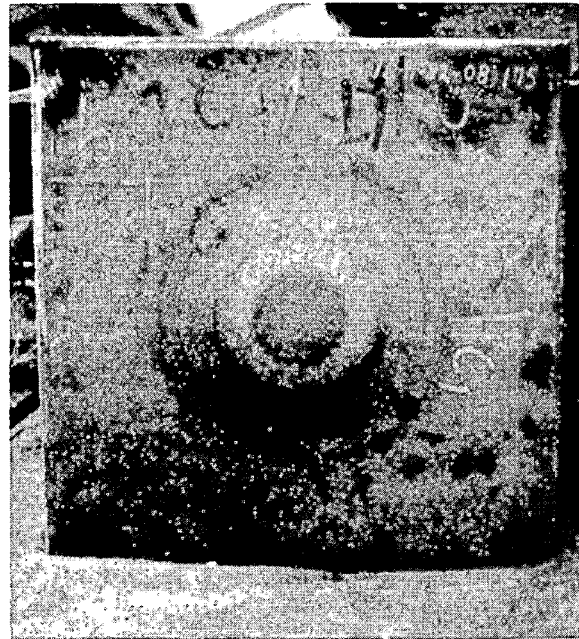
BOTTOM SIDE

Figure B8: Steel Plate Response to 5.5 Inch Flat Tup in Test Number 8

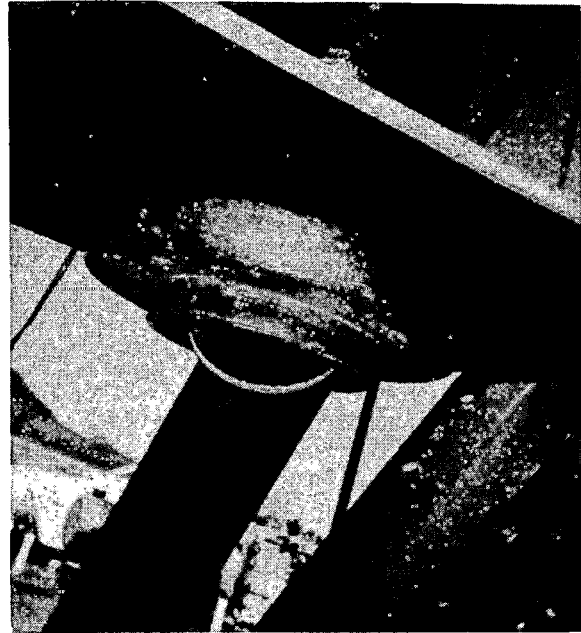
IMPACT SIDE

BOTTOM SIDE

Figure B15: Steel Plate Response to 5.5 Inch Hemispherical Tup in Test Number 15

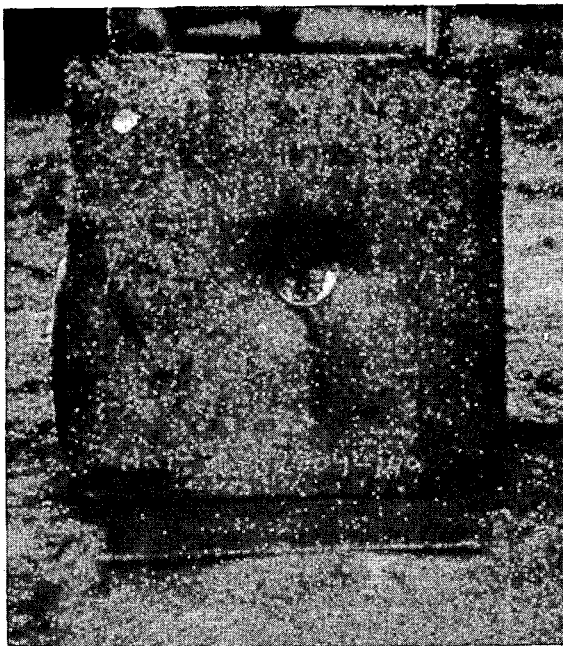
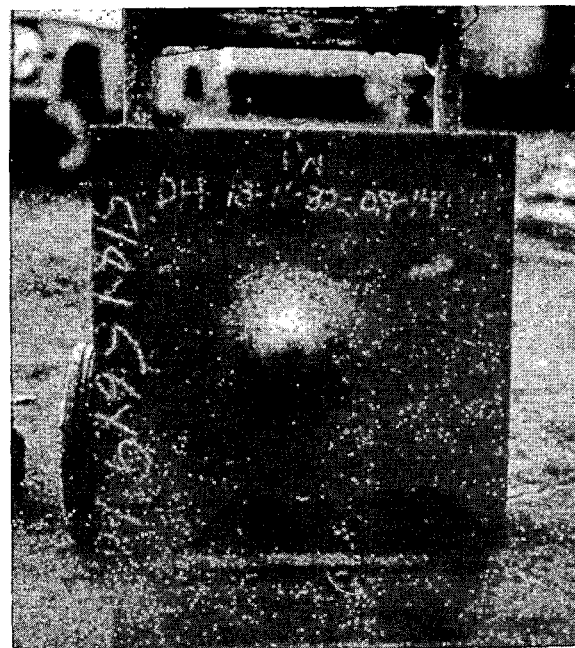
IMPACT SIDE

BOTTOM SIDE

Figure B18: Steel Plate Response to 5.5 Inch Hemispherical Tup in Test Number 18

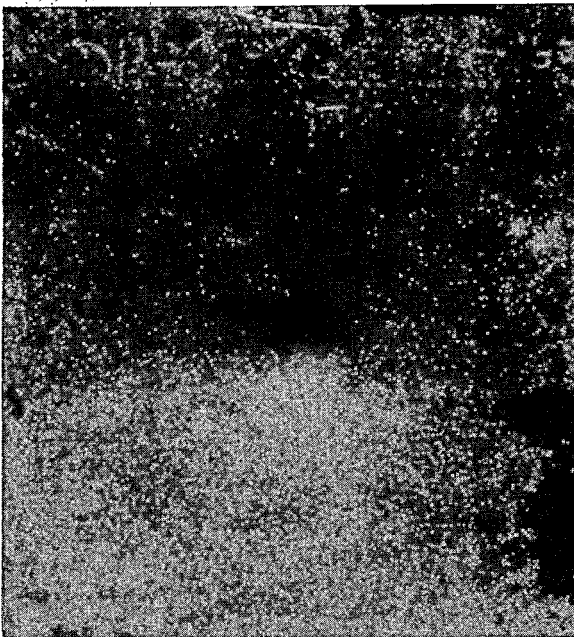
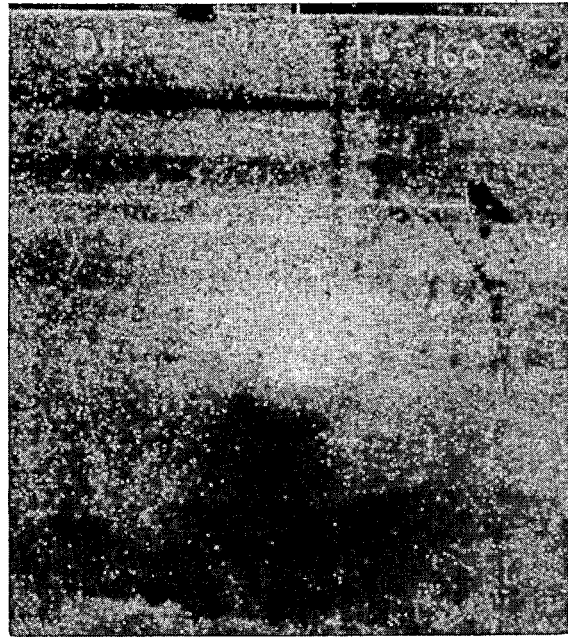
IMPACT SIDE

BOTTOM SIDE

Figure B26: Steel Plate Response to 5.5 Inch Hemispherical Tup in Test Number 26

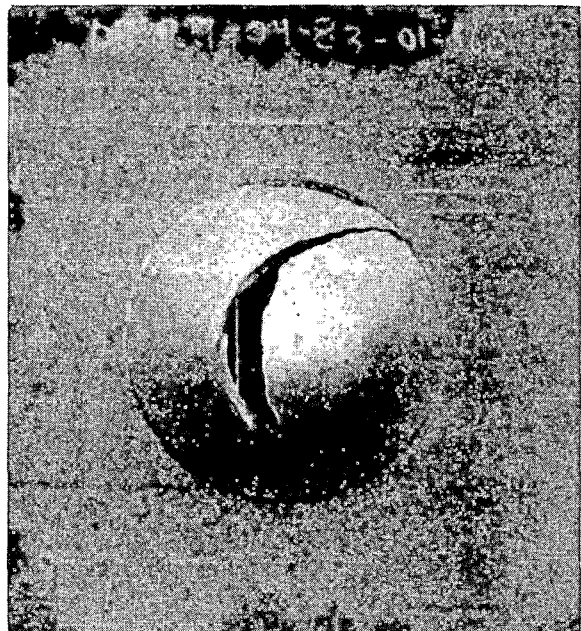
Figure B32: Steel Plate Response to 5.5 Inch Hemispherical Tup in Test Number 32

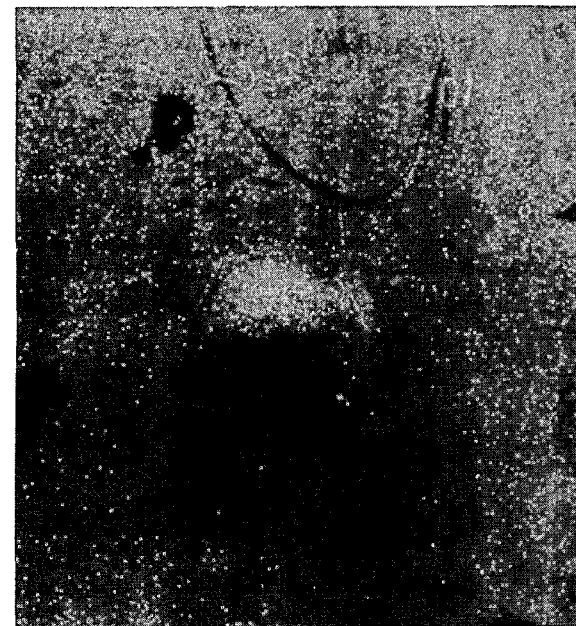
Figure B34: Steel Plate Response to 3.75 Inch Hemispherical Tup in Test Number 34

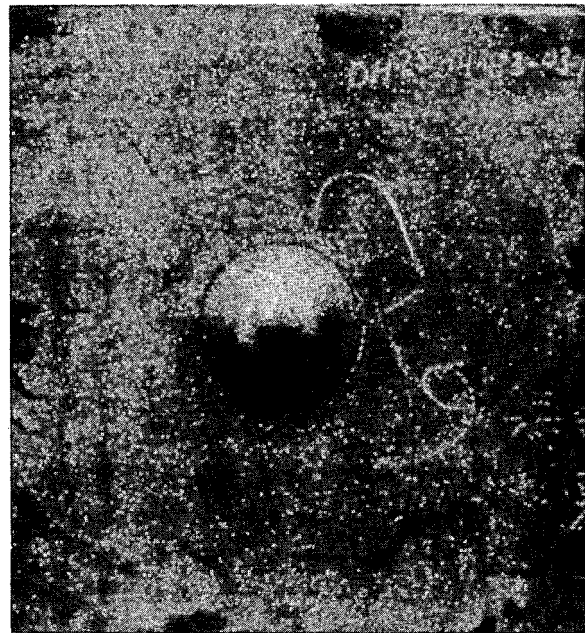
Figure B36: Steel Plate Response to 3.75 Inch Hemispherical Tup in Test Number 36

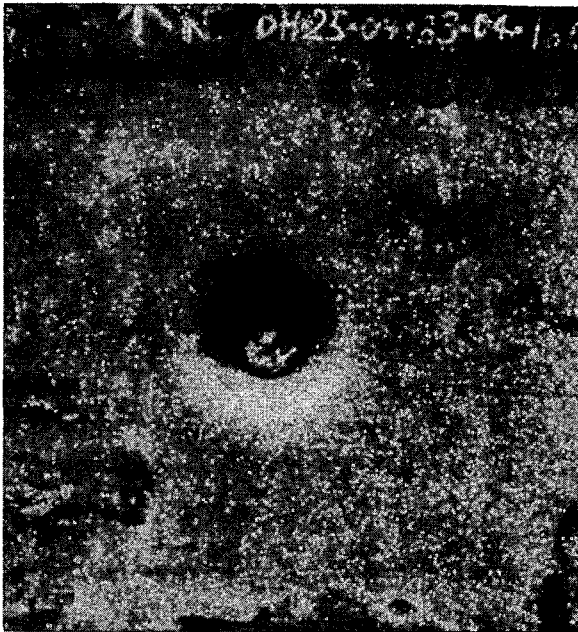
Figure B37: Steel Plate Response to 3.75 Inch Hemispherical Tup in Test Number 37

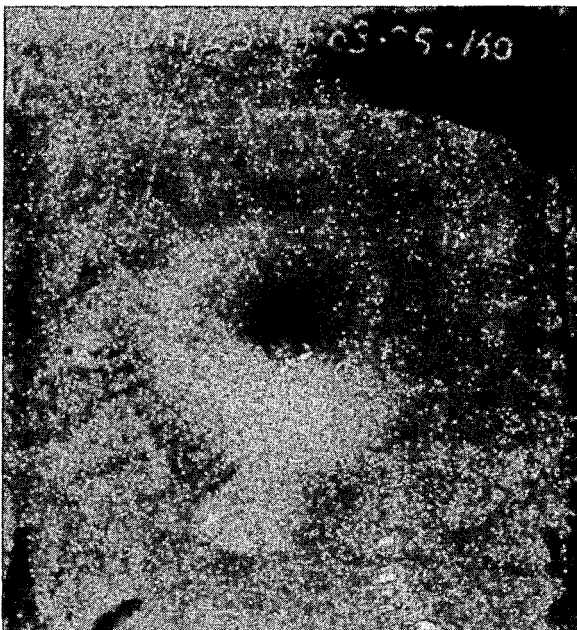
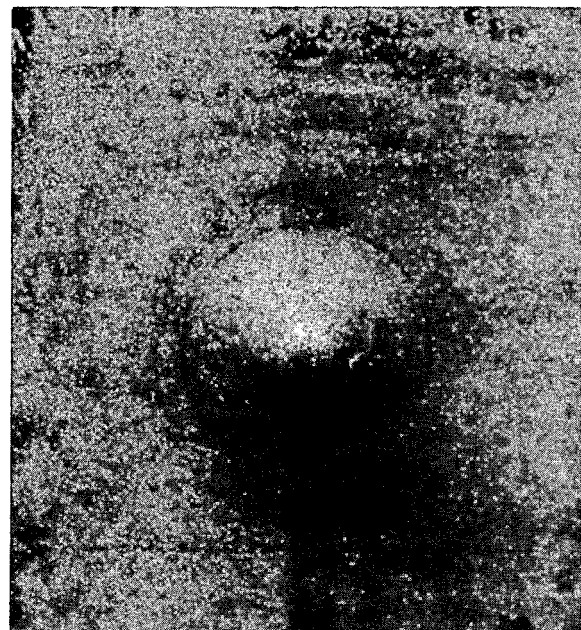
Figure B38: Steel Plate Response to 3.75 Inch Hemispherical Tup in Test Number 38

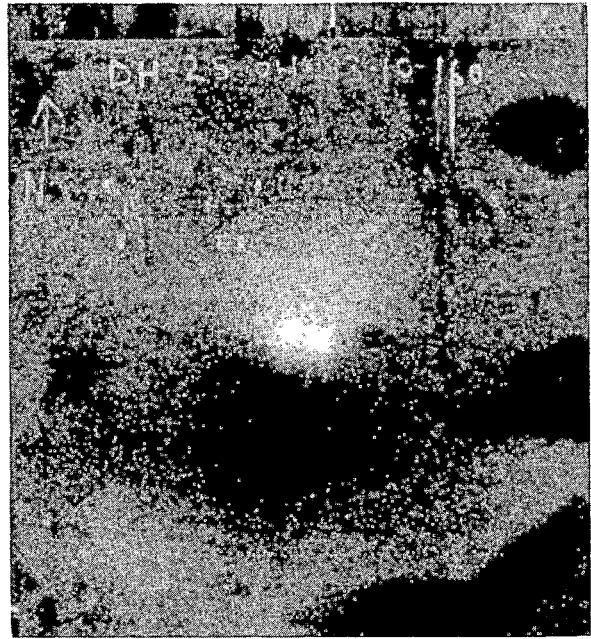
Figure B43: Steel Plate Response to 3.75 Inch Hemispherical Tup in Test Number 43

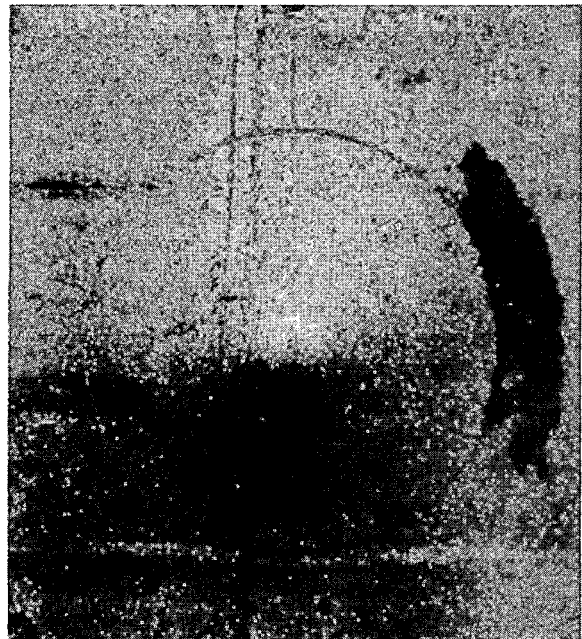
Figure B46: Steel Plate Response to 3.75 Inch Hemispherical Tup in Test Number 46

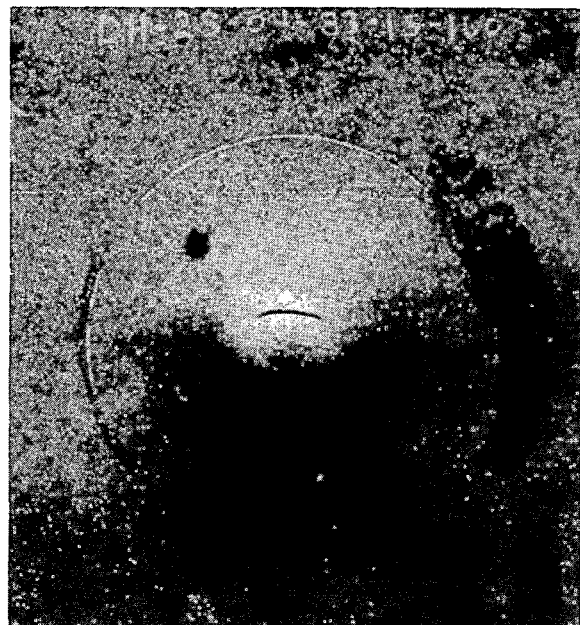
Figure B48: Steel Plate Response to 3.75 Inch Hemispherical Tip in Test Number 48

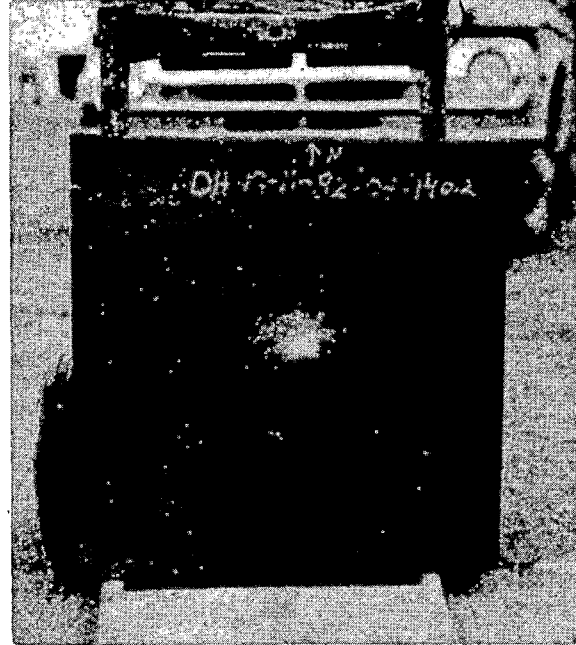
Figure B51: Steel Plate Response to 2 Inch Hemispherical Tup in Test Number 51

In practically all of the T_{SH} tup tests, visible cracks were observed on the bottom side of the plates at or near the apex of the bulges. The seriousness of this type of crack with respect to a tank car rupture cannot be estimated at the present. However, the data indicates that for a bend with a radius of curvature of 2.54 cm {1.0 inches} and a dent depth of 3.81 cm {1.5

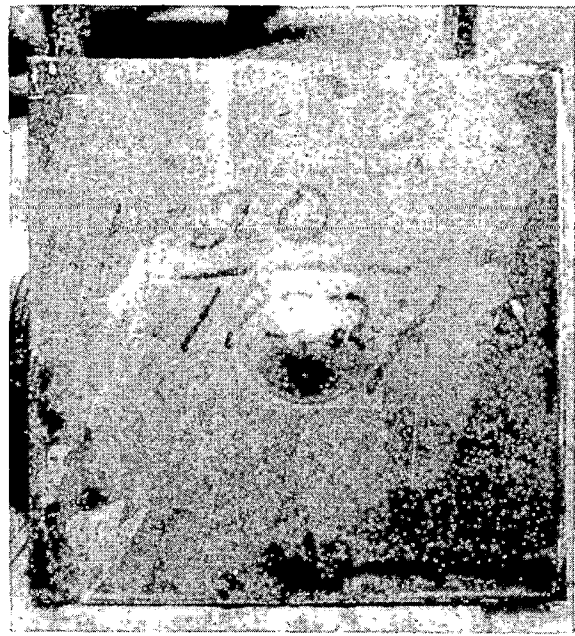
BOTTOM SIDE

Figure B54: Steel Plate Response to 2 Inch Hemispherical Tup in Test Number 54

IMPACT SIDE

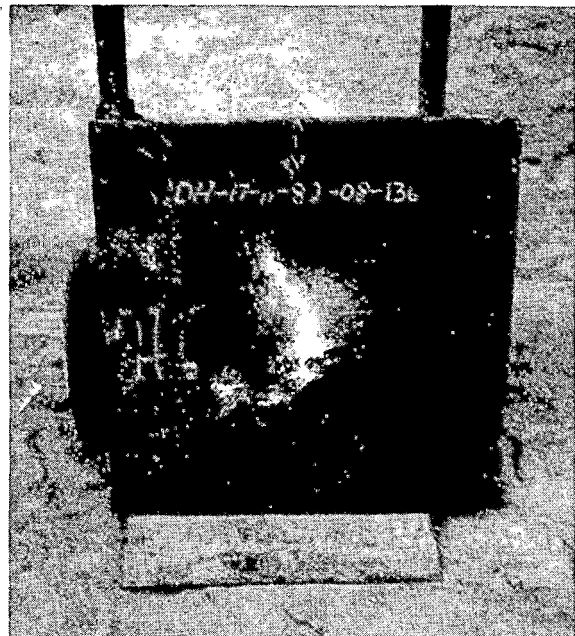
BOTTOM SIDE

Figure B55: Steel Plate Response to 2 Inch Hemispherical Tup in Test Number 55

IMPACT SIDE

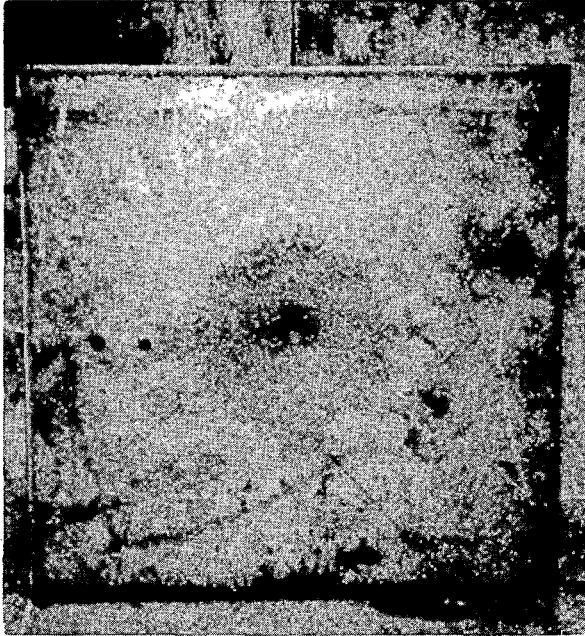
BOTTOM SIDE

Figure B56: Steel Plate Response to 2 Inch Hemispherical Tup in Test Number 56

IMPACT SIDE

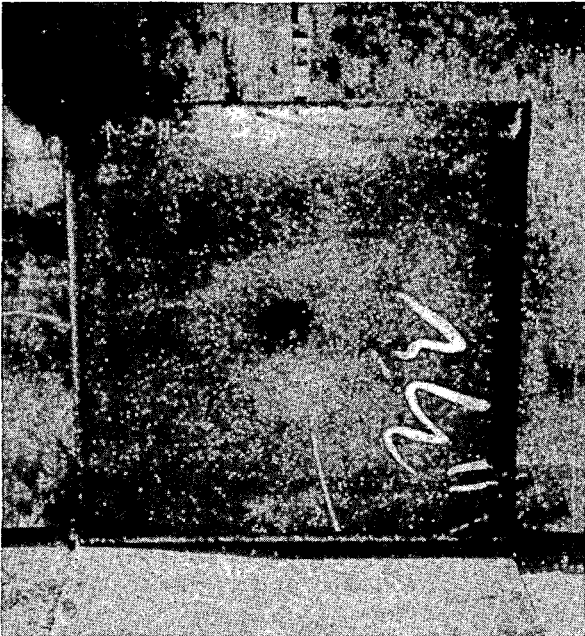
BOTTOM SIDE

Figure B57: Steel Plate Response to 2 Inch Hemispherical Tup in Test Number 57

IMPACT SIDE

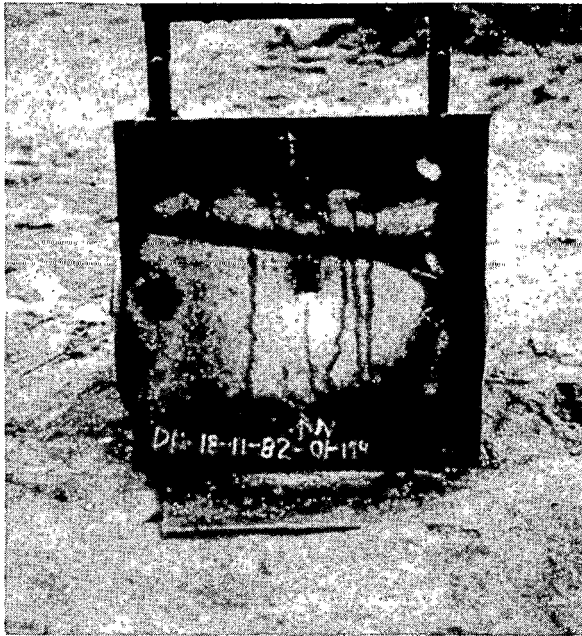
BOTTOM SIDE

Figure B58: Steel Plate Response to 2 Inch Hemispherical Tup in Test Number 58

IMPACT SIDE

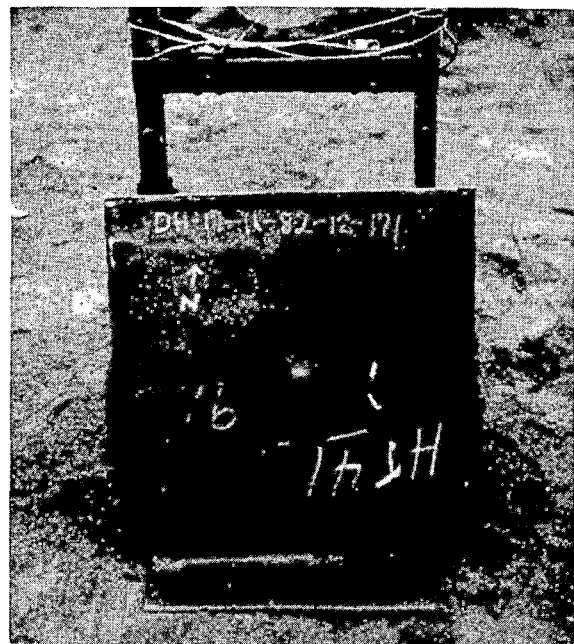
BOTTOM SIDE

Figure B59: Steel Plate Response to 2 Inch Hemispherical Tup in Test Number 59

IMPACT SIDE

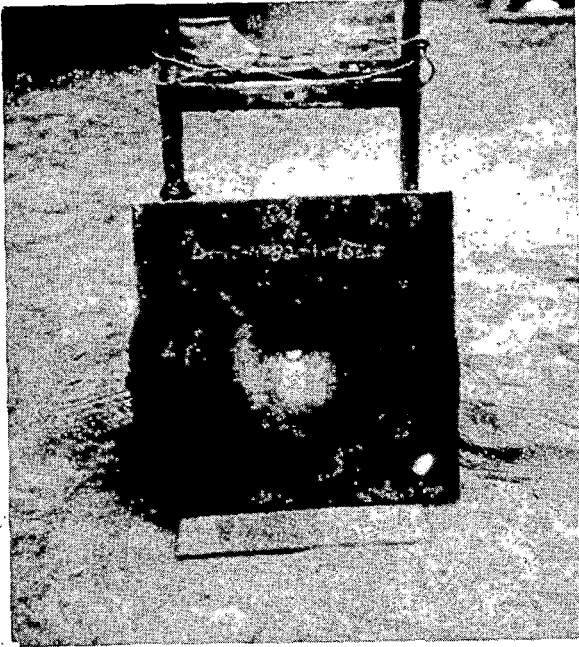
BOTTOM SIDE

Figure B60: Steel Plate Response to 2 Inch Hemispherical Tup in Test Number 60

IMPACT SIDE

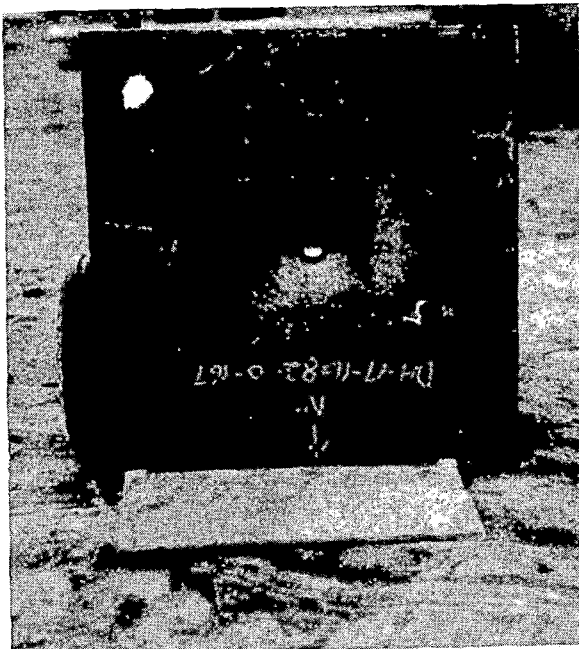
Figure Bb1: Steel Plate Response to 2 Inch Hemispherical Tip in Test Number 61

IMPACT SIDE

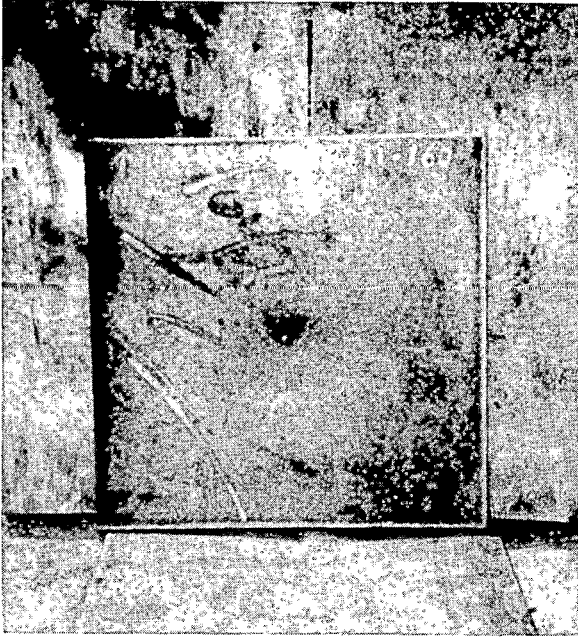
BOTTOM SIDE

Figure Bb2: Steel Plate Response to 2 Inch Hemispherical Tip in Test Number 62

IMPACT SIDE

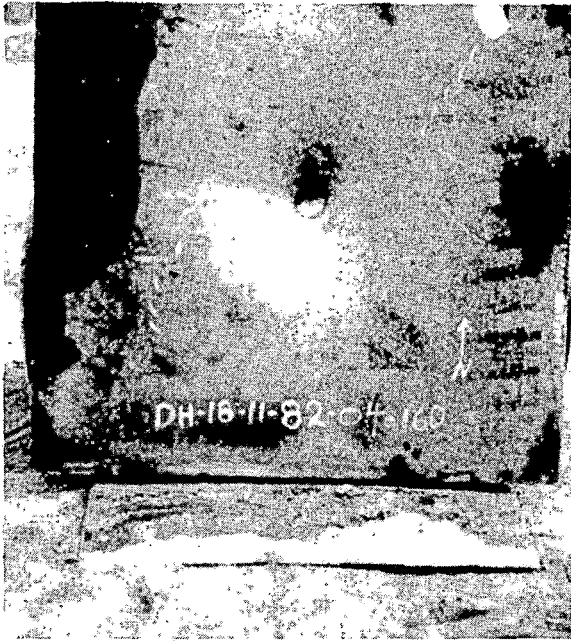
BOTTOM SIDE

Figure B64: Steel Plate Response to 2 Inch Hemispherical Tup in Test Number 64

IMPACT SIDE

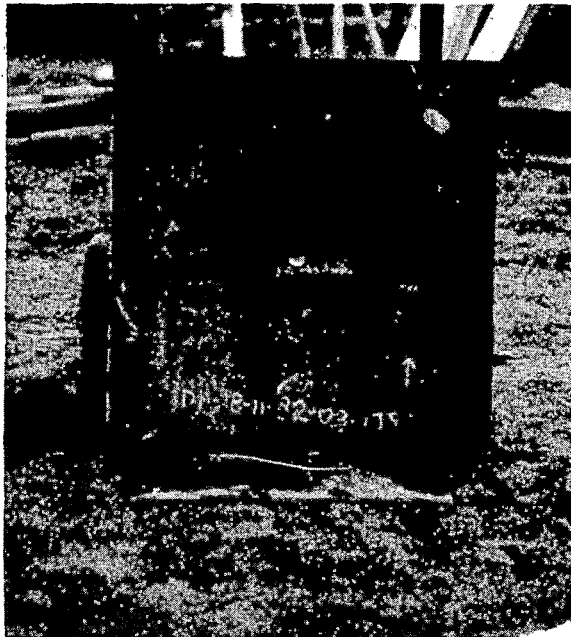
BOTTOM SIDE

Figure B65: Steel Plate Response to 2 Inch Hemispherical Tup in Test Number 65

IMPACT SIDE

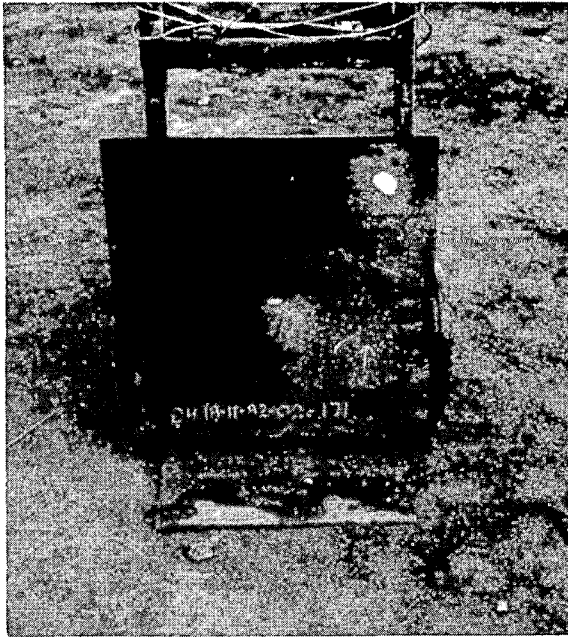
BOTTOM SIDE

Figure B66: Steel Plate Response to 2 Inch Hemispherical Tup in Test Number 66

IMPACT SIDE

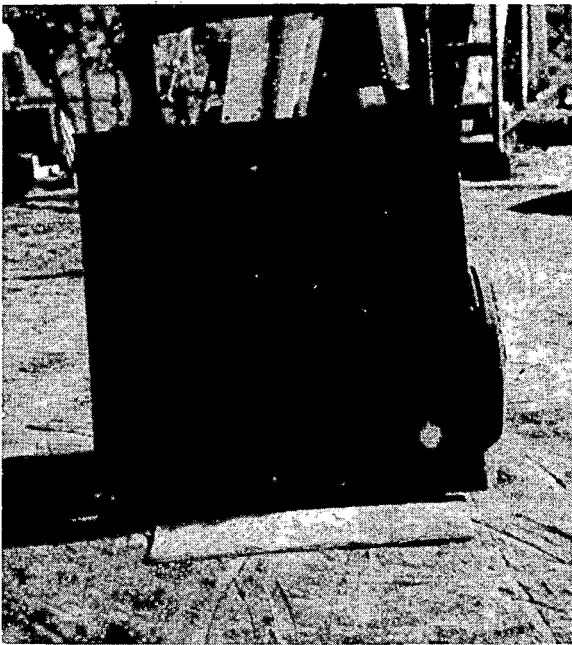
BOTTOM SIDE

Figure B69: Steel Plate Response to 2 Inch Hemispherical Tup in Test Number 69

IMPACT SIDE

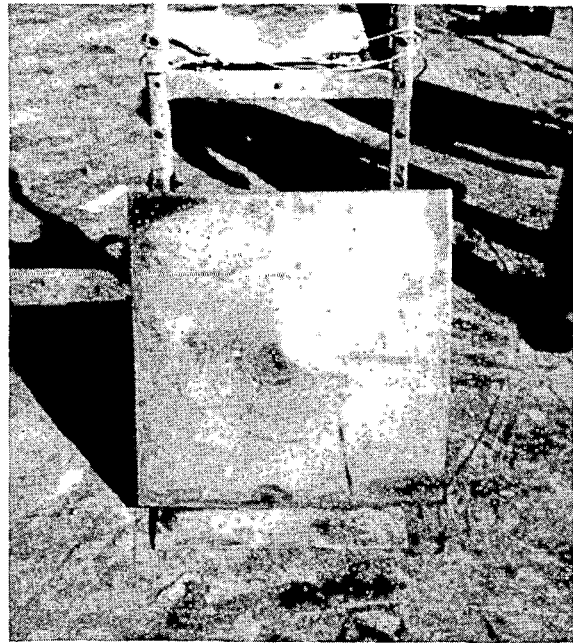
BOTTOM SIDE

Figure B70: Steel Plate Response to 2 Inch Hemispherical Tup in Test Number 70

IMPACT SIDE
