FULL-SCALE SHELL IMPACT TEST OF A DOT-105 TANK CAR

SUMMARY

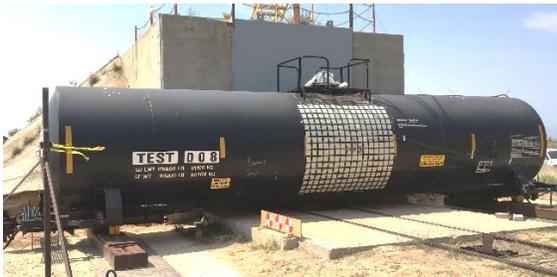
On August 1, 2018, the Federal Railroad Administration (FRA) conducted a full-scale shell impact test of a DOT-105A500W (DOT-105) tank car at the Transportation Technology Center (TTC) in Pueblo, CO. The shell of the car was struck at its mid-length by a 297,000 pound ram car equipped with a 6-inch by 6-inch impactor. [Figure 1](#) shows the tank car in its pre-test position against the impact wall at TTC.

Figure 1. Pre-test Photo of DOT-105 Tank Car

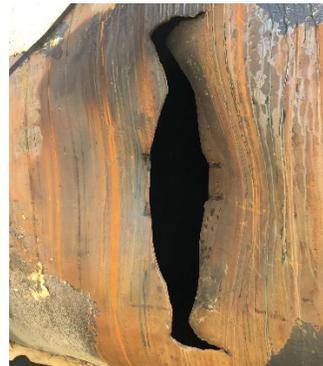
The tank was punctured after an indentation of 27 inches, at a peak force of ~840,000 pounds. Based on review of the test measurements, the impactor slowed to less than 1 mph when puncture occurred, confirming the model prediction that an impact speed of 9.7 mph only slightly exceeds the speed necessary to puncture this tank car. [Figure 2](#) shows the vertical tear in the post-test shell.

Figure 2. Post-test Photo of the Punctured Shell with Jacket Cut Out
