Railroad Infrastructure Trespassing Detection Systems Research in Pittsford, New York

Highway-Railroad Grade Crossing Safety Research

DOT/FRA/ORD-06/03-1

Final Report
(revised)
November
2012

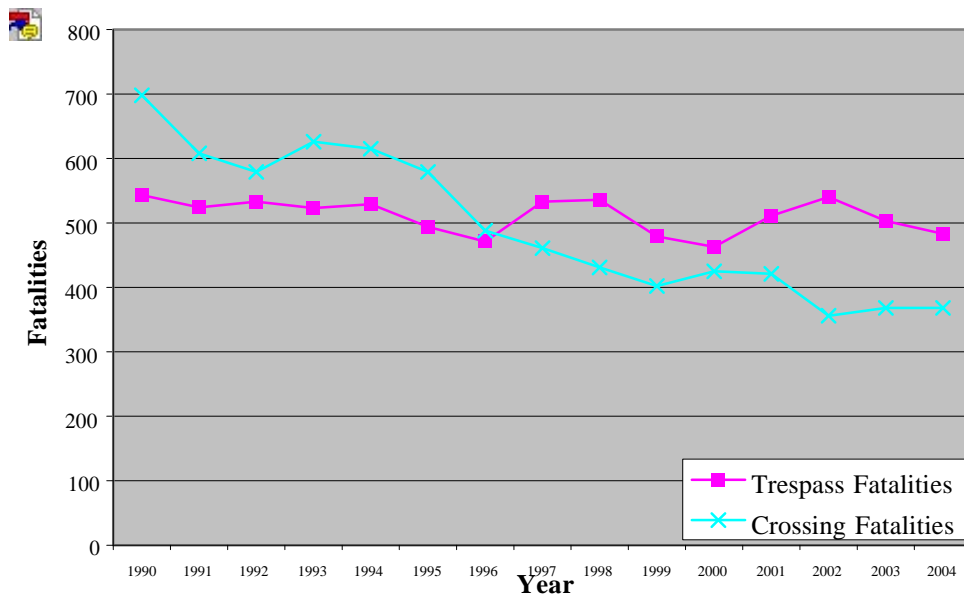
Figure 1. Railroad Trespassing/Crossing Fatalities (1990-2004)

Trespassing on railroads' ROW has long been a safety concern, especially since many tragic incidents involve children and young adults. While railroad crossing-related incidents have been on a recent declining trend, trespassing fatalities have been holding steady at an average of just over 500 per year. As seen in Figure 1, the trespassing problem actually surpassed the crossing problem in 1996, the first year in which trespass-related fatalities outnumbered crossing-related fatalities [1]. Railway security is another developing concern, which has been gaining much more scrutiny since the terrorist events of September 2001, as well as the recent Madrid, Moscow, and London train bombings. Securing rolling stock, as well as the infrastructure (track and signals/switches, bridges, tunnels, and facilities), has become a top issue within the rail industry, as well as within all levels of government.

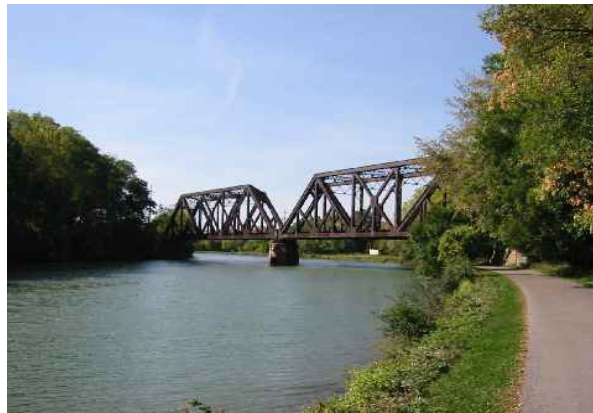
Figure 2. Railroad Bridge Chosen for Demonstration Project

A through-truss railroad bridge built in 1918 and owned by CSX Transportation was chosen for this demonstration project and is shown in Figure 2. The selection of this bridge, located in Pittsford, New York, was based both on the 1997 incident resulting in two trespass fatalities, as well as the bridge's prior trespassing history. Although not documented, teenagers have been historically known to use this railroad bridge as a meeting place, and locals were using it as a shortcut. A pedestrian walkway that passes under the bridge on the eastern approach provides easy access to the bridge. The bridge is also often used as a fishing spot. The bridge itself lies about 800 feet east of the Monroe Avenue railroad crossing and spans the Erie Canal (see Figure 3). It is situated at CSX Milepost 353.4, and the nearest crossing is designated identification number 521097M. The bridge was originally double-tracked, but only one track remains in place. The route serves as a mainline bypass around the city of Rochester and has centralized traffic control. An average of approximately nine freight trains travel over the bridge per day at speeds up to 60 mph. No regular passenger service exists on this line. The canal carries light boat traffic from May through November.

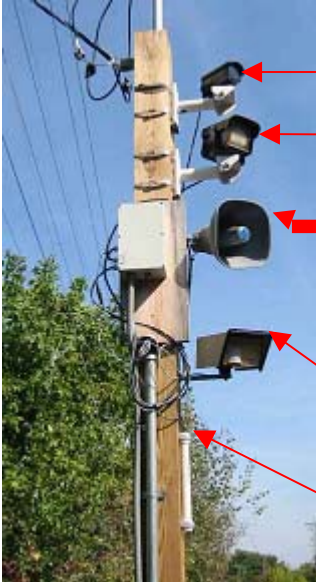
Figure 6. Pole Configured with Monitoring and Detection Components

- Video Camera: daytime color and nighttime black and white.
- Infrared Illuminator: floods the scene with infrared lighting during nighttime, triggered by photoelectric sensor, invisible to human eye.
- Speaker: connected to a telephone line so that an authorized official can dial in and warn the trespassers via the amplified speaker system.
- Motion Detector: dual-technology motion detector combining stereo Doppler microwave technology (motion detection) with a dual element passive infrared sensor (heat detection).
- Magnetometer: used to screen out trains.

Planning and design began in 1999, and the system was installed in August 2001. Several surveillance approaches were extensively researched, and a potential system was drawn up as shown in Figure 5. The system was composed of video cameras, motion detectors, infrared illuminators, magnetometers, and speakers mounted on two poles, one on each end of the bridge monitoring the bridge entrance. A central processing unit (CPU), located on one of the poles and equipped with a remote video surveillance software package, received all of the inputs from these components and served as a communication point to the monitoring station as well as a repository for alarm images. Figure 6 shows a picture of one of the poles along with a brief description of each component.

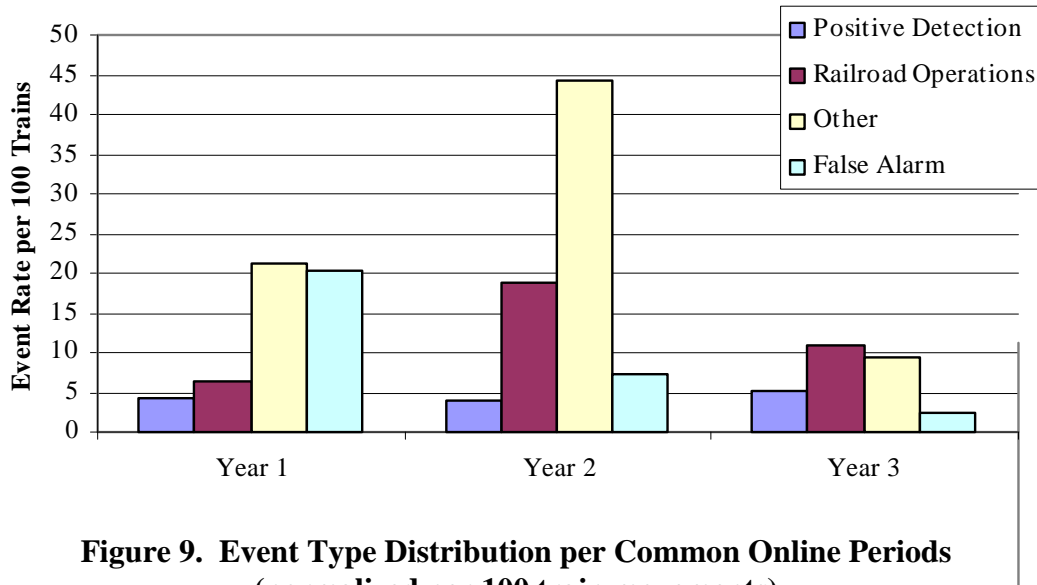
Figure 9. Event Type Distribution per Common Online Periods (normalized per 100 train movements)

Figure 9 shows the normalized distribution (per 100 train movements) of the four event types per Common Online Periods encompassing 129 days in each of the 3 years. This shows a dramatic decrease in false alarm events over time. It also reflects the overall alarm event rate decrease achieved by the third year. When comparing Year 1 to Year 3, the overall alarm rate was reduced by roughly half, from 52 to 28 alarm events per 100 train movements.

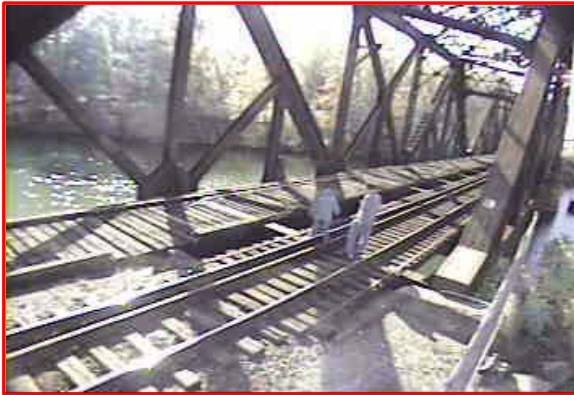
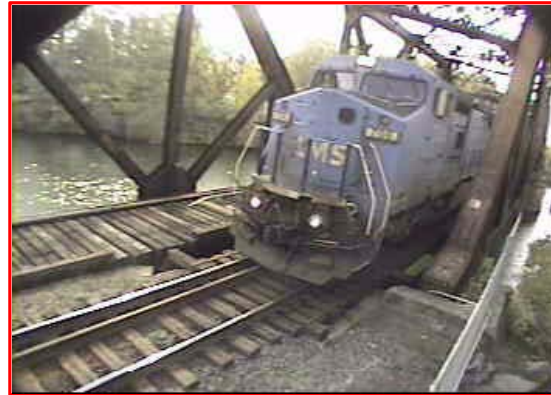
Event 1: At 1:40 p.m. on October 20, 2001, two teens were detected on the east end of the bridge and were subsequently warned by the Doyle Security attendant (Figure 13a). They left the scene, and the system recorded the presence of an eastbound train 1 minute later (Figure 13b).

Figure 13a. Two Trespassers at 1:40 p.m.

Figure 13b. Train at 1:41 p.m.

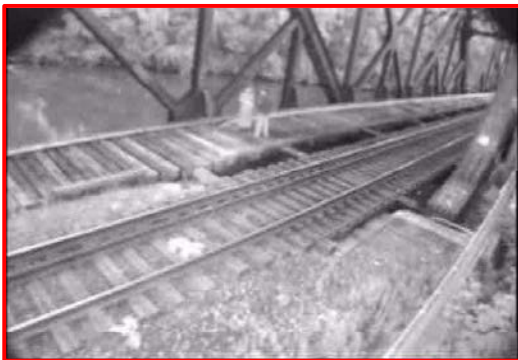
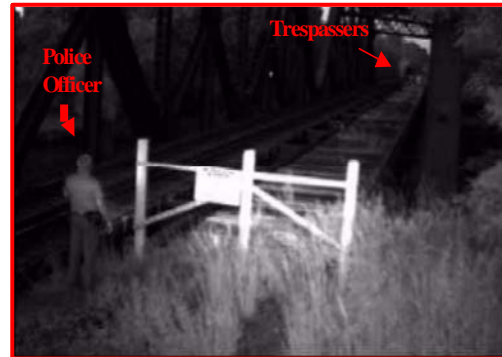
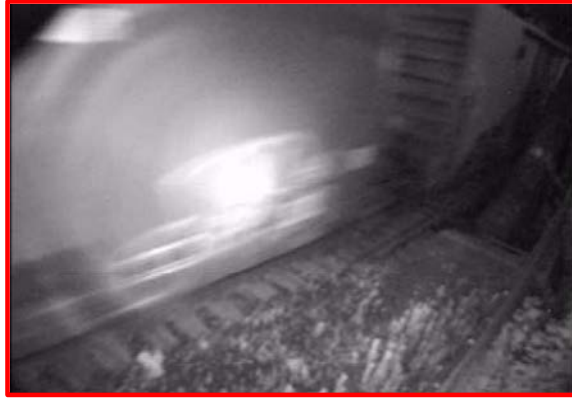
Event 2: At 9:11 p.m. on June 20, 2002, two trespassers were detected on the east end of the bridge (Figure 14a). They were immediately warned by the Doyle Security attendant but did not leave the area. The attendant followed procedures and notified the local police who responded to the scene and physically removed the trespassers from the bridge at 9:28 p.m. (Figure 14b). The detection system then recorded the presence of a train 5 minutes later (Figure 14c).

Figure 14a. Two Trespassers at 9:11 p.m.

Figure 14b. Police at 9:28 p.m.

Figure 14c. Train at 9:33 p.m.

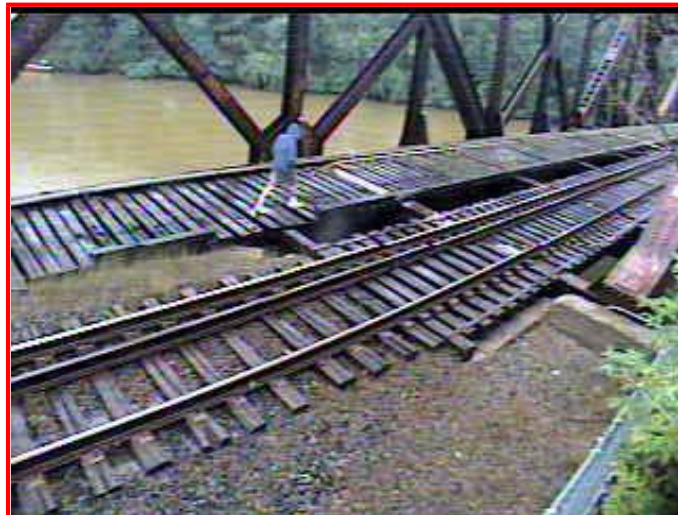
Figure 15. Trespasser Detected at 6:28 a.m.

Event 3: At 6:28 a.m. on September 8, 2004, one person was detected on the east end of the bridge and proceeded to walk across the bridge. The Doyle Security attendant subsequently warned the trespasser. He/she left the scene and the Doyle Security attendant noted the presence of a train immediately after.
