VSP Technologies

Six Sigma Fluid Sealing Management

FRA Region 8 - Billings, MT September 2013

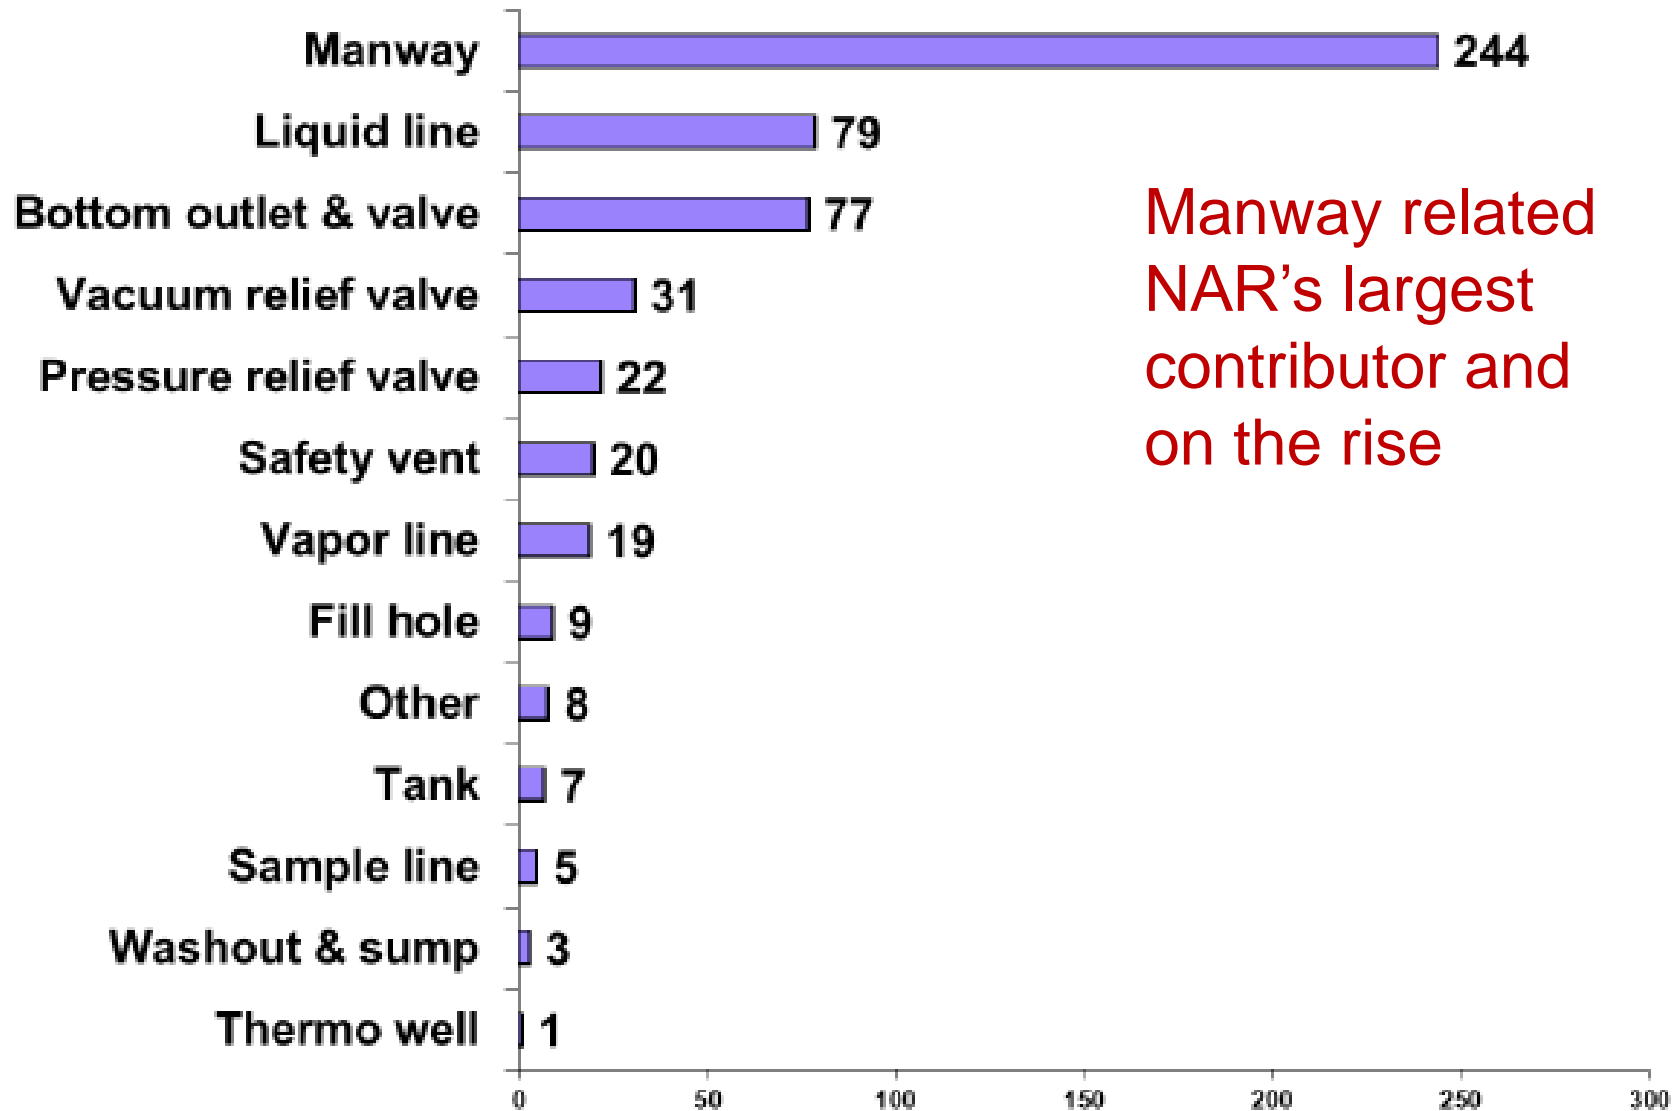
2012 Non-Pressure Car NARs By Component

Manway related
NAR's largest
contributor and
on the rise

Source: AAR/BOE NAR data

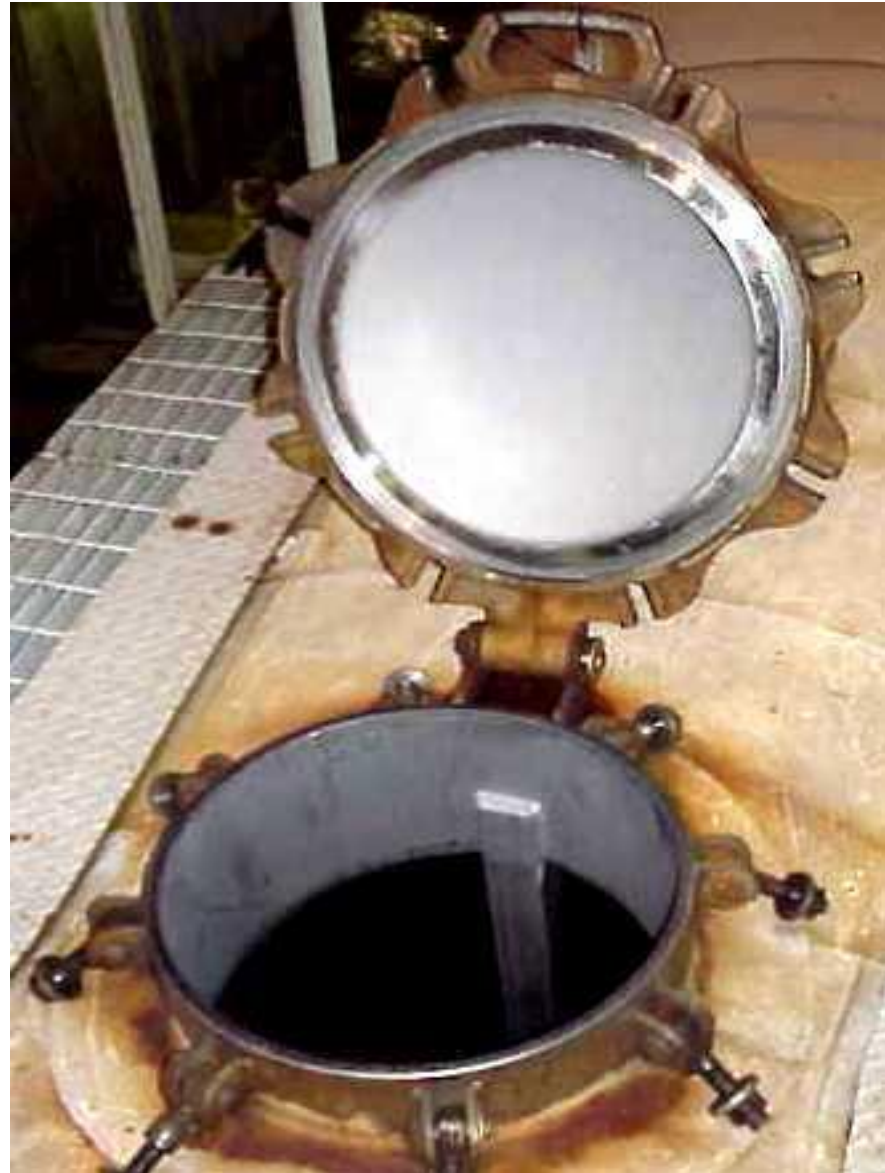
- 20" GP Manway typically 6 or 8 bolts 7/8" or 1"
- NPS 20 Class 150 has (20 1-1/8" bolts)
- Typical Torque Values for Manways

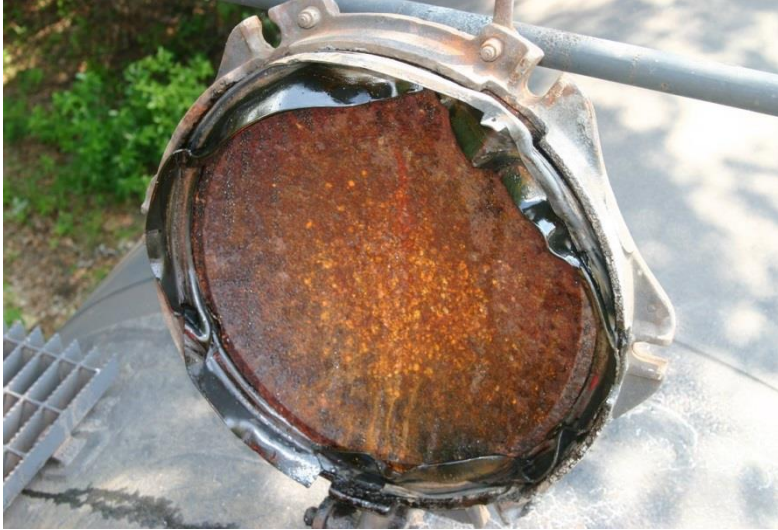
Typical GP Railcar Manway Gasket Damage

Buna-N (Nitrile) in Asphalt
[Buna-N = 200°F, Asphalt = 400°F]

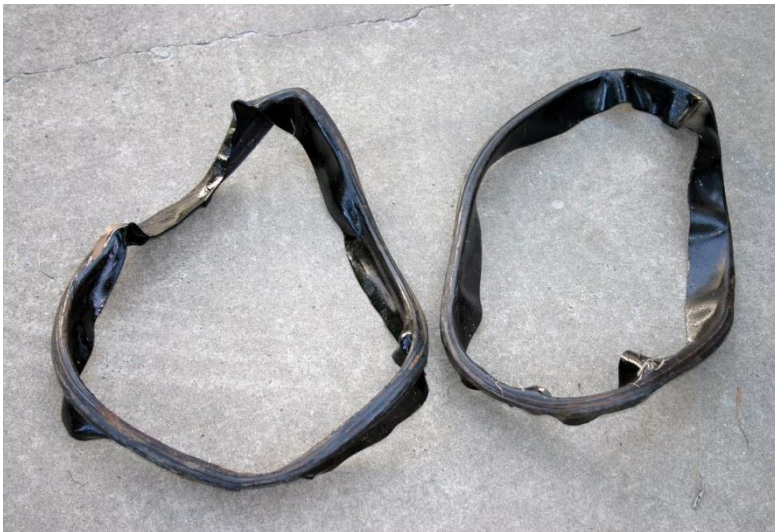
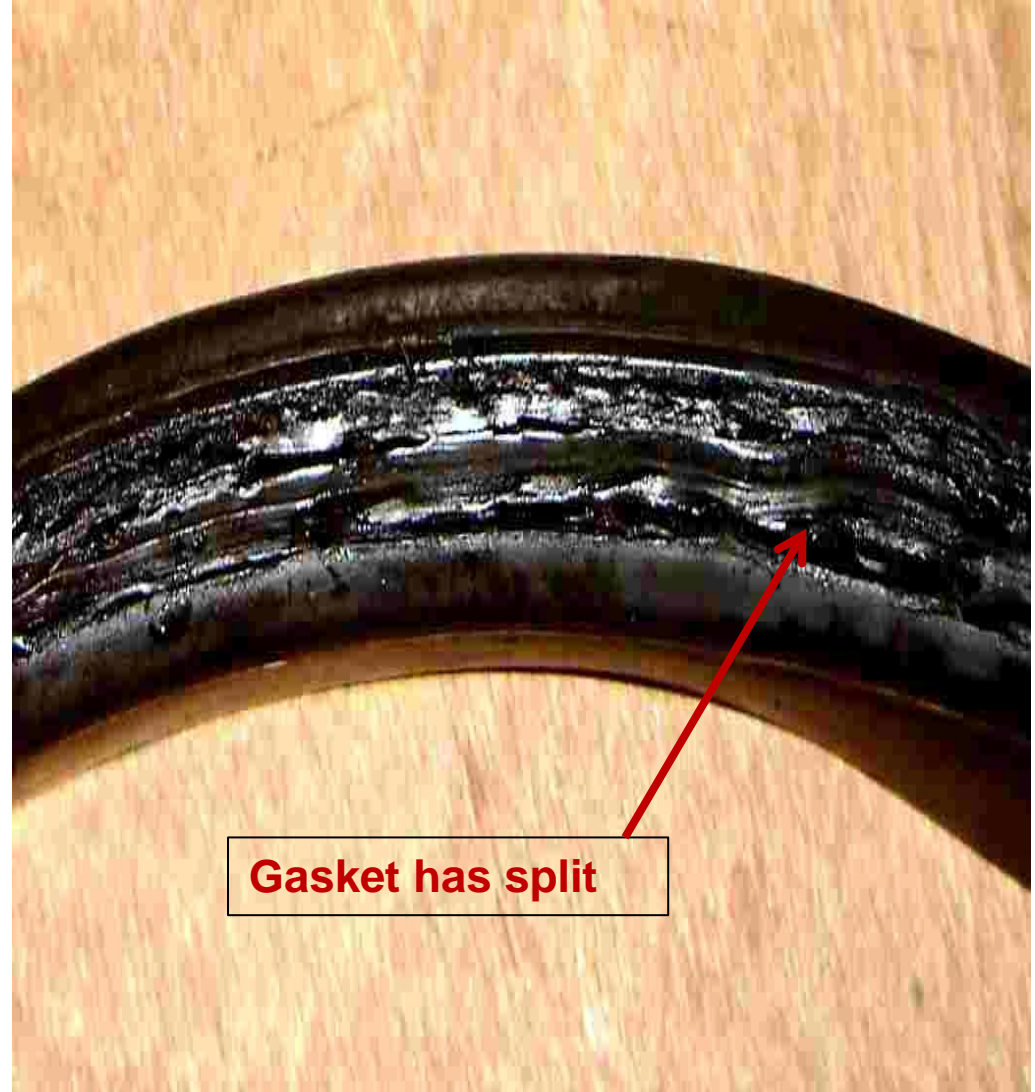
Gasket has split

Viton® in Asphalt [Viton® 450°F, Asphalt = 400°F]

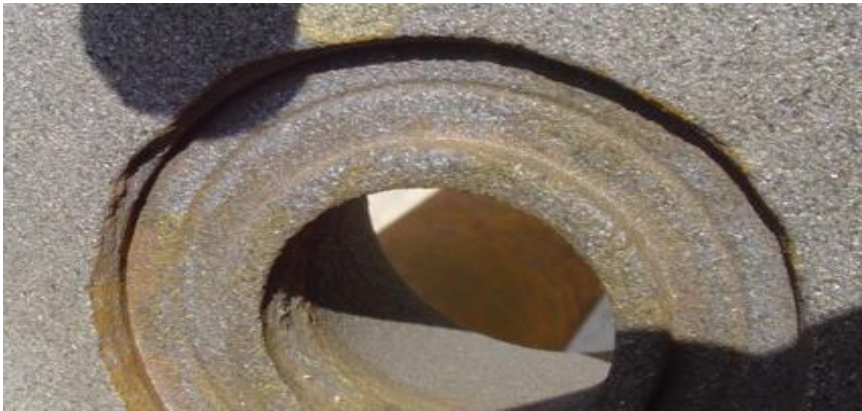
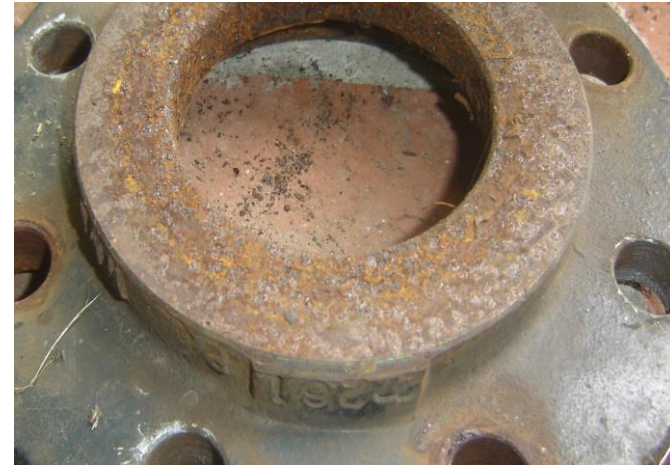
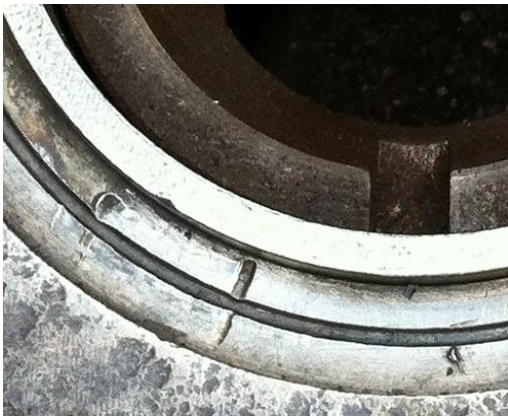
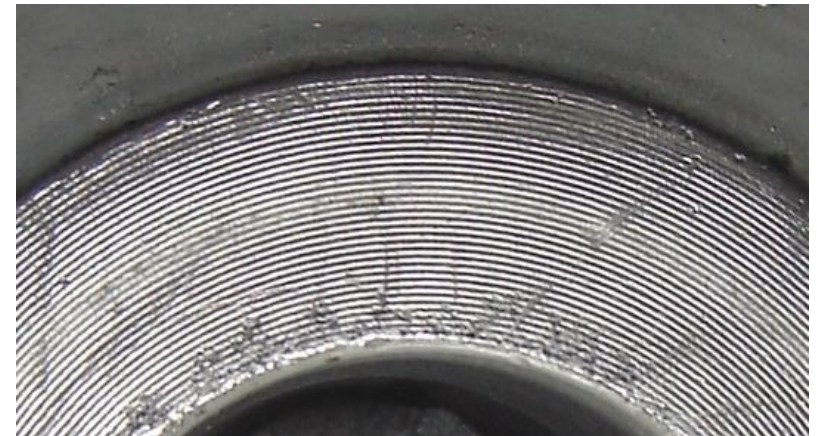
Flange Inspection and Cleaning

Before a flange can be reassembled a proper inspection must be performed to ensure the flanges are free of nicks, pits, and/or gouges that could prevent the gasket from performing its intended function reliably. The examples below illustrate flanges with damage that should be documented and reported to the customer to receive approval for reassembly.

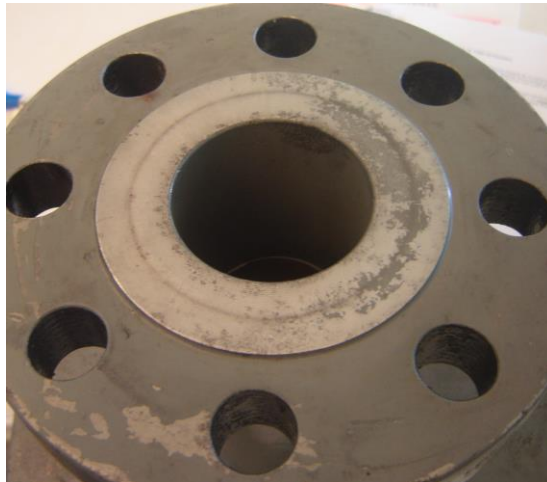
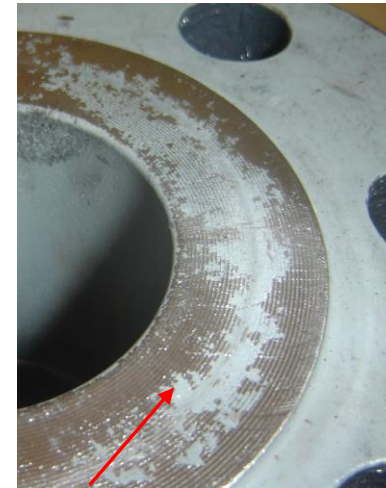
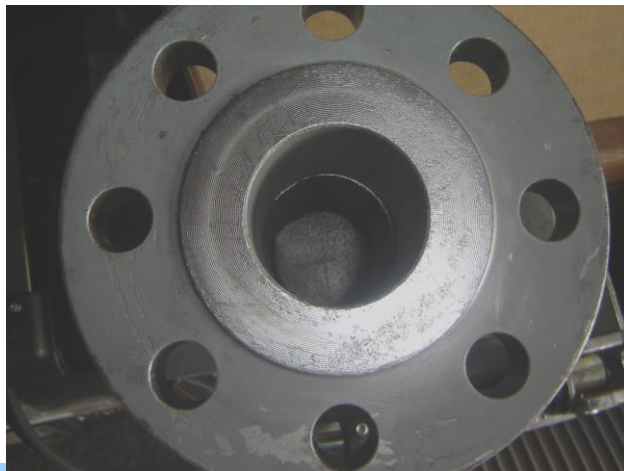
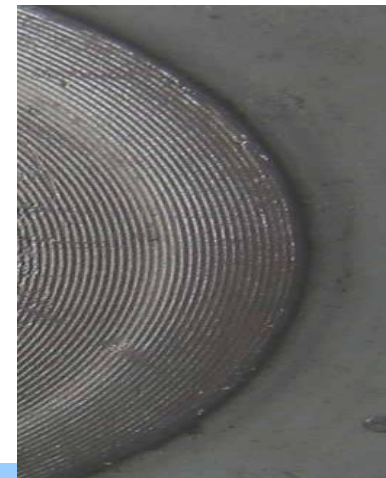
Flange Inspection and Cleaning

Before a flange can be reassembled a proper inspection must be performed to ensure the flanges are true and free of contamination. The presence of contamination on the flange sealing surface can prevent the gasket from performing its intended function reliably. The below examples illustrate a flange with contamination and how it should look after being cleaned adequately.

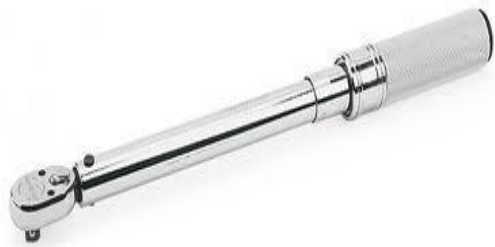
Provides Controlled Assembly

Zero Torque Wrench before storing

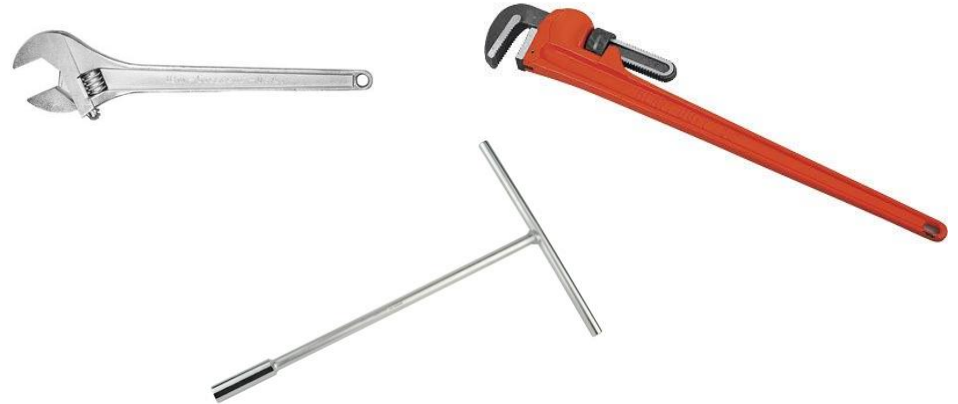
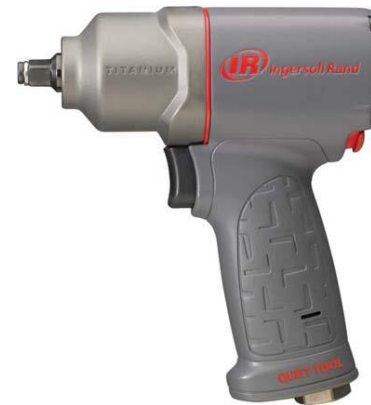
RAD® 350SL

Pneumatic Torque Wrench

Uncontrolled Assembly

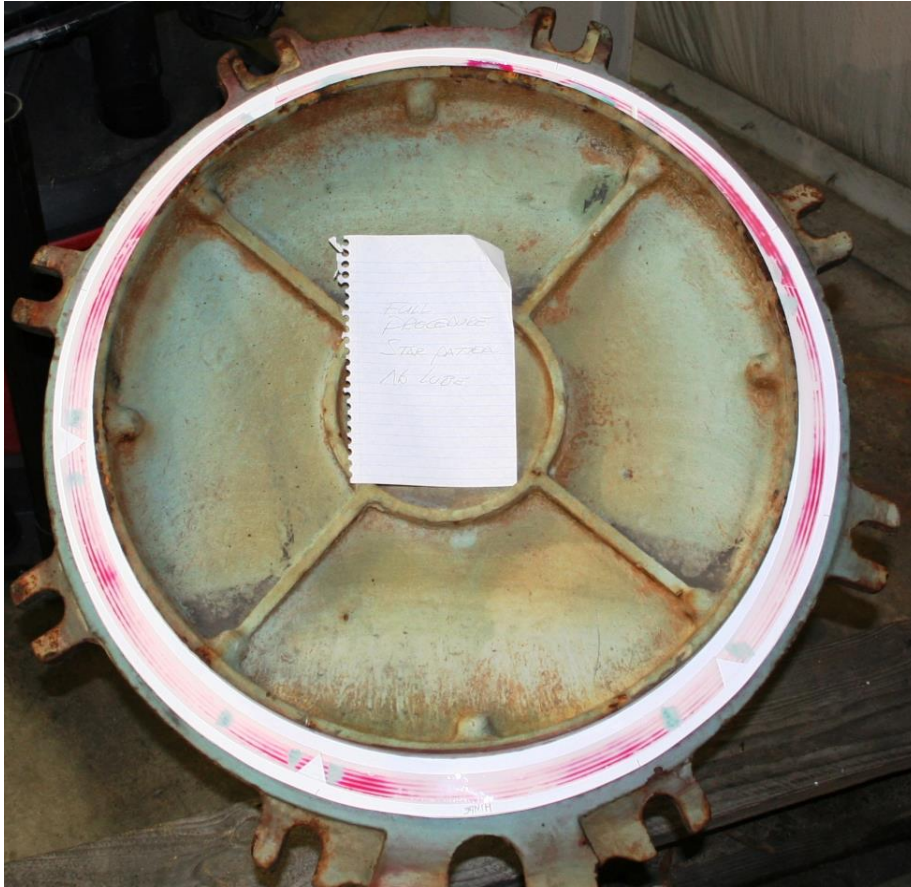
Unlubricated Eyebolts
**Non-Uniform, Lower Overall
Gasket Stress**

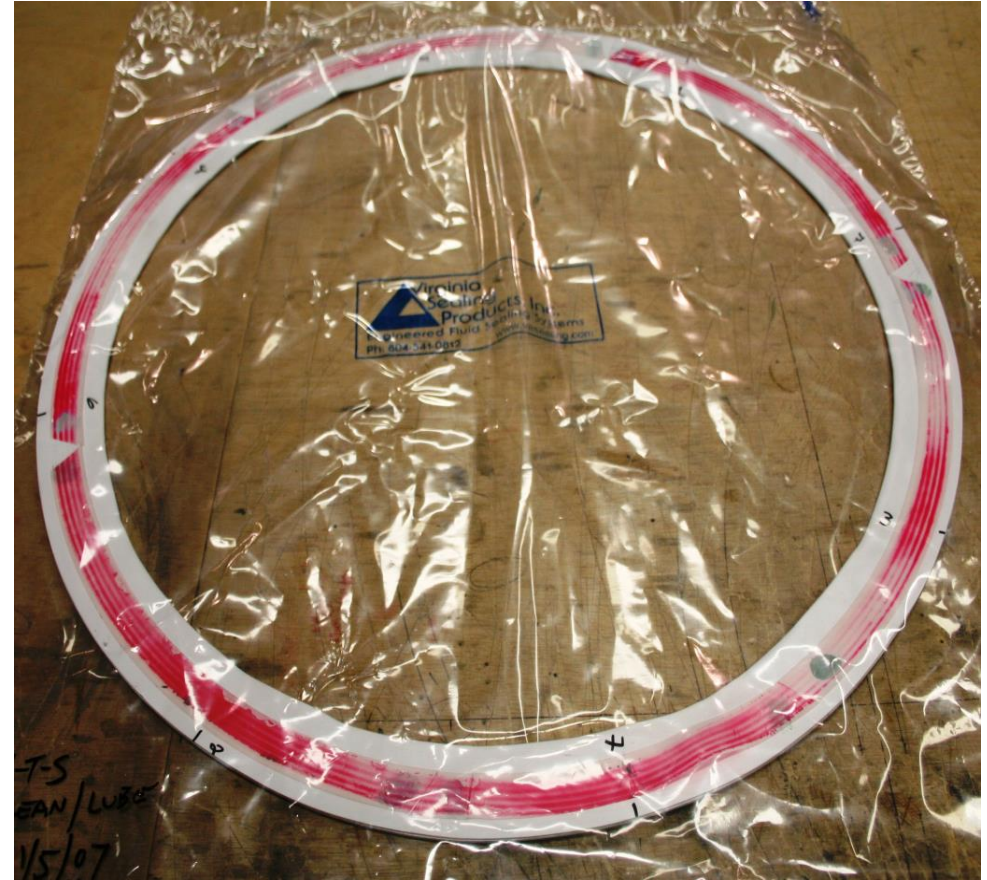
Cleaned & Lubricated Eyebolts
**More Uniform, Higher Overall
Gasket Stress Developed**

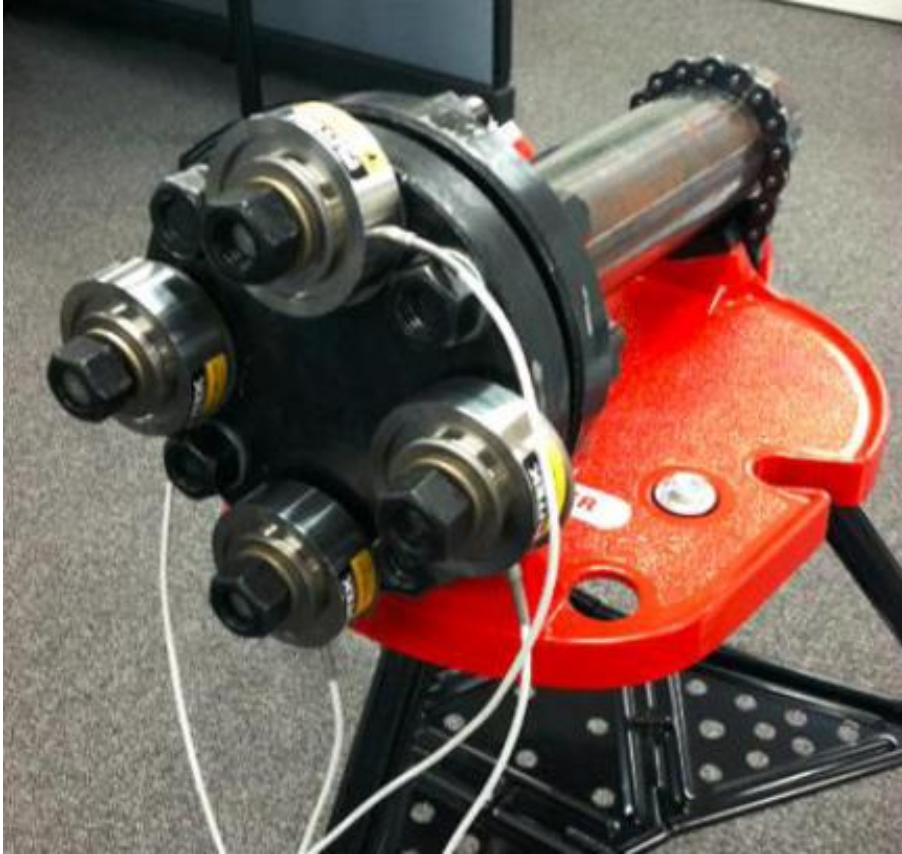
(MQA) Mechanic Qualification Assembly Unit

- Used as Training Tool
- Used for R&D Projects

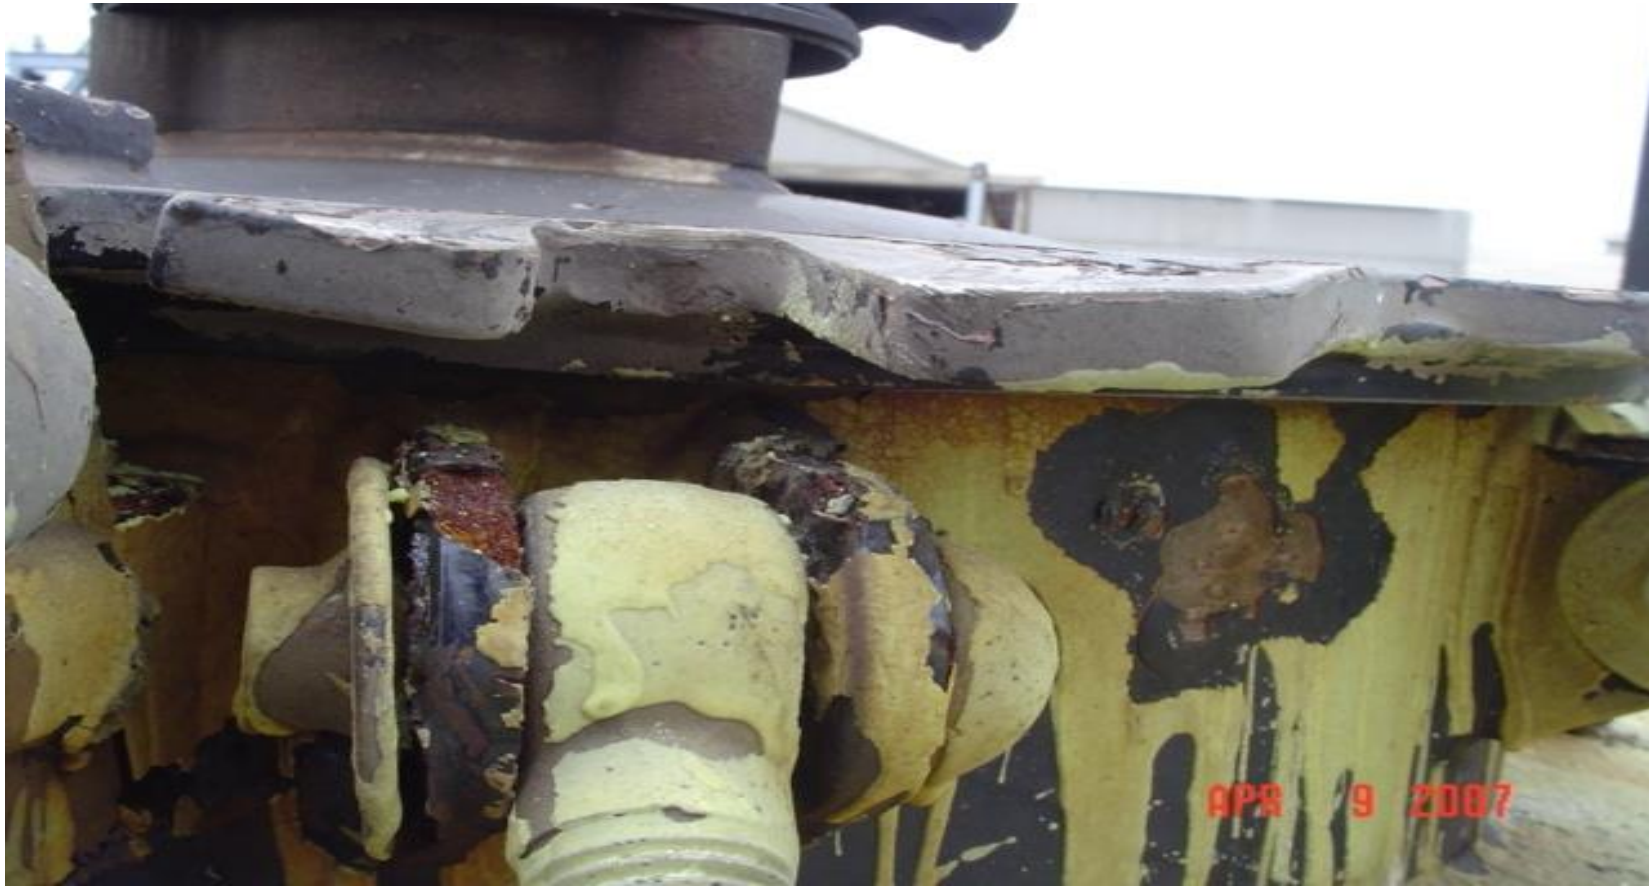
Over Tightening of Manway

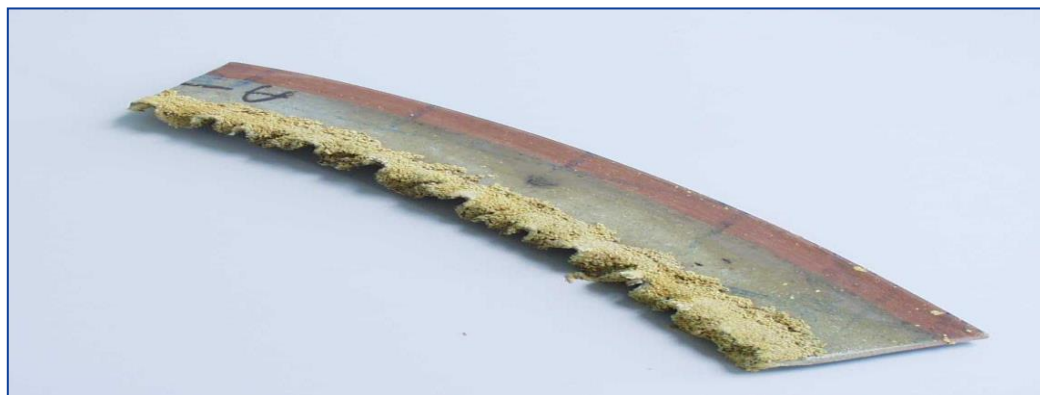
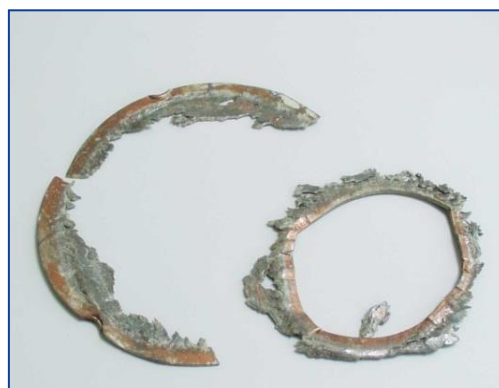
Gasket Material Not Compatible with Media being Transported

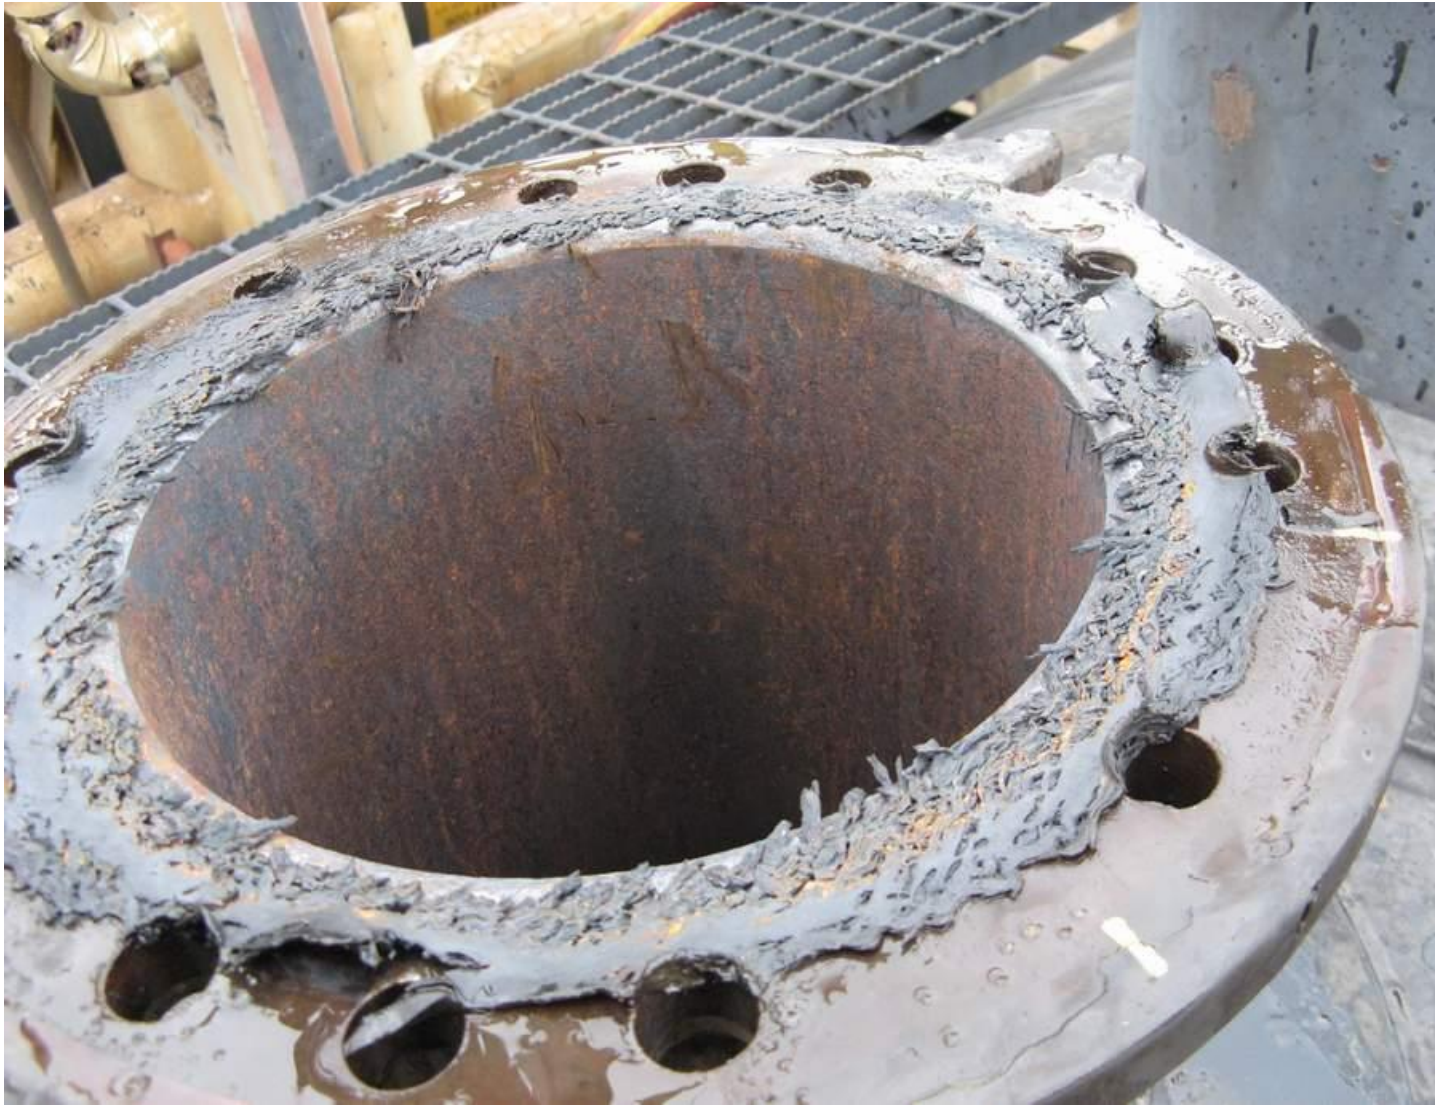
Over Compression of Gasket

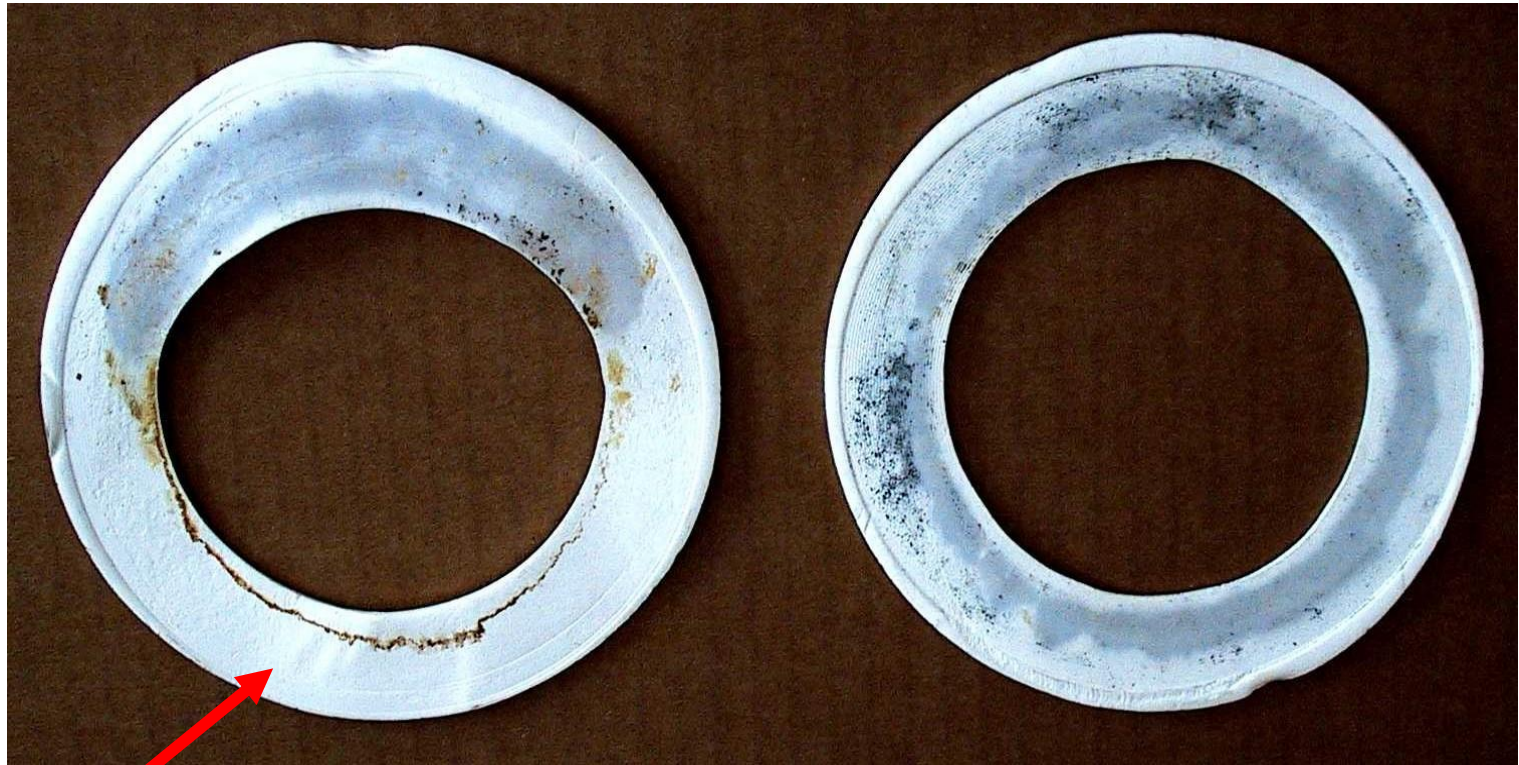
Excessive Gasket Stress Caused by Flange Rotation

**Leak Path Created Due to
Insufficient Gasket Compression**

**Properly Compressed
Gasket**

Following Proper Assembly Procedures will Ensure Flanges are Assembled Parallel Avoiding Flange Rotation

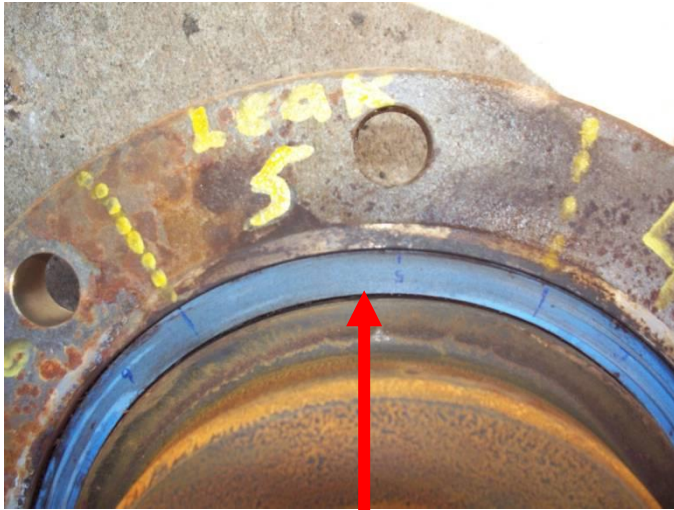
Insufficient Gasket Stress Caused by Flange Assembly

This quadrant as shown is the area where the leak was observed. Note the lack of witness groove marks on the gasket

The witness grooves from the flange are clearly visible in this quadrant of the gasket

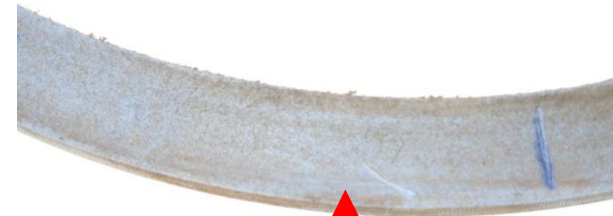
There are no corresponding imprints on this quadrant of the gasket

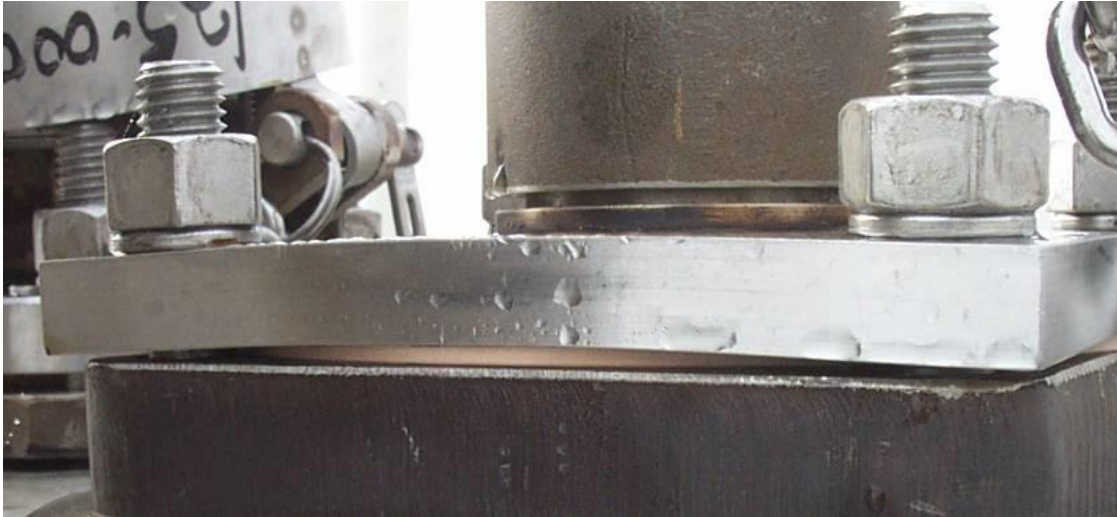
Insufficient Gasket Stress Caused by Flange Rotation

Example of a Flange assembled and Rotated

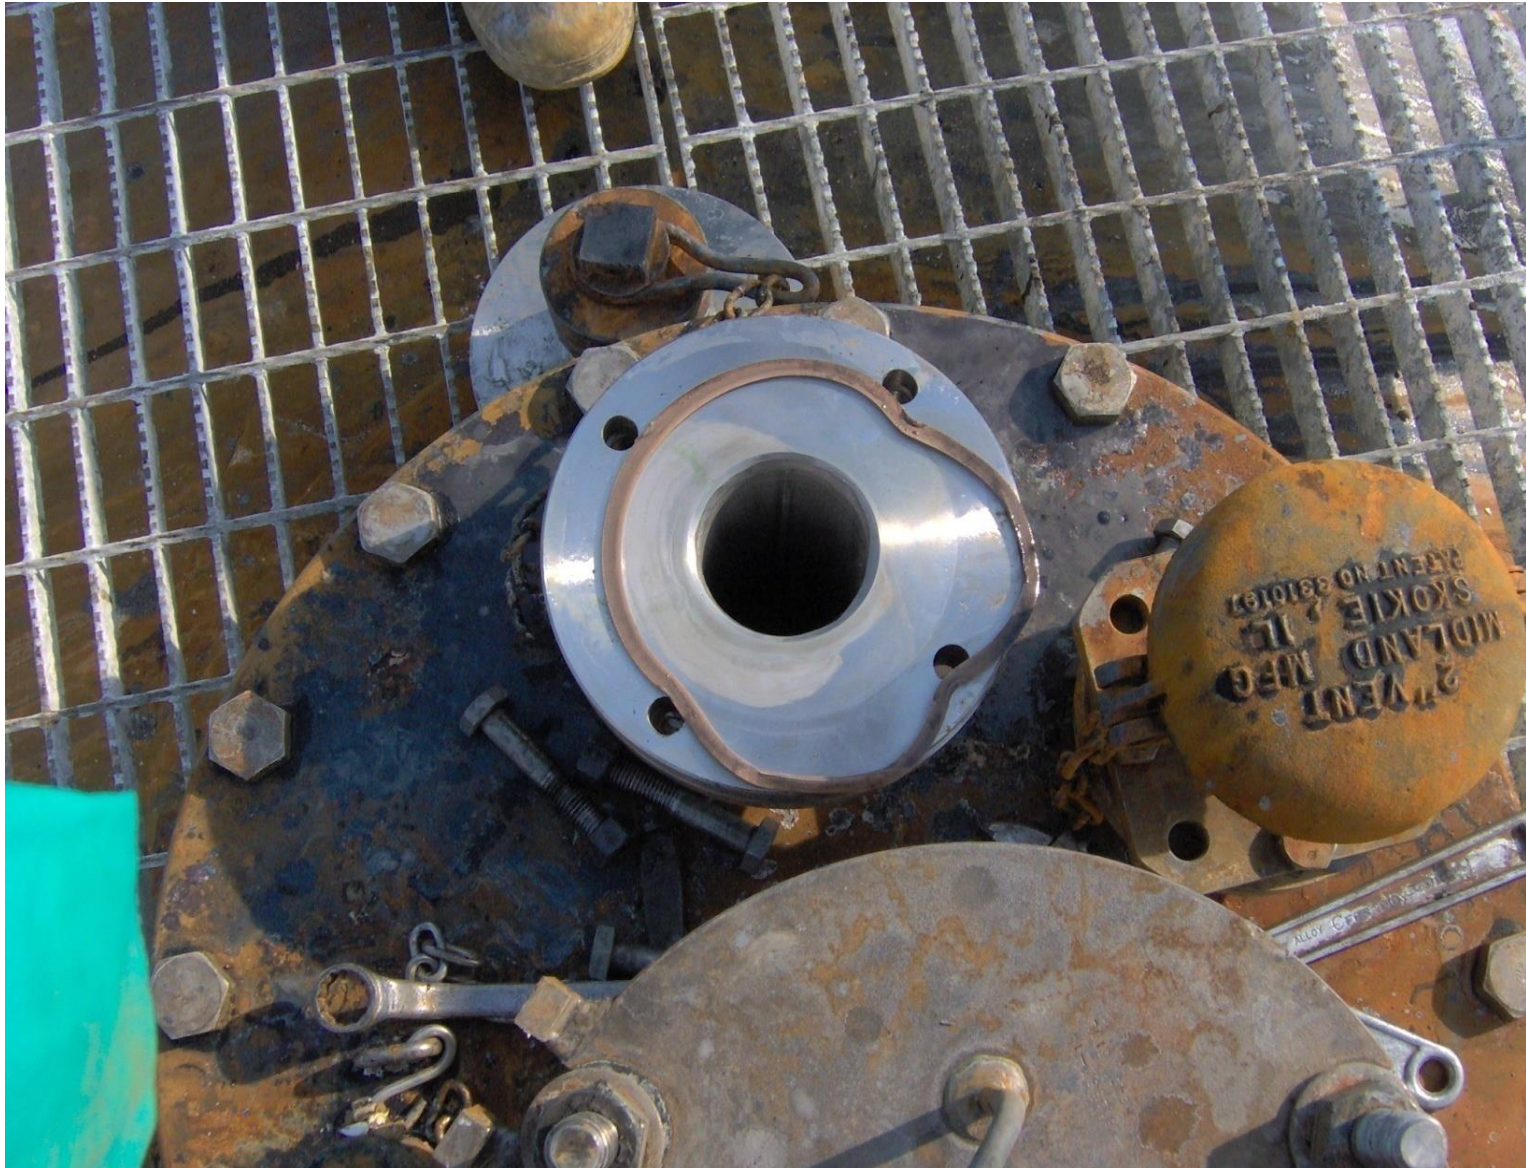
Example of Poor Gasket Design/Material Choice

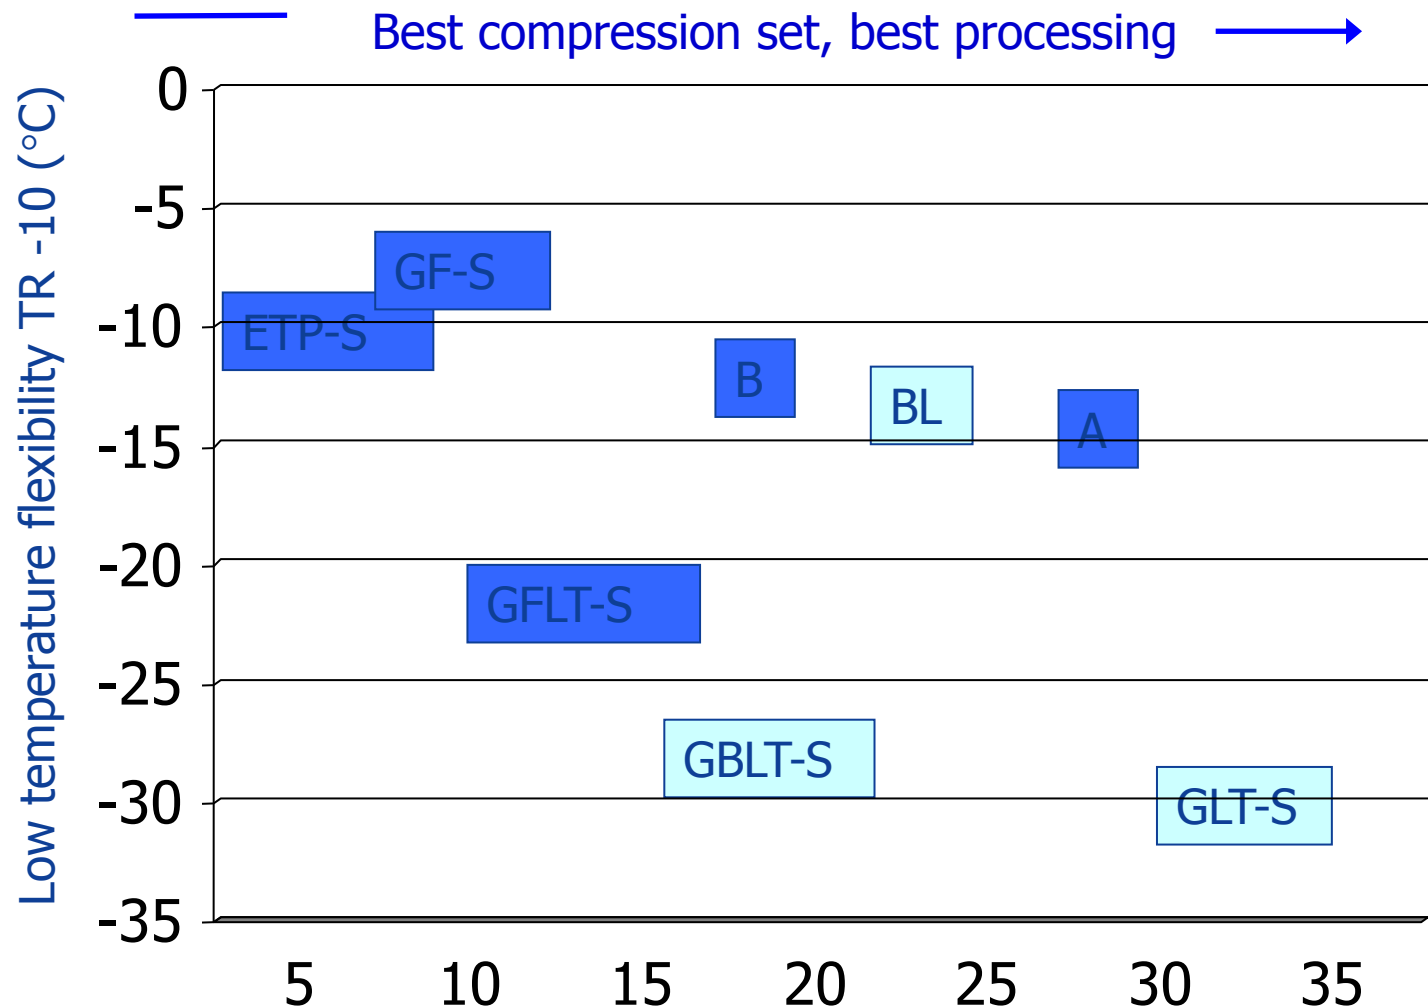
Viton® Material Properties

← Higher fluorine content = Best fluid resistance

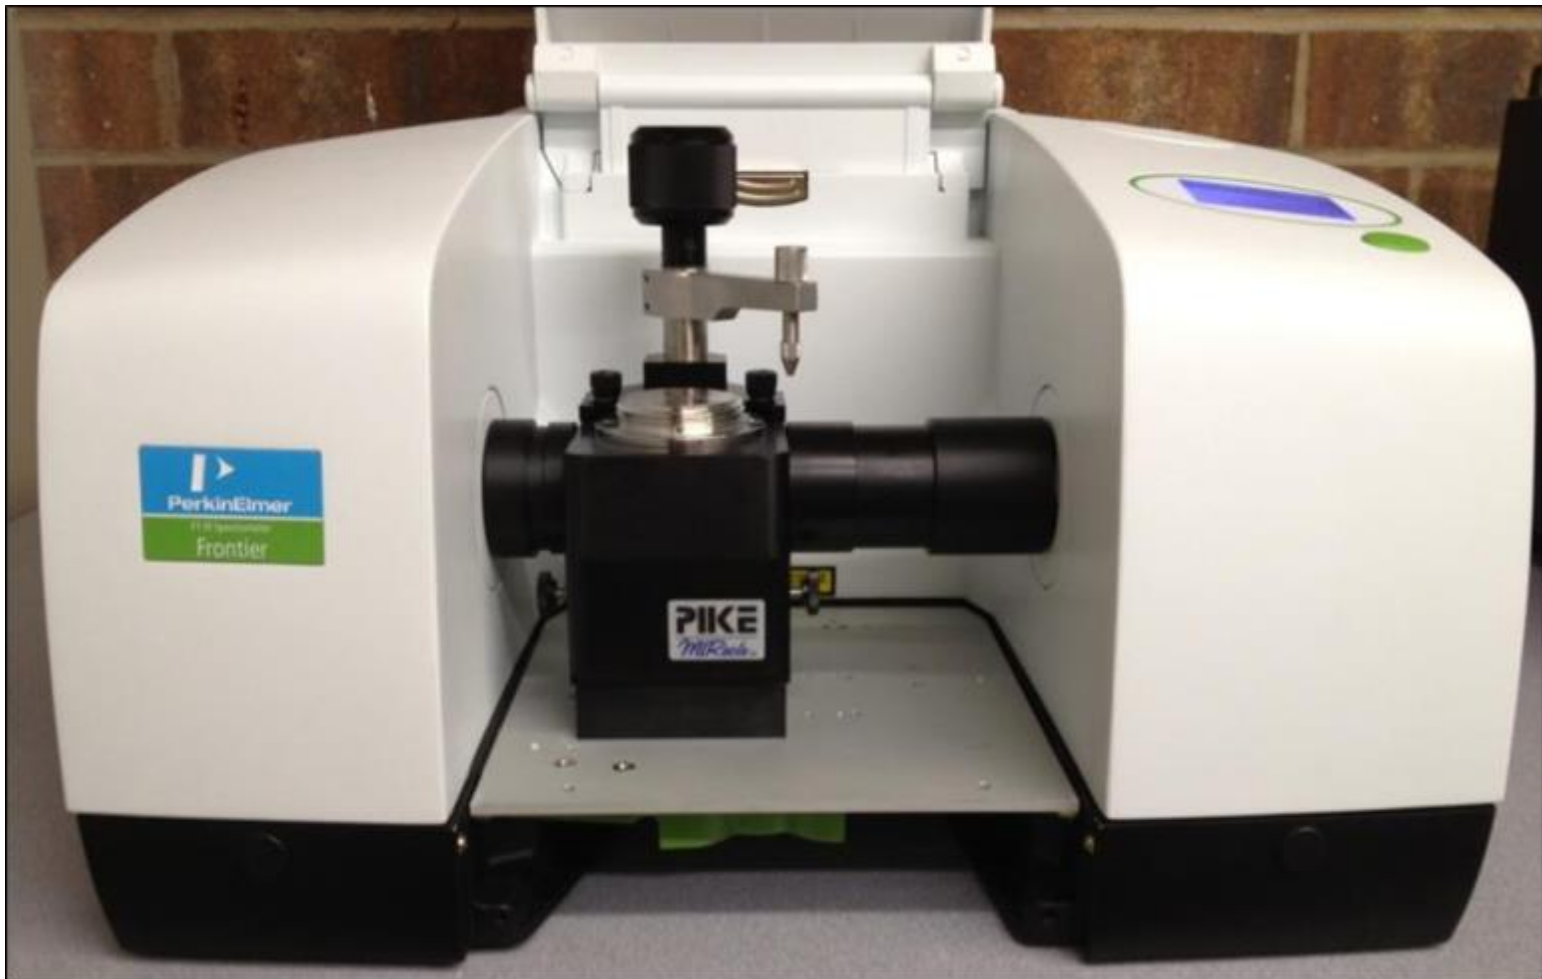
CSI - Material Analysis (FTIR Spectrometer)

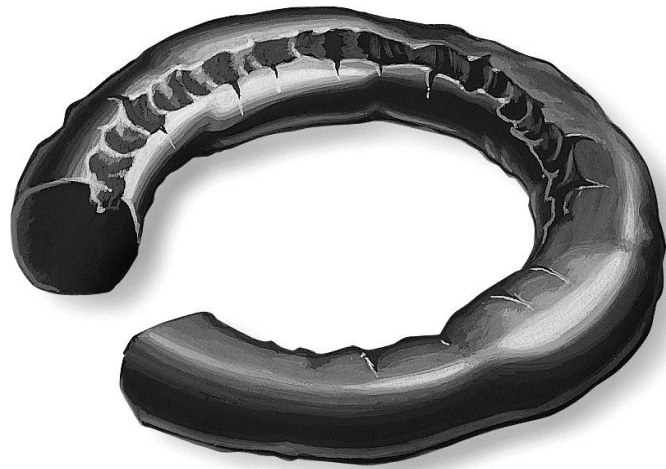
Chemical Degradation

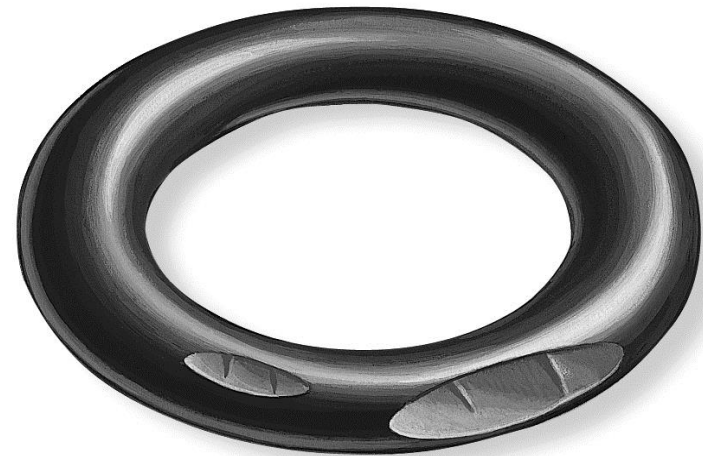
Installation Damage

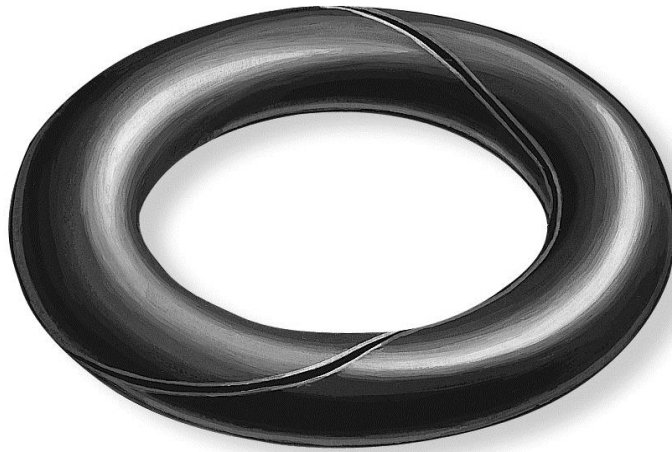
Spiral Failure

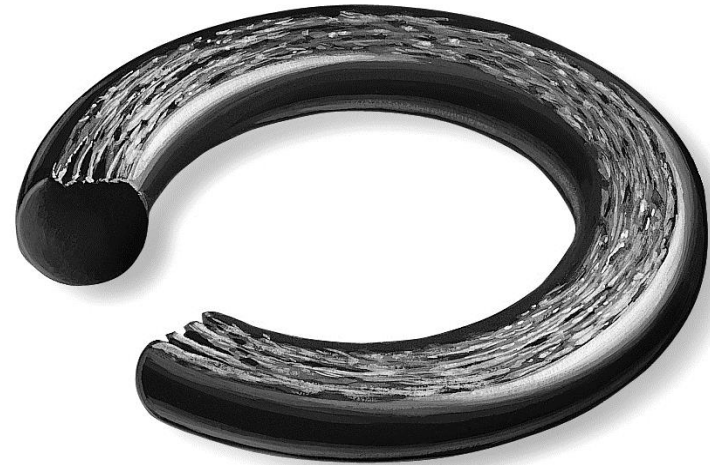
Abrasion

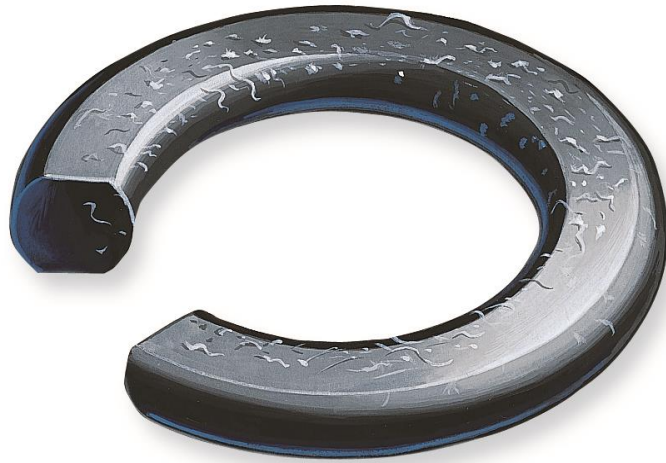
Contamination

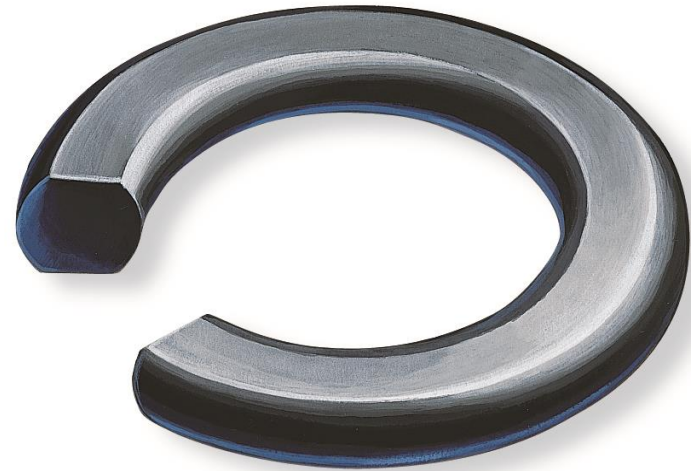
Compression Set
