VSP Technologies

Six Sigma Fluid Sealing Management

FRA Region 8 - Billings, MT September 2013

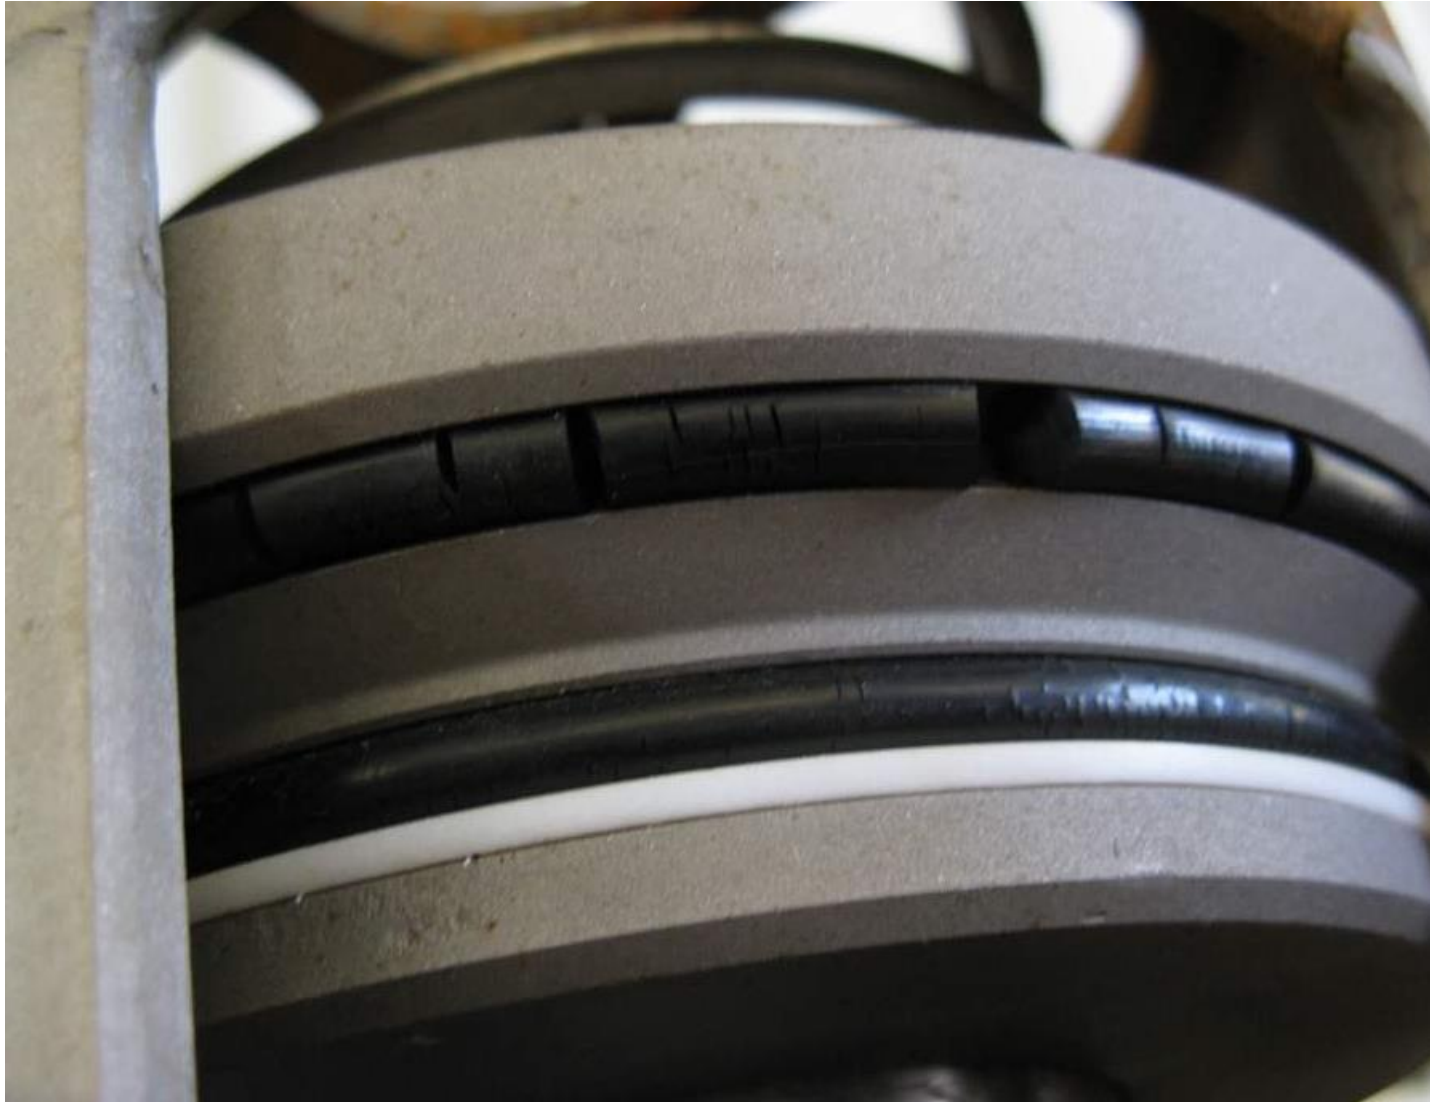
Weathering/Ozone Can Deteriorate O-Rings

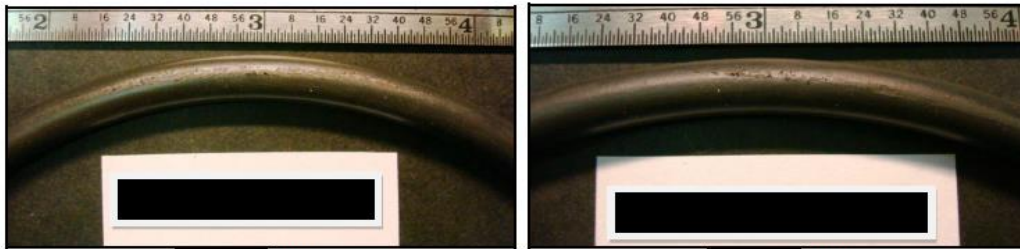
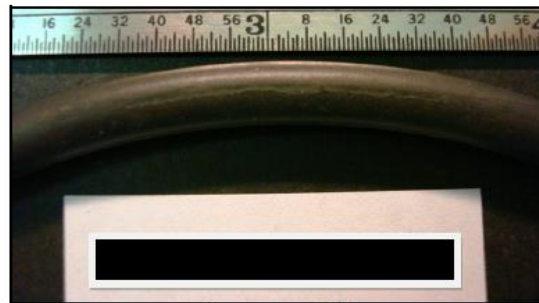
4. Commodity residue, coupled with the adhesion, is also a contributor to the pitting and surface degradation seen in the following photographs of the Stem O-Rings. This is intensified by minor swell of the elastomer in the presence of the commodity vapors. The stem O-Rings do not exhibit the same level of degradation, but should be pointed out as contributing factors to the valve's failure.

Reference Photos under the following names: [REDACTED]_2b(1), [REDACTED]_2a(2), and [REDACTED]_2b(2)

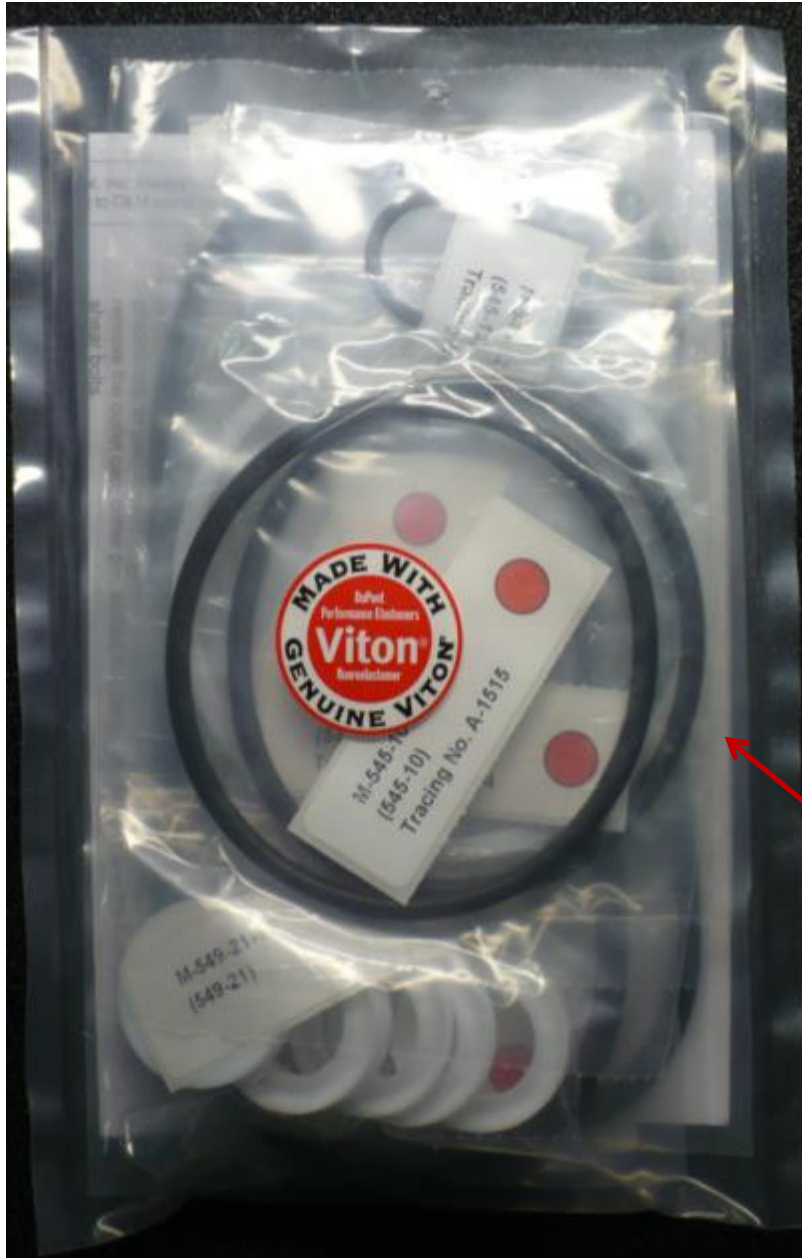
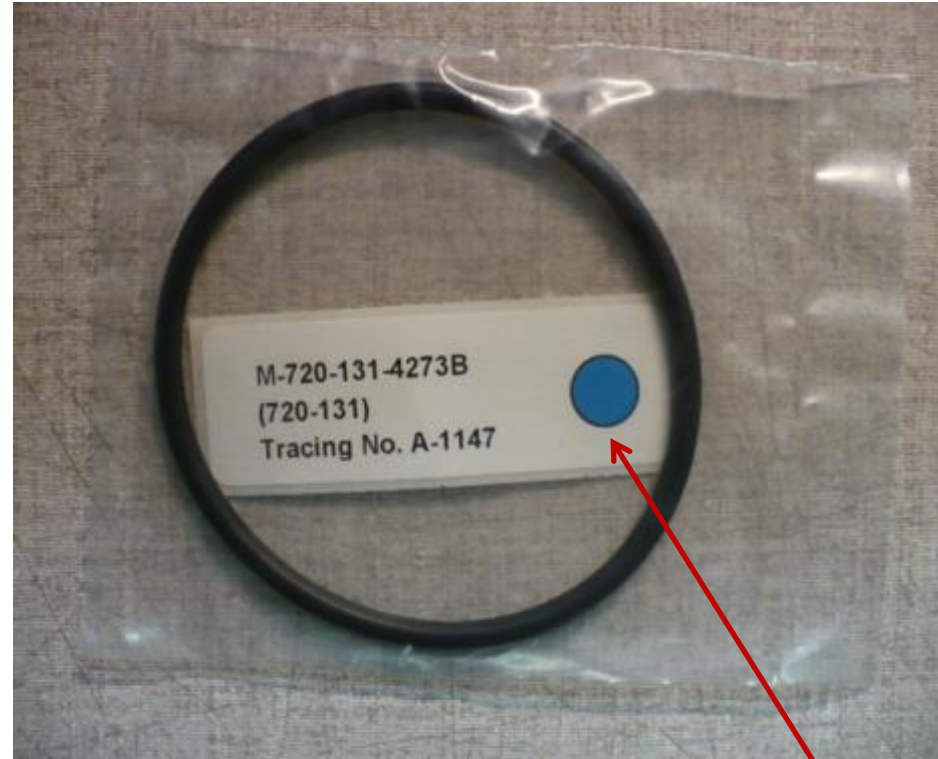
Carolina Seal – Repair Kit Packaging

Each Component Individually Bagged w/ Color Coded Label

All Components Packaged Together for each Kit
