U.S. Department
of Transportation

**Federal Railroad
Administration**

On-Line High-Speed Rail Defect Detection, Part II

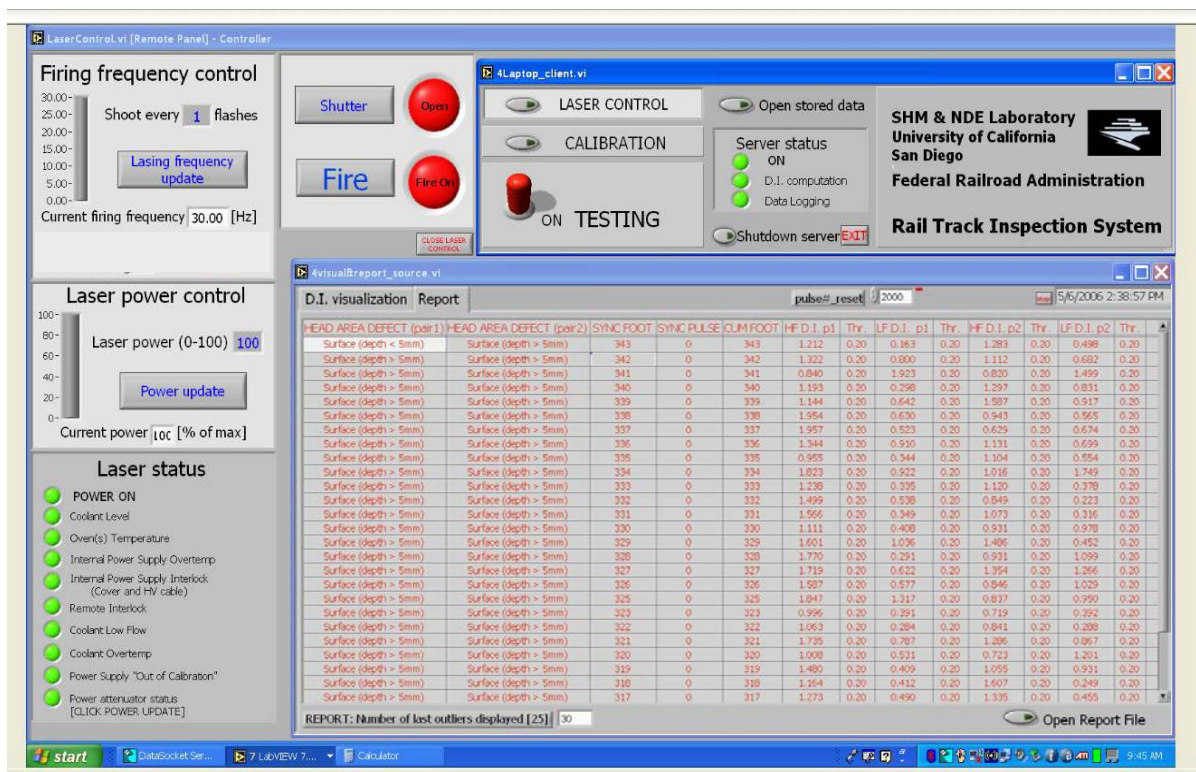
Figure 3.6. Snapshot of the 4visualreport_source.vi with the Test Report; the LaserControl.vi Is Still Visible in the Background

After the Report tab is selected, the front panel will appear as in Figure 3.6. Whenever a defect is detected, the top row of the report is updated. The report shows the type of defect and its position, along with the associated defect detection settings.

The current version of the software classifies three types of head defects: “small” surface defects, “large” surface defects, and IDs (the meaning of “small” and “large” depend on the filtering bandwidth selected during the calibration phase). The same information contained in the Report window is stored as an .xls file that can be opened by clicking on the button “Open Report File” placed in the bottom right corner of the window. A control placed in the bottom left corner of the window allows selecting the number of rows simultaneously visible in the report screen. The current time is displayed in the top right.

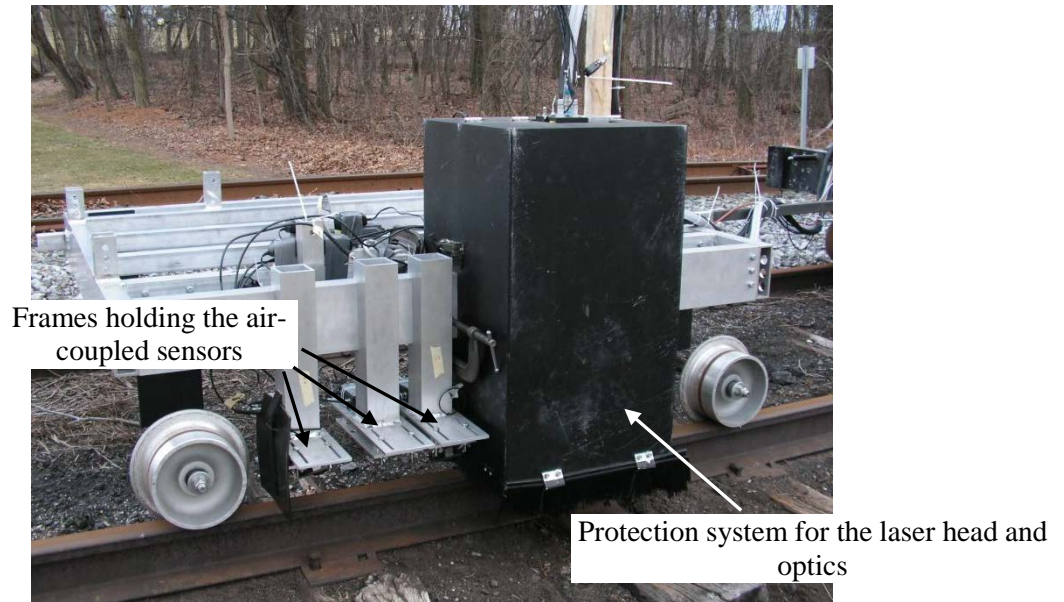
Figure 4.6. Laser Head and Sensors on ENSCO's Cart during First Field Tests

Pictures of the laser- and air-coupled sensors installed on the cart are shown in Figures 4.6 and 4.7. The cart was designed and constructed by ENSCO under an FRA University-support task. The black metallic box was devised to protect the laser head and the lenses from accidental impacts and dust; in addition, the box prevents accidental reflections of the laser beam.

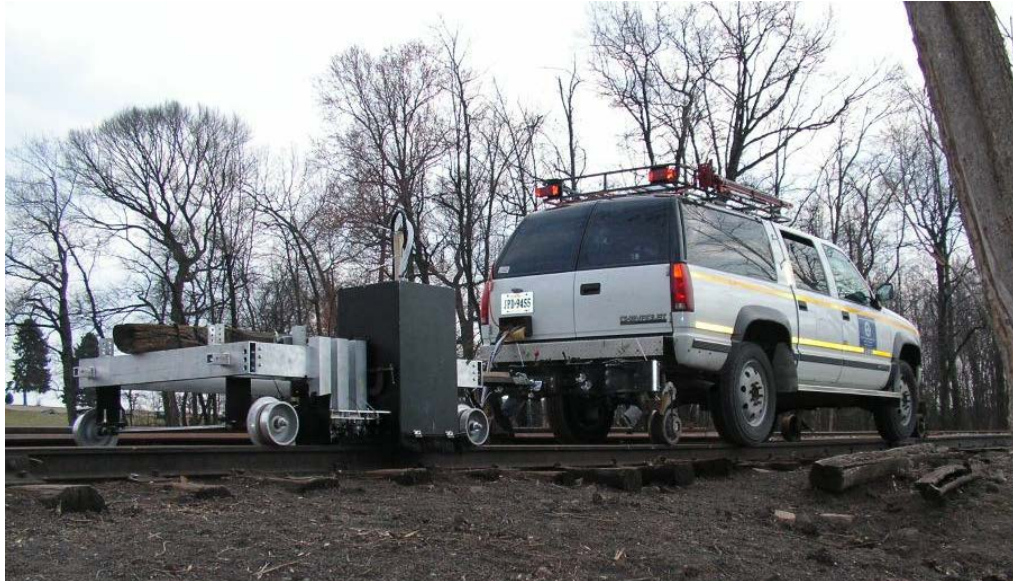
Figure 4.9. The Inspection Prototype Towed by the FRA Hy-Railer Managed by ENSCO during the First Field Test

The inspection prototype towed by the hy-railer is shown in Figure 4.9. The back end of the truck housed the laser power supply, the PXI unit, and the laptop client. A 1,200-watt generator was used to power all equipment.

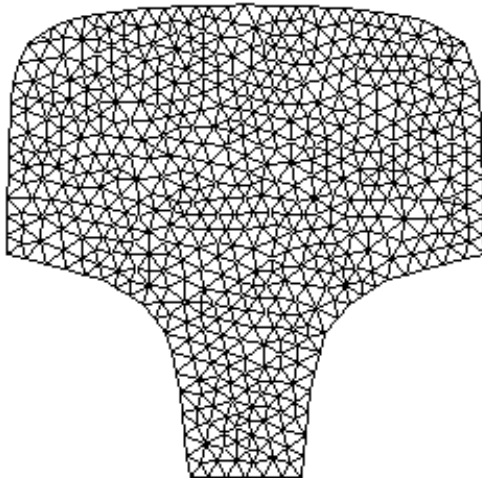
To predict strain energy densities at high frequency, a finer mesh was applied to the rail model analyzed by SAFE (Figure 5.3). Only the top half of the rail was modeled, because the frequencies considered of negligible energy travel into the web or base.

Figure 5.3. SAFE Mesh of the Rail Head for Predicting Cross-Sectional Distribution of the High-Frequency Ultrasonic Energy

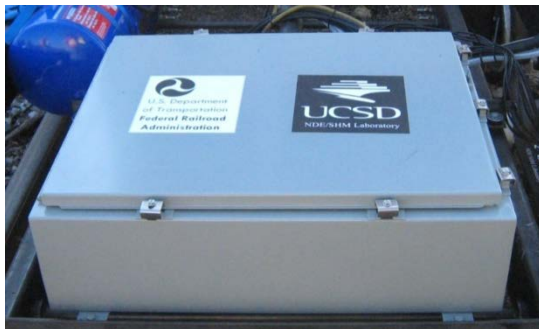
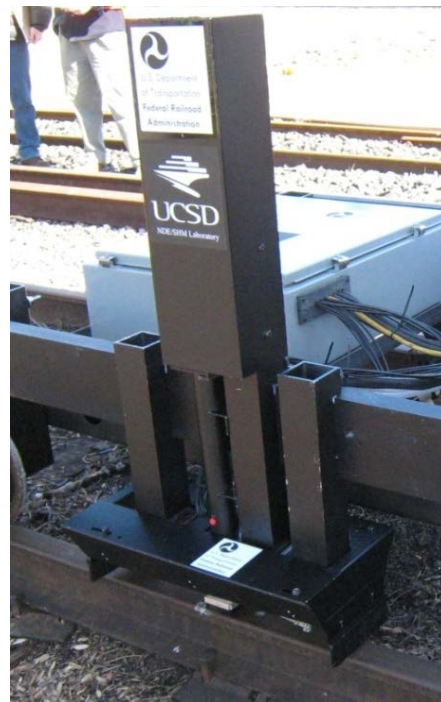
Figure 6.3. (left) Water-Tight Steel Case Containing All Electronic Components Attached to the Sensing Lines; (right) Improved Covers for Laser and Sensors

- (b) use of sensor arrays based on the new piezocomposite devices (Figure 6.2), which cover different frequency bands;
- (c) improved compactness of the system, including electromagnetically shielded and water-tight boxes containing all sensor electronics (amplifiers, filters, etc.) and data acquisition unit (Figure 6.3-left); simplified covers for laser and sensors (Figure 6.3-right). The new covers also provided complete enclosure of the laser beam via an aluminum tube, which improved safety of standby personnel and minimized the need for wearing laser-protection glasses in close proximity to the system.

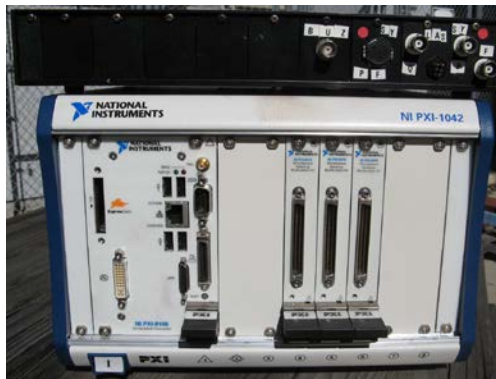
Figure 7.1. Breakout Box and PXI Unit; the Box Is Connecting the Sensor Lines to the PXI Data Acquisition Unit

The electronic components were housed in a metal box positioned on the outdoor deck of R-4. The system included a breakout box, which connected the shielded multichannel cable coming from the metal box to the acquisition unit located inside the Hy-Railer. The breakout box is depicted in Figure 7.1, along with the PXI unit, which hosted the software for the real-time acquisition and processing of the ultrasonic signals.

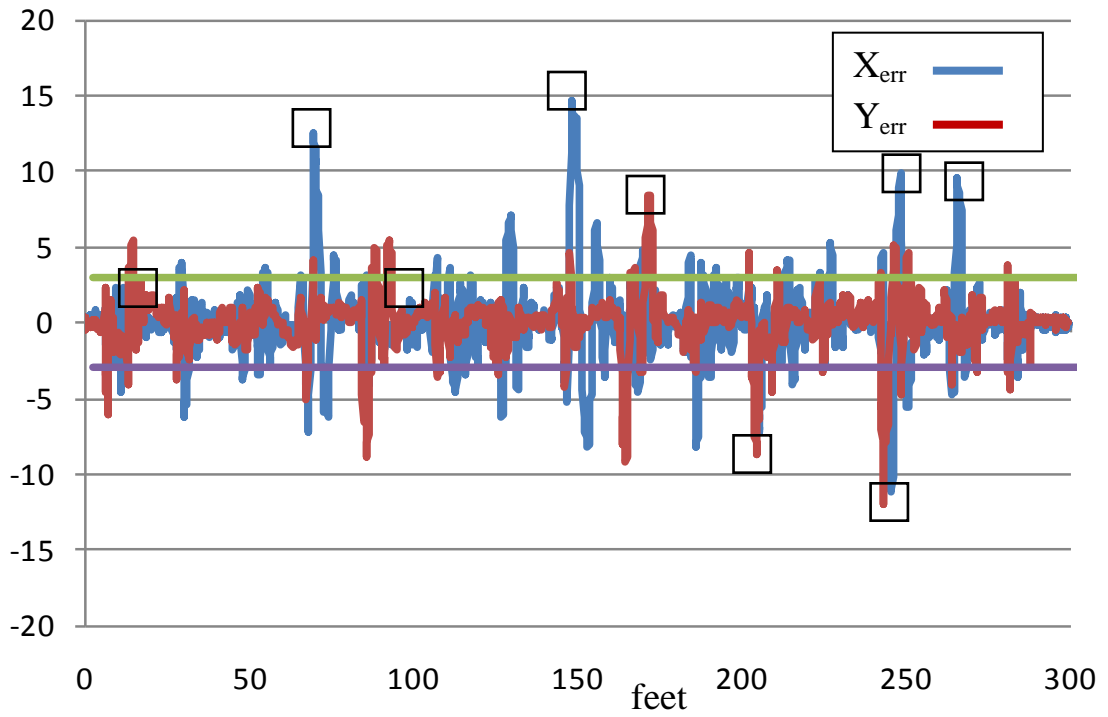
Figure 8.4. D.I. Graph and Servo-Log X-Y Positioning Error Acquired along a Tangent Track while Testing at Walking Speed (run #4, day #1)

During days #1-2-3 and the morning of day #4, the prototype was setup and aligned, the ENSCO TGMS positioning system was calibrated, and multiple *Defect Detection* and *Raw Data Test* runs were performed, with the objective of assessing the performance of the system and servo along different track layout geometry (tangent and curved track); no defect was expected to be detected during this phase. In the afternoon of day #4, multiple *Defect Detection* and *Raw Data Test* runs were performed in the GET defect farm, with the objective of assessing the defect detection performance of the prototype. From the analysis of the results of day #1 tests, it was observed that many potential defects were identified by the prototype; a parallel check performed on the servo-log data provided by ENSCO indicated that at the different positions along the track where defects had been detected, the servo-system was not keeping the prototype over the rail within the requested tolerance of $\pm 1/8$ in (~ 3.2 mm) horizontal and vertical. This phenomenon can be observed in Figures 7.3–7.5, which show the D.I. graphs along with the servo-log X-Y positioning errors for different type of track (tangent track, right and left curves). A detailed analysis of the data showed that the presence of joints and the rail pitch angle varying along the rail span were keys to the unexpected poor servo-tracking performance. UCSD came to the conclusion that the servo cannot be used as a reliable positioning system for the prototype at walking speed.

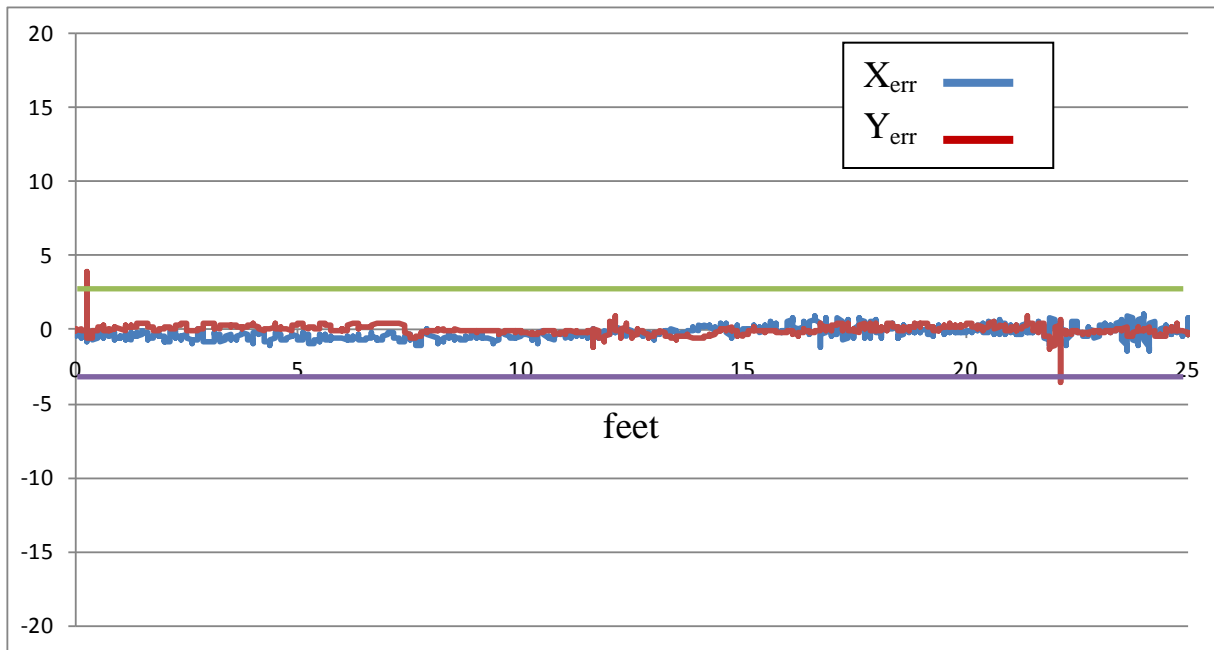
Figure 8.8. D.I. Graph and Servo-Log X-Y Positioning Error Acquired along a 8° Left Curve while Testing at Crawling Speed (run #24, day#3)

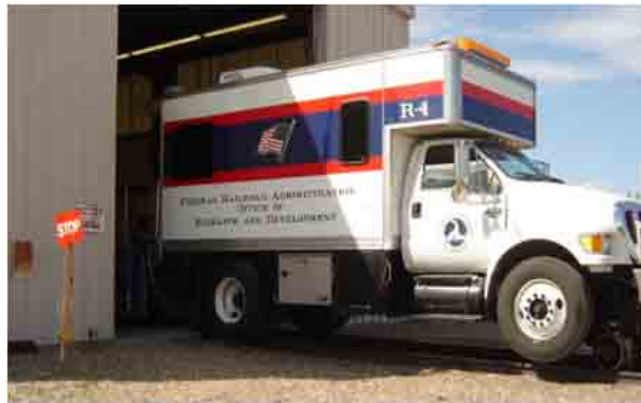
Figure 9.1. R-4 in the TMB Building (TTC)

Days #1 and #2 were spent by UCSD and ENSCO teams setting up the prototype on R-4 in the TMB building of TTC (Figure 9.1); on day #2, ENSCO encountered problems with one of the servo-motors, hence, it was decided to start testing with the cart.

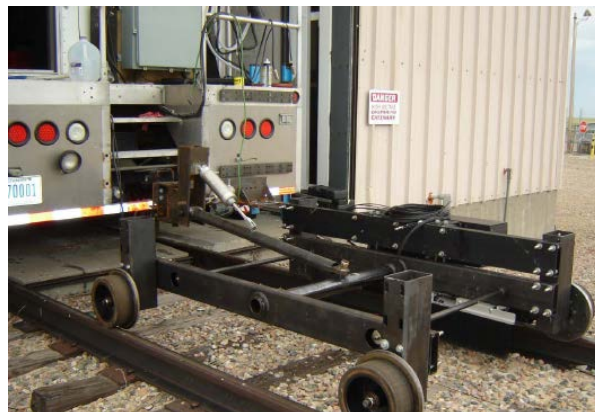
Figure 9.2. The Cart with the Prototype Installed before Cabling

The installation of the cart on R-4 was smooth; the prototype was mounted on the cart beam (Figure 9.2) and the laser sensor, used for tracking the position of the cart relative to the rail, was mounted off-center on the cart beam to allow for a closer installation of the ultrasonic transducers (Figure 9.3).

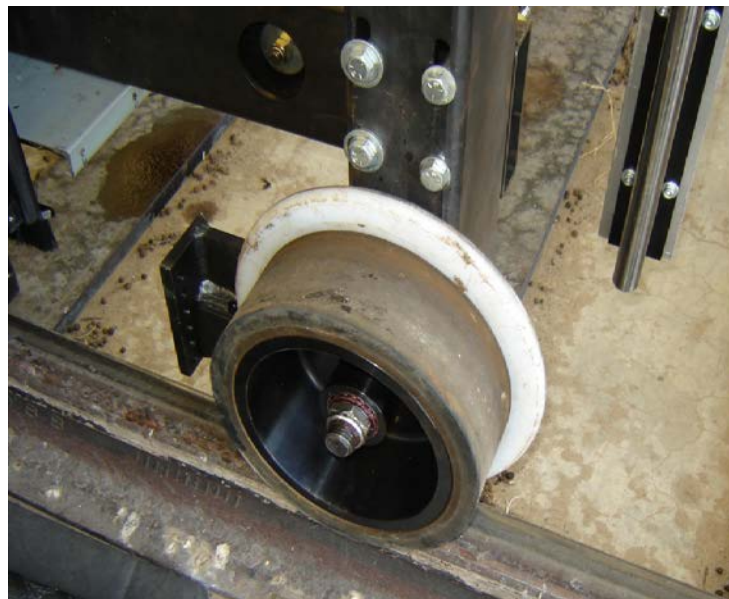
Figure 9.4. Detail of the New Nylon Wheel Flanges Required for Noise Reduction

Figure 9.4 shows a detail of the cart new nylon wheel flanges, required to eliminate any noise eventually generated by the friction between the wheel and the rail during an inspection.

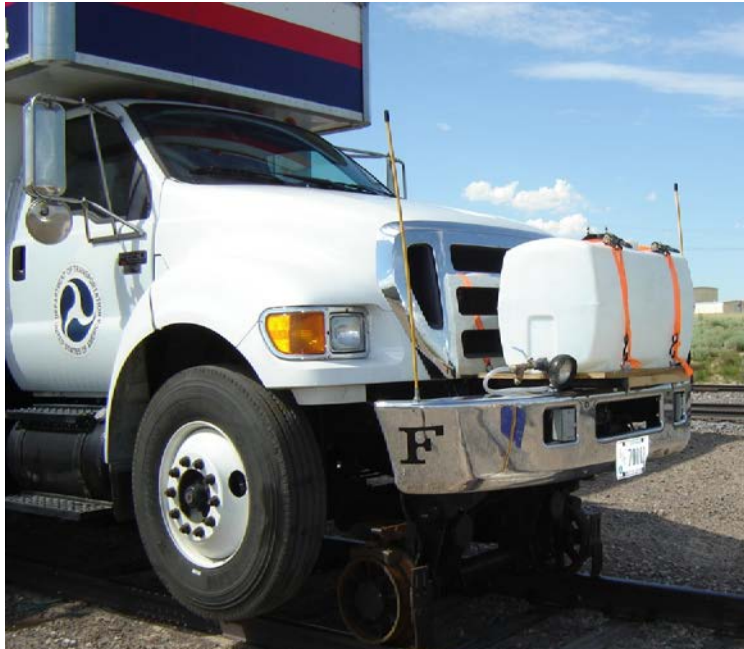
Figure 9.5. The 50-Gallon Water Tank for the Water Spray System Mounted on the Front of R-4

As required by UCSD, ENSCO installed a 50-gallon water tank on the front of R-4 to supply a water spray system needed to improve the ultrasonic generation in the rail (Figure 9.5).

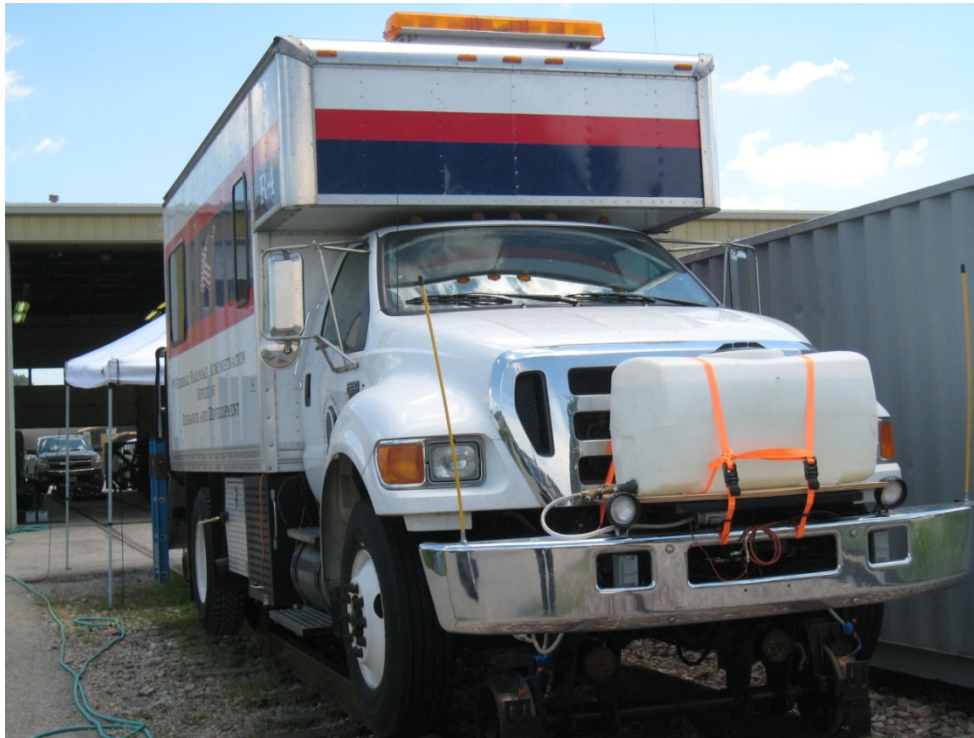
Figure 10.1. Water Reservoir for the Supply of the Water Spray System Installed to Reduce the Noise Created at the Wheel-Rail Interface

Day #1 and part of day #2 were spent by UCSD and ENSCO teams setting up the prototype on R-4 in Herzog Services' main building. R-4 was equipped with a new system of nozzles spraying water at the four R-4 wheel locations, aiming at reducing the noise occurring at the wheel-rail interface. The water reservoir was installed in the front of R-4 (Figure 10.1).

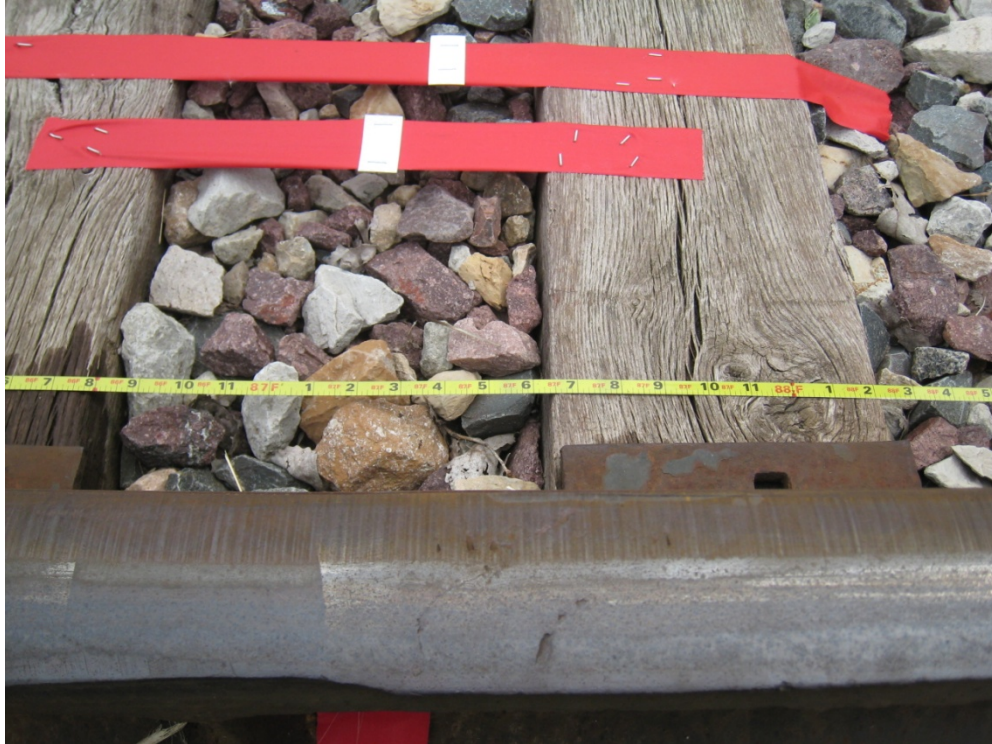
Figure 10.2. Reflective Targets Placed in Correspondence of Joints, Weld, and Defects

During day #3, after Mr. Elbert released a list with the known defect locations, ENSCO installed and tested reflective targets near the flaws (Figure 10.2).

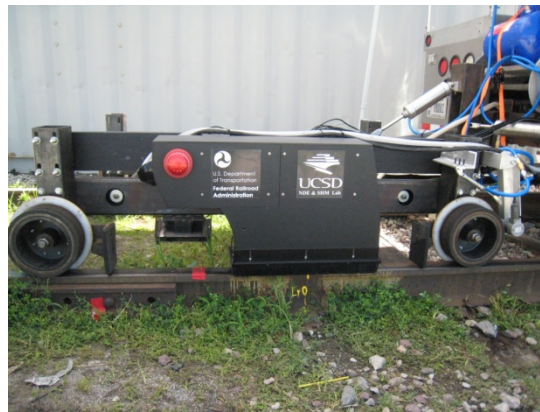
Figure 10.3. The UCSD Prototype at Herzog and Picture of Some of the Test Participants and Observers from UCSD, ENSCO, FRA, Volpe Center, Herzog, BNSF Railway, and UP

Figure 10.3 shows pictures of the UCSD prototype as well as a group picture of participants to the tests.

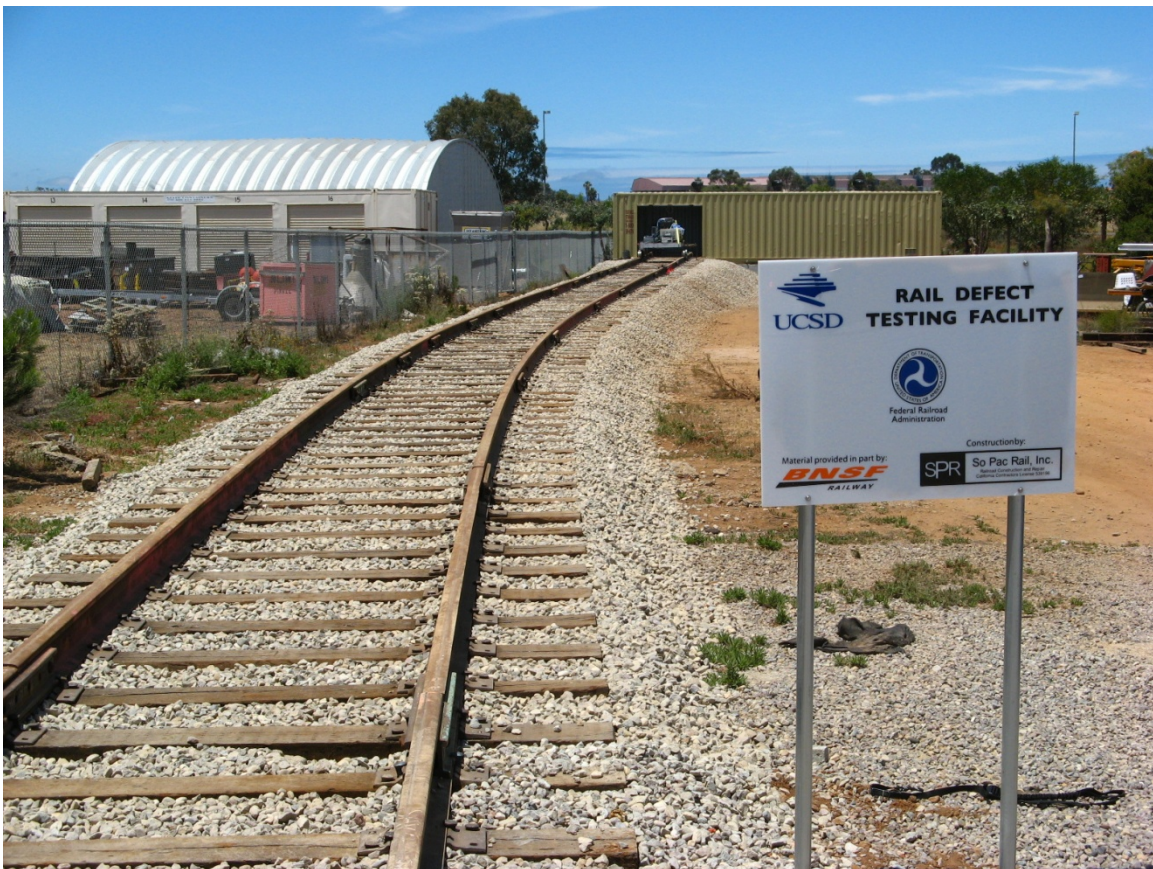
Figure 11.1. The New Rail Defect Farm at UCSD for Development of Rail Inspection Technologies

The new UCSD/FRA Rail Defect Farm (Figure 11.1) is a 250-foot-long track with a tangent portion and an 8° curved portion. BNSF donated the rails and most of the ties and ballast. Sopac Rail, Inc., performed the construction. The track features approximately 15 natural rail defects, including TDs under shelling, and some artificial rail defects. This facility will be used primarily for the technology development of the FRA/UCSD rail inspection prototype. It is also expected that the facility will be available to other developers of rail inspection technologies.
