RR 20-16 | September 2020

## **LOCATING AND SIZING RAIL HEAD DEFECTS FOR RAIL HEAD REPAIR WELDS USING PHASED ARRAY ULTRASONICS**

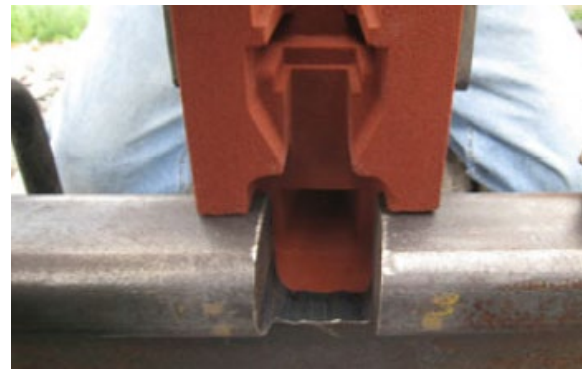
**Figure 1. Thermite rail HRW process showing a portion of head removed with the mold fitted to the rail and positioned above the cutout**

A rail HRW is made by cutting out a portion of the rail head containing a defect and replacing it with a clean section of head material that is welded in using a thermite or flash-butt process. The technique provides a cost-effective method for removing transverse defects (TD) in rail without disturbing the rail neutral temperature. Successful rail head repair requires precisely locating the TD to assure it is completely removed during the repair process. Required location accuracy of the defect is  $\pm 1$  inch from the actual defect location. Figure 1 shows a photo of a mold fitted to the rail and positioned above the cutout.

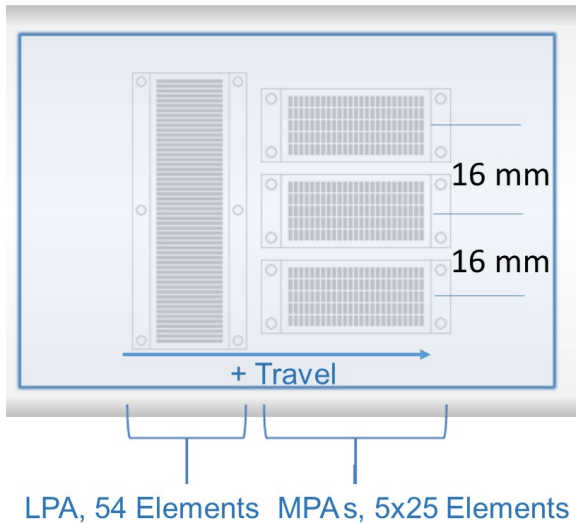
geometries and positions of the probes, it is possible to precisely locate defects within the rail based on the timing of the signals received at each probe. Figure 2 shows the probe arrangement on the TTCl prototype with three 125-element matrix phased arrays (MPA) and one transverse 54-element linear phased array (LPA).

Figure 2. PAUT probe configuration

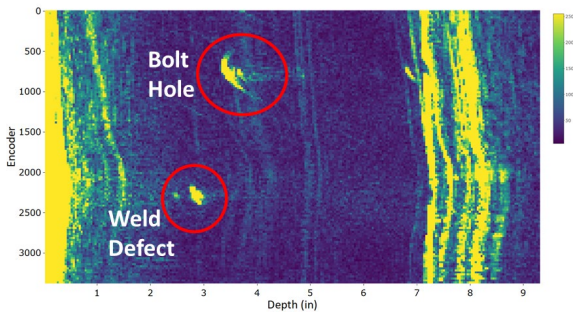
Figure 3. Heat map showing bolt hole and weld defect from the LPA

The color code in the heat map shows the amplitude signal value for each encoder at a specific true depth. The lowest amplitude value is shown in dark blue and represents no indication. Yellow is equivalent to the highest amplitude value (255). Stronger indications (lighter colors) are used to identify features and flaws within the rail. This scan is from the LPA in the 0-degree direction (looking straight down into the rail head). Several features are visible as the probe traverses the weld joint (increasing encoder values from top to bottom). The top of rail is at the transition to blue from the heavy yellow zone near zero depth. The bottom of rail is the blue-to-yellow transition at about a 7-inch depth. This is consistent with a 136-lb. rail. There is a large reflection from a bolt hole in the web. The true depth of the top of this bolt hole is about 3.25 inches from the top of the rail. There also is an indication of a defect within the weld itself, about

2.25 inches below the surface. This indication is centered on encoder value 2,250.

The A-scan database is subset into groups based on the probe, primary angle, secondary angle, and cycle. For each combination of these elements, information about the encoder and its corresponding true depth are found. A heat map is used to visualize the defects. The heat map has 256 colors representing the reflection amplitudes. Figure 3 is a heat map showing a bolt hole and a weld defect.

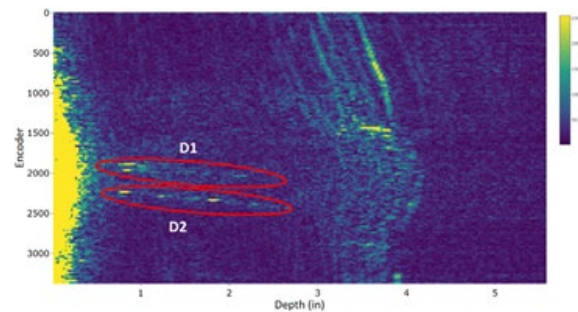
Figure 4 shows the weld defect from the gage side MPA in the minus 45-degree primary direction. Two defects are visible within the weld.

Figure 4. The -45 degree heat map from the gage side MPA showing two transverse defects in the weld

The indication encoder values range from about 1,800 to 2,500, similar to the LPA indication. This is consistent with probe layout and inspection angle. The MPA passes over the defect before the LPA but, due to a rear-facing inspection angle, additional encoder steps accumulate before the indication appears on the heat map.

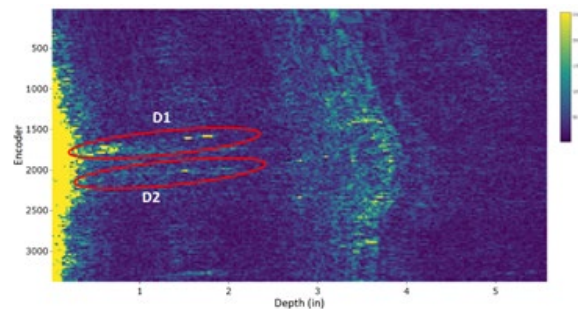
Figure 5 shows the +45-degree inspection angle from the same MPA probe. Here, the encoder values range from 1,500 to 2,100 for the pair of indications. Considering the probe configuration and forward inspection angle, this is consistent with expectations. Triangulating visually, the two transverse defects are located directly under the gage MPA when the encoder value is 2,000.

Figure 5. The +45-degree heat map from the gage side MPA showing two transverse defects in the weld

The LPA and gage MPA are 16 mm (0.63 in.) apart. The predicted defect position from the two

readings differ by about 11 mm (0.43 in.); thus, the uncertainty is the difference or 5 mm (0.20 in.) between these indications. The greatest uncertainty comes from determining the extents of the indications, which is one encoder trigger increment, 6 mm ( $\pm 0.25$  in.). Locating the defect within the rail requires measurements relative to a known datum (e.g., the bolt hole). From the LPA PAUT data, the weld defect is located 311 mm (12.25 in.) from the bolt hole center.
