Low-Cost Coupler Force Calculation from Impact Testing

6. AUTHOR(S) Timothy Martin ORCID 0000-0002-5280-3142				
7. PERFORMING ORGANIZATION NAME(S) AND ADDRESS(ES) ENSCO, Inc 5400 Port Royal Rd., Springfield, VA 22151			8. PERFORMING ORGANIZATION REPORT NUMBER SERV-REPT-0002903

9. SPONSORING/MONITORING AGENCY NAME(S) AND ADDRESS(ES) U.S. Department of Transportation Federal Railroad Administration Office of Railroad Policy and Development Office of Research and Development Washington, DC 20590			10. SPONSORING/MONITORING AGENCY REPORT NUMBER DOT/FRA/ORD-23/11

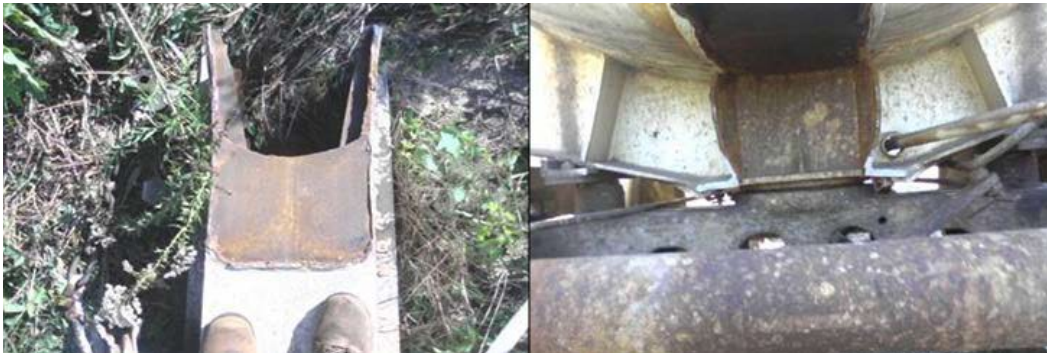
Figure 1. Stub Sill Fracture Observed in Callahan, FL, December 2009 (Sundaram, 2016)

Examples of stub sill fractures observed by CSX Transportation are shown in [Figure 1](#) and [Figure 2](#). These fractures are catastrophic in nature. The industry has improved weld design so the weld between the head brace and stub sill should fail before the weld between the pad and tank.

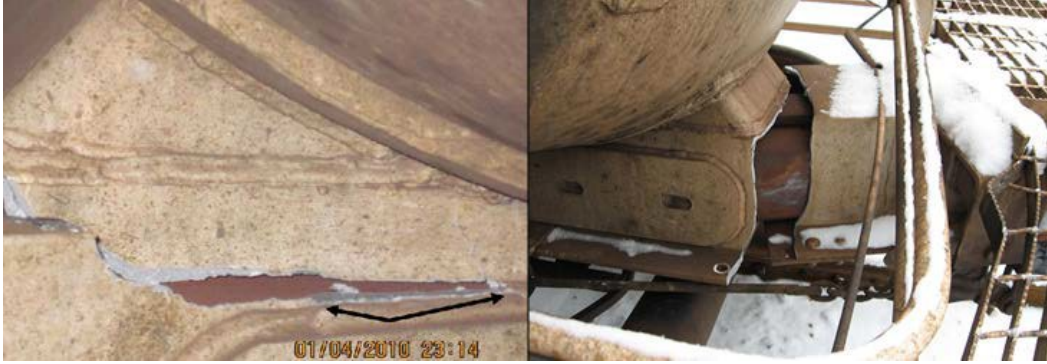
Figure 2. Stub Sill Fracture Observed in Charleston, WV, January 2010 (Sundaram, 2016)

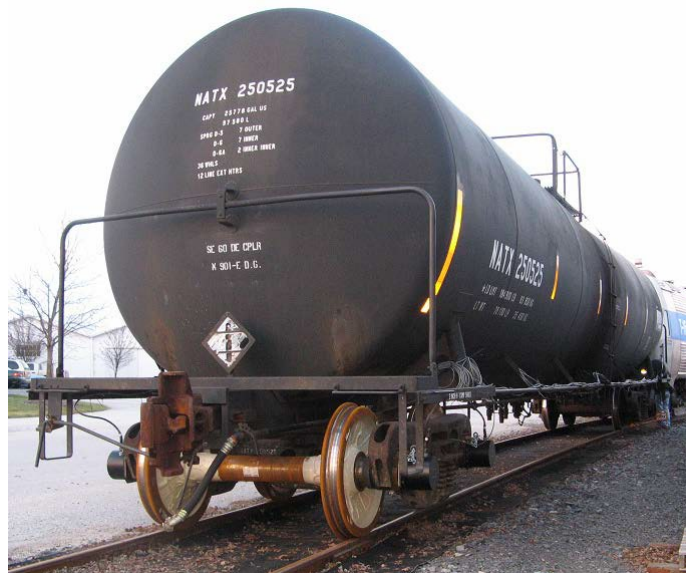
Figure 3. Instrumented Tank Car

To better characterize the load environment of the tank car operations in yards, FRA, Union Tank Car, and Amsted Rail conducted a cooperative test program at Amsted Rail's test facility in Camp Hill, PA, in 2018. Under this effort, researchers instrumented a tank car loaned to FRA by Union Tank Car with multiple transducers. The team employed a data collection system that supported high sampling rates required for conducting impact testing. The team collected impact data for different car configurations, end-of-car units, and coupling speeds during 702 impact tests. Researchers collected a data file for each impact test with 40 data channels comprised of acceleration, force, speed, and strain data. [Figure 3](#) shows the tank car used for this effort. [Figure 4](#) shows a detailed view of the end of the tank car with the stub sill attachment. A previous report by FRA (Meymand, 2020) documented detailed results of this impact testing.

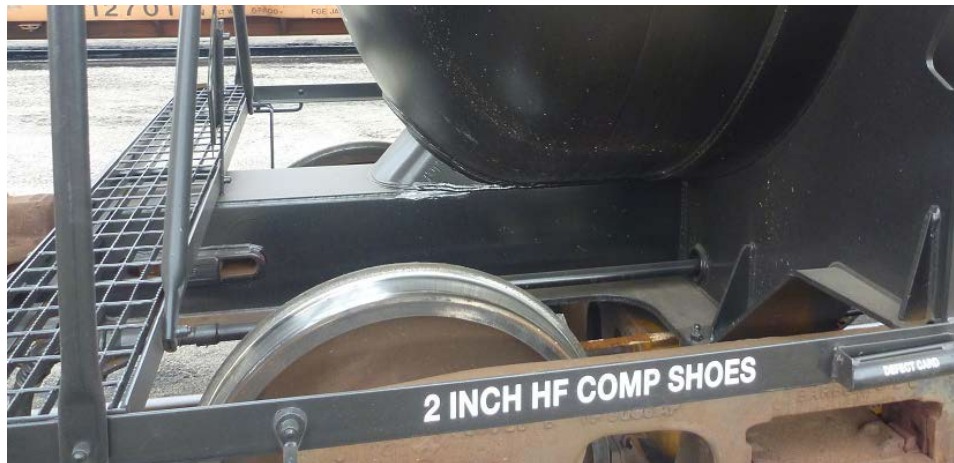
Figure 4. Detail View of the Stub Sill and Head Brace Attached to the Tank of the Instrumented Tank Car

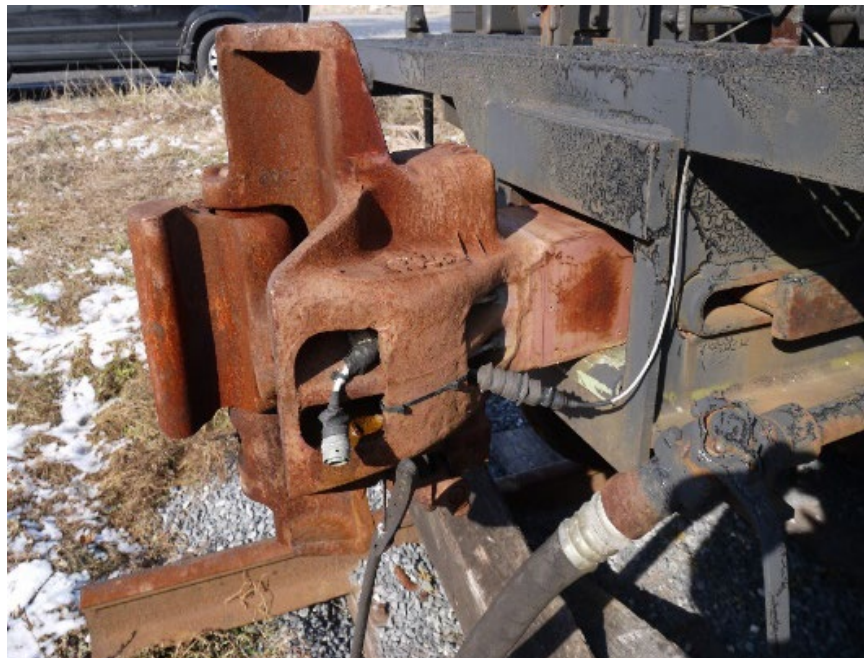
Figure 6. Instrumented Coupler for Measuring Longitudinal Coupler Forces

Researchers measured the longitudinal coupler forces on both the A-end and B-end of the tank car. Two instrumented couplers outfitted with strain gauge bridges measured the longitudinal forces. Figure 6 shows an image of an instrumented coupler installed on the A-end of the car.

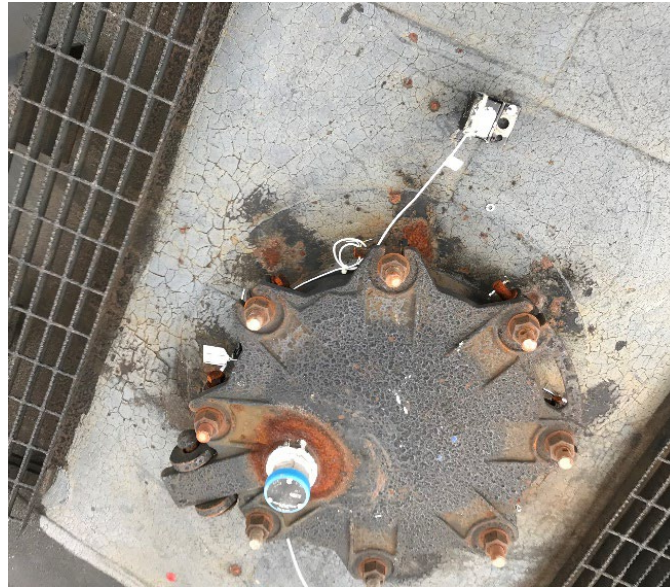
Figure 7. Triaxial Accelerometer Mounted on Top of the Carbody

Researchers installed five accelerometers at multiple locations on the tank car. A triaxial accelerometer mounted on top of the carbody (see [Figure 7](#)) measured accelerations in longitudinal, lateral, and vertical directions. Two dual axis accelerometers, mounted on the stub sill at each end of the car (see [Figure 8](#)), measured accelerations in the longitudinal and vertical directions. Two uniaxial accelerometers mounted to the bearing adapter measured the vertical acceleration on the axles.

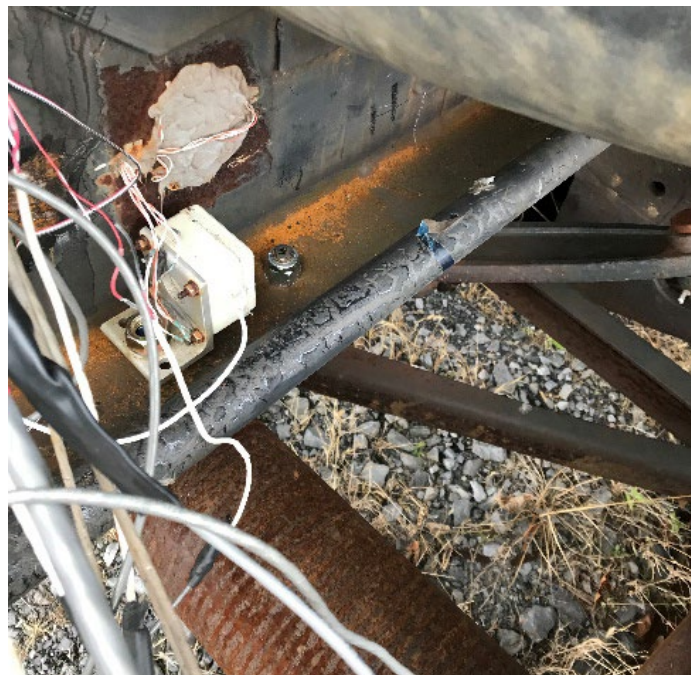
Figure 8. Dual-Axis Accelerometer Mounted on the Stub Sill at Each End of the Car

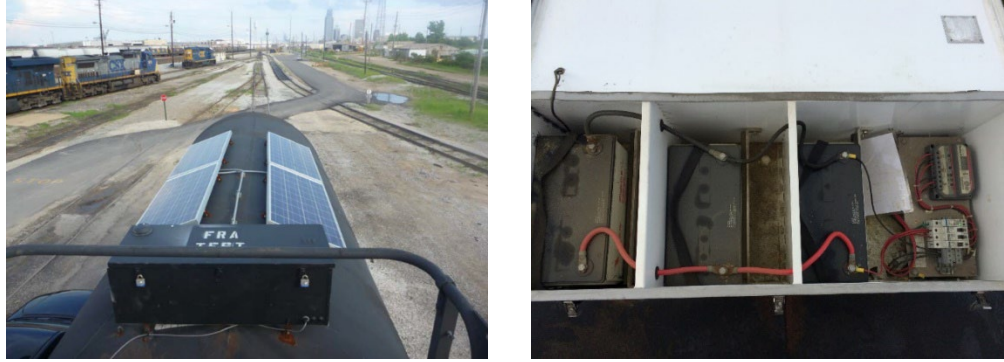
Figure 10. Solar Panel and Battery Box on Top of Instrumented Tank Car

Four 115 W, 12 V solar module solar panels and a set of 110 Ah, 12 V AGM batteries powered the system. [Figure 10](#) shows the solar panels and the battery box. The battery box also contained the electronics that controlled battery charging.

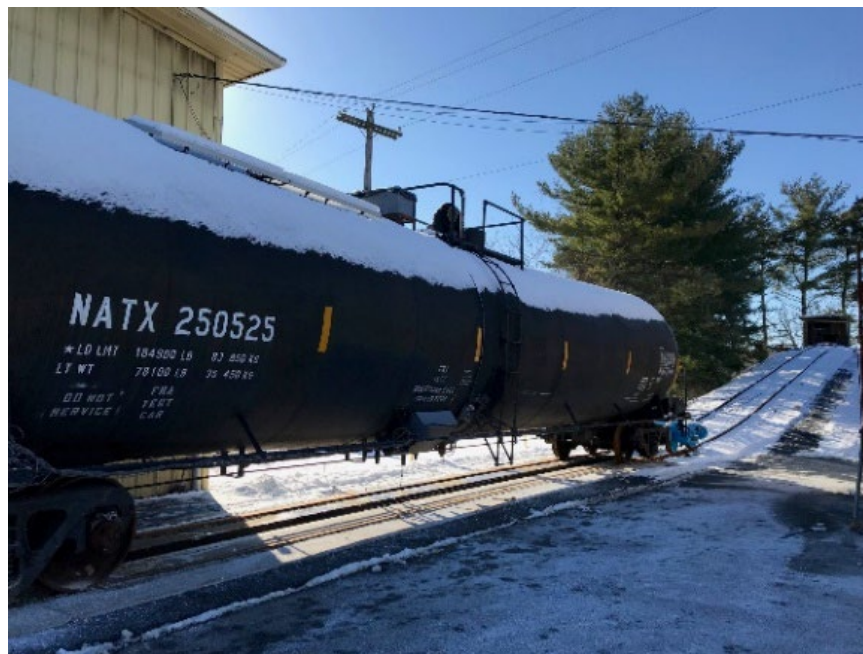
Figure 11. Instrumented Tank Car at the Amsted Test Track

The research team conducted the impact test program on Amsted Rail’s test track between January 2018 and June 2018. The test program included a series of impact tests for different car configurations, end-of-car units, and coupling speeds that are detailed in the next section. [Figure 11](#) shows the instrumented tank car at Amsted’s test track.

To initiate the impact, a bogie coupled to the tank car was attached to a winch that was used to pull the vehicle up a hill. When the car reached the proper position for the intended impact speed, it was released, sending the car toward the stationary test vehicles. This simulated the

real-world hump yard operation used for making up trains. In impact testing of this nature, the striking car that is in motion is referred to as the hammer and the stationary cars that are parked down the hill are referred to as the anvil.

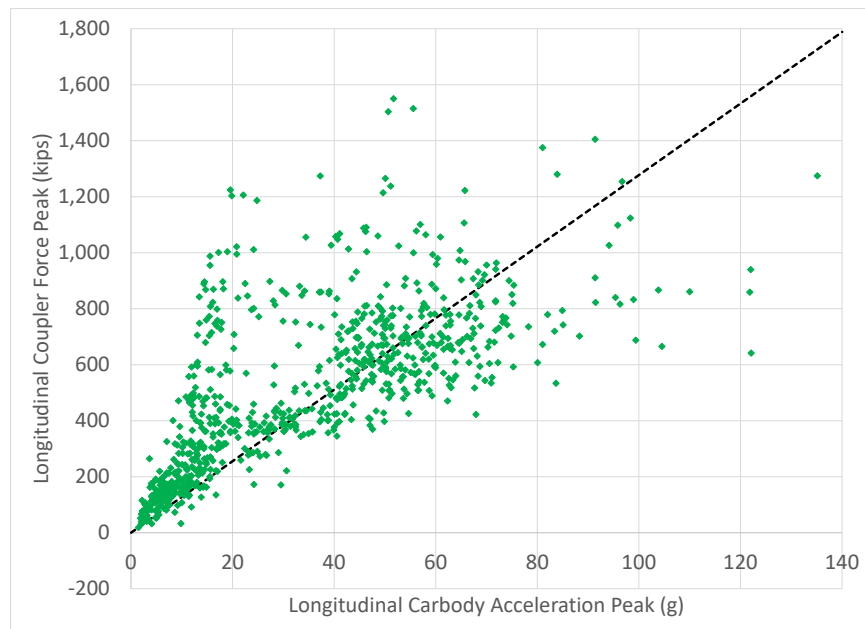
Figure 14. Longitudinal Comparison Using 1,000 Hz Filter and Carbody Accelerations

[Figure 14](#), [Figure 15](#), and [Figure 16](#) show the comparison between the measured longitudinal coupler forces and the carbody longitudinal accelerations filtered with 1,000 Hz, 180 Hz, and 60 Hz cutoff frequency, respectively. All three plots show a similar linear trend. However, the plots for 180 Hz and 1,000 Hz cutoff frequency have large scatter throughout the data range. The plots for 60 Hz cutoff frequency plot shows the best linear fit. Therefore, the team selected the 60 Hz cutoff filter for further development of the algorithm.

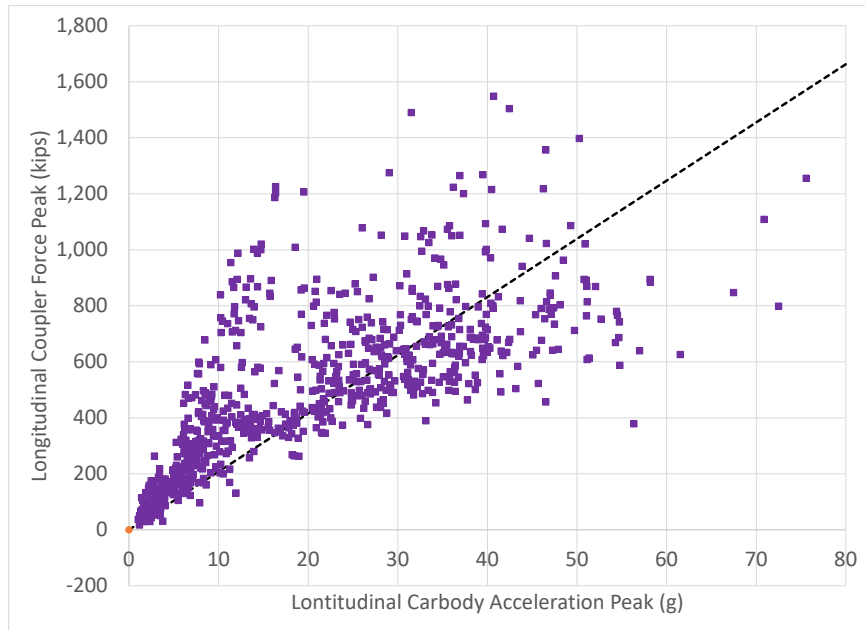
Figure 15. Longitudinal Comparison Using 180 Hz Filter and Carbody Accelerations

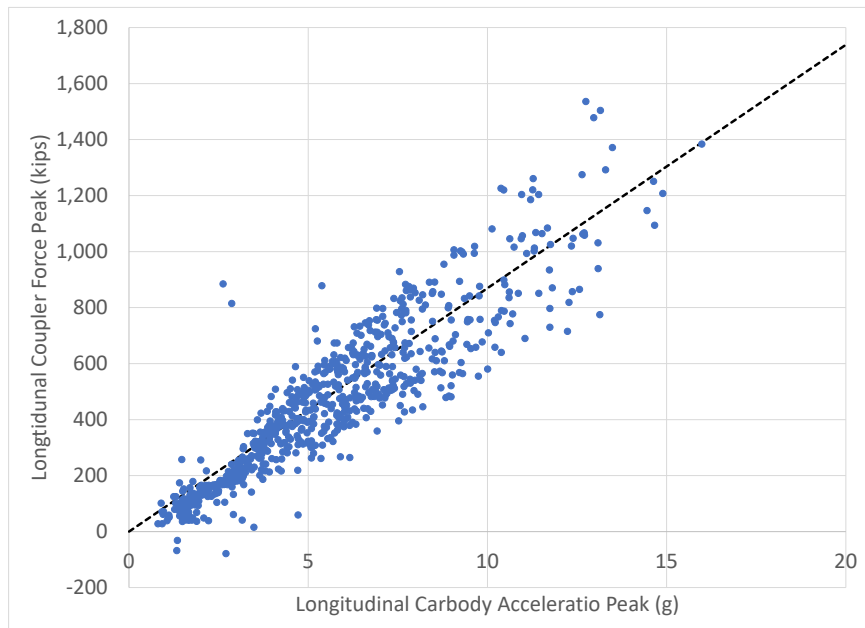
Figure 16. Longitudinal Comparison Using 60 Hz Filter and Carbody Accelerations

In the next step, the team investigated which available accelerometer placement produced the best results. [Figure 16](#), [Figure 17](#), and [Figure 18](#) show the comparison between the measured longitudinal coupler force and the longitudinal accelerations using a 60 Hz cutoff filter on the carbody, Stub Sill A, and Stub Sill B, respectively. The carbody acceleration plot showed the best linear fit. The Stub Sill A acceleration plot showed a large amount of scatter and a poor linear fit, and the Stub Sill B acceleration plot showed large scatter and no discernable trend. Therefore, the team selected the carbody accelerations to develop the final algorithm.

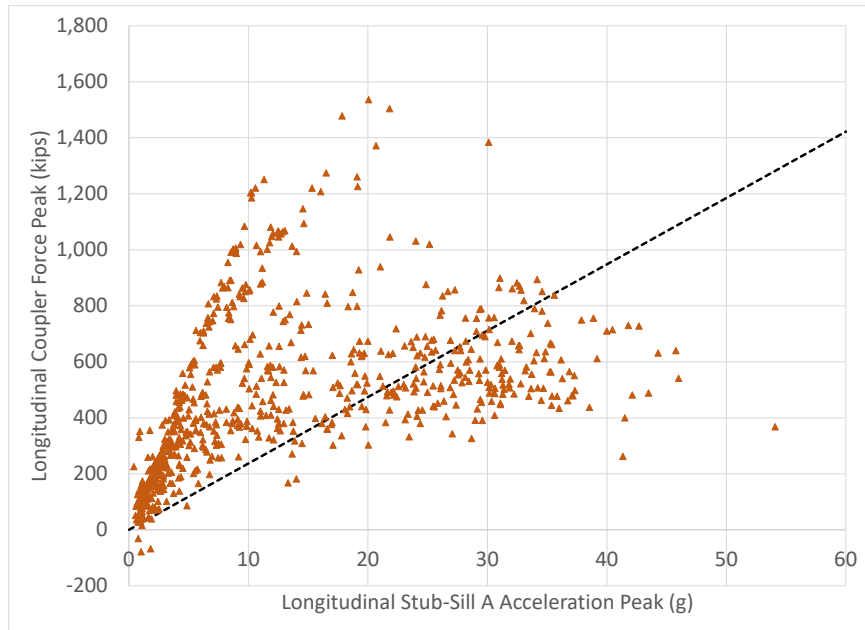
Figure 17. Longitudinal Comparison Using 60 Hz Filter and Stub Sill A Accelerations
