RR 24-10 | September 2024

EFFICACY OF INCREASED FLASH RATE OF RAILROAD GATE FLASHERS

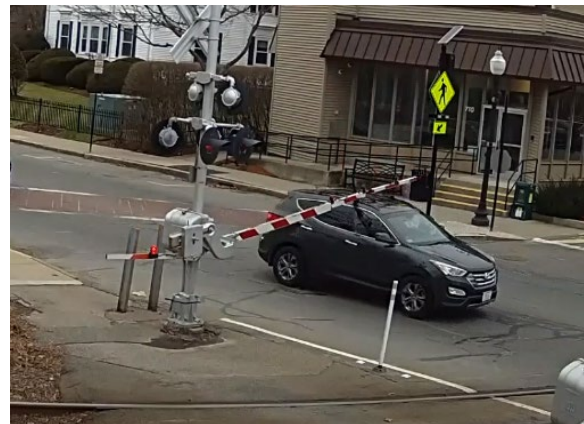
Motorists whose visibility is obscured or who are distracted while approaching a rail-highway at-grade crossing may not notice the standard railroad gates and flashing lights. This can lead to unsafe situations such as motorists stopping within the dynamic envelope of the crossing, breaking the descending or horizontal gate, or driving through the crossing and colliding with a train. [Figure 1](#) shows an incident involving a driver violating the crossing gate at the study

crossing on Washington Street in Canton, MA (ID# 546 729P), which resulted in a broken gate.

Figure 1. Crossing Gate Violation Example (Crossing ID# 546 729P)

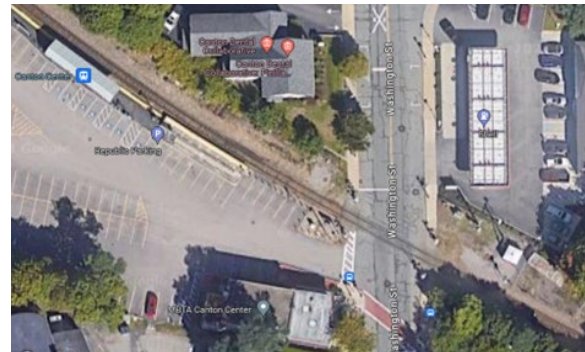
The MBTA is the primary operating railroad using the crossing, with an estimated 28 trains per day on weekdays. There is no weekend commuter rail service. The Canton commuter rail station lies to the west of the crossing on the south side of the tracks, as shown in [Figure 2](#).

Figure 2. Washington Street Grade Crossing (Canton, MA)

Data Collection and Analysis: The grade crossing location selected is on Washington Street in Canton, MA (ID# 546 729P). This is a public, at-grade crossing equipped with 8-inch mast-mounted flashers and 4-inch gate-mounted flashers on each of the two approach lanes. It also has pedestrian gates in all four quadrants.

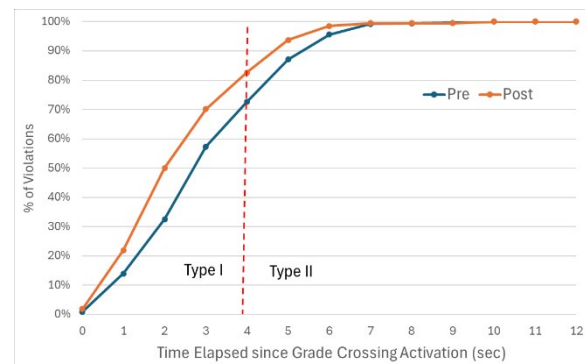
Figure 4 shows the percentage cumulative distribution of violations by elapsed time since grade crossing activation for both periods. This figure shows that for the post-installation period, fewer violations occurred later into the activation after the installation of the rapid flashers.

Figure 4. Percentage Cumulative Distribution of Violations by Time Elapsed since Grade Crossing Activation

For observed violations, the average time of violation was 3.4 seconds for the pre-installation period. For the post-installation period, the average time of violation had decreased by 18 percent to 2.8 seconds. This means that violations tended to occur earlier in the activation after the rapid flashers' installation.
