MODERN CONCRETE CROSSTIE EXPERIENCE IN FRANCE AND MEXICO

MARCH 1979

Prepared for
U.S. DEPARTMENT OF TRANSPORTATION
FEDERAL RAILROAD ADMINISTRATION
Office of Research and Development
Washington, D.C. 20590

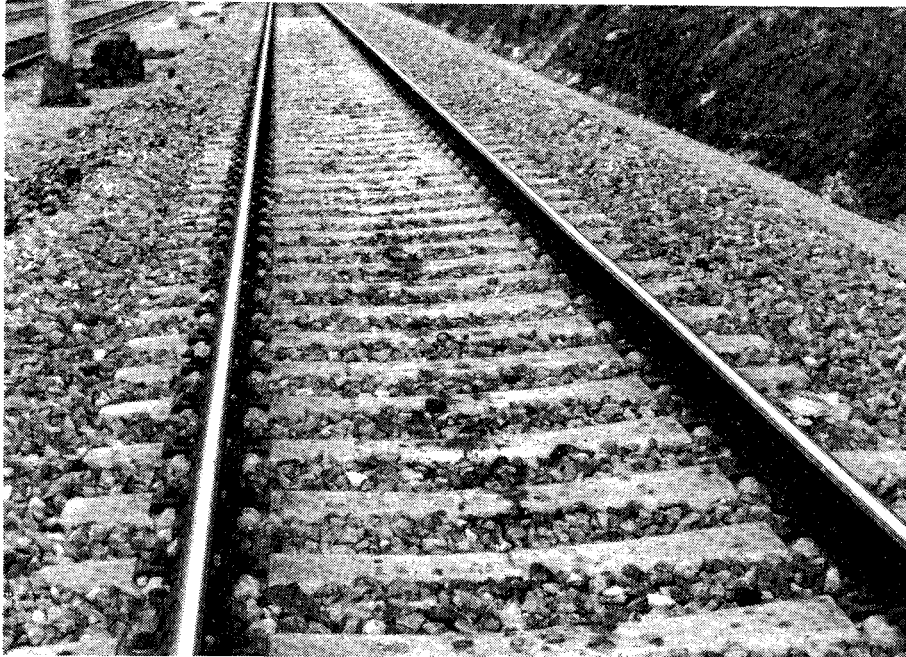
FIGURE 12. TEST ZONE IN MONOBLOCK CROSSTIE TRACK

Some prototype ties were installed in March, 1973, in the Paris Belt line in a track for which the traffic has been, primarily, freight operating at a speed of 90 km/hr (56 mi/h) and accumulating tonnage at the rate of 100,000 tonnes (125,000 tons) per day. Even though these (prototype) ties did not meet the requirements of the exceptional load tests, their behavior was acceptable overall (see figure 12 for referenced installation). The production of subsequent versions having greater load resistance was undertaken and some of these were put in-track during 1976.

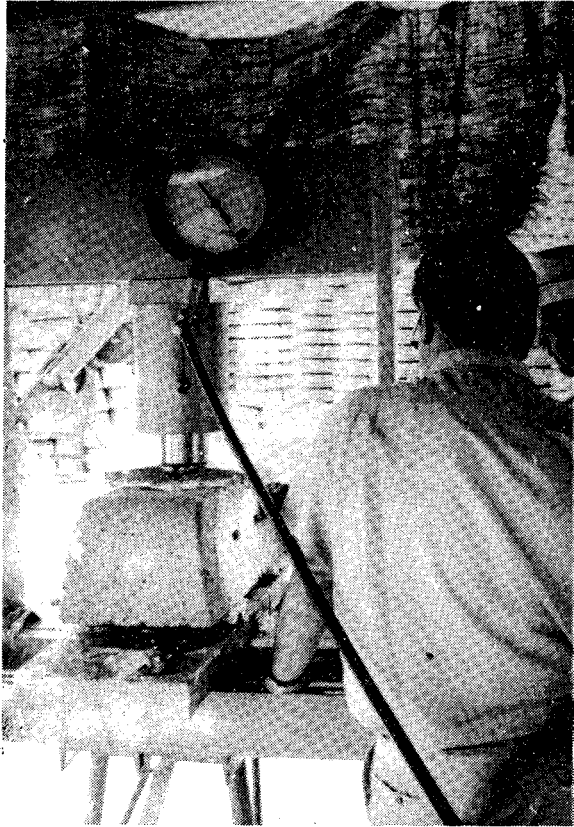
PLATE 13. BENDING TEST OF BLOCK IN NORMAL TIE POSITION

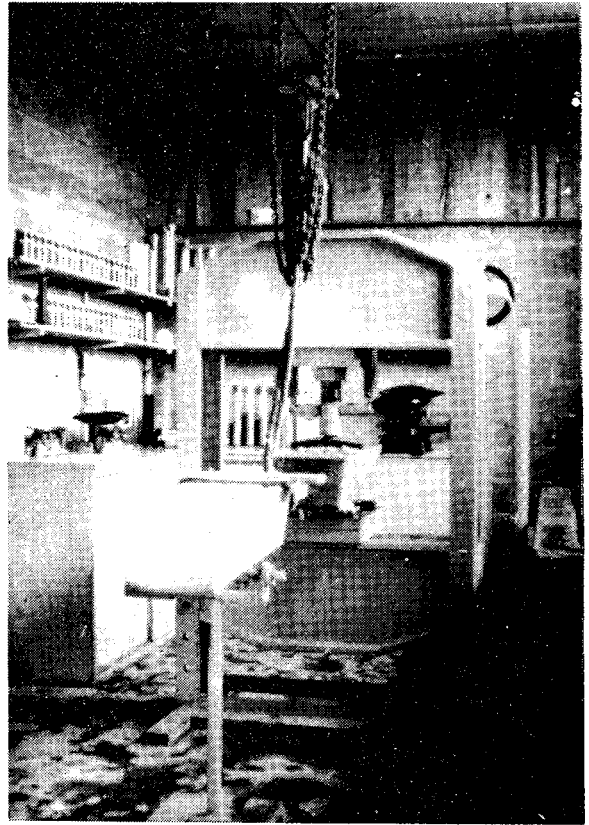
PLATE 14. BENDING TEST OF BLOCK IN REVERSE TIE POSITION

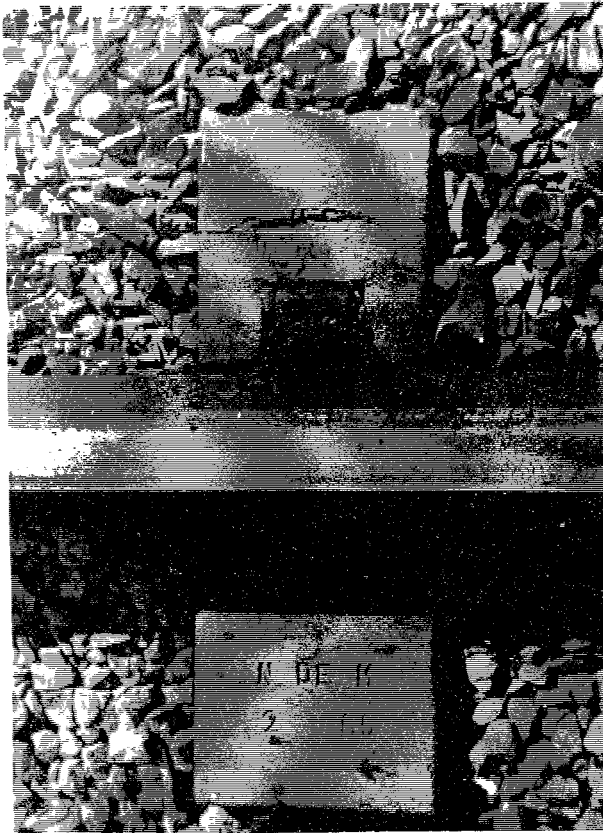
PLATE 37. DAMAGE TO CONCRETE AT SEAT OF RAIL CLIP CAUSED BY SLACK IN FASTENING

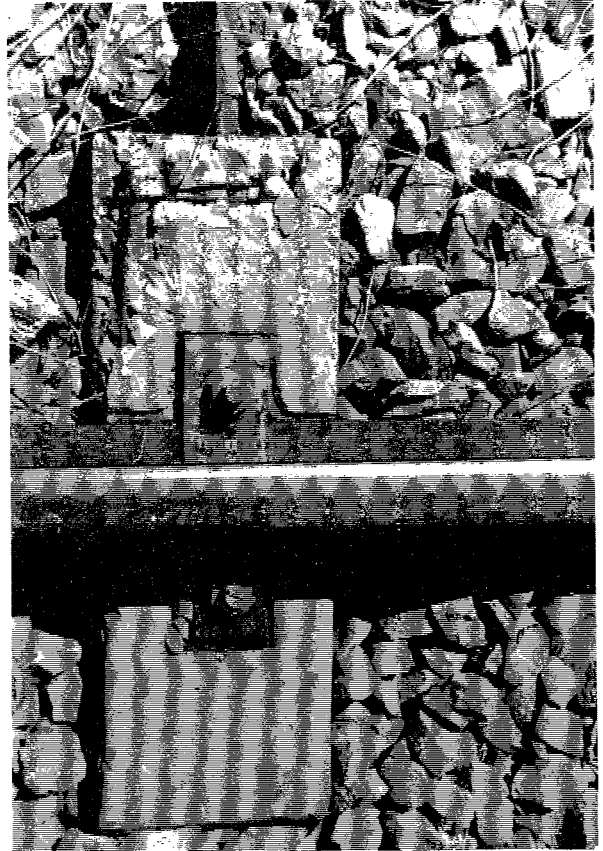
PLATE 41. REINFORCING STEEL AFFECTED
BY CORROSION

e. Corrosion of tiebars of the RS ties was detected in certain sections of the lines San-Carlos-Ciudad Acuna, Chihuahua-Topolobampo and Coatzacoalcos-Estacion Allende. In the first case it commenced with oxidation of the bar in several sections of the track. In the second, the effect was severe in the swamp near Topolobampo in which a considerable percentage of the bars was badly corroded. A limited number of ties was damaged at the entrance of the bar in the concrete block, which affected the reinforcing steel (plates 39 through 42).
