**Federal Railroad
Administration**

Status of the Transportation Technology Center - 2015

13. ABSTRACT (Maximum 200 words) The Transportation Technology Center (TTC) is a Federally owned, privately operated test facility in Colorado. It has over 50 miles of test track arranged in different configurations for testing all aspects of vehicle-track interaction. Maximum test speed is 165 mph (265 km/h). Overhead and 3rd rail electrification is available. Eighteen large buildings house offices, test fixtures, workshops and maintenance facilities. Outside facilities include the Security and Emergency Response Training Center, a crash wall, a rail vehicle squeeze test frame, and a fully functioning Positive Train Control test bed. Investment in TTC since its construction in the 1970s has ensured most of the assets are in good working order. Some long-life assets are at the end of their useful lives and are due to be replaced.

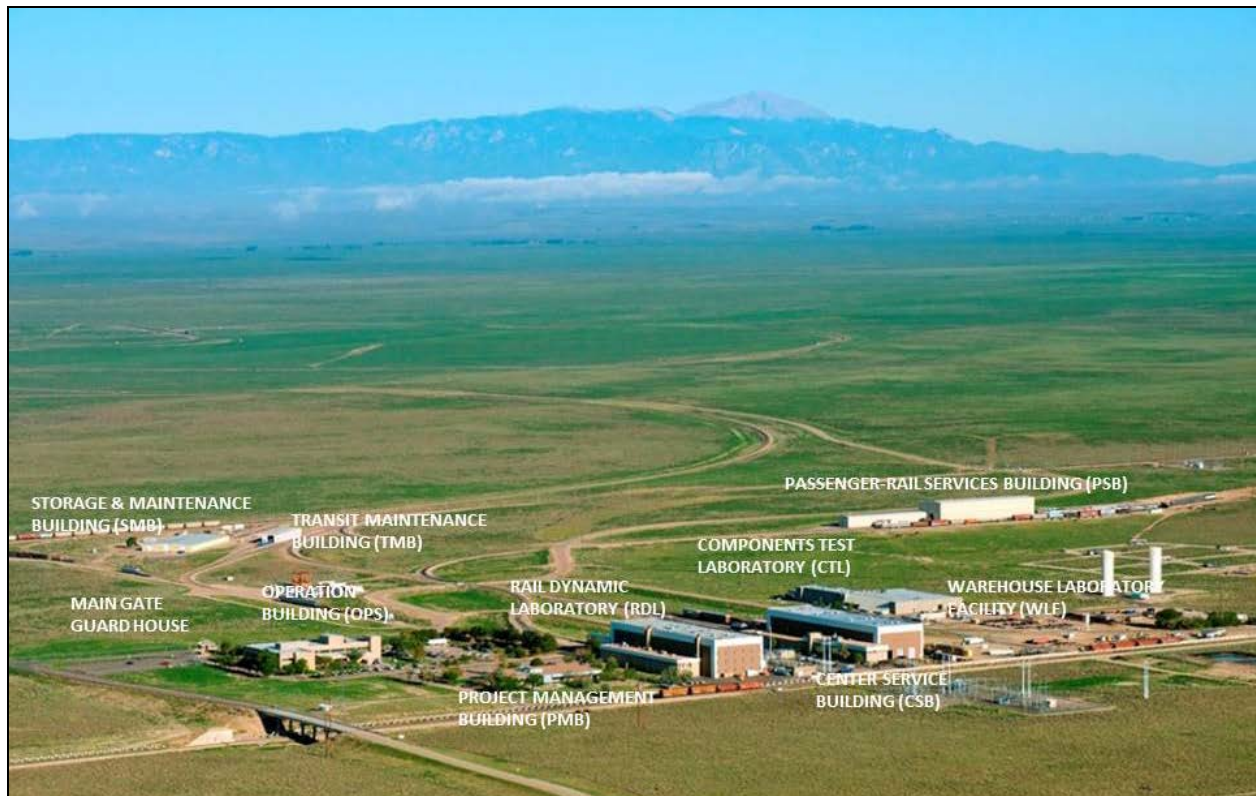
Figure 3. Core Area at the Transportation Technology Center

There are eighteen buildings at TTC that each has a floor area greater than 2,000 square feet (186 m²). These buildings house offices, laboratories, test equipment, storage, maintenance services and support facilities for ongoing research work at TTC. Figure 3 shows the core area where several of the principal buildings are located.

Yard and service tracks for the core area are shown in Figure 3. Tracks were constructed using recycled materials with predominately wood ties. Tracks are maintained to FRA Class 2 safety standards. Maximum track curvature is 12 degrees.

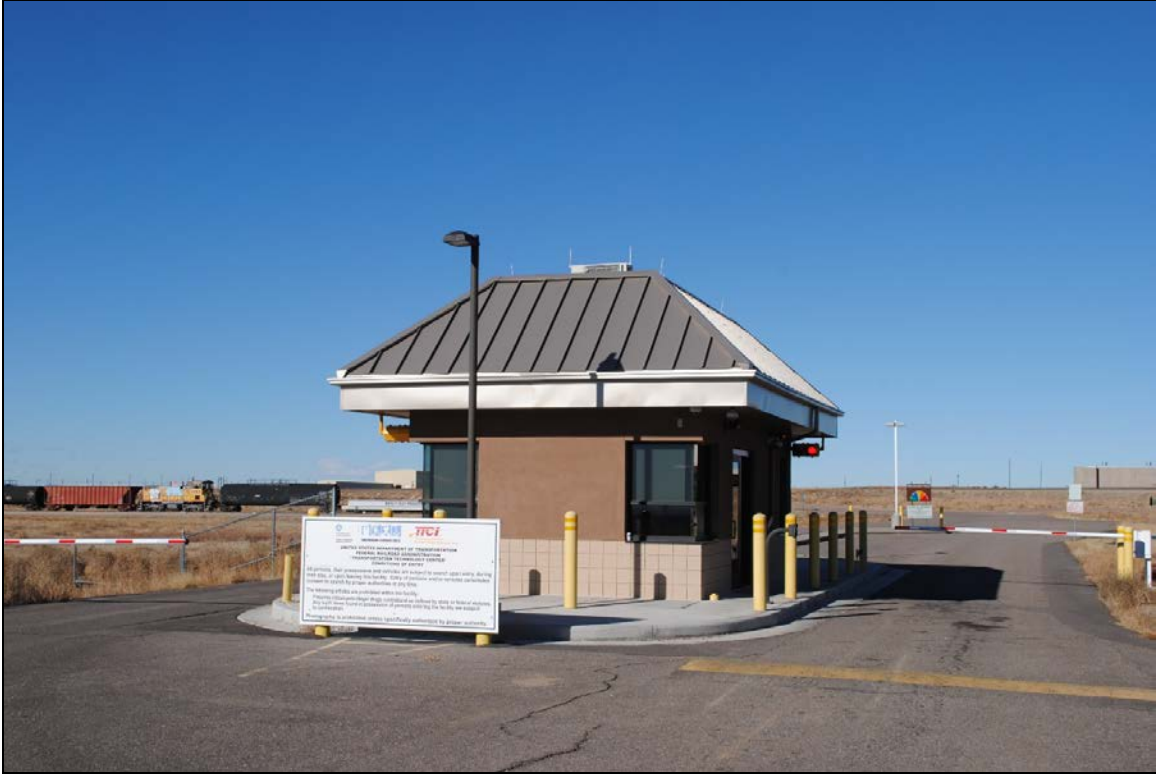
Figure 4. Main Gate Guard House

The Main Gate Guard House, shown in Figure 4, is located directly west of the Operations Building (OPS) on the main entrance road to the facility. The original structure, which was constructed with the OPS in 1975, was replaced in 2013. It now has many of the improvements recommended in a Physical Security Assessment that was conducted in April, 2012. Such items include bullet resistant glass and exterior wall construction, surveillance monitoring capability, panic alarm to local emergency response station, secured storage for firearms not allowed into the facility, badge reader system for employee entrance and exit, and improved vehicle barrier protection.

The central fire alarm station and a satellite water system monitoring station are located in the Main Gate Guard House.

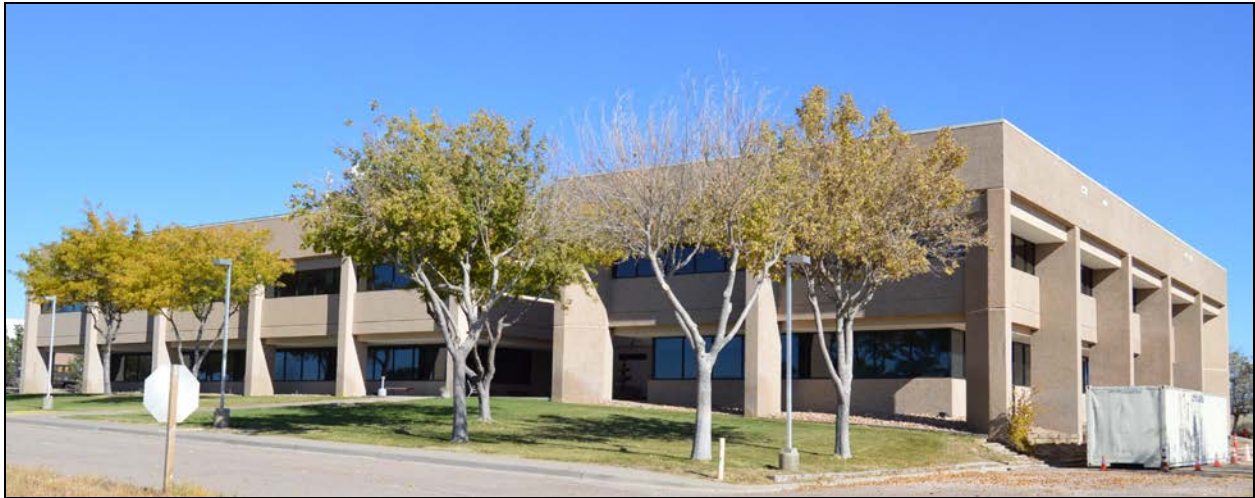
Figure 5. Front View of the Operations Building (OPS)

The Operations Building (OPS) (see Figure 5) is the main office building on site. The primary structure was constructed in precast concrete in 1976, followed by a southern addition in 1980. The combined building contains 54,487 square feet (5,062 m²) of floor area. It includes a 42 by 24 feet (12.7 m by 7.3 m) conference room called Harris Hall. A data processing area and the Operations and Control Center (OCC) share a raised floor 75 by 55 feet (22.8 m by 16.8 m). In

The general interior and exterior condition and appearance of the OPS Building is good.

Building sustainability improvements to the OPS started in 2011, and are still in progress. To-date, the windows, exterior wall and roof insulation, boiler, air handlers and condensing units of the heating, ventilating and air conditioning (HVAC) system, fire suppression system, water efficient faucets, LED office lighting, LED parking lighting, Energy Management System (EMS) have been replaced with high energy efficient components. To bring the building to LEED Silver standard would require refurbishment of the kitchen and restrooms, as well as landscaping around the building.

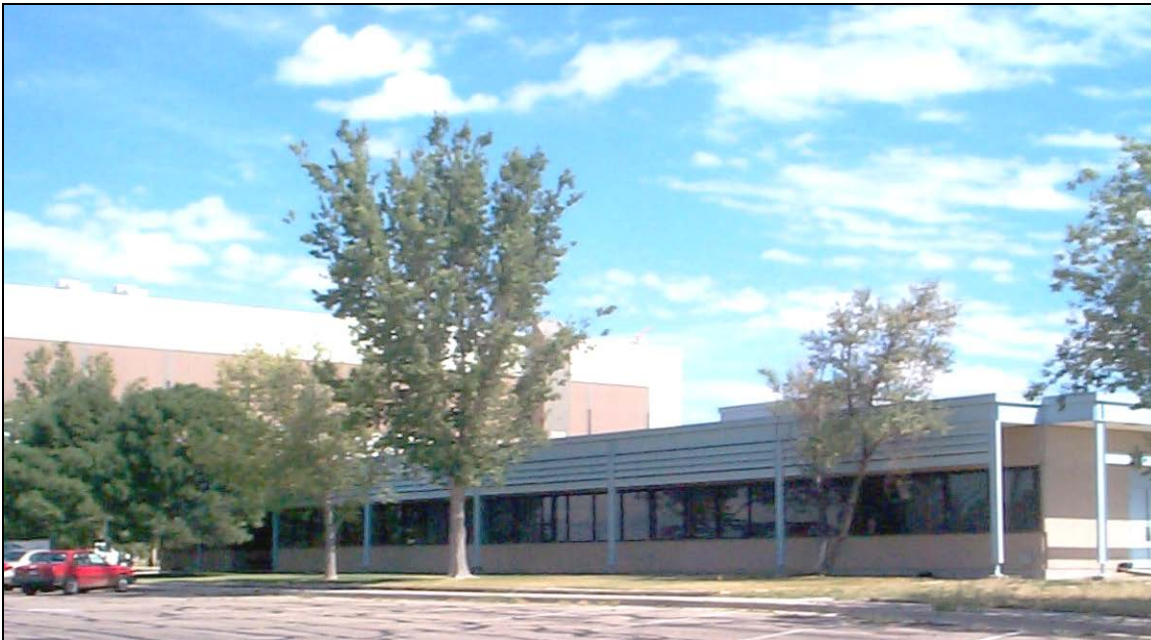
Figure 6. The Project Management Building (PMB)

The Project Management Building (PMB) (see Figure 6) was constructed of pre-cast concrete panels supplemented with steel and aluminum trim work in 1972. This one-story building is 180 feet (49 m) long and 100 feet (33.5 m) wide, providing 17,400 square feet (1,616 m²) of office space.

The PMB has not been used since 2007. The exterior is in good condition. The ceilings in the interior contain asbestos, which needs to be mitigated before the building can be reoccupied. A preliminary design was performed in 2011 to refurbish the PMB and convert it into a multiple use training and conference center. All lighting fixtures, heating and air cooling systems are original to the building.

The structure of the PMB is in good condition, but the interior finishes are showing normal wear for a 44 year old building.

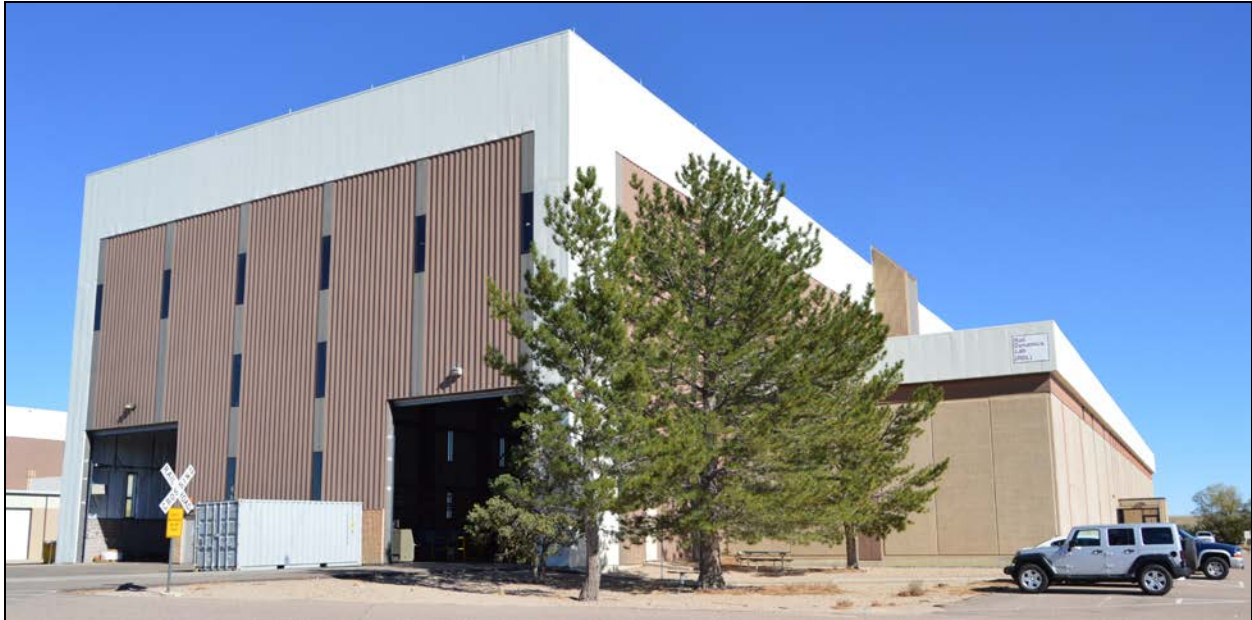
Figure 7. The Rail Dynamics Laboratory (RDL)

The Rail Dynamics Laboratory (RDL) (see Figure 7) houses three major rail vehicle simulators, several smaller test stands and facilities to support laboratory testing. Construction began in June 1972 and occupation started in April 1974. The high-bay area of the building is constructed of structural steel and has exterior walls covered with fabricated metal panels. The walls of the low-bay area are constructed of concrete masonry units and pre-cast concrete panels. The floors of both sections of the building are of cast-in-place concrete. Built-in provisions to reduce noise and vibration permit most activities in the low-bay area to continue while testing is being conducted in the high bay. The high-bay area is served by two 100 ton (91 tonne) rated overhead cranes with hook heights of 42 feet (11.2 m). The cranes with support rigging are capable of lifting fully loaded freight cars, locomotives, or passenger vehicles and setting them on the simulators.

The structure of the RDL is in good condition, but finishes are showing normal wear for a 40 year old building except in some office areas that have been recently refurbished. The roof of the building was replaced in 2014. Installation of LED light fixtures, high efficiency windows and wall insulation in the high bay was completed in 2015.

The mechanical heating and ventilating systems are original to the building. The air conditioning systems have R-22 Freon, and will need replacement in the near future.

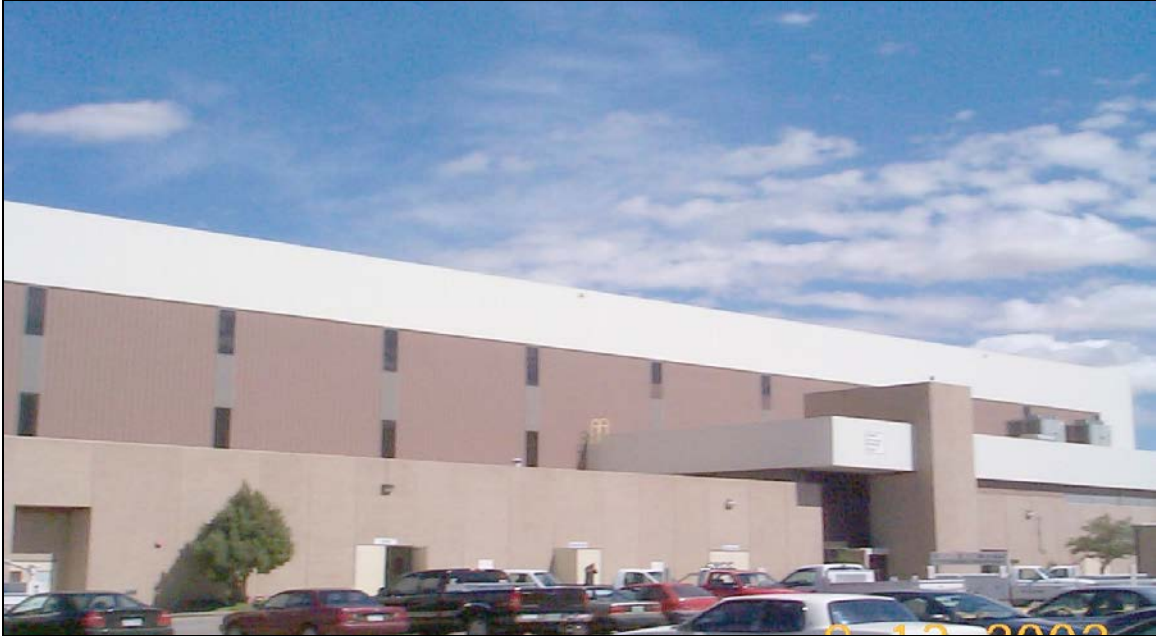
Figure 8. The Center Service Building (CSB)

The Center Service Building (CSB) (see Figure 8) is located in the core area. It is the primary maintenance facility for TTC, providing for minor overhauling, repair, maintenance and test preparation in the high bay. The facility also provides office space, motor pool area, parts storage, and craft shop areas for vehicle and building maintenance. Located outside the CSB are a loading dock, a rail car squeeze fixture, yard tracks, vehicle fueling stations, and a locomotive servicing facility.

The structure of the CSB is in good condition, but finishes are showing normal wear for a 40 year old building. The mechanical heating and ventilating systems were replaced with modern, energy efficient propane boilers in 2015. The air conditioning systems have R-22 Freon, and will need replacement in the near future.

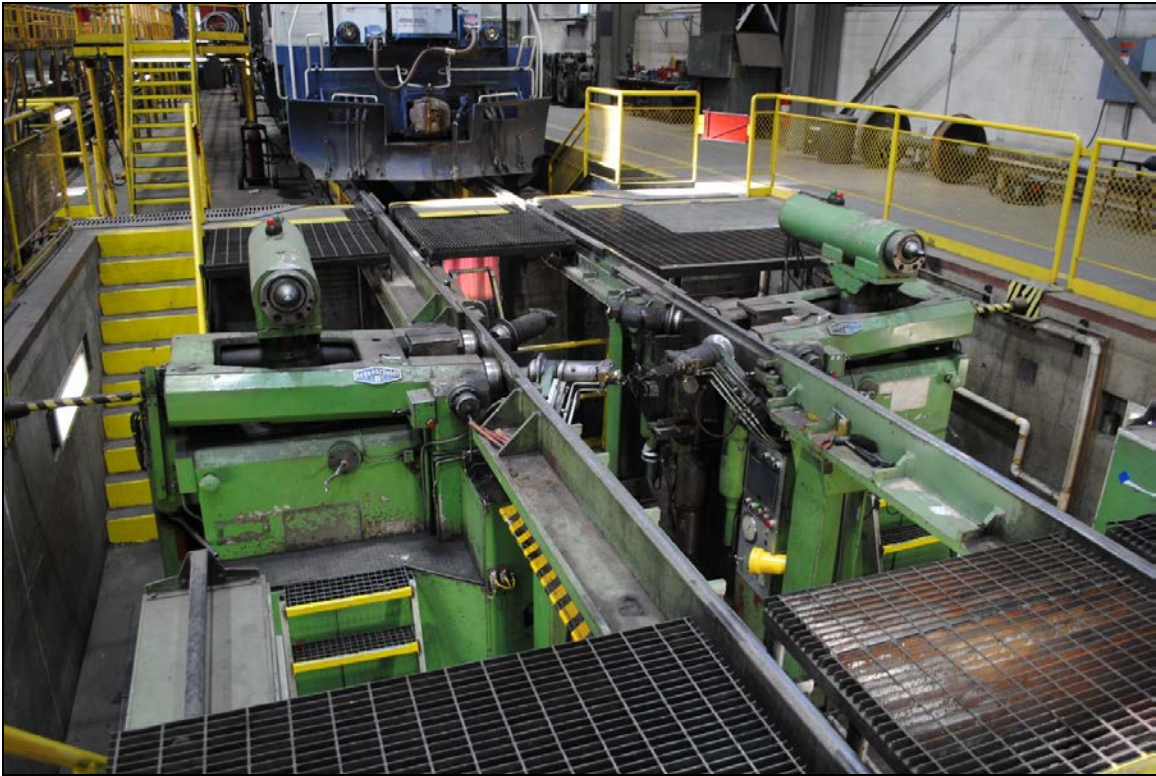
Figure 9. Wheel Truing Machine in the CSB

Four tracks enter the high-bay area from the west. The most northern track (Track #4) continues through the building, to a concrete slab on grade east of the building. This features a repair pit with air, water, and power at convenient locations. A drive-on, wheel-truing machine is located at the center of the building on this track (see Figure 9). Installed in 1975, it is an under-floor, tracer lathe fabricated by Hegenscheidt MFD Corporation. The lathe was refurbished in the late 1980's for hydraulic lines and components, and in 1990 for a control system upgrade. A review

of costs to refurbish the main hydraulic cylinders showed them to be economically cost prohibitive. Wear in this area will degrade tolerance control over time, limiting use to freight wheels where tolerances are not as critical as higher speed passenger applications.

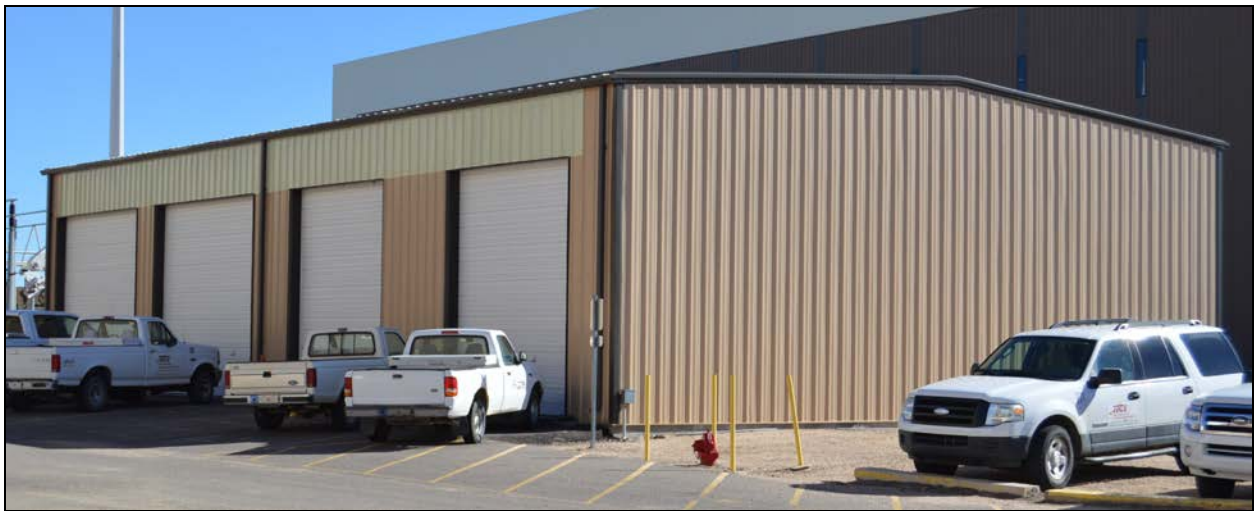
Figure 10. The CSB Storage Building (aka the TTX building)

The TTX Building (see Figure 10) was constructed in 2007 under a joint funding agreement between TTCI and TTX. The building is FRA real property, with TTX receiving long term use under an agreement with TTCI.

The TTX Building is in very good condition.

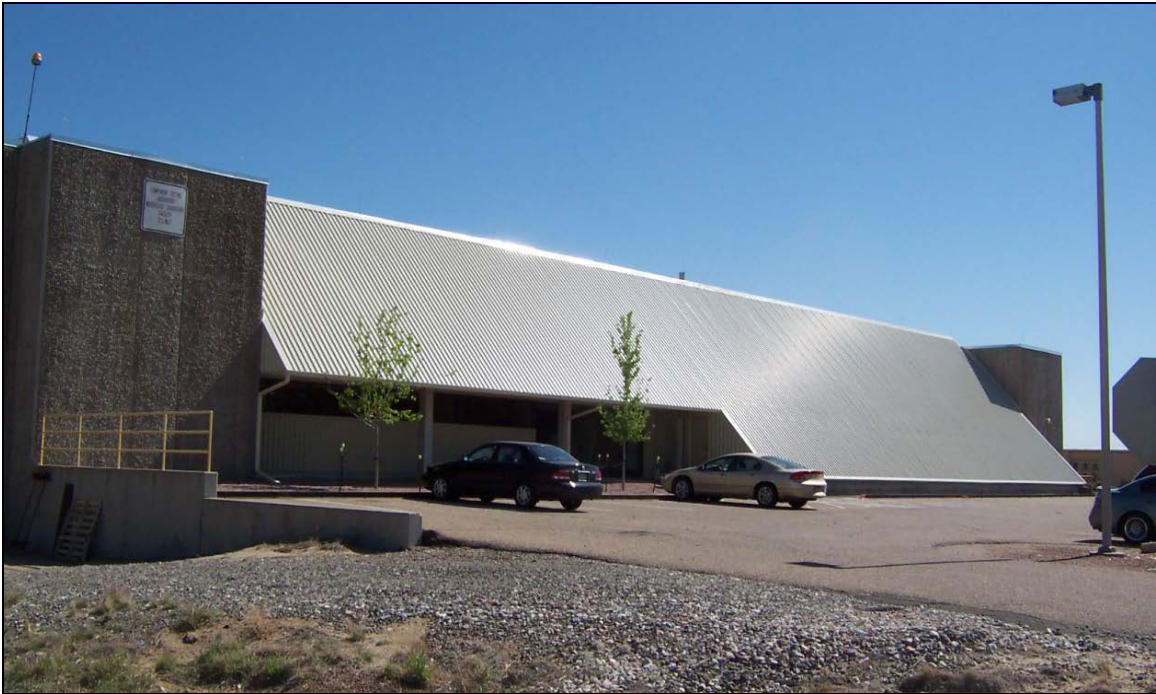
Figure 11. Warehouse Laboratory Facility (WLF) and Components Test Laboratory (CTL)

The building shown in Figure 11 was constructed in two phases, with the initial phase currently called the Warehouse Laboratory Facility (WLF) and the second phase called the Components Test Laboratory (CTL). Both phases were constructed in between 1979 and 1980. The completed building is a pre-cast, pre-stressed concrete structure. The total floor space is 53,428 square feet (4,964 m²).

The CTL houses dynamic test equipment including the dynamometer for railroad wheel and brake testing, rolling load machines for rail and component wear and fatigue testing, and a tie wear machine.

The structure of the WLF/CTL building is in good condition, but finishes are showing normal wear for a 35 year old building. The mechanical heating and ventilating systems are original to the building. The current diesel fired boiler was designed to handle half of the design load, with a second boiler planned, but never installed. The air conditioning systems have R-22 Freon, and will need replacement in the near future.

From 2009 to 2010, the WLF roofs and the sloping wall on the front of the building (which were originally covered with solar panels) were replaced.

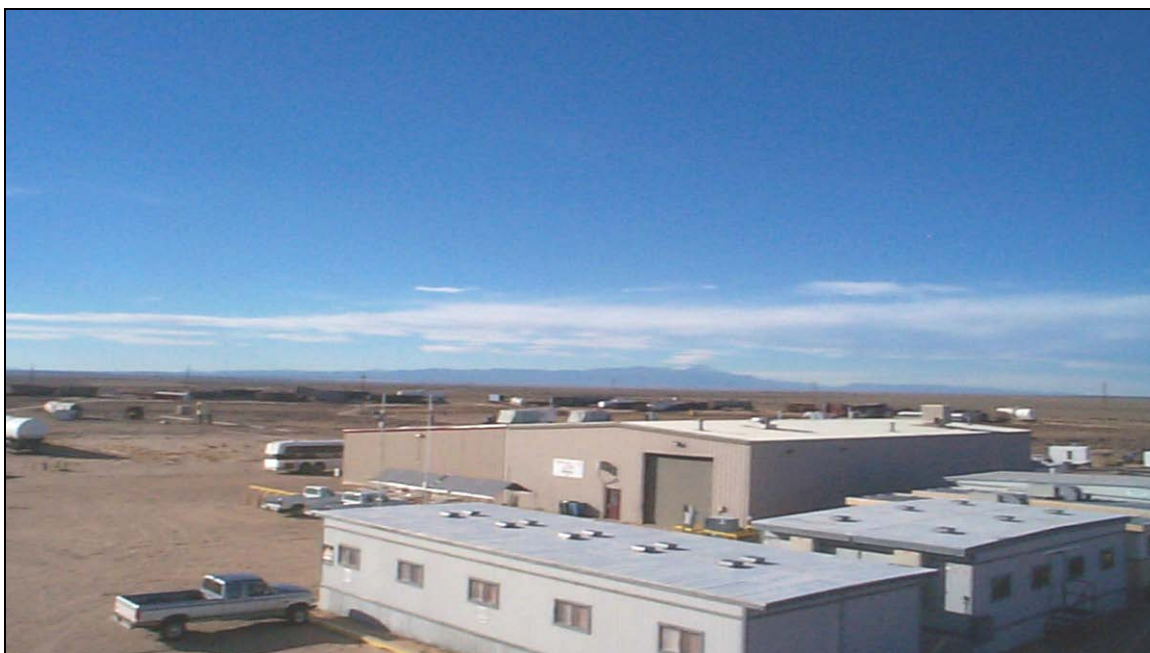
Figure 12. Security and Emergency Response Training Center (SERTC)

The Security and Emergency Response Training Center (SERTC) (see Figure 12) provides classroom and full-scale simulation training for emergency responders to rail and highway incidents. The initial building was constructed in 1973 to house and maintain the Prototype Tracked Air Cushion Vehicle (PTACV). The main structure is a pre-engineered metal building, 60 feet (18.3 m) wide by 120 feet (36.6 m) long. The PTACV program was completed in 1974, with the building modified in 1978 for testing of insulated tank car test assemblies.

The main SERTC building interior is maintained in a like new condition. The exterior finish is in good condition, but showing some oxidation of the paint coating. The five modular units used for personnel offices are in poor condition and require a lot of maintenance.

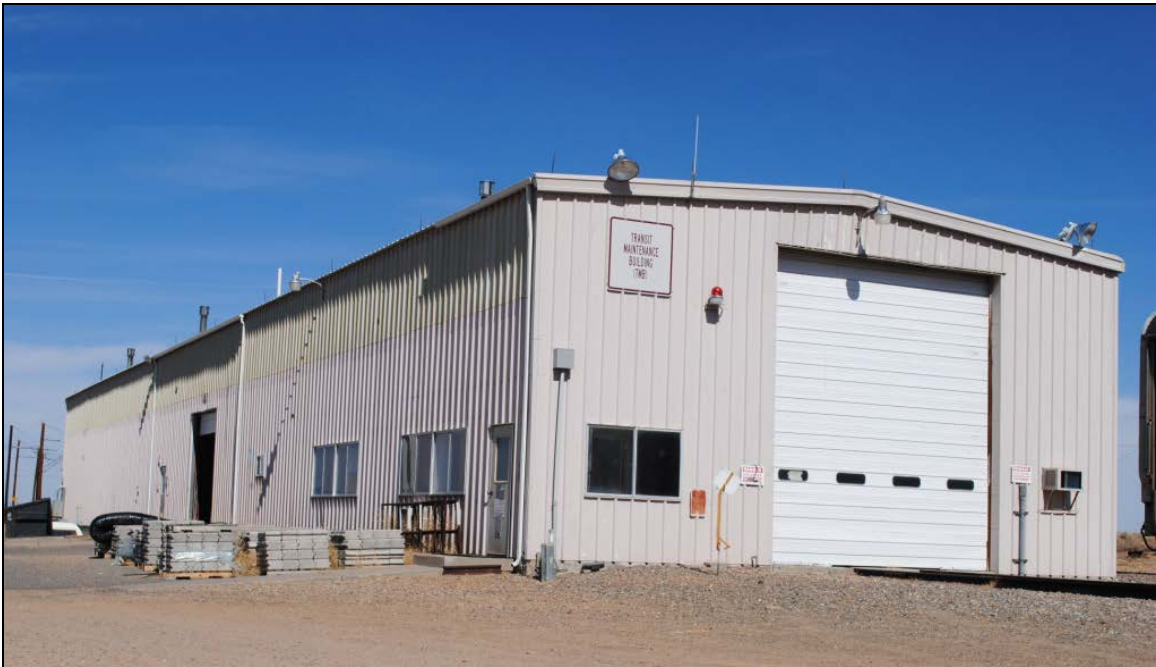
Figure 13. The Transit Maintenance Building (TMB)

The Transit Maintenance Building (TMB) (see Figure 13) was constructed in 1973 as a temporary facility for mass transit vehicle testing. It is currently used as a project maintenance facility. The building is pre-engineered metal construction, insulated and heated, 40 feet (12.2 m) wide by 192 feet (58.5 m) long, with a single through track. The building has a 100 feet (30.5 m) long service pit between the rails with flat track for the remainder of the building.

The building structure is in good condition, but both exterior and interior finishes are in fair condition. The fiberglass light panels on the exterior walls, although intact, are oxidized with excessive weathering.

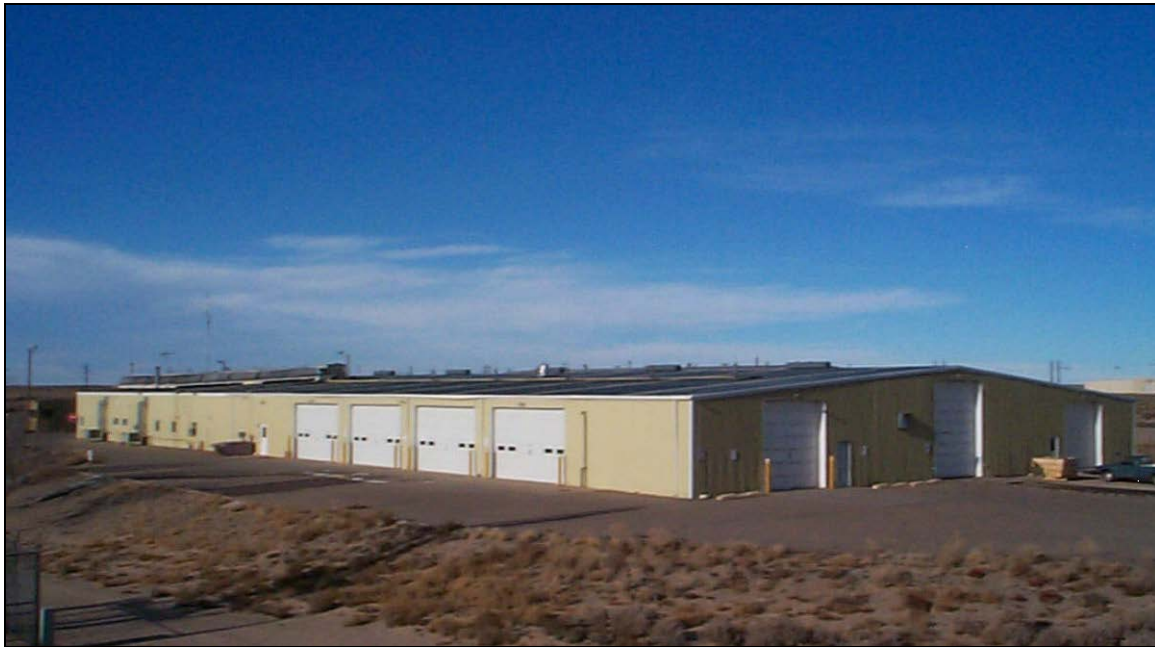
Figure 14. The Site Storage and Maintenance Building (SMB)

The large one-story Site Storage and Maintenance Building (SMB) (see Figure 14) with track access was constructed in 1973 as interim warehousing and offices. The building is pre-engineered metal construction with a non-insulated and un-heated high bay, 130 feet (39.6 m) wide by 277 feet (84.4 m) long. A single track runs through the building. This building serves several purposes, including; craft material storage, lading and damage material staging, and emergency response vehicle staging. Areas available for project use, include ballasted track through the building for staging (no jacking), limited inside secured and un-secured storage, outside secured storage, large office space area (4,000 square feet (372 m²)), which includes separate offices, conference rooms, a break room with kitchen, and restrooms with showers.

The structural frame and exterior walls are in good condition. Half of the roof decking was replaced to remove excess penetrations in 2010. The other half over the storage area will need replacing when the fiberglass light panels degrade and weather seals on screw fasteners fail. The existing deck panel is an obsolete rib design that buckles under personnel traffic causing cracks

at the top of the rib. Exterior and interior finishes are worn, but in an acceptable condition for the type of building use.

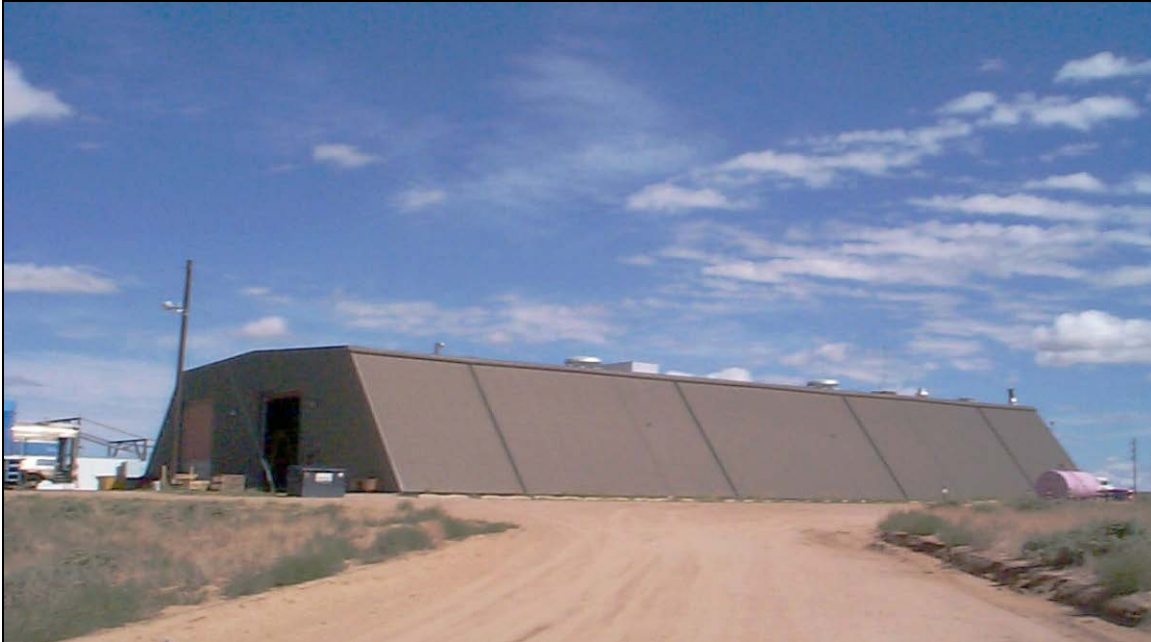
Figure 15. The Urban Rail Building (URB)

The Urban Rail Building (URB) (see Figure 15) and adjacent yard tracks were constructed in 1980 as a permanent maintenance facility for vehicles using the Transit Test Track (TTT). A Wye track extends to the building from the TTT to allow turning of vehicles without leaving the TTT test area. Third rail power is extended along the Wye track into the building, with the power source controlled from the building. A portable stinger system can move rail cars from the end of the 3rd rail into the building. The DC power supply is separate from the TTT, allowing isolation of the URB facility from TTT testing. Each of the two rectifiers in the URB can provide up to 1,000 volts DC, with 1,000 amps.

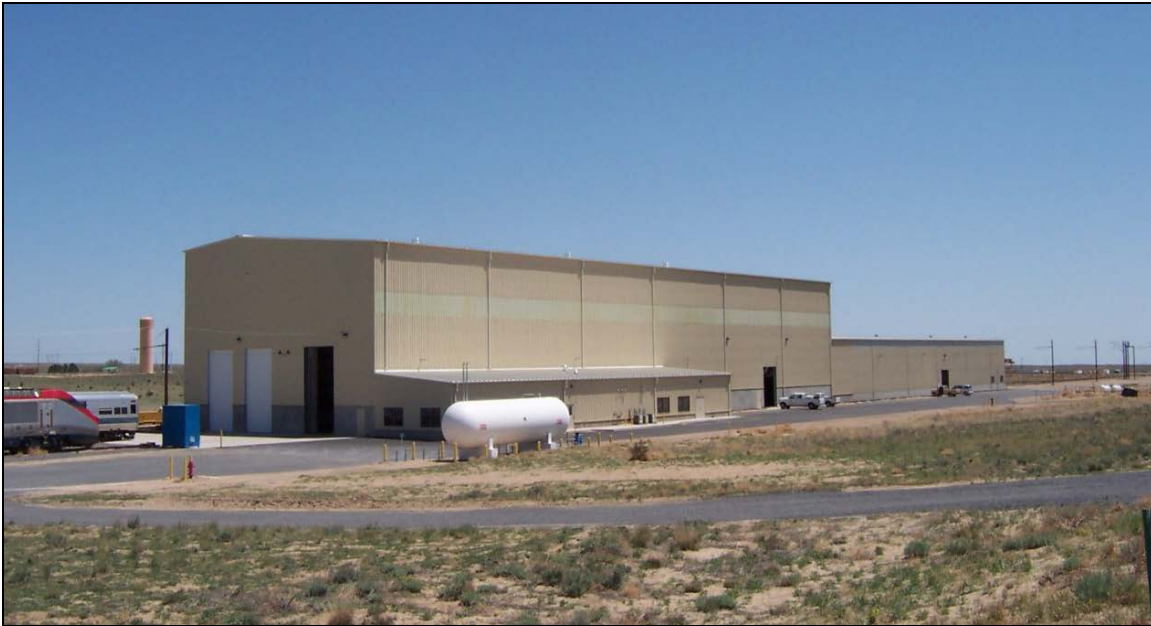
Figure 16. The Passenger-Rail Services Building (PSB)

preparation for the unit. A wheel truing pit was also installed in Track #3 for a future in-floor, CNC wheel truing machine (see the yellow panels in Figure 16). In addition to the tracks that extend through the building, Track #4 runs parallel and to the east side of the building. All four tracks extend approximately 300 feet (91.4 m) north of the building.

The PSB is in very good condition. The HVAC systems are modern and in good working order.

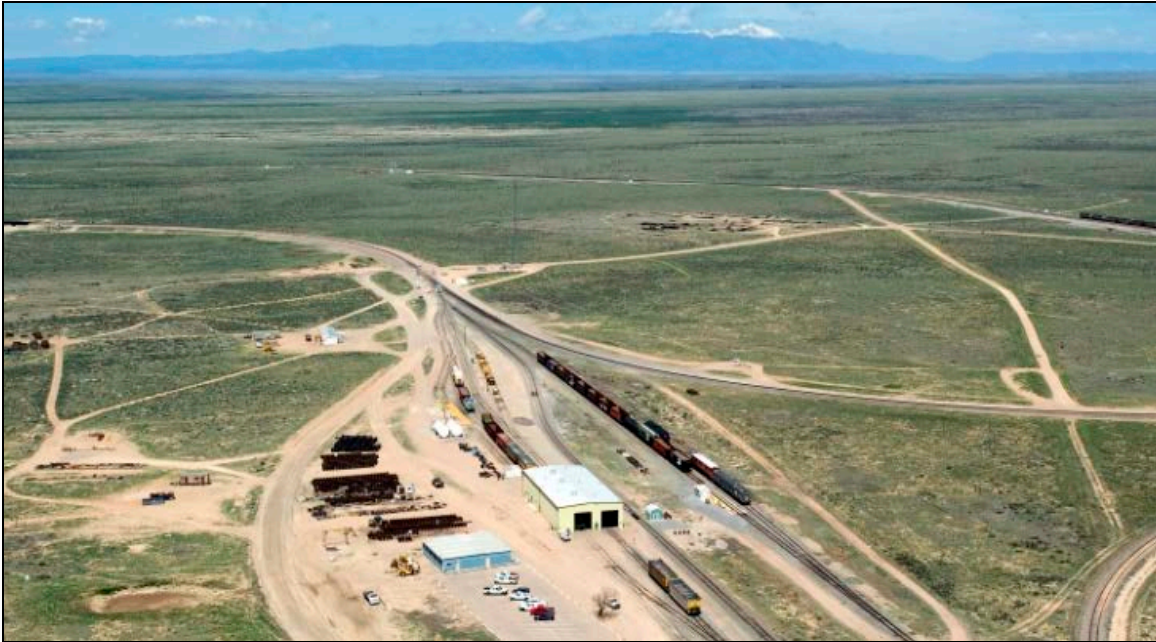
Figure 18. The FAST Modular Building (left) and the FAST Maintenance Building (right)

The FAST Facility contains two primary structures to house project personnel and to perform routine maintenance on equipment and vehicles associated with the program – a maintenance building and a modular unit (see Figure 17). The FAST maintenance building is pre-engineered metal construction, 60 feet by 140 feet (18.3 m by 42.7 m) in size, insulated, and heated. It has two service tracks extending through the building, with a service pit under one of the tracks. The FAST modular unit is 3,600 square feet (334 m²) in size, containing offices, restrooms, and a break room.

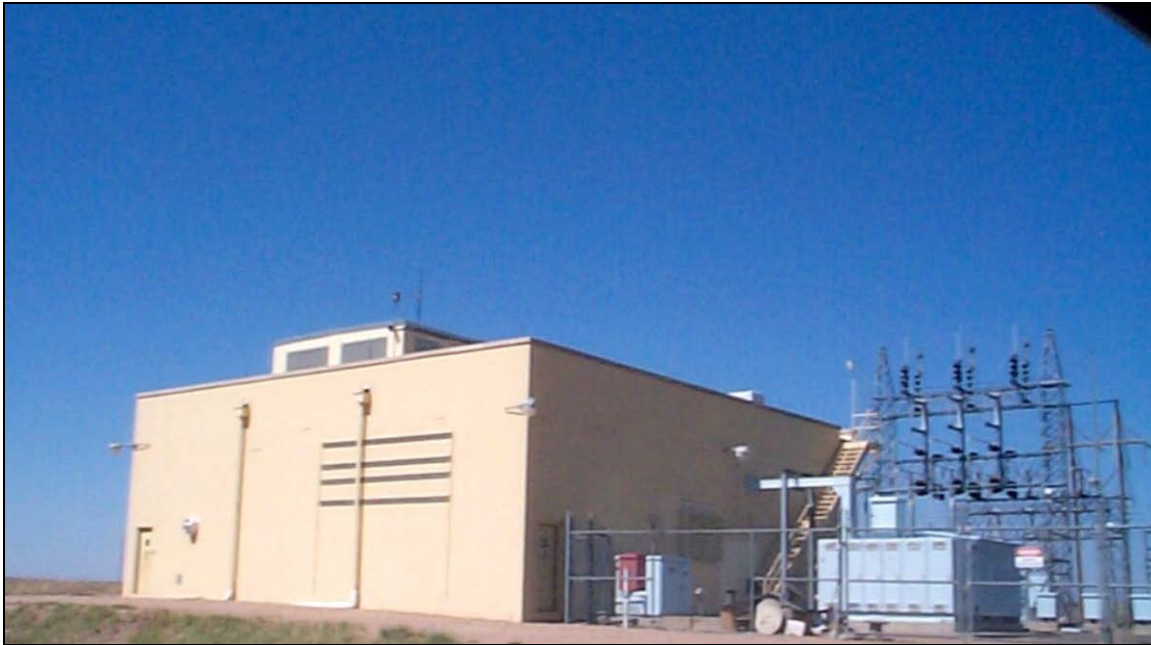
Figure 19. DC Rectifier Substation #1

Figure 18 shows one of the two substation buildings that were constructed in 1976 to house the DC Rectifiers and associated controls for the Transit Test Track (TTT) loop. The units are a mirror image of each other, with DC Rectifier Substation #1 located on the east side of the TTT near the Post 85 road crossing, and DC Rectifier Substation #2 near the west side of TTT. Each building is 62 feet by 65 feet (18.9 m by 19.8 m), masonry wall and steel roof deck construction.

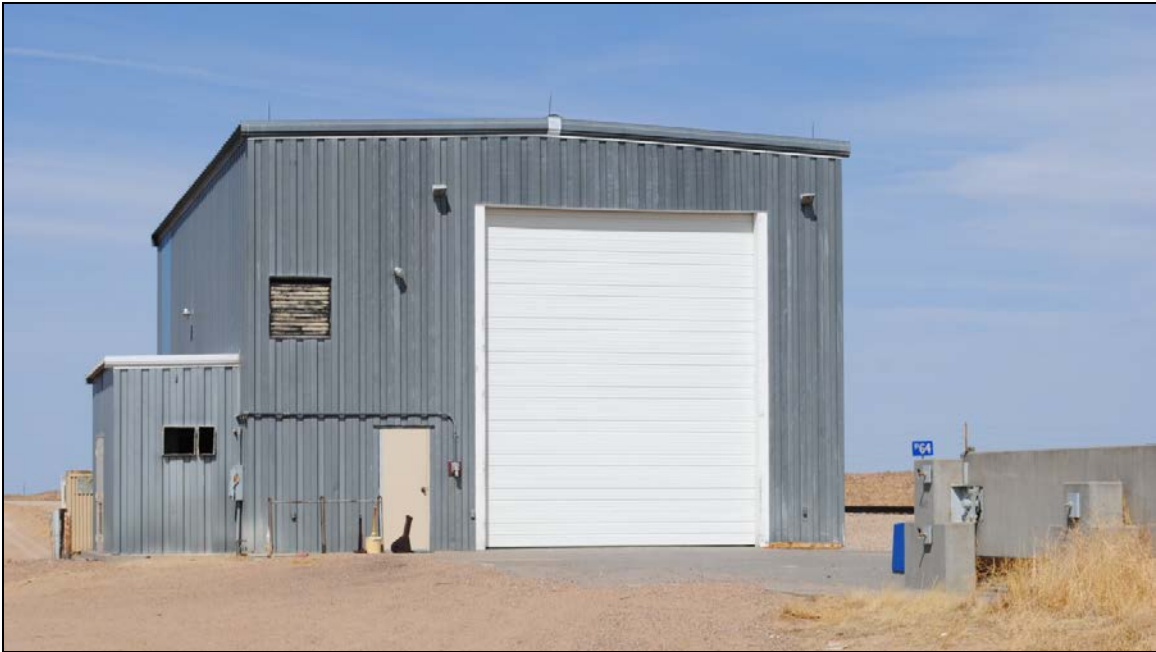
Figure 20. The TLRV Maintenance Building

The building shown in Figure 19 was constructed in 1973 to house and maintain the Tracked Levitated Air Cushion Vehicle (TLRV). It is located at the north end of the concrete “U” Channel (TLRV) Guideway. The building is pre-engineered metal construction, 40 feet (12.2 m) wide by 62 feet (18.9 m) long, with a concrete floor. The building is currently used for storage of site materials and equipment.

The interior of the TLRV maintenance building was insulated in 2014. The exterior walls, although intact, are oxidized with severe weathering.

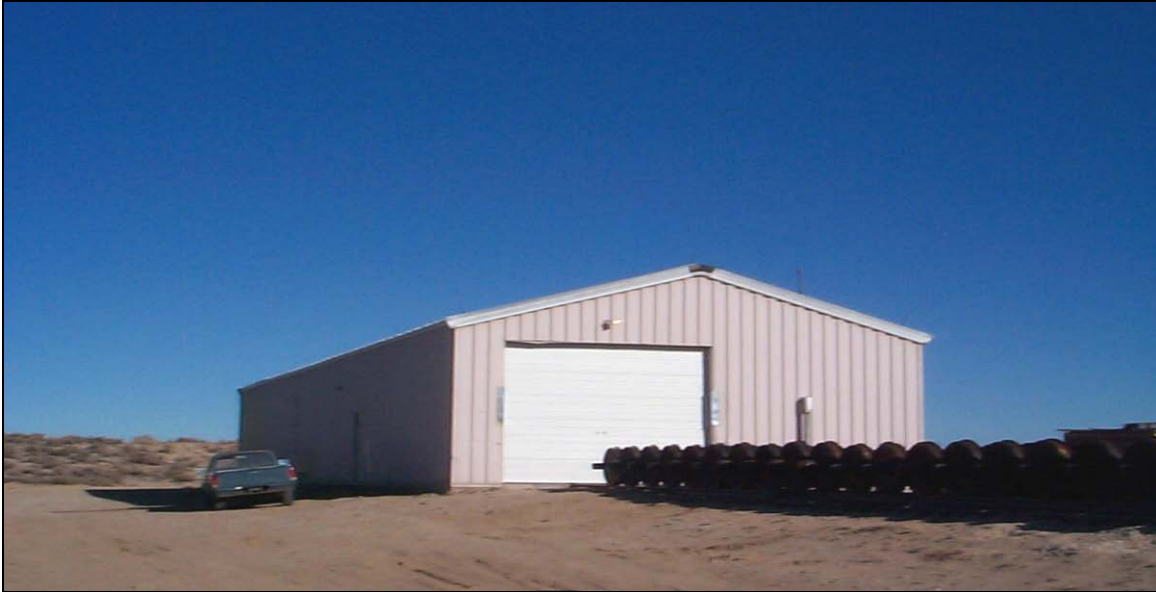
Figure 21. The LIMRV Maintenance Building

The building shown in Figure 20 was constructed in 1971 to house and maintain the Linear Induction Motor Research Vehicle (LIMRV). The building is pre-engineered metal construction, 32 feet (9.75 m) wide by 100 feet (30.5 m) long, insulated, electrical heat, with the track extended inside the building. The building is located at the north end of the LIMRV Test Track, now called the Precision Test Track (PTT). The LIMRV maintenance building is in fair condition and is used for storage of materials and equipment, as well as project space for test programs.

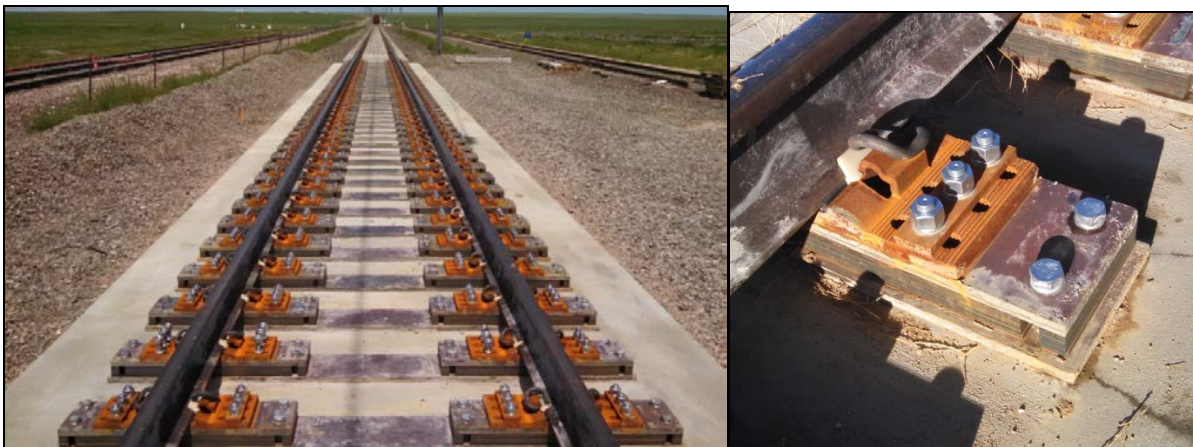
Figure 23. RTT Precision Geometry Slab Track and Adjustable Fastener

Figure 22 shows a Precision Geometry Slab Track section installed on the RTT in 2014. The section is 500 feet (152 m) long located on the tangent in section R16 where the maximum speed for testing in this section is at 165 mph (265 km/h).

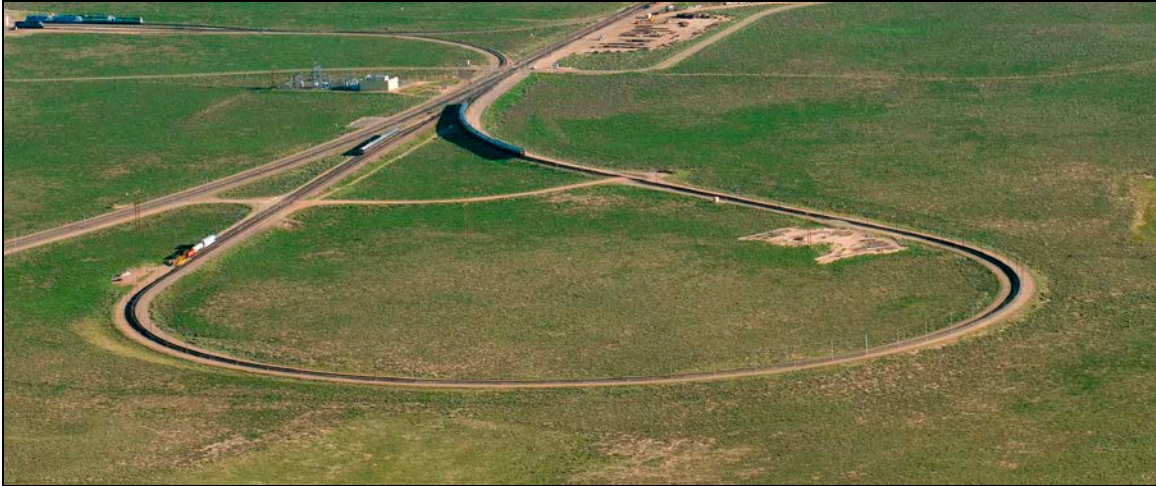
Figure 30. Balloon Loop Looking Northwest

The Balloon Loop has also been modified to install the Rail Defect Test Facility (RDTF) (see Section 4.13). Rail defects have been added to the track on a set of parallel rails installed on the same set of cross ties. Movable switch points are used at each end of the parallel rails for access to the defect set of rails.

The ties on the Balloon Loop are in poor condition. All wood ties on the RDTF portion of the loop need to be replaced with 10 foot wood ties equipped with an elastic rail fastening system.

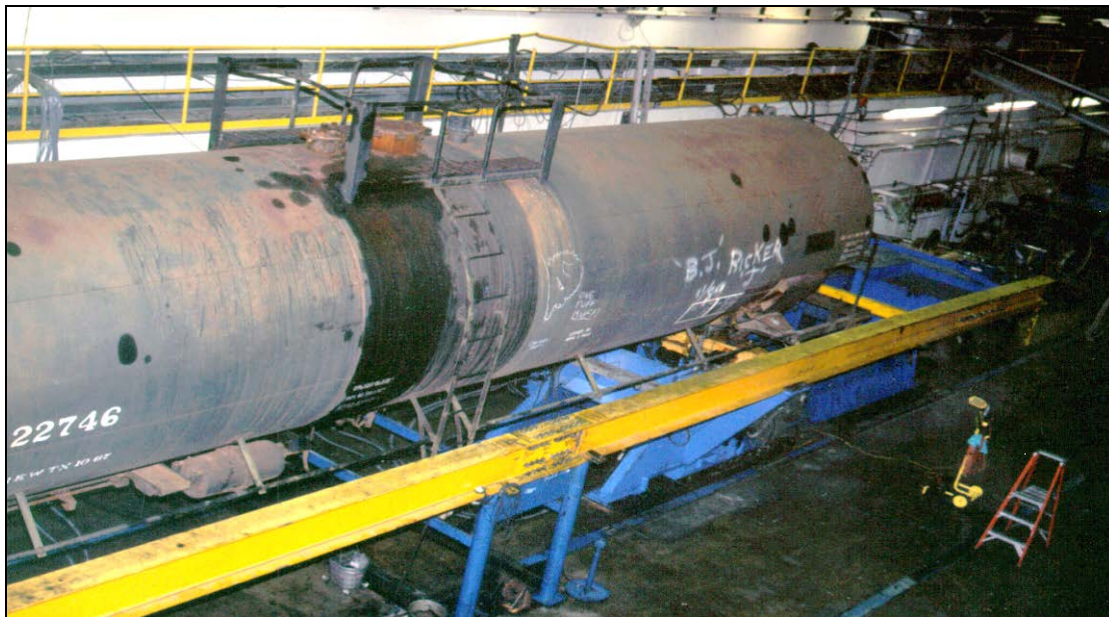
Figure 37. Simuloader (SMU)

The SMU is in the final stages of a general overhaul and upgrade of the control system, actuators, and modifications to the foundation anchor system.

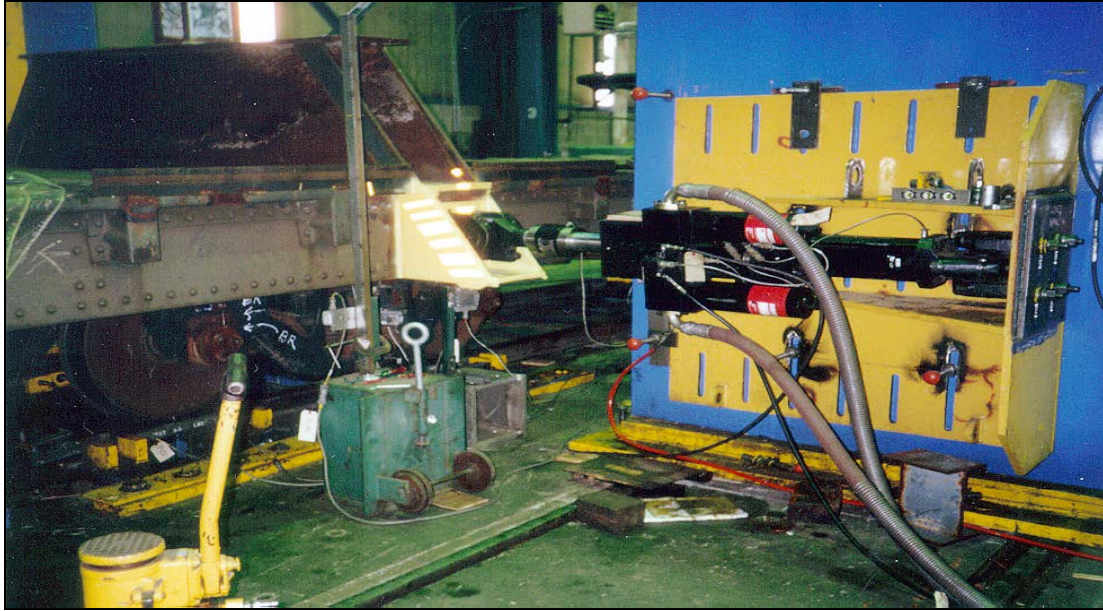
Figure 38. Mini-Shaker Unit Attached to Flat Car

The test vehicle can experience up to 210 kips (934 kN) through its suspension during a full stroke. The MSU is equipped with special instrumented rail sections to measure wheel-rail forces. Airbag assisted bearing tables under the wheels of the test vehicle allow for inter-axle shear and yaw stiffness measurements.

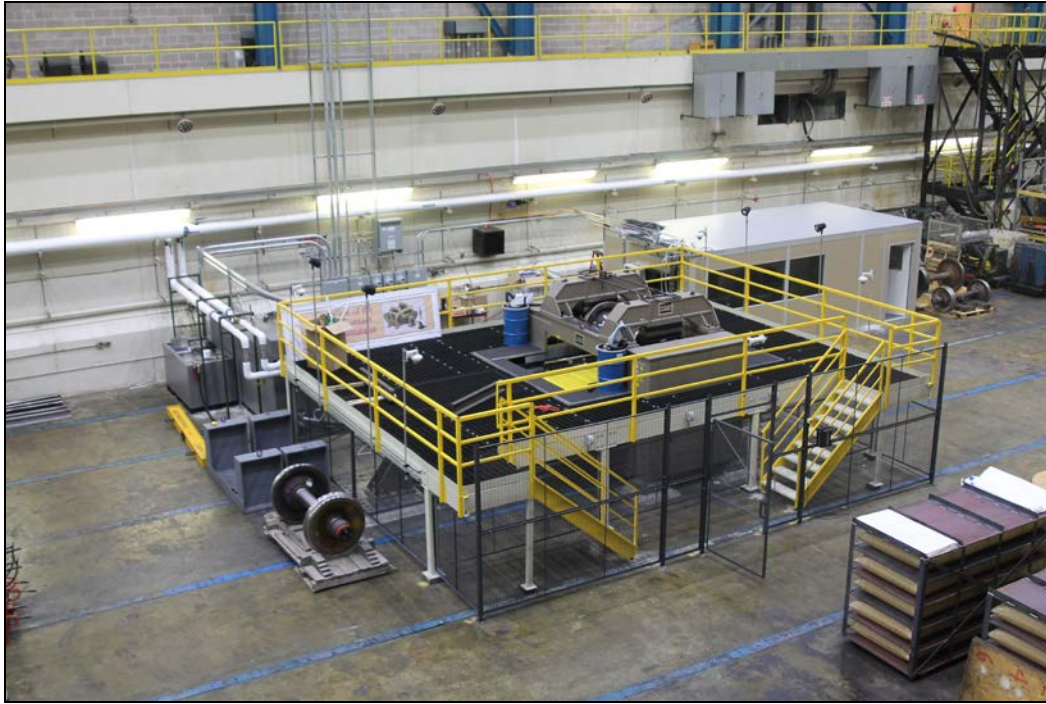
Figure 41. Rolling Contact Fatigue Simulator (RCFS)

generate RCF on wheels and rails. It was manufactured and installed by MTS Corporation (see Figure 40).

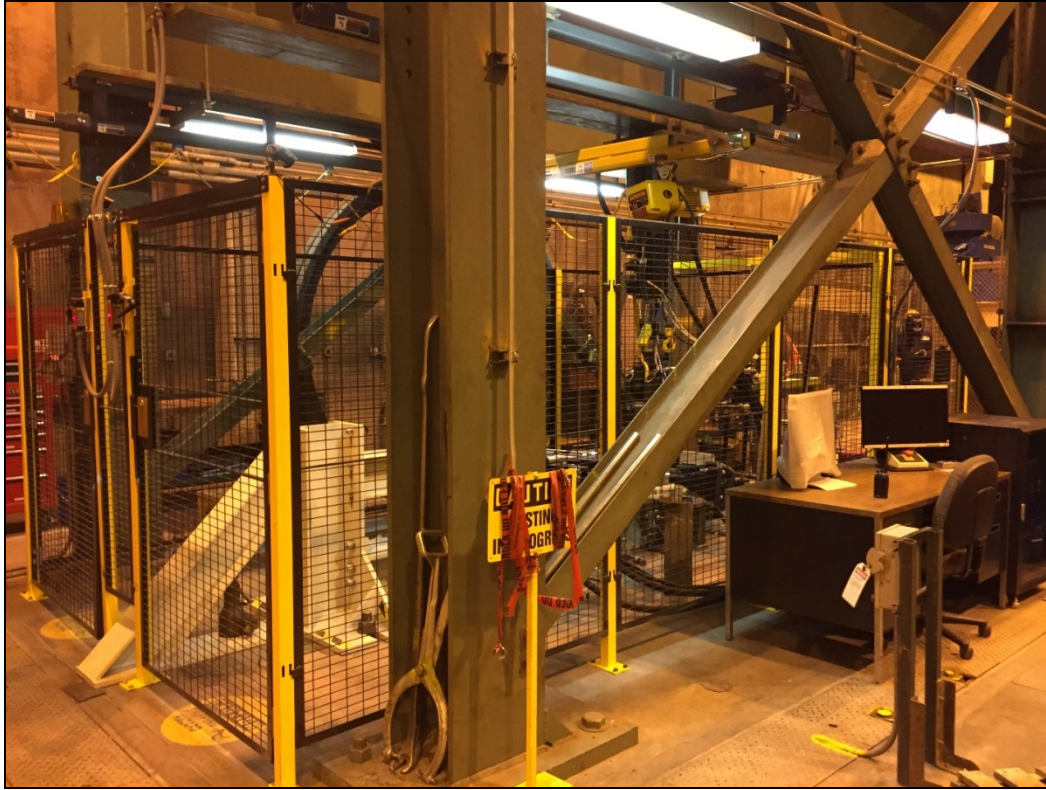
Figure 43. New Tie Wear Machine in the CTL

There are currently two test load configurations. The first simulates an axle load of 50,000 pounds (222 kN). The loads applied through the actuators are 25,000 pounds (111 kN) vertical and 13,000 pounds (58 kN) lateral (L/V ratio=0.52). The second configuration simulates an axle load of 65,000 pounds (289 kN). The loads applied through the actuators are 32,500 pounds (145 kN) vertical and 16,900 pounds (75 kN) lateral (L/V ratio=0.52). A 1,000 pound (4.4 kN) return force mechanism is attached to the rail base to maximize repeated rail base travel and simulate actual field conditions.
