**Federal Railroad
Administration**

Status of the Transportation Technology Center - 2015

13. ABSTRACT (Maximum 200 words) The Transportation Technology Center (TTC) is a Federally owned, privately operated test facility in Colorado. It has over 50 miles of test track arranged in different configurations for testing all aspects of vehicle-track interaction. Maximum test speed is 165 mph (265 km/h). Overhead and 3rd rail electrification is available. Eighteen large buildings house offices, test fixtures, workshops and maintenance facilities. Outside facilities include the Security and Emergency Response Training Center, a crash wall, a rail vehicle squeeze test frame, and a fully functioning Positive Train Control test bed. Investment in TTC since its construction in the 1970s has ensured most of the assets are in good working order. Some long-life assets are at the end of their useful lives and are due to be replaced.

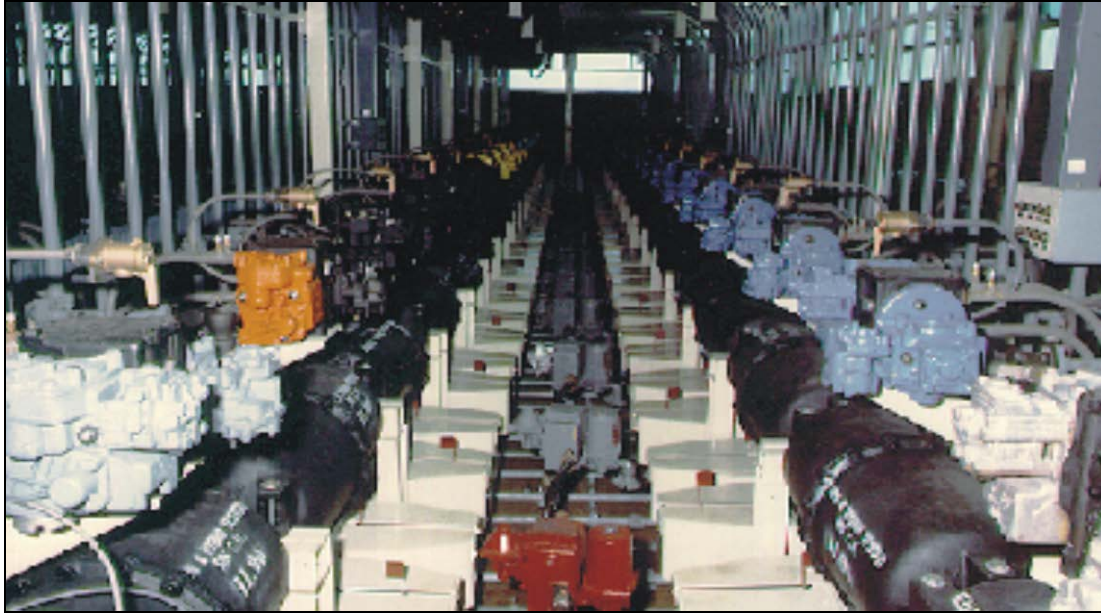
Figure 44. Air Brake Lab

The air brake lab is owned by the AAR. It has not been used since 2000.

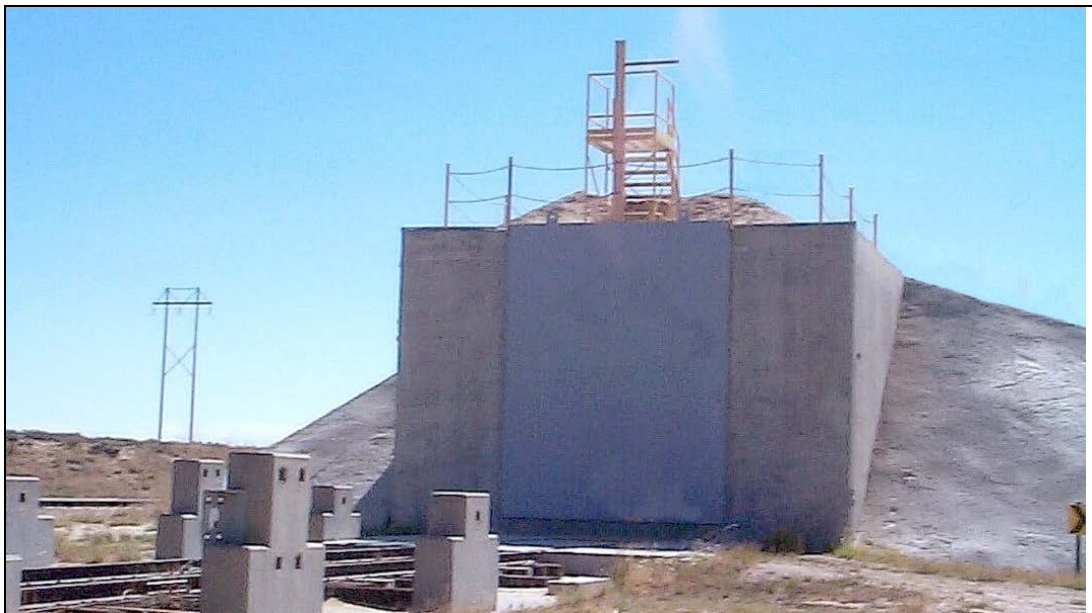
Figure 45. Vehicle Impact Wall

The vehicle impact wall shown in Figure 44 was constructed at TTC in October 2008. An inclined railway track leads to the rigid barrier, which is constructed from structural steel and reinforced concrete and backed by an earth embankment. The wall is capable of taking an impact load of approximately 3,000,000 pounds (13.4 MN).

The wall is faced with a 3-inch (76 mm) steel plate. Anti-climb bars or vehicle body ends can be mounted on the front of the wall if such a test is required. It is also possible to mount a target wall separated by load cells from the main barrier if a direct measurement of force is required.

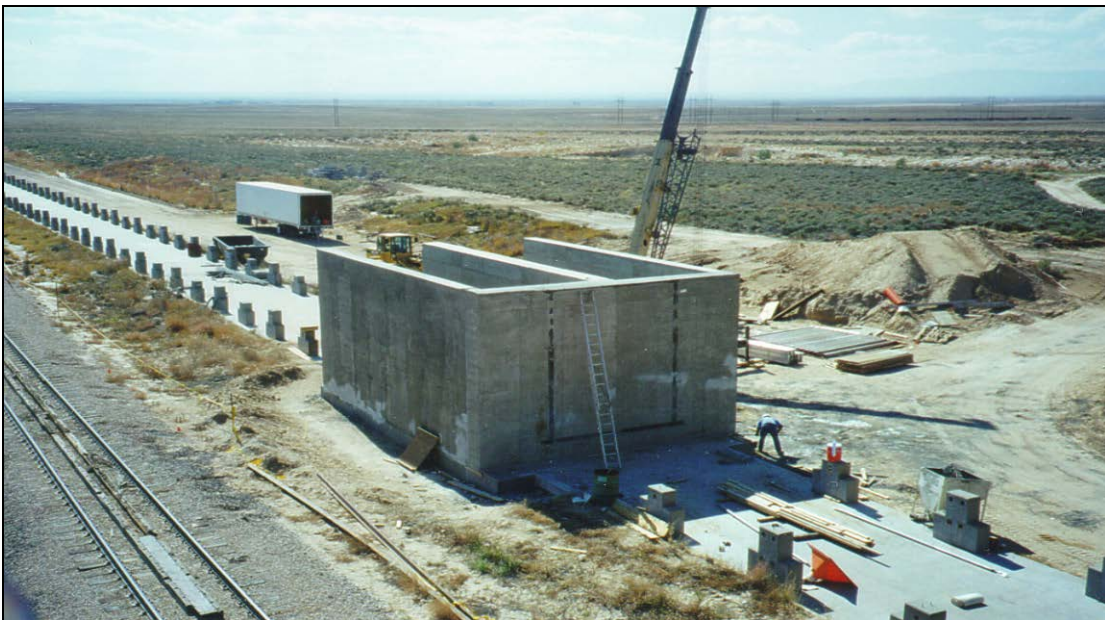
Figure 46. Vehicle Impact Wall Under Construction

The front wall is 2 feet (610 mm) thick reinforced concrete, 25 feet (7.62 m) wide by 18 feet (5.49 m) high. This wall is supported by three longitudinal walls (see Figure 45) each 2 feet (610 mm) thick by 36 feet (10.97 m) deep and 18 feet (5.49 m) high. In between these three walls there are another two vertical support walls 18 inches (457 mm) thick by 20 feet (6.10 m) deep and 8 feet (2.44 m) high, designed to adsorb high impact loads associated with side sills on railcars. Native soil was compacted into the gaps between these walls and piled up against the two side walls and the rear. Over 1,000 tons of earth was used in the construction.

Further additions have been made to the Vehicle Impact Wall since its original construction. A concrete pad with the rails built-in has been constructed immediately in front of the wall. This allows easier access to the wall and fixes the rails rigidly in front of the barrier. This concrete pad has a pit to allow a camera and lights to look up at the impact zone. Extra power outlets have been provided either side of the wall and at the top of the wall for cameras and lights.

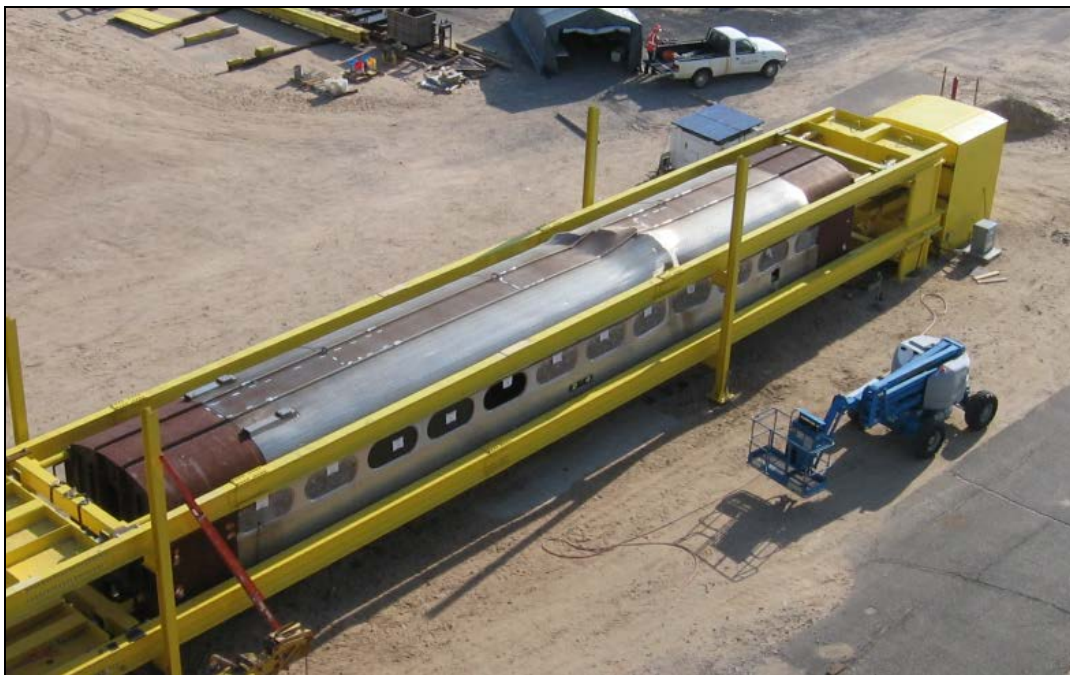
Figure 47. Squeeze Test Fixture

The Squeeze Test Fixture is in good condition.

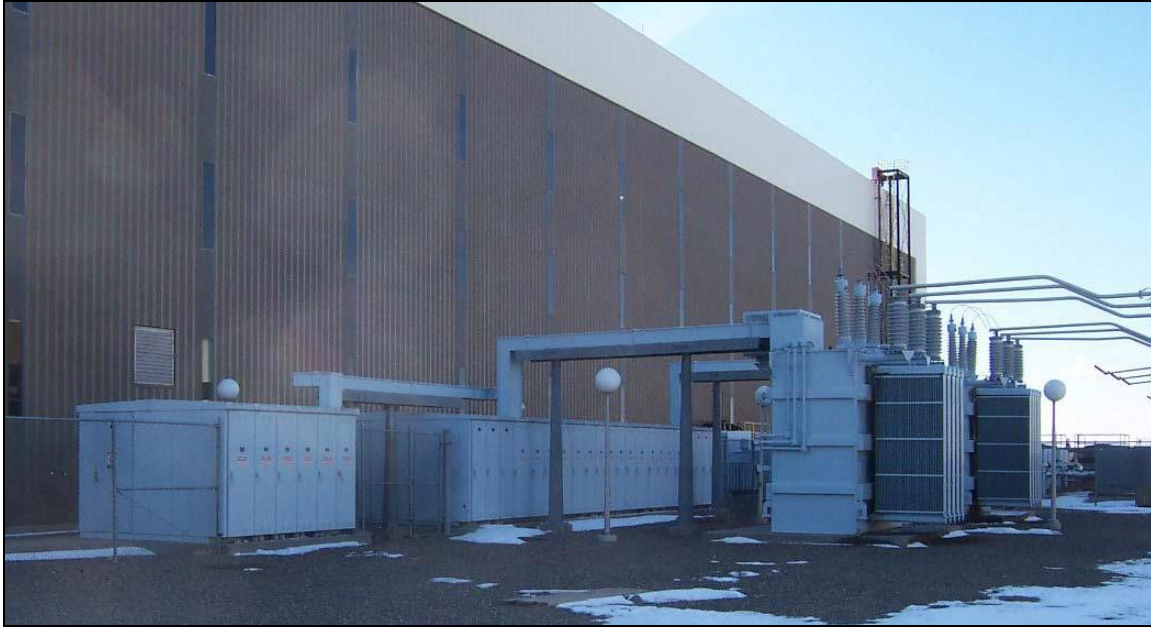
Figure 49. Main Core Area Substation

The Main Core Area Substation (see Figure 48) is located between the CSB and RDL Buildings. The two primary transformers feed a common switch gear bus system that has 17 air circuit breakers (six spares) divided into three sections for metering and control. The switch gear can be configured to feed the system with either primary transformer for redundancy, or zoned to feed separate sections. Individual circuit breakers feed secondary building or facility transformers that further reduce the voltage to 480 volts, 3-phase. Common building power voltage is 480 / 208 / 120 volts. Power demand for 220 volt supply is available in some locations.

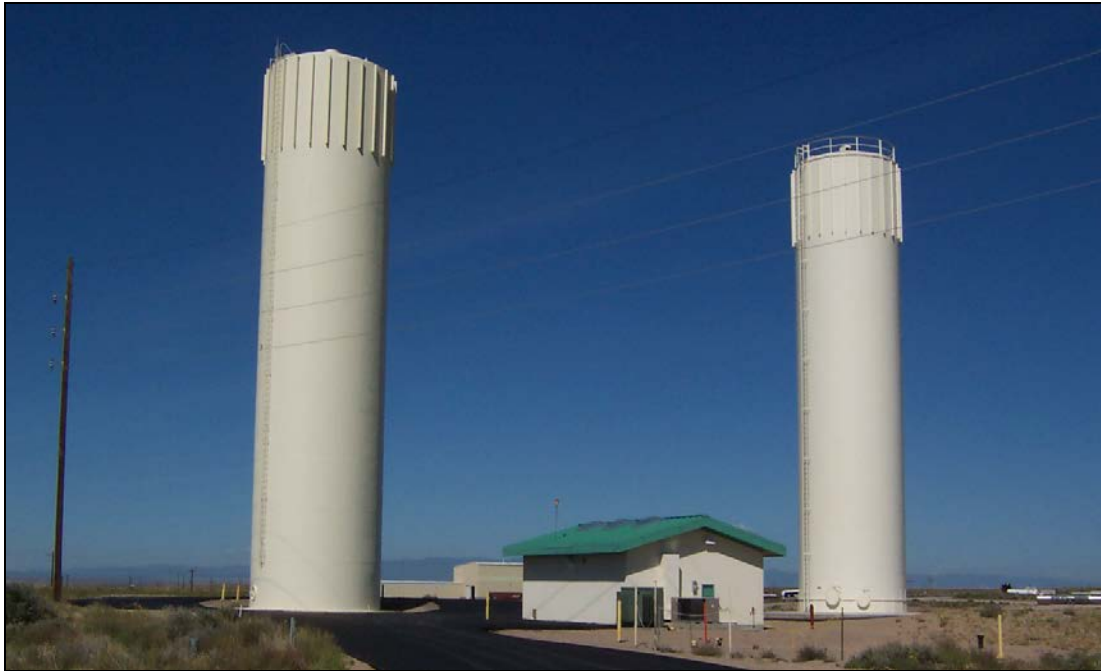
Figure 50. Water Reservoir and Distribution Pump House.

serviced from the transmission lines varies from 40 to 50 psi (276 to 345 kPa) when there are normal operating levels in the water towers.
