REPORT NO. FRA-TTC-79-01

ANALYSIS OF DATA FROM THE FIRST WHEEL EXPERIMENT AT THE FACILITY FOR ACCELERATED SERVICE TESTING

JULY 1979

INTERIM REPORT

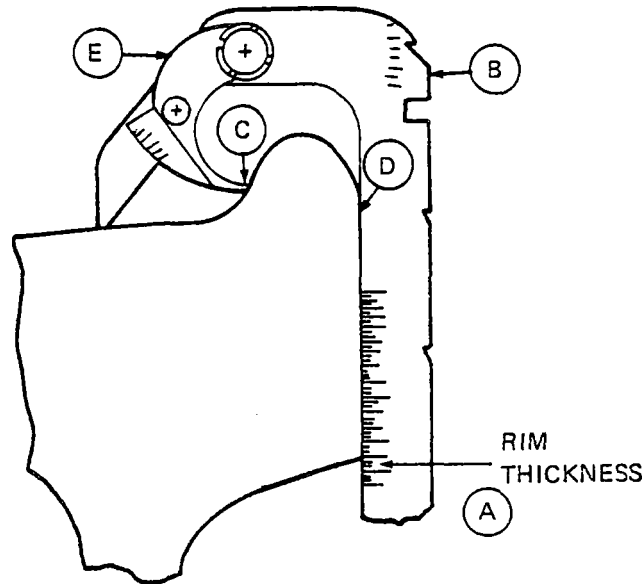
Flange thickness, flange height, and rim thickness are all measured using the standard AAR finger gage. Figure 1 (next page) is a diagram of a finger gage positioned over a wheel for measuring both the flange thickness and the rim thickness. The rim thickness is measured by

reading the scale on the vertical arm at the point of contact with the lower edge of the rim face (point A). The flange thickness is measured by rotating the pivot element until point C meets the flange, removing the finger gage and measuring the distance between point C and point D with a finely graded scale. Flange height measurements are taken by rotating the movable arm until point E meets the tip of the flange and reading the height on the vernier scale (point B).

FIGURE 1. FINGER GAGE IN POSITION FOR MEASURING FLANGE THICKNESS, RIM THICKNESS, AND FLANGE HEIGHT.

With this instrument, all measurements are referenced to the tread face. Since this is a wearing surface the reference point for both the flange thickness and the flange height is changing and the absolute position on the flange for the flange thickness measurement is also changing. That is, it is constantly moving downward to a wider portion of the flange. Since the tread wear was minimal during this experiment, the effect probably had little or no influence on the data. If there were significant tread wear, this effect would have to be factored into an analysis of flange thickness. Also, the point of measurement for rim thickness is not a sharp edge so there will be some error in reading the scale.

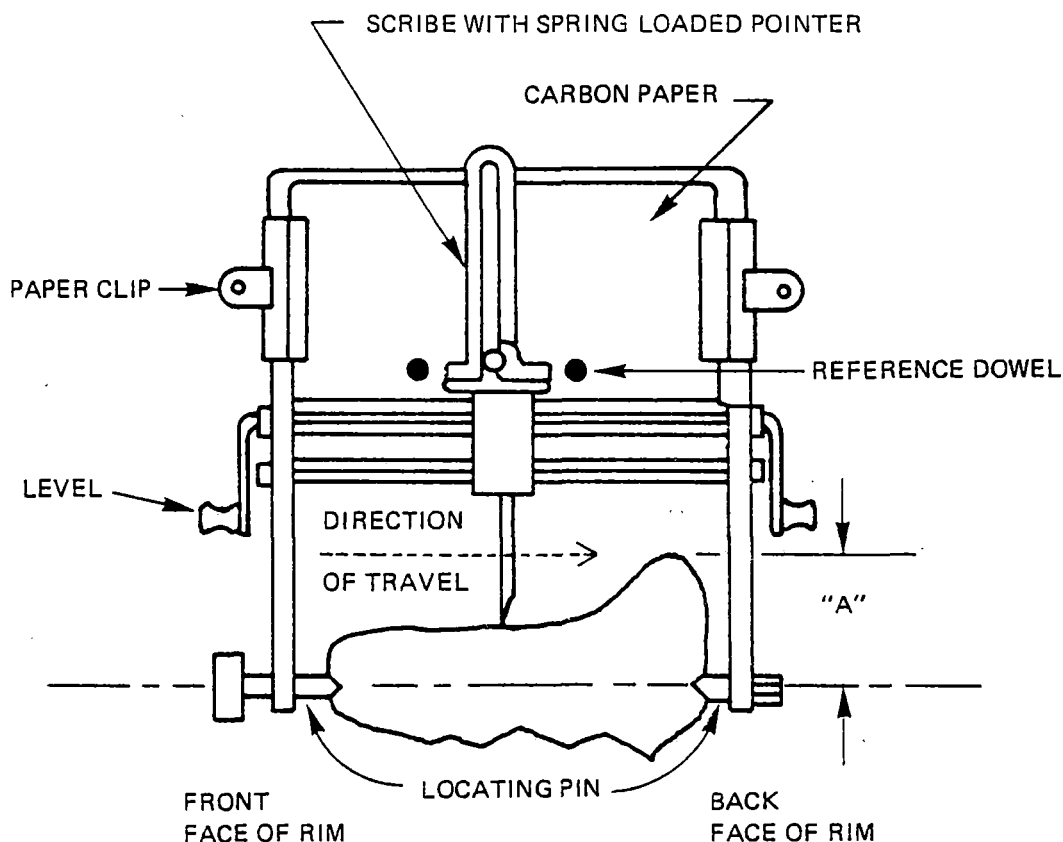
Wheel profiles are taken with a wheel profilometer illustrated in figure 2. The profilometer device is clamped to the wheel using three locating pins which match up with punch marks on the sides of the rim. A carbon paper sheet is placed on the board over the reference dowels and clamped in place. As the spring-loaded pin is traversed along the contour of the rim, a stylus runs over the carbon forms and traces a profile. This profile is then labeled and digitized for analytical use. Several problems were encountered in the use of this device. First, no clear reference marks are created at the ends of the pointer travel so that it becomes difficult to overlay subsequent profiles for comparison purposes. Secondly, the unit could not always be placed back in precisely the same position for each measurement. Third, metal rollover such as that which may occur at the rim face or at the top of the flange is not indicated in these profiles. The lack of accurate reference points made the analysis of the digitized data, particularly the earliest measures, extremely difficult and no computer analysis was used. The profiles for this analysis will be used mainly to illustrate the types of wear occurring.

FIGURE 2. WHEEL PROFILOMETER.

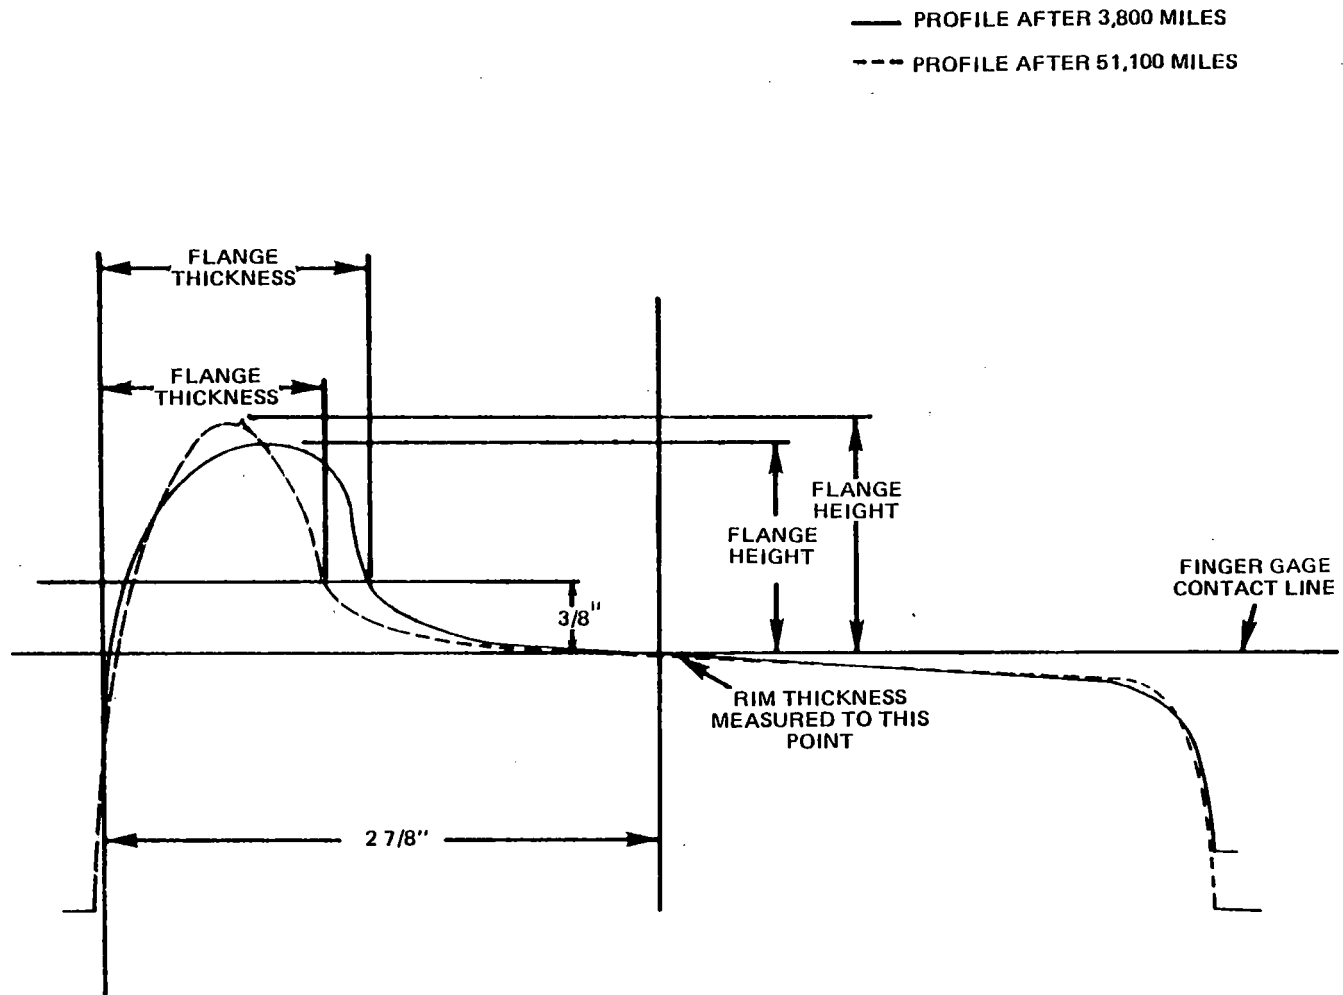
The FAST track, being a loop, has a large percentage of curved track--1.8 miles (2.9 kilometers) curve, 0.8 mile (1.3 kilometers) spiral, 2.2 miles (3.5 kilometers)--tangent. Thus, the wear that was seen in experiment 1 was predominantly flange wear. Also, since the same wheels tend to move over the same track repeatedly, both the track and the wheel flange tend to wear towards conforming shapes in areas of contact. Figure 4 shows an overlay of two wheel profiles taken on one of the test wheels -- one taken after 3,834 miles (6,134 kilometers) and the other taken after 51,107 test miles (81,771 kilometers). The shape and area of wear show up clearly.

It can be seen that there was practically no tread wear and extensive flange wear. There is also growth on the flange tip and possibly on the tread near the front face. These are due to metal flow. The shape as shown is not entirely accurate due to the fact that the profilometer does not indicate overlaps. Also, the magnitude of the changes are only approximate because the profiles lack consistent reference points and are thus difficult to overlay. The profiles therefore have been overlaid so that the wear shown matches that measured with the finger gage readings. The profiles shown are for a treated wheel. However, wear on the untreated wheels produced a similar shape. The main difference was that untreated wheels exhibited a greater rate of wear.

FIGURE 4. WHEEL PROFILE COMPARISON SHOWING NATURE OF WHEEL WEAR.

Also superimposed on the diagram are the finger gage measurement locations. It should be noted that they give a somewhat incomplete picture of the wear on the wheel. The flange thickness is measured at only one point and provides no information on the changing shape of the front face of the flange. The flange height is heavily influenced by the metal flow on the tip of the flange, a thin strip of metal not directly related to overall wear although it has been implicated in the development of flange cracks (see discussion on reasons for removal given below). Finally, there seems to be very little tread wear. The limitations of these measures should be kept in mind in evaluating results of further analysis.

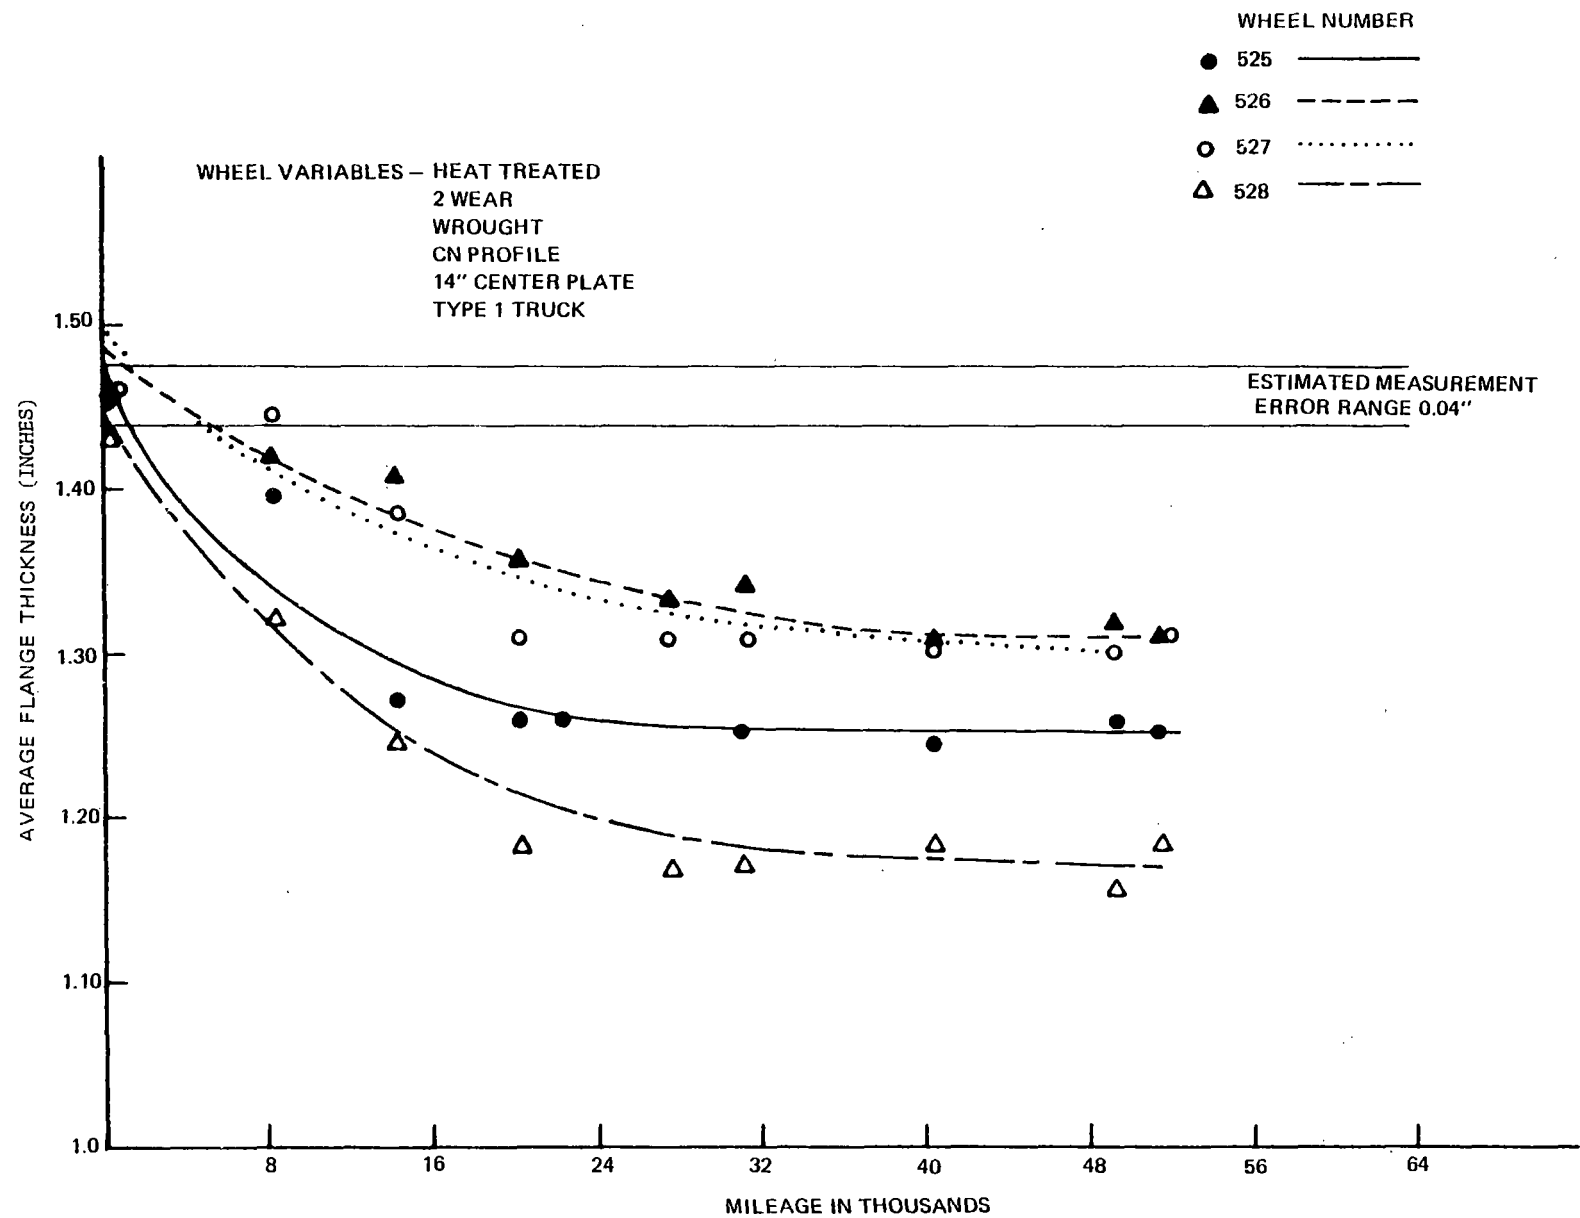
Figure 5 is a plot of the average of the two flange thickness measurements against mileage for a typical treated wheel (treated, 2 wear, wrought, CN profile, 14-inch center plate, type 1 truck), and figure 6 is similar plot for a typical untreated wheel (untreated, 1 wear, cast, AAR profile, 14-inch center plate, type 1 truck). Several things can be observed from these. First, the difference in wear rates between treated and untreated wheels is apparent. Many untreated wheels

FIGURE 5. FLANGE THICKNESS VERSUS MILEAGE SCATTER PLOT FOR EXAMPLE TREATED WHEELS FROM FAST EXPERIMENT 1.

are near condemning limits after 19,000 miles (30,400 kilometers), while many treated wheels still have flange life after 50,000 miles (80,000 kilometers). The mileage and wear differentials vary considerably among the wheels. Some untreated wheels, in fact, lasted longer than some treated wheels, but in general the difference in performance is clearly seen.

A second observation is that there is a clear difference in performance between the wheels within a group. As an indication of this, the slope of the average flange thickness versus mileage was calculated for each wheel. Although this is not the most accurate way of portraying the wear curve, it is conceptually easy for some purposes and does provide a general indication of the overall rate of wear of the flange. These slopes were then grouped by wheel type and the ratio of the largest slope to the smallest slope was calculated for each wheel group. The ratios ranged from 1.13 to 8.47. The mean ratio was 2.91. Of the 55 wheel types for which this was tabulated, 24 had ratios between 1 and 2, 12 had ratios between 2 and 3, 9 had ratios between 3 and 4, 2 had ratios between 4 and 5, and 8 had ratios greater than 5.

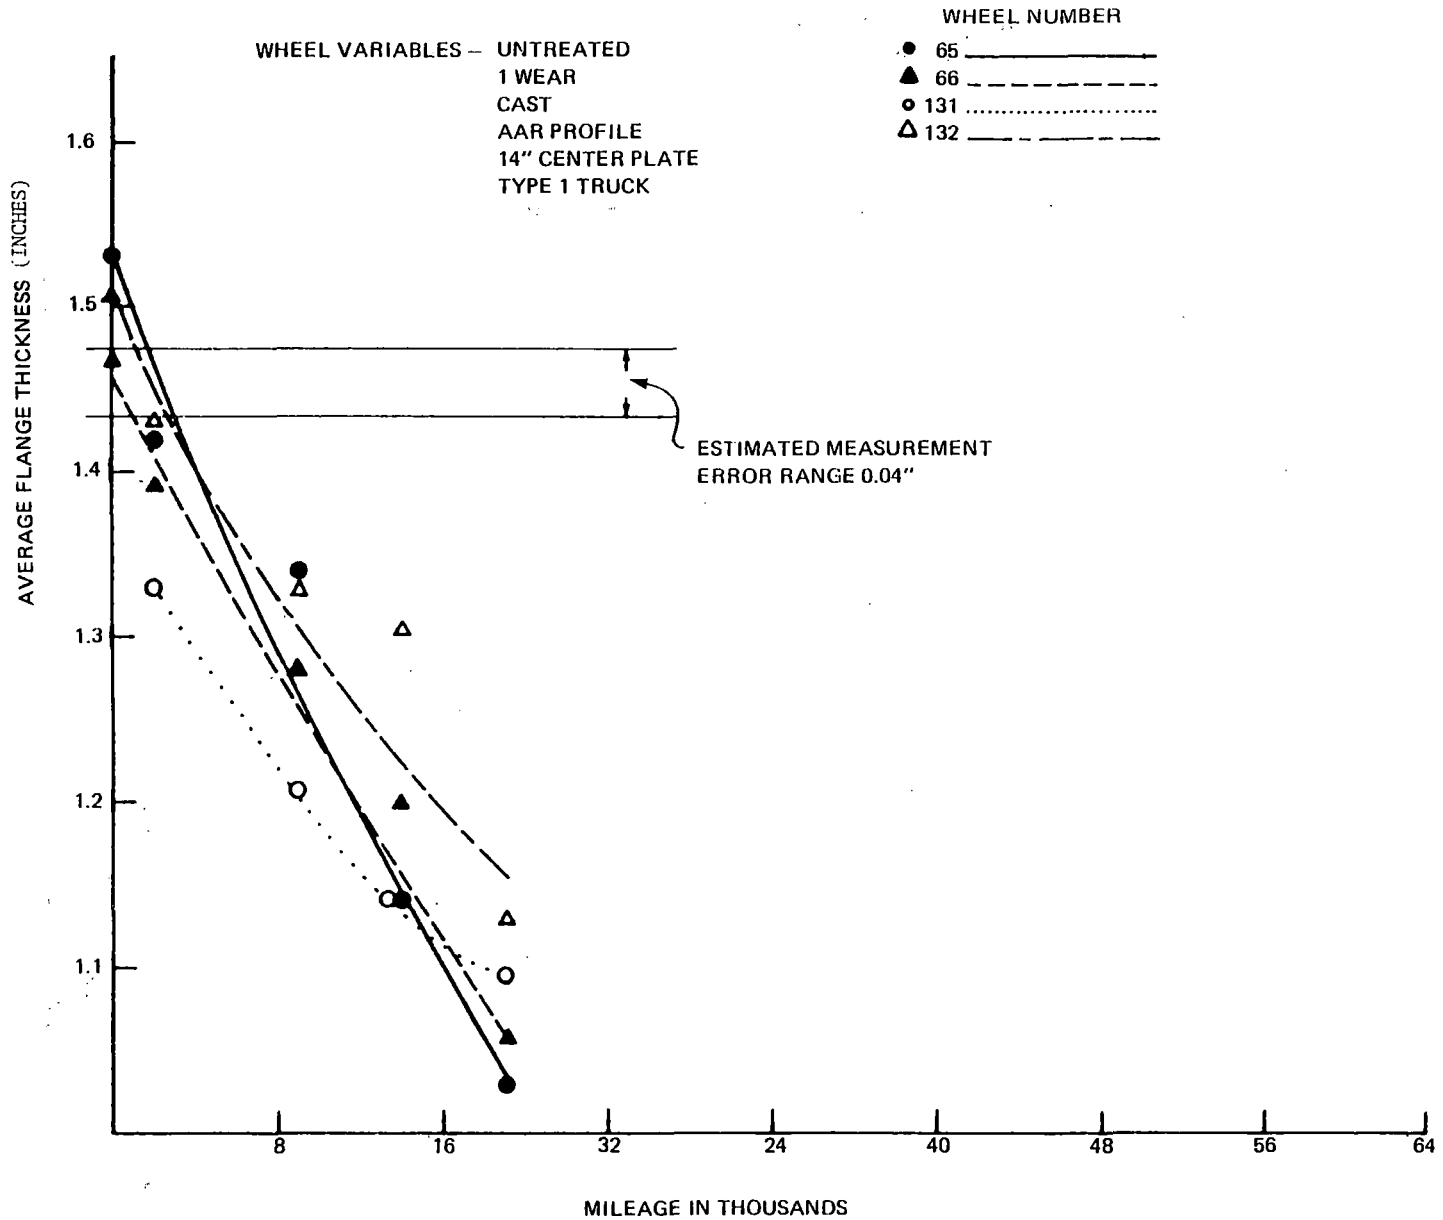
FIGURE 6. FLANGE THICKNESS VERSUS MILEAGE FOR EXAMPLE UNTREATED WHEELS FROM FAST EXPERIMENT 1.

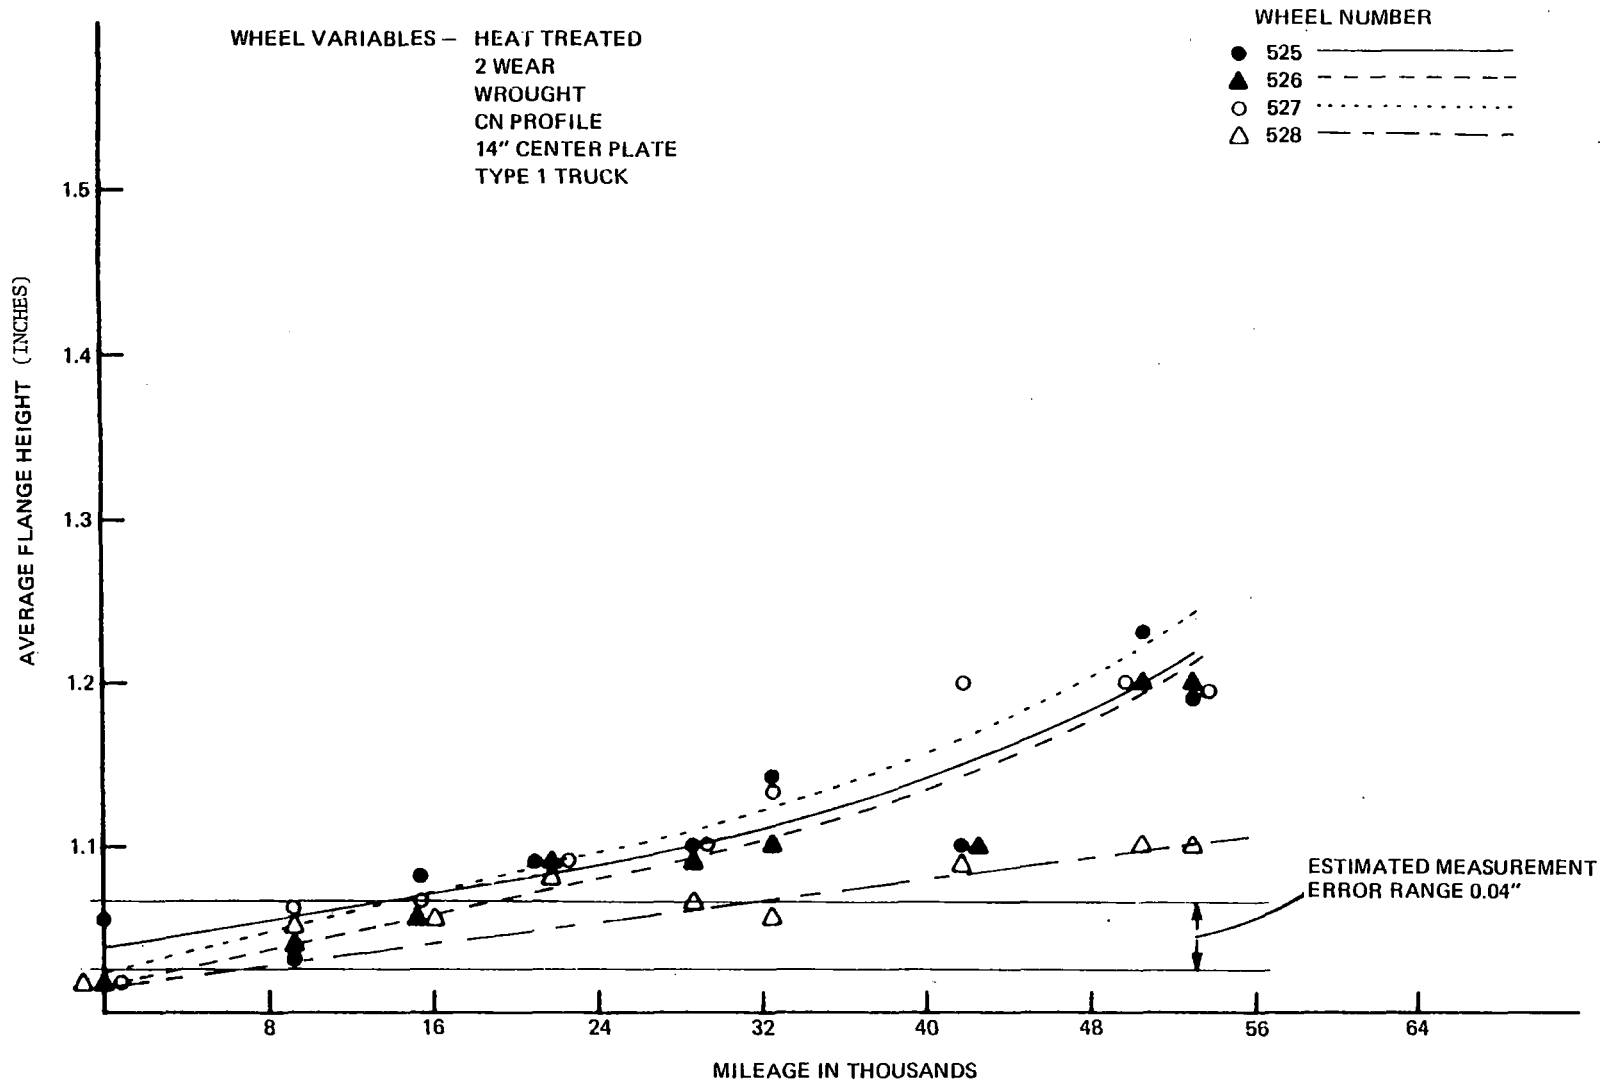
Figure 7 is a plot of the average of the two flange height measurements against mileage for a typical treated wheel (treated, 2-wear, wrought, CN profile, 14-inch center plate, type 1 truck) and figure 8 is a similar plot for a typical untreated wheel (untreated, 1-wear, cast, AAR profile, 14-inch center plate, type 1 truck).

FIGURE 7. FLANGE HEIGHT VERSUS MILEAGE FOR EXAMPLE TREATED WHEELS FROM FAST EXPERIMENT 1.

Again, several observations can be made on the flange height measurements. First, it should be noted that the flange is growing. Because of the nature of the measurement techniques, some of this growth can be attributed to tread wear but not all of it, since in this experiment the tread wear was slight. There was also the growth of a small metal ridge at the tip of the flange. This tip was brittle metal which would, on occasion, break off the flange. In this case, also the differences in performance between wheels of the same type can be observed.

For these plottings, the measurement error was again estimated at 0.04 inch (0.10 centimeter). The vernier scale was readable to 1/64 of an inch (0.04 centimeter), but the problems with alinement, rough surfaces at both the tread face and the flange tip, and the tendency for the flange tip to break cause deterioration in this basic reading accuracy. The change in flange height ranged from a decrease of 0.15 inch (0.38 centimeter) to an increase of 0.29 inch (0.73 centimeter) with the mean change being an increase in height of 0.11 inch (0.28 centimeter) for treated wheels and 0.12 inch (0.3 centimeter) for untreated wheels. It is difficult to make a reasonable quantitative estimate of how much of this change is due to flange growth and how much of it is due to tread wear. Thus, it was decided that quantitative analysis of this data to determine relations would not be productive.

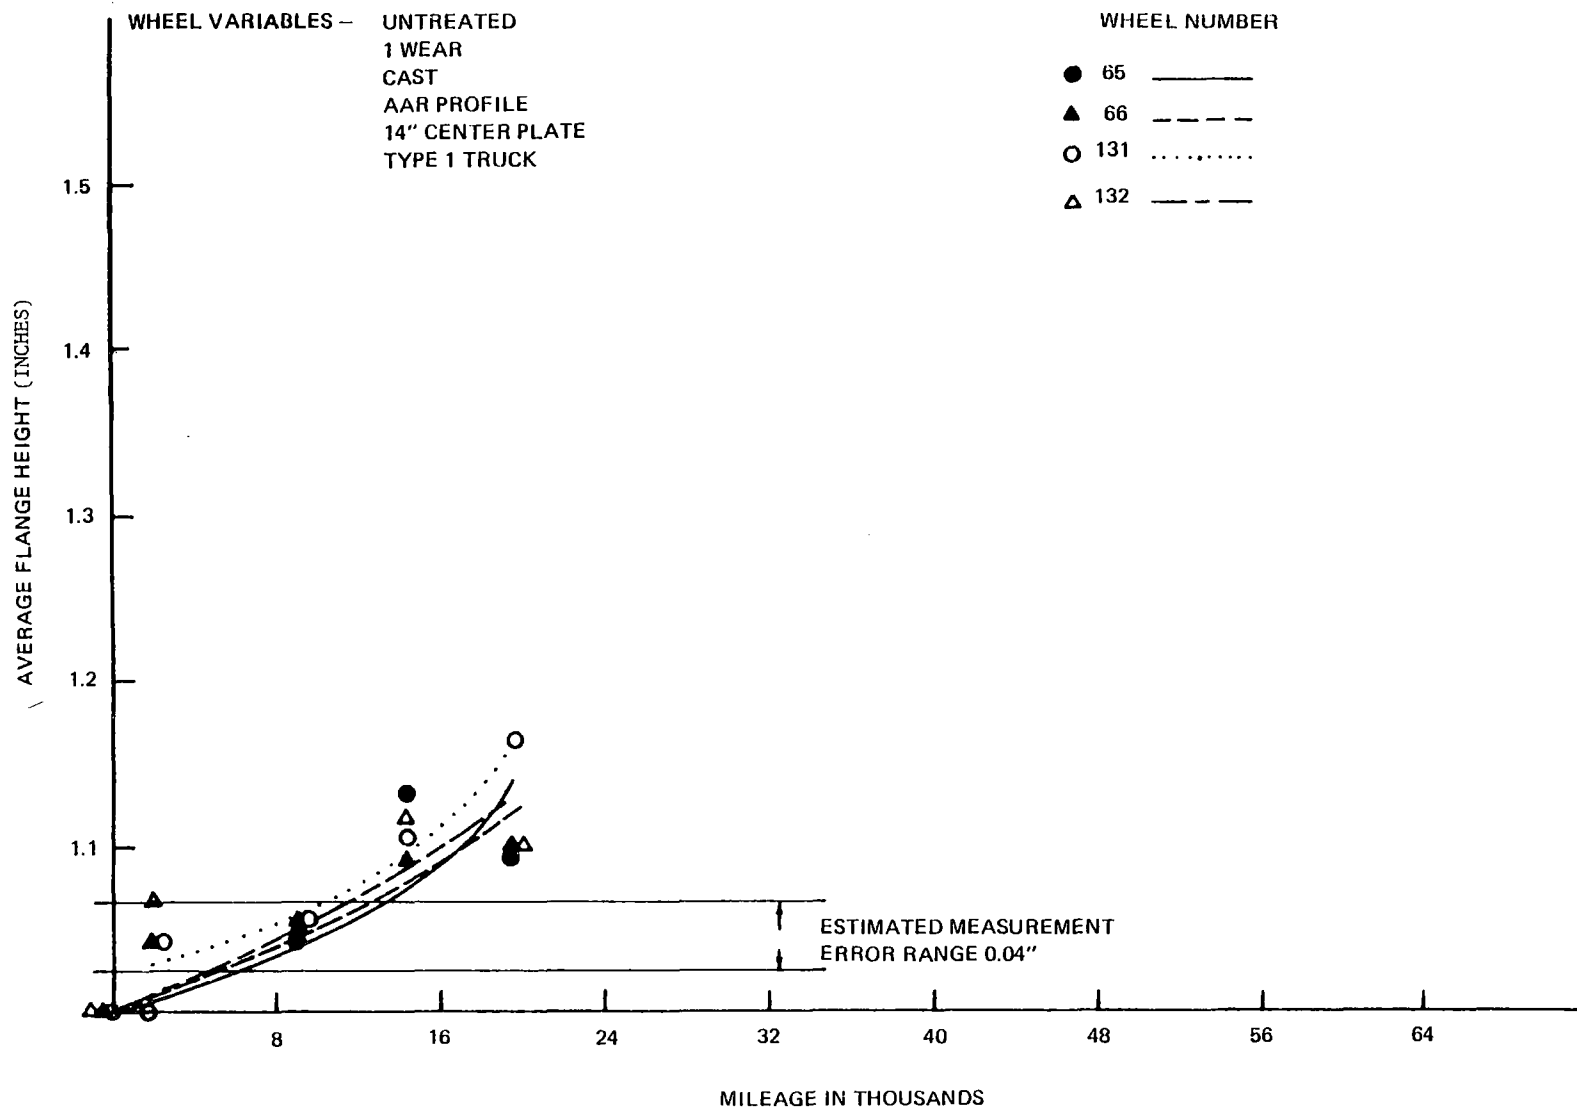
FIGURE 8. FLANGE HEIGHT VERSUS MILEAGE FOR EXAMPLE UNTREATED WHEELS FROM FAST EXPERIMENT 1.

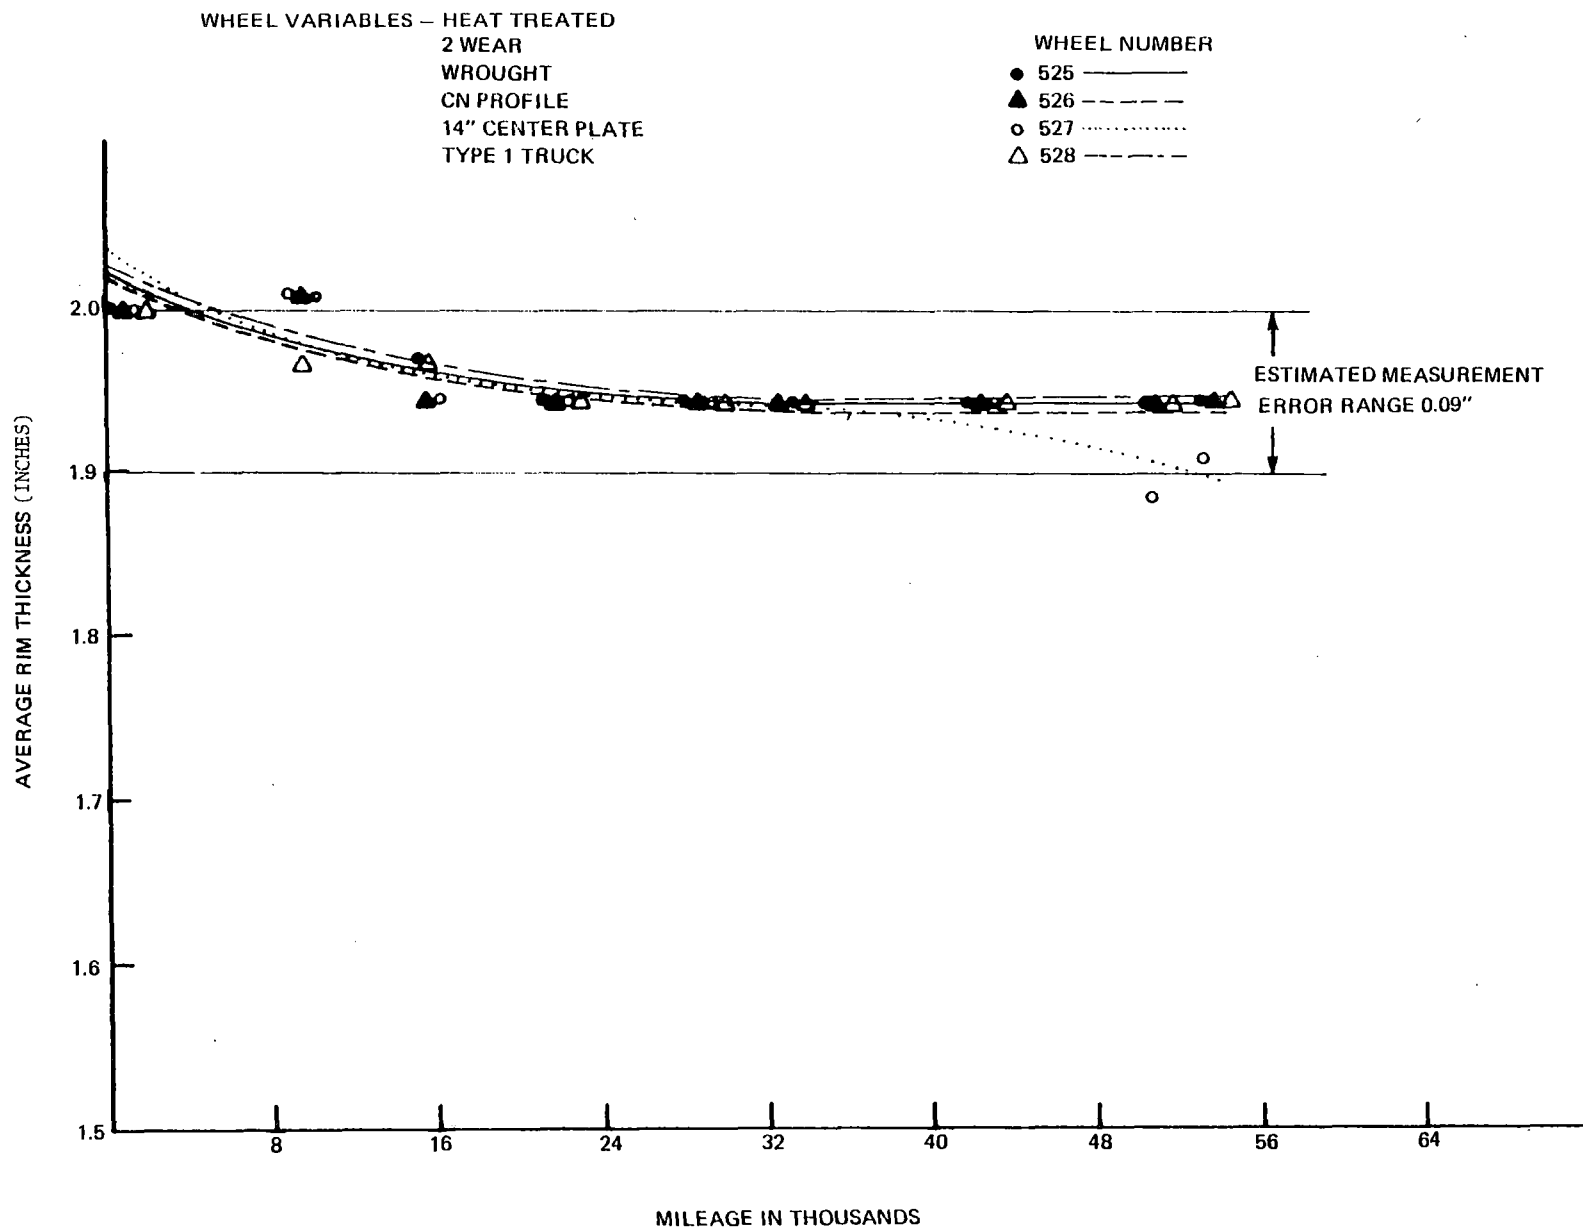
Similar plots were made of rim thickness versus mileage for the first turning for each of the two types of example wheels. Figure 9 is for treated wheels and the figure 10 is for untreated wheels. The measurement error was estimated at 0.09 inch (0.23 centimeter). The scale on the finger gage was read only to the nearest 1/16 of an inch (0.16 centimeter) and problems with gage alinement coupled with the fact that the edge of the face of the rim where the measurement was taken is rounded would reduce this accuracy. In this case, the reading accuracy was reduced by a factor of 1.5.

FIGURE 9. RIM THICKNESS VERSUS MILEAGE FOR EXAMPLE TREATED WHEELS FROM FAST EXPERIMENT 1.

The change in rim thickness was calculated for each wheel by subtracting the final measurement from the initial measurement. These differences ranged from a decrease in rim thickness (wear) of 0.57 inch (1.43 centimeters) to an increase in rim thickness (growth) of 0.17 inch (0.43 centimeter). The average change for all wheels was a decrease (wear) of 0.08 inch (0.20 centimeter). It can be seen from the overall averages and from examining graphs of the flange thickness versus the mileage such as figures 9 and 10 that some wear is occurring; however, it is also clear that the large measurement error relative to the total changes greatly reduces the ability to draw quantitative conclusions from the data. Further analysis of the rim wear data was not done as part of this study.

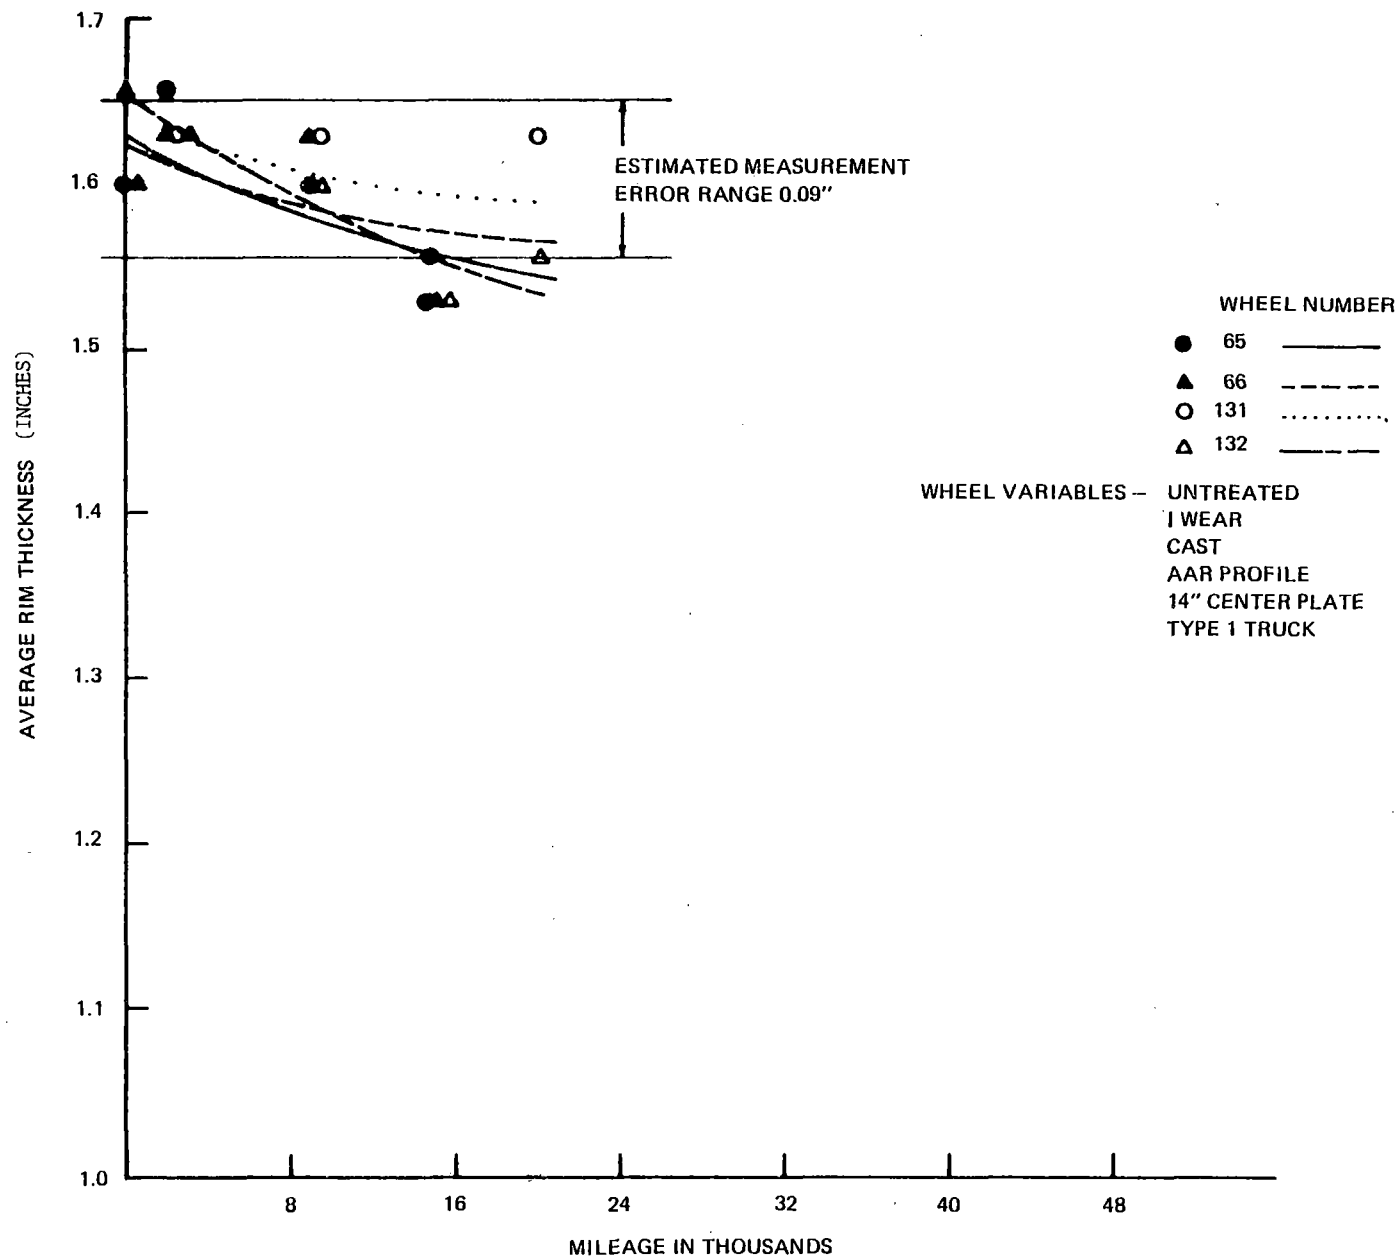
FIGURE 10. RIM THICKNESS VERSUS MILEAGE FOR EXAMPLE UNTREATED WHEELS FROM FAST EXPERIMENT 1.

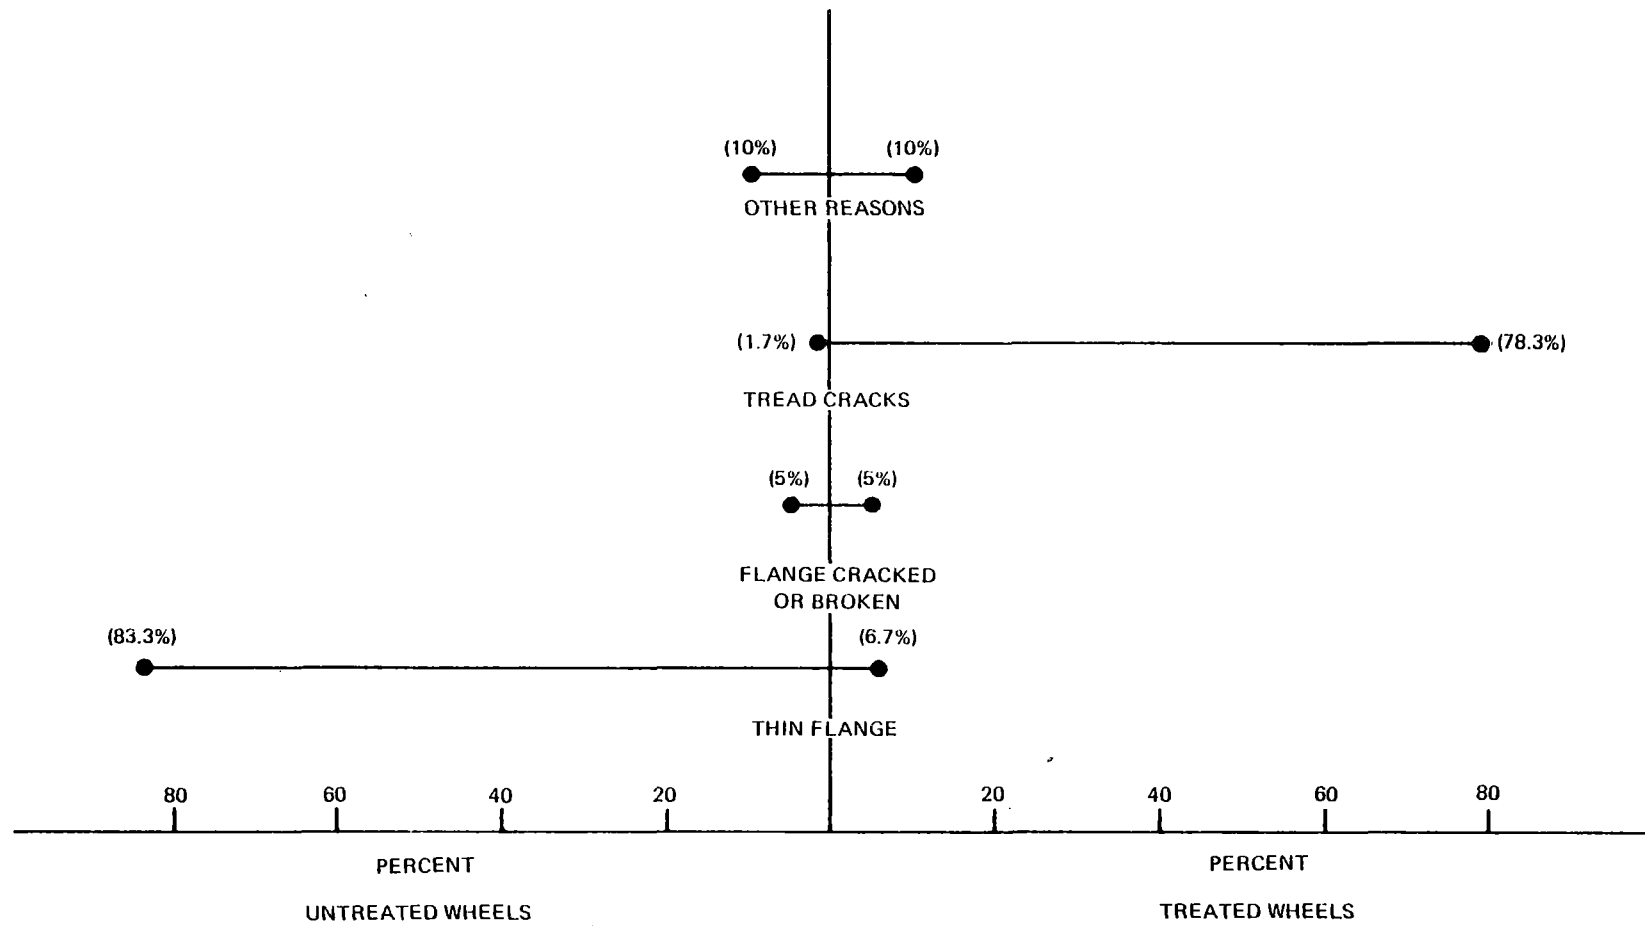
Table 1 shows the percentage of wheelsets removed for the first turning for various reasons for treated and untreated wheels. This information is presented graphically in figure 11. In this case, wheelsets were treated as one unit, since if one wheel failed both wheels had to be removed. It should be noted that the treated and untreated wheels had not seen the same mileage since untreated wheels reached thin flange condemning limits much sooner than treated wheels.

FIGURE 11. REASONS FOR FIRST REMOVAL BY WHEELSET IN EXPERIMENT 1 -- COMPARISON OF TREATED AND UNTREATED WHEELS.
