# TECHNICAL AND ECONOMIC FEASIBILITY STUDY OF AT-GRADE CONCRETE SLAB TRACK FOR URBAN RAIL TRANSIT SYSTEMS

**Amir N. Hanna**

CONSTRUCTION TECHNOLOGY LABORATORIES  
A Division of Portland Cement Association  
5420 Old Orchard Road  
Skokie, IL 60077

AUGUST 1981  
FINAL REPORT

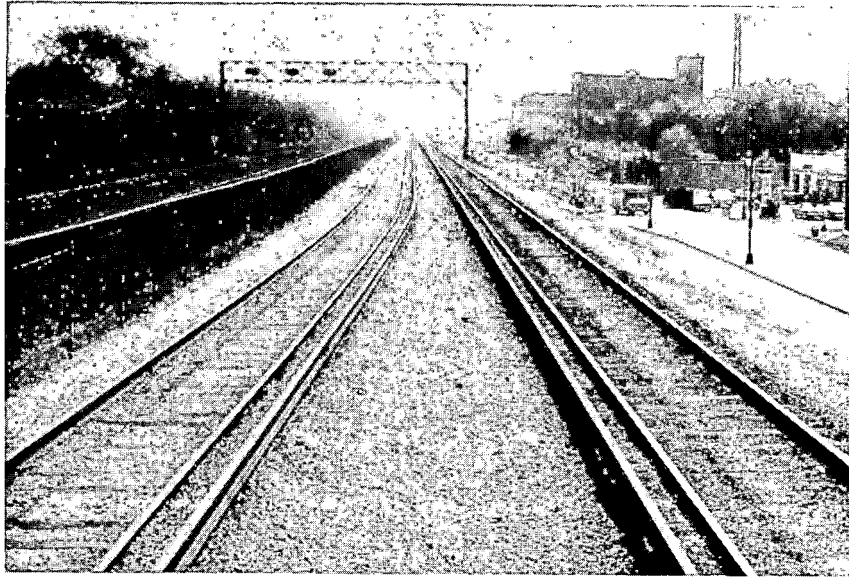
FIGURE 1-1. WOOD TIE TRACK

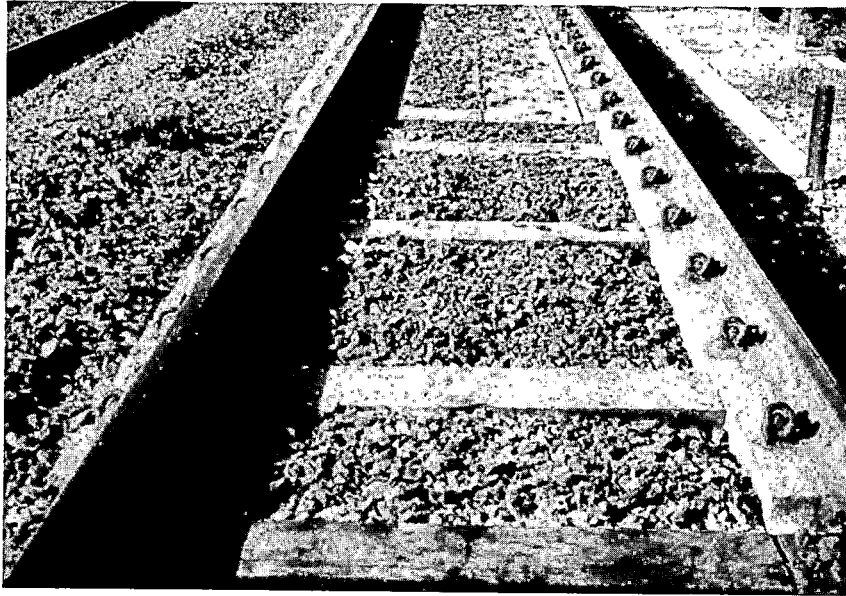
FIGURE 3-50. TRANSITION BETWEEN SLAB TRACK AND BALLASTED TRACK

The slab was slip-formed using a special paving machine. Transitions between slab and adjoining track consisted of two longitudinal and three transverse concrete beams as shown in Figure 3-50.

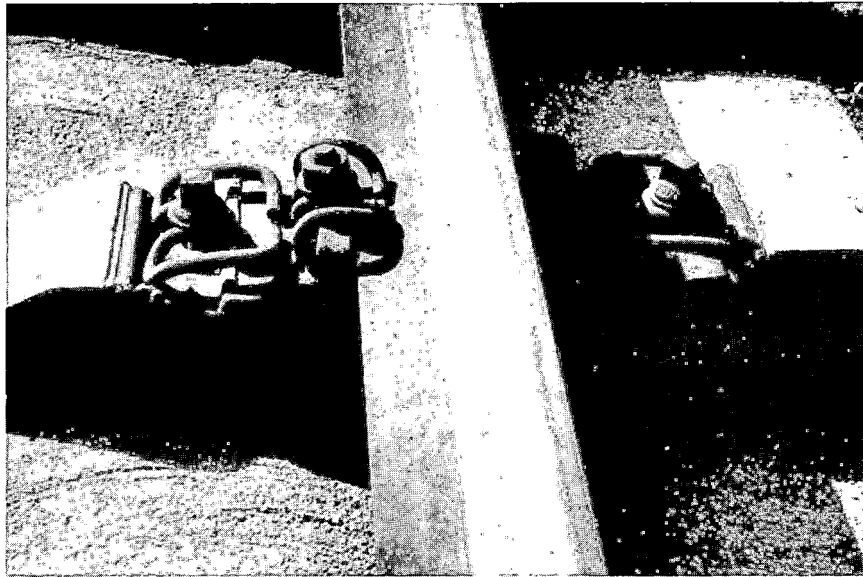
FIGURE 4-10. GERMAN RAILWAYS FASTENER AT KARLSFELD

A fastening system, shown in Figure 4-10, was used in projects at Rheda, Karlsfeld, and Munich-Nordring. This fastener was used to secure rails to precast concrete slabs or ladder units, or to embedded concrete ties or blocks. Fastener consisted of a ribbed base plate supported on a rubber pad. Angled guide plates and plastic shims were placed between base plate and concrete shoulders at rail seats. Base and guide plates

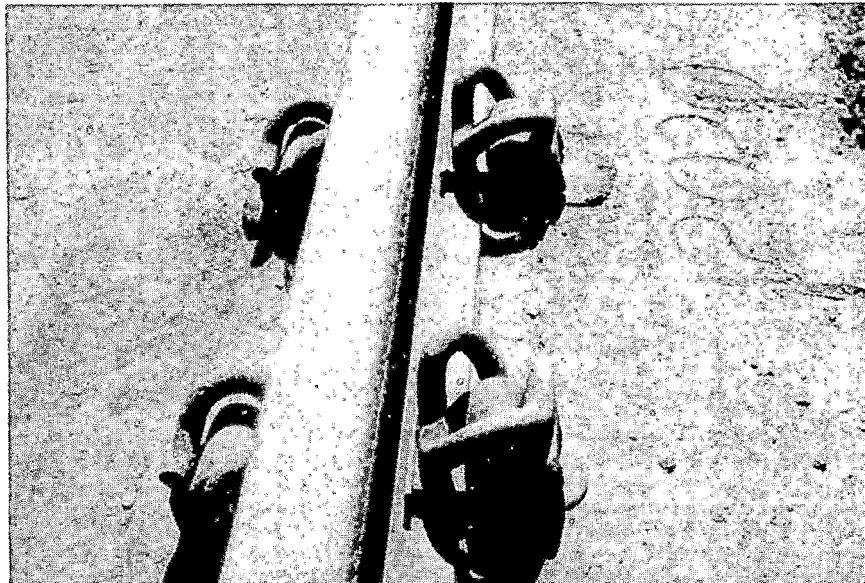
FIGURE 6-2. ADDITIONAL FASTENERS INSTALLED BETWEEN  
LOOSE ONES

Several problems were encountered on the slab track at Duffield. The most frequent problem was loosening of fastening inserts. Loosening was attributed to the passage of transverse cracks through fastening position and excessive slab deflection under load that caused spalling and working of cracks. Additional fasteners were installed by drilling new holes away from the crack and bonding new fastening inserts, as shown in Figure 6-2.

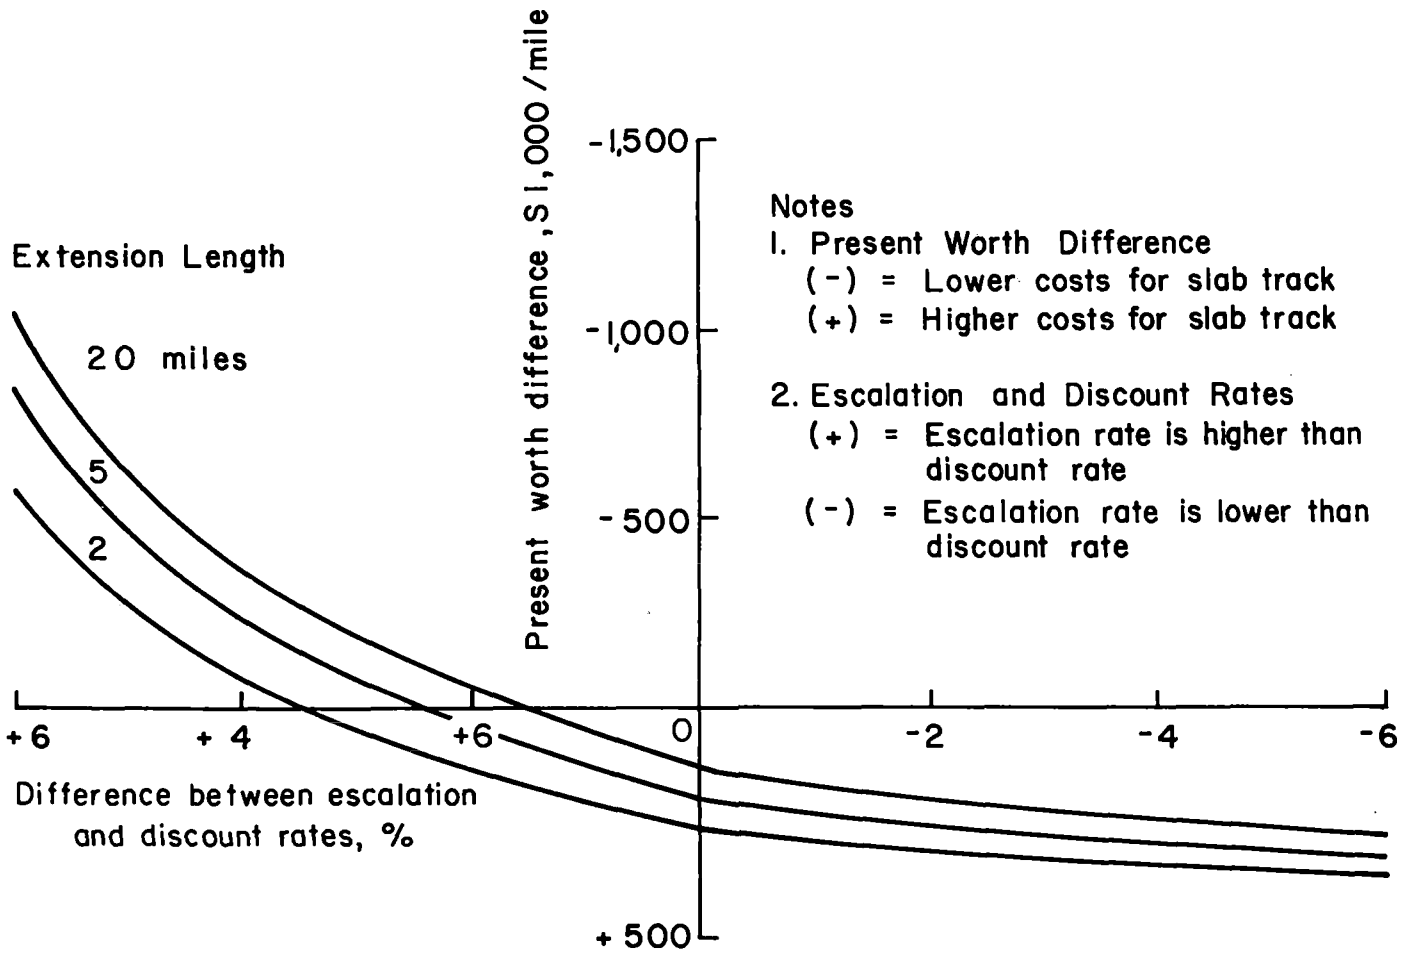
FIGURE 8-3. DIFFERENCE IN PRESENT WORTH BETWEEN CONCRETE SLAB AND WOOD TIE TRACKS FOR EXTENDING A WOOD TIE TRACK
