U.S. Department of
Transportation

Federal Railroad
Administration

Ground Penetrating Radar Technology Evaluation and Implementation: Phase 2

1. AGENCY USE ONLY (Leave blank)	2. REPORT DATE September 2017	3. REPORT TYPE AND DATES COVERED Technical Report, March 2014	
4. TITLE AND SUBTITLE Ground Penetrating Radar Technology Evaluation and Implementation: Phase 2		5. FUNDING NUMBERS DTFR53-00-C-00012 Task Order 248

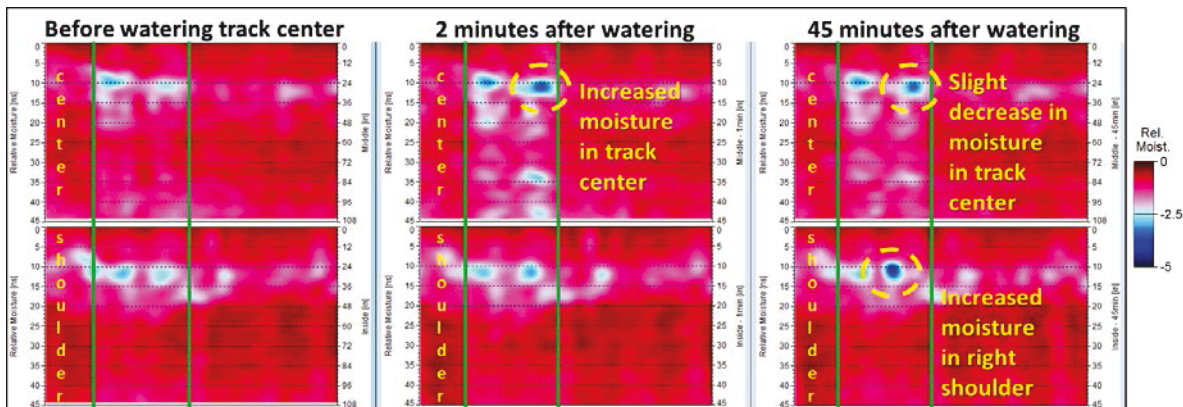
As an example, Figure 6 shows the change in moisture measured by System 3 from water being added to the track center and draining laterally to the right ballast shoulder. The data in Figure 6 was taken during the Phase 1 evaluation and shows the increase in moisture after adding water to the track in the test section at Transportation Technology Center (TTC) in November 2010.

Figure 6. Example of System 3 Sensitivity to Moisture Being Added to the Track Center and Draining to Right Shoulder

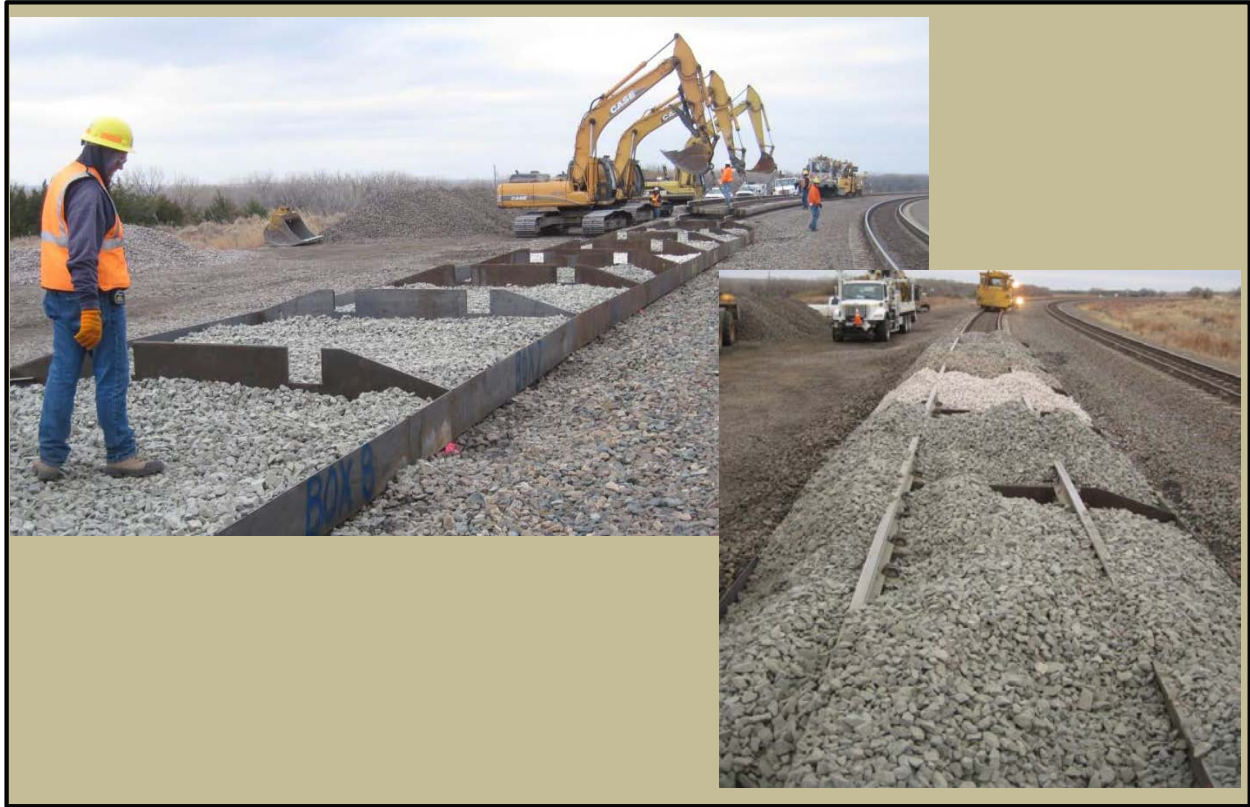
A ballast test was initiated in 2010 as a joint UP and TTCI effort to monitor degradation of different ballast types in a high tonnage, heavy axle load environment. Test zones were established on tangent track at MP 50.05 and on a 2-degree curve at MP 50.50 of the UP South Morrill subdivision. Both zones included eight steel boxes that were used to separate the various ballast types (Figure 13). The boxes in the curve zone had steel bottoms and the boxes in the tangent zone had fabric bottoms. Ballast samples have been taken two times a year from the boxes installed in November 2010 for gradation analysis to monitor particle size breakdown.

The western GPR site (MP 49.0 to 51.0) overlapped the ballast box test zones, and ballast box sampling coincided with all the GPR surveys.

Figure 13. Installation of the UP Ballast Box Test

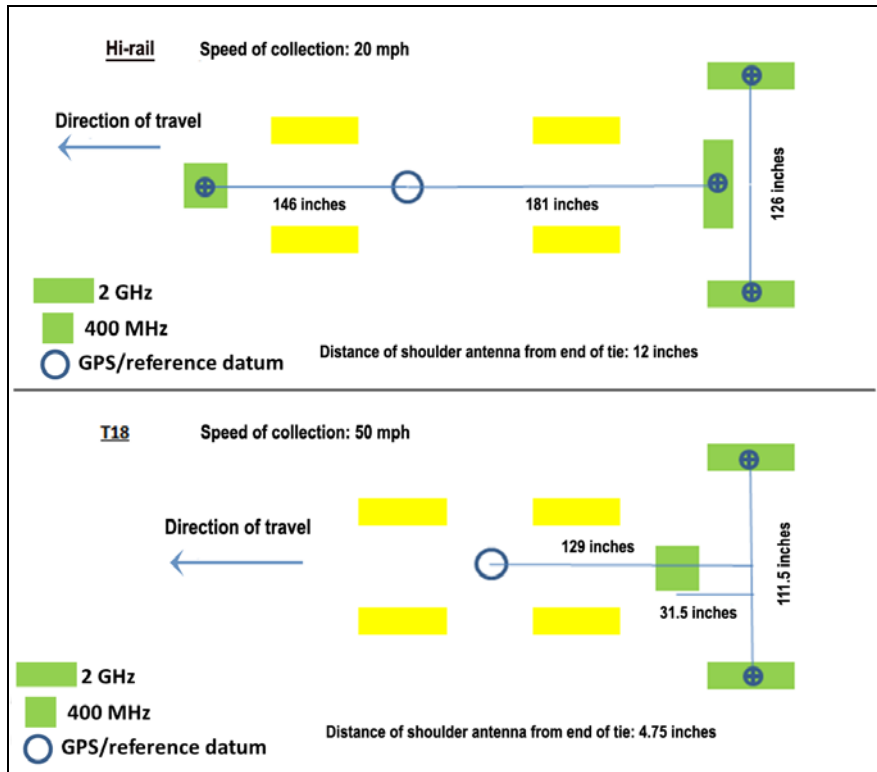
As Figure 19 shows, the T18 GPR survey speed over the western site was 50 mph and the hi-rail speed was 20 mph.

Figure 19. System 1 Hi-Rail and T18 Antenna Configuration

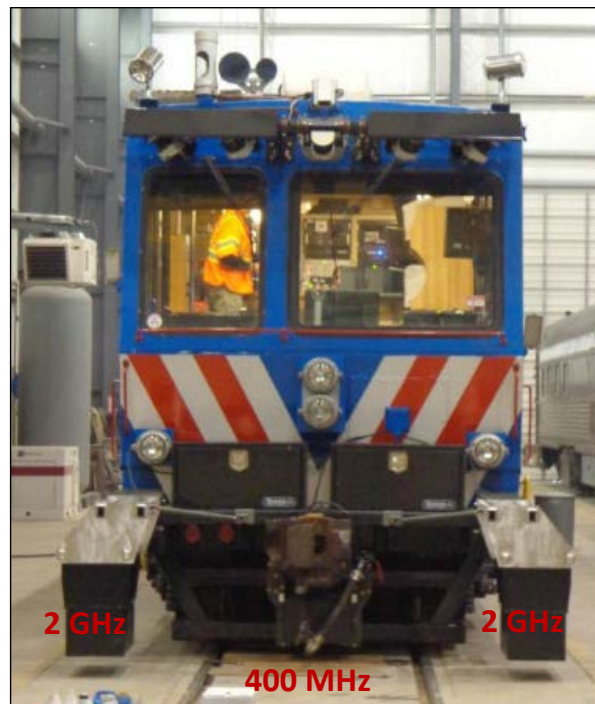
Antennas were mounted on the rear of the T18 vehicle using custom-designed brackets, as Figure 20 shows. The T18 antenna deployment included shielded housings to minimize potential interference from stray signal reflections bouncing off the vehicle body and to reduce the effects of electromagnetic interference from external sources such as cell phone transmitters. Acquisition of the GPR data was controlled by the same SIR-30 GPR control unit used on the hi-rail.

Figure 20. Antenna Deployment and Shielded Housings on the Rear of the T18 Vehicle

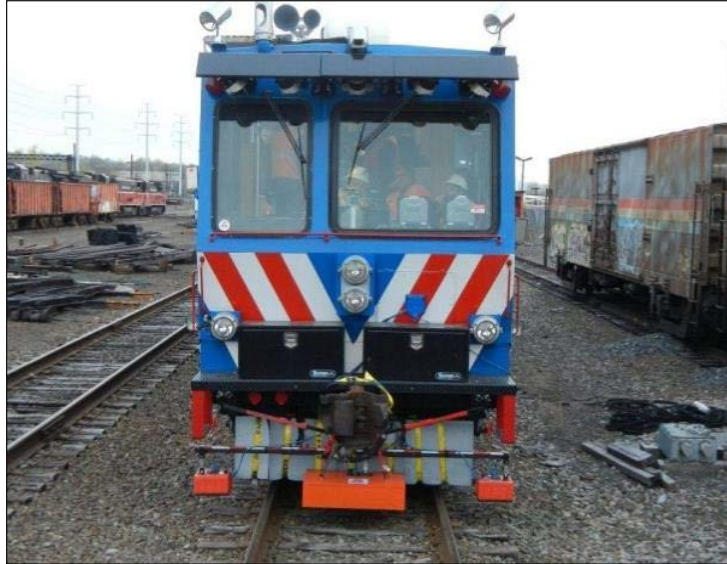
The installation of the GPR System 3 antenna on the T18 vehicle closely resembled the hi-rail antenna deployment. Three 400-MHz antennas were mounted at the T18 rear platform, 12 to 14 inches above top of tie at the track center and each end of tie (Figure 24). Echo-absorbing foam was installed to minimize ringing of the radar signal from nearby metal under the T18. Two GSSI SIR-20 control units (each 2 channels) and a single SIR-30 (4 channels) control unit were used during the evaluation.

Figure 24. System 3 Installation on Rear of T18 Vehicle Showing Antennas at Track Center and Shoulders and Foam Barrier

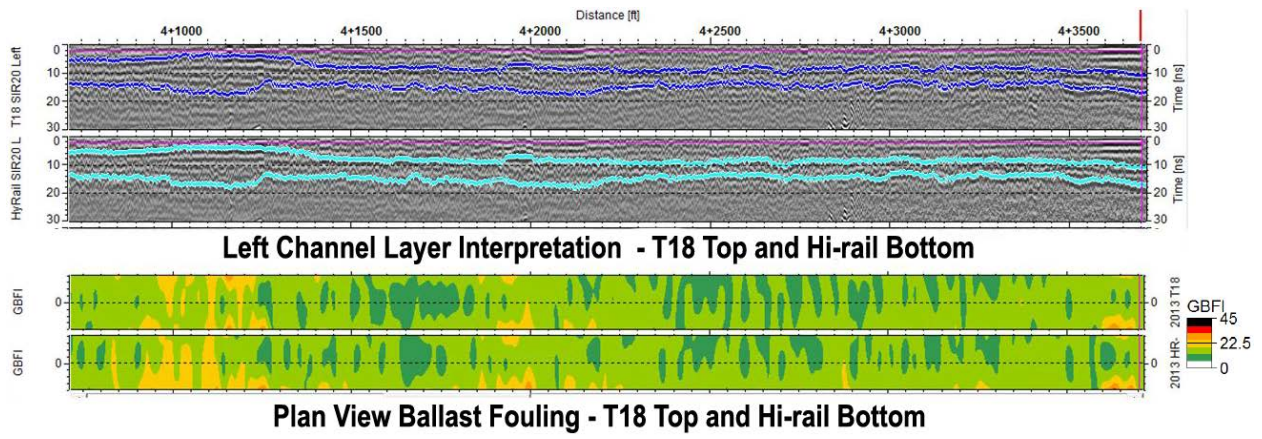
The slight differences between the T18 and hi-rail based fouling results were attributed to slight noise in the T18 data from the T18. In addition, there were also slight differences in fouling results from the SIR-20 and SIR-30 controllers on the T18 caused by inherent differences between the two units. The fouling results were based on calibrations with the SIR-20 based

system. Minor calibration adjustments to the SIR-30 data would produce similar fouling results as the SIR-20 data.

Figure 25. Comparison of System 3 T18 and Hi-Rail GPR Outputs
