UP 5802 (AC44CWCTE – GE) Locomotive Noise Test Battery Report

Document Number: 00002457-A

Contract Number FR-TEC-0003-11-01-00

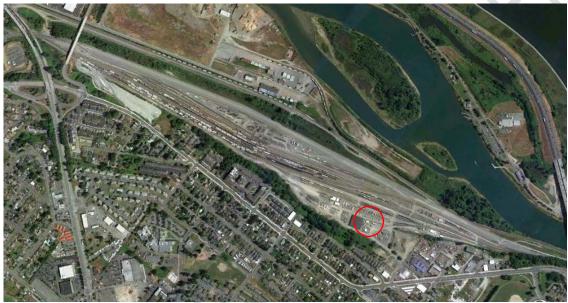
BNSF Delta Yard Figure 1

The testing location for this locomotive was in Everett WA at the BNSF Delta yard. The locomotive was located on a siding near the entrance to the yard and was stationary throughout the testing period.

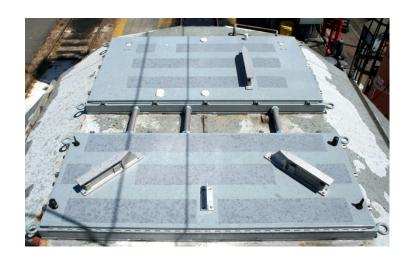
UP Antenna Array Figure 4

The antenna system was comprised of a UP designed "Hoffman Box" assembly. It included a single VHF, two Sinclair 220 MHz PTC antennas, three Sinclair UHF antennas for HOT, DPA, and DPB, LAIRD series 900 MHz antennas, and LAIRD series cellular antennas.

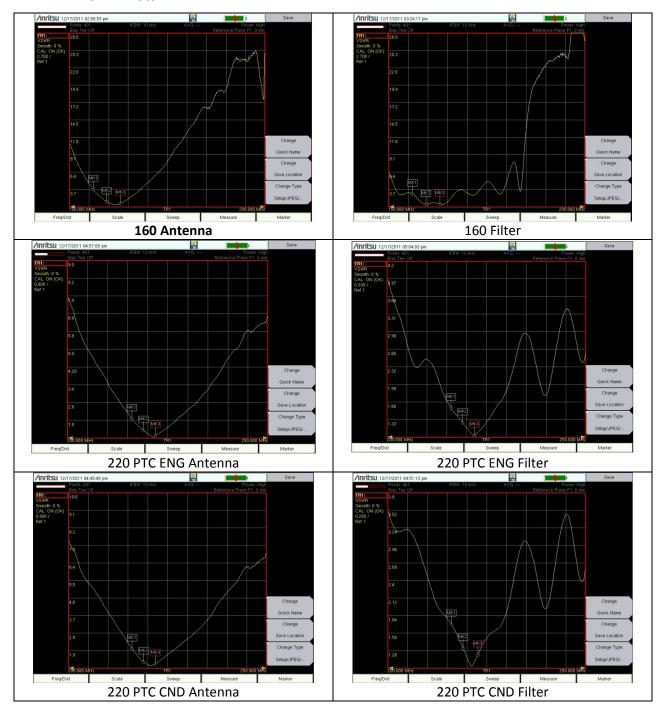
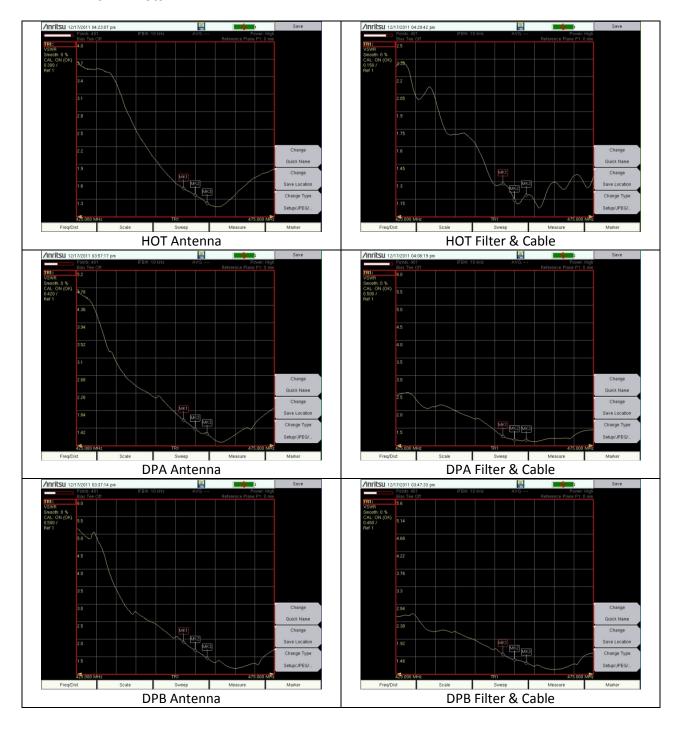
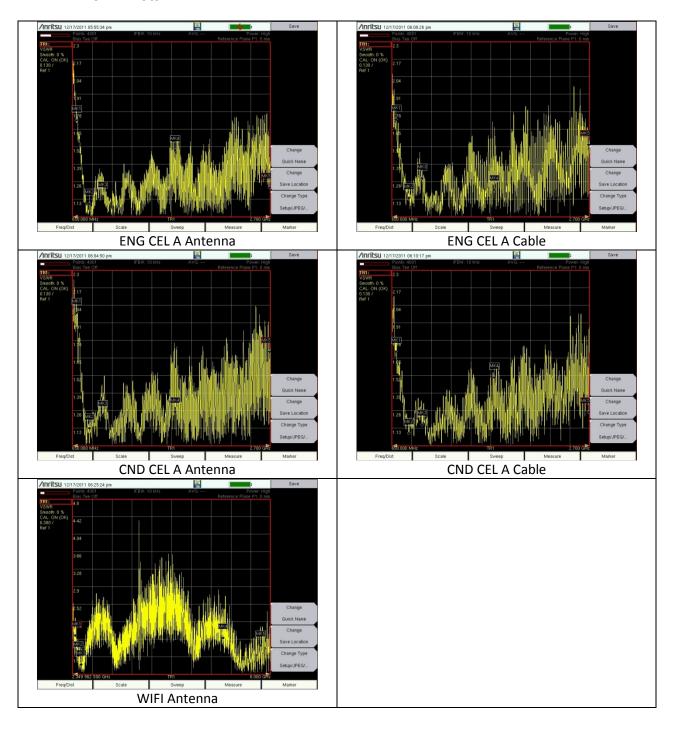
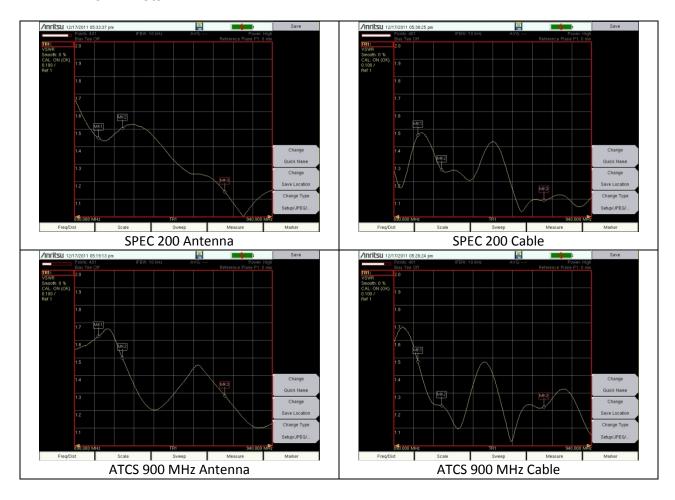
This test helps us to characterize the band pass parameters of the antenna. The information is useful in determining how much the antenna element contributes to filtering out of band energy as well as whether or not the antenna is functioning correctly. The results from the VSWR testing indicated all antennas and associated components were functioning properly. The full data from this testing has been presented in Appendix A. Typical data recorded from the locomotive is presented in Table A below.

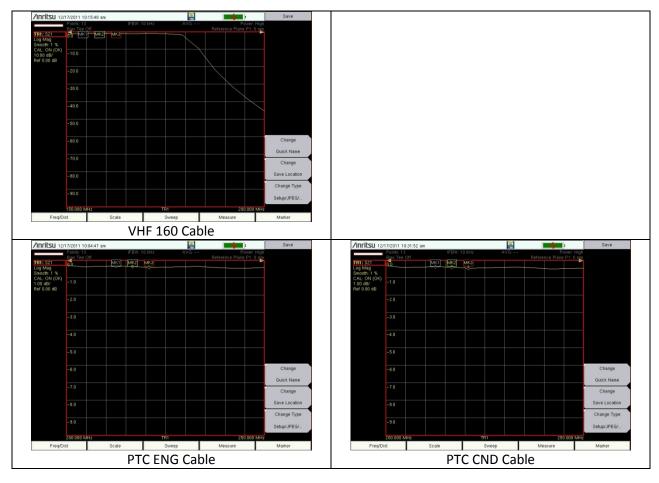
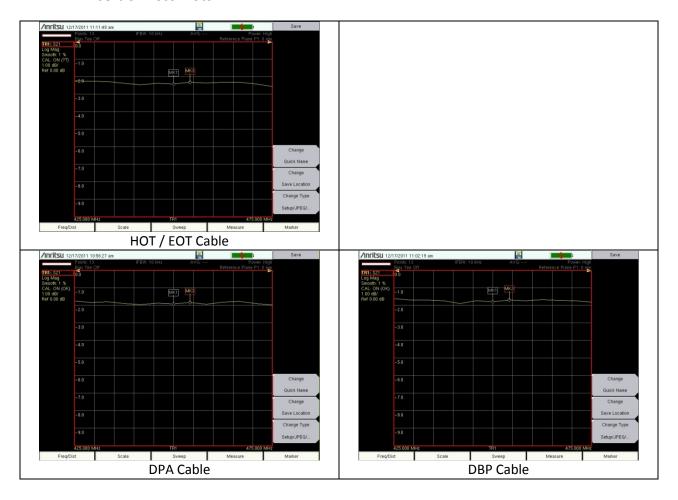
TABLE B Insertion Loss Plots

This report is useful for evaluating cable integrity and is representative of any losses that are present in the system. At the completion of this testing it was found that all on-board elements were in compliance as compared to planned values. A full report has been included in Appendix B.

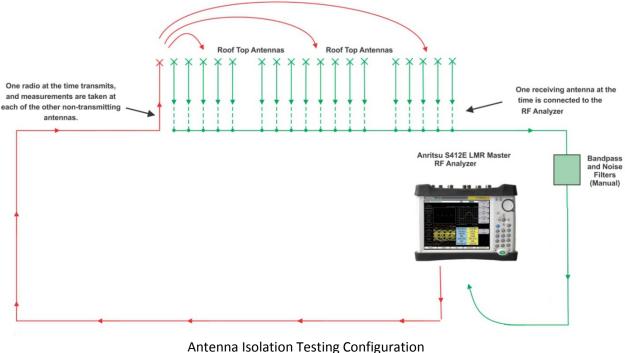
Figure 16

The test was performed by measuring the loss from the transmitting radio antenna to each other antenna, and the data was recorded in decibel format. The information gathered from this test correlates to the amount on intermodulation that is present in the roof environment, and possible prevention methods.

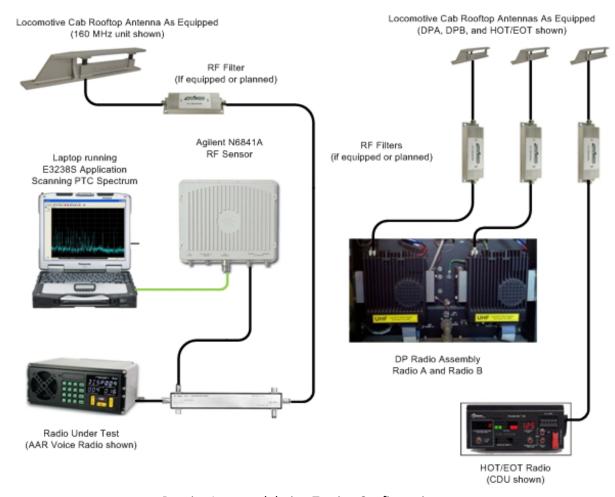
Receive Intermodulation Testing Configuration Figure 23

Each of the on board radios transmits at nominal power, and using a dual directional coupler the radio under test is measured for the amount of intermodulation products generated at the front end of the radio receiver and re-radiated back through the same antenna. Note that the radio under test is not transmitting.

A Dual Directional Coupler rated for a maximum power handling of 500 Watts was used to separately measure signals coming from the antenna to the radio receiver front end, and from the receiver front end travelling to the antenna and being transmitted as intermodulation products.

This Dual Directional Coupler has six ports, one for Antenna, one for Radio, two for 50 ohms loads, one to measure signals coming from the antenna to the radio transceiver, and one port to measure signals from the radio transceiver to the antenna.

In the IMD Test Apparatus diagram, the initial radio under test shown is the AAR Voice Radio, operating at ~ 160 MHz. Its Receiver is coupled directly to its existing transmission path, including Antenna (and Filter, if equipped or planned). The RF Sensor is coupled 20 dB down to the Receiver in the Radio under Test. The other radios of interest on the Locomotive (DPA, DPB, and HOT/EOT) are then keyed and RF energy from those radios pass through their respective existing transmission paths, including Antennas (and Filters, if equipped or planned). The RF energy then propagates into the Antenna of the Radio under Test, and then into the Receiver under test. Any IMD products in the 220 MHz spectrum generated in the Receiver that would be propagated via the Antenna system are measured by the RF Sensor.

A permutation of the IMD Test Apparatus is configured for each of the other radios of interest (DPA, DPB, and HOT/EOT), so that each of them is connected as a Radio under Test, and the process is repeated.

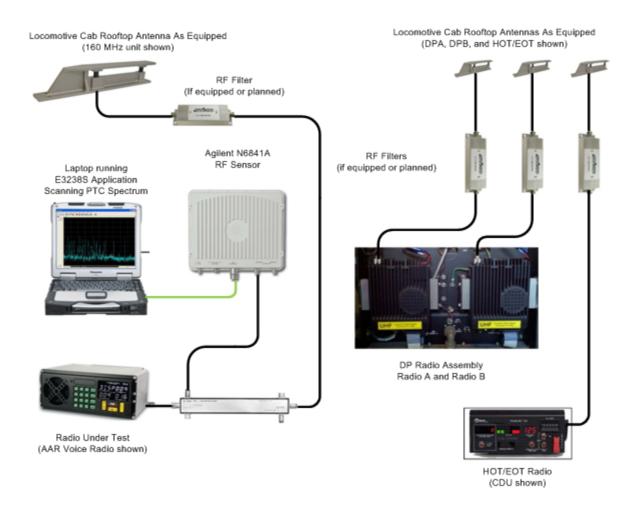
Transmit Intermodulation Testing Configuration Figure 24

Two, three, four or more on-board radios combined in different groups transmit simultaneously. Each of the radios transmits at nominal power, and using a dual directional coupler each other non-transmitting radio is measured for the amount of signals received from the transmitting radios entering through the antenna, and for the amount of intermodulation products generated at the front end of the radio receiver and transmitted back through the same antenna.

A Dual Directional Coupler rated for a maximum power handling of 500 Watts is used to separately measure signals coming from the antenna to the radio receiver front end, and from the receiver front end travelling to the antenna and being transmitted as intermodulation products.

This Dual Directional Coupler has six ports, one for Antenna, one for Radio, two for 50 ohms loads, one to measure signals coming from the antenna to the radio transceiver, and one port to measure signals from the radio transceiver to the antenna.

In the IMD Test Apparatus diagram, the initial radio under test shown is the AAR Voice Radio, operating at ~ 160 MHz. Its Transmitter is coupled directly to its existing transmission path, including Antenna (and Filter, if equipped or planned). The RF Sensor is coupled 20 dB down (or more, as needed to protect the RF Sensor) to the Transmitter in the Radio under Test. The other radios of interest on the Locomotive (DPA, DPB, and HOT/EOT) are then keyed and RF energy from those radios pass through their respective existing transmission paths, including Antennas (and Filters, if equipped or planned). The RF energy then propagates into the Antenna of the Radio under Test, and then into the Transmitter under test. Any IMD products in the 220 MHz spectrum generated in the Transmitter that would be propagated via the Antenna system are measured by the RF Sensor.

A permutation of the IMD Test Apparatus is configured for each of the other radios of interest (DPA, DPB, and HOT/EOT), so that each of them is connected as a Radio under Test, and the process is repeated.

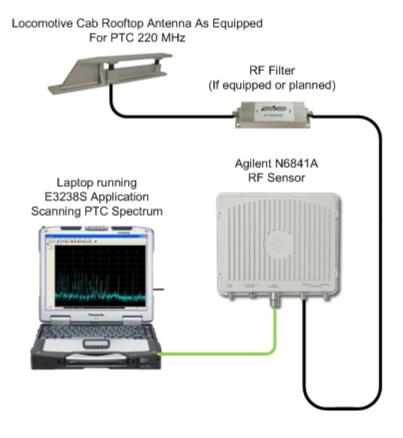
EMI Testing Configuration Figure 25

The testing results showed some increases in the noise floor level while operating through the start-up and shut-down phases. There were not significant variations while changing through the various power conditions. A very minor difference between the conductor and engineer side noise floor (only about 1-2 DB) was indicated during testing. This may be attributed to the physical location of the antenna feed point relative to some on-board power sources, the pattern characteristic differences between the two antennas, or the routing of the two different cable bundles.

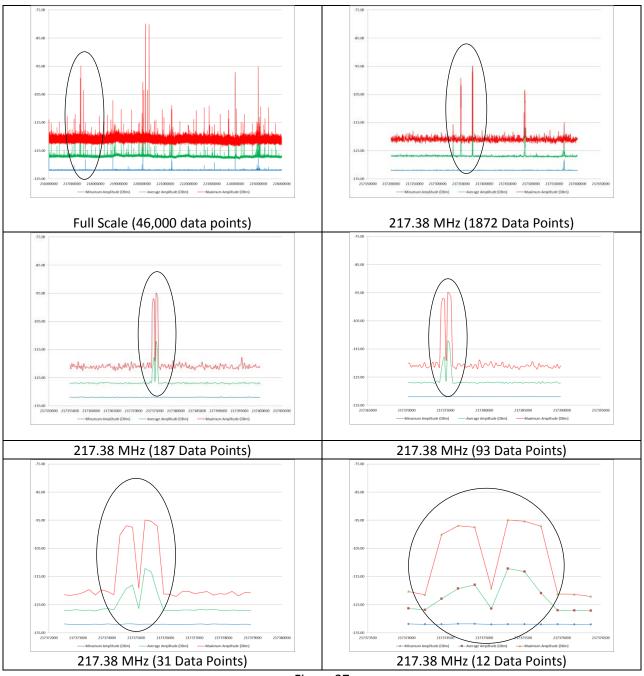
Figure 27

The following charts represent XY scatter chart with lines in EXCEL. Because of the amount of information shown in each chart the data might appear to be a spectrograph exported from a spectrum analyzer, rather than a record of the signal amplitude levels or duration information extracted and plotted from the energy history files that it actually represents. In Figure 27, three different resolutions of the information have been created to show the individual data points and how they are interconnected.

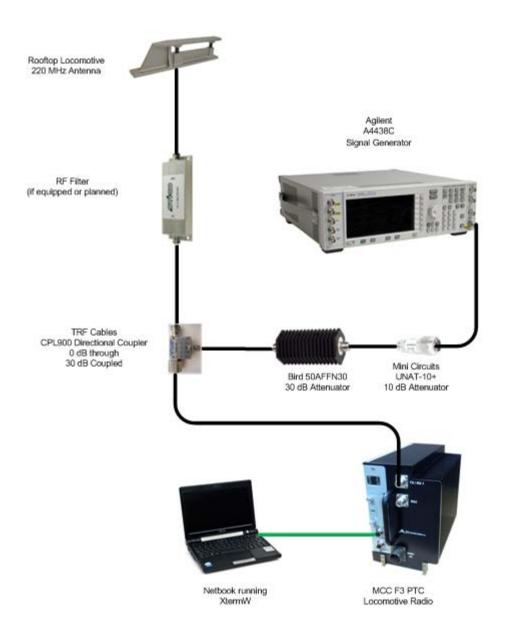
BER Testing Configuration Figure 40

The purpose of this test is to determine the impact on receiving PTC transmissions in the locomotive noise environment, with the focus on capturing the minimum signal level needed for radio network planning. To accomplish this, a PTC Locomotive Radio (F3) was connected through a Directional Coupler to a Signal Generator equipped with an attenuator pad, and to the worse-case locomotive PTC Antenna. See Figure 40.

The PTC Radio's design is based on a Receiver noise floor of -123 dBm, and a C/N ratio (for sustaining a BER of E-4) of 11 dB, and a C/I (for sustaining a BER of E-4) of 14 decibels.

To establish a baseline, the PTC Antenna was disconnected from the Directional Coupler port, and the port was terminated. This effectively isolated the radio from the noise environment. The Signal Generator was configured to send a Test Pattern, and the signal level was set so that a BER of E-4 was sustainable. In this configuration, the PTC Radio was able to report a BER of E-4 at -113 dBm. Note that this radio, under these test conditions, was performing slightly better than spec with a C/N of 10 decibels.

The PTC Antenna was then reconnected, and the test was repeated for each of ten Locomotive Operational States (Engine Off, Idle, and Notches 1 through 8). The limitations of the test do not permit reliable BER measurements for brief conditions such as Startup Sequence and Shutdown Sequence, so these two locomotive operational states were not tested.

The worse-case level observed for a reliable BER of E-4 was -103 dBm.

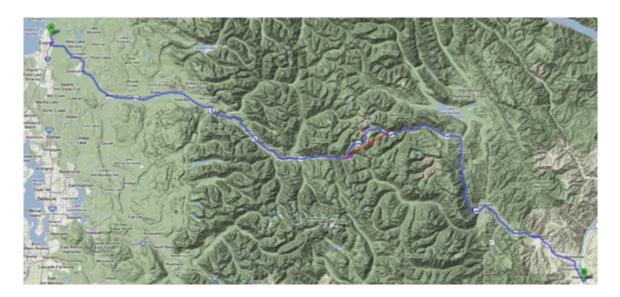
Stevens Pass Run Figure 41

During testing of the Locomotive, an opportunity to measure aggregate noise in the 220 MHz spectrum while in motion and under load was presented. The locomotive under test was coupled into a Consist of seven Locomotives, carrying a typical revenue train from the BNSF Delta Yard in Everett, Washington, following the US Route 2, over Stevens Pass (see Figure 41), through some tunnels, most notably, the Cascade Tunnel (red line segment), which is some 8 miles in length, finally terminating in Wenatchee Washington. The route was then reversed. The original intent was to capture any detectable EMI being generated by the Traction Motors of this specific locomotive. During testing, it soon became evident that separating the EMI of the locomotive under test from the other six locomotives in the Consist, as well as the passing Locomotives of other trains would not be possible. However, the information is still useful in that it reflects what the PTC-220 Radio receiver would be exposed to in an actual operating environment.

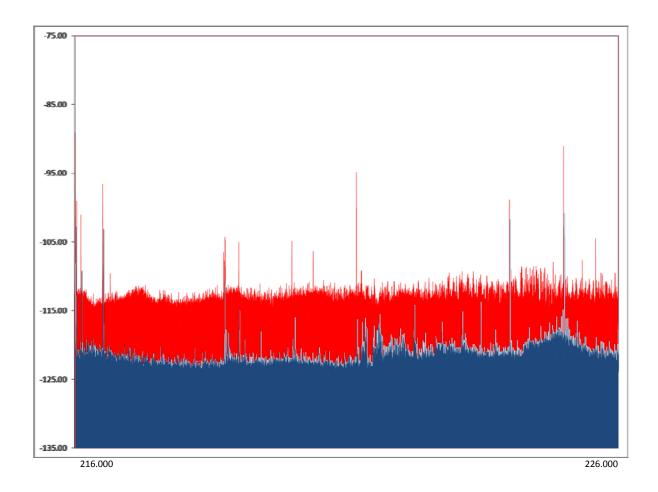
Departing yard Figure 43

The first condition of interest that presented itself occurred as the Consist departed the yard. The instrument had been allowed to build an Energy Environment Threshold, and the threshold was set at 1 dB above Ambient Peak. As the train left the yard, there was a series of very brief transient events ranging from 4 dB to 11 dB over Ambient Peak. The events were few (order of magnitude of E+1 detections or less), narrow in bandwidth, and short lived (E-1 milliseconds or less). It is unclear what equipment on the yard perimeter may have been responsible for these disturbances, and, given the revenue nature of the run, it was not feasible to stop the train in order to explore the disturbances. See associated files labeled 'Idle Rolling Noise Departing Yard'.

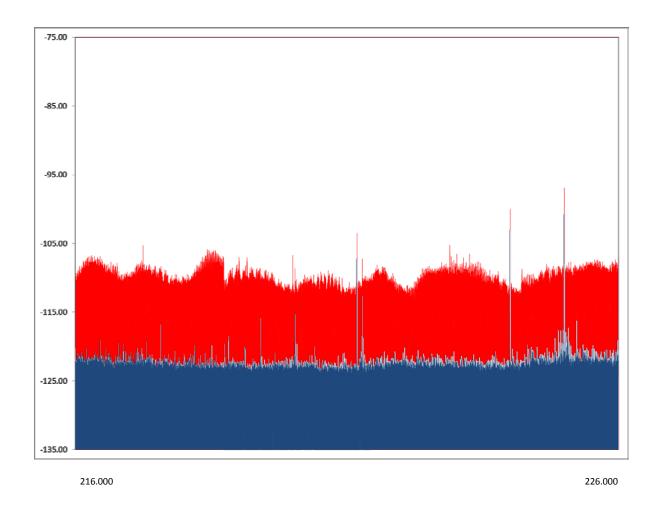
Power Lines Figure 44

The next condition of interest involved passing another freight train. The instrument had been allowed to build an Energy Environment Threshold, and, again, the threshold was set to 1 dB above Ambient Peak. As the other train's locomotives passed, there were no Detections of any energy above Ambient Peak. However, there was a series of brief transient events when several Automobile Carrier type rolling stock passed by. It appeared that the rolling stock was empty, and a quick visual scan of the surrounding environment identified a three phase power utility line running parallel to the tracks, then diverging way. These appeared to be at least sub-station intertie level voltages (likely in the 120kV range or higher). Given the nature of the disturbance, and no easily associative observations regarding the passing train, it is possible that the transient events were generated by the proximal electrical utility facilities. See associated files labeled 'Rolling Noise 3'.

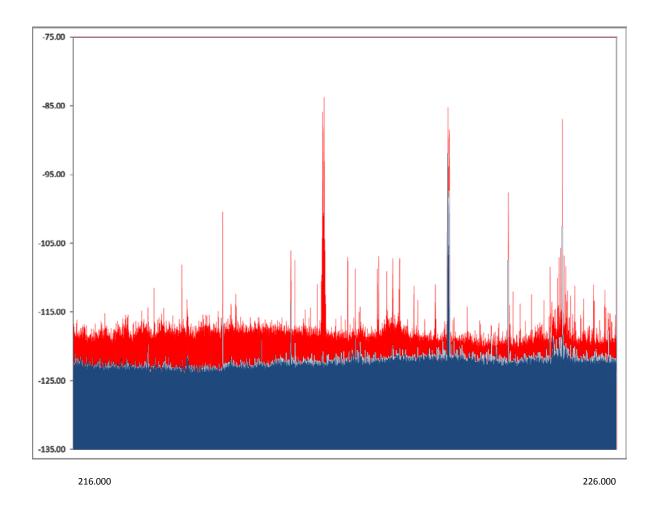
Cascade Tunnel Figure 45

The next condition of interest involved the approach to, and the traverse within, the Cascade Tunnel. The instrument had been allowed to build an Energy Environment Threshold, and, again, the threshold was set to 1 dB above Ambient Peak. The intent was to observe how much, if any, EMI Noise generated by the locomotive would be reflected by the confined space and materials of such a tunnel back into the PTC 220 Antenna aperture. Not surprisingly, Energy Amplitude rose once inside the tunnel. Much of the noise characteristics captured are similar to what was seen in the Static EMI Testing elsewhere in this report. However, given the isolated nature of the tunnel environment, it is unlikely that the anomalous signals (spikes) shown in the above figure were being generated by 'non-PTC-220 users' when actually inside the tunnel. However, it is of note to explain that human occupation of any Locomotives other than the Lead locomotive while inside the Cascade Tunnel is prohibited by BNSF for Environmental Human Exposure reasons, so it is possible that these anomalous signals (spikes) were intercepted at the Tunnel Portals while the Test Operators were unable to observe the Test Equipment in real time. Given the logistics of a revenue run, it was not feasible to stop the train to explore the source of these disturbances. See associated files labeled 'Cascade Tunnel'.
