# NS 8898 (C40-9W - GE) Locomotive Test Report

FR-TEC-0003-11-01-00

Contract Number FR-TEC-0003-11-01-00
Dates of Survey March 26<sup>th</sup> to 28<sup>th</sup>, 2012

Locations Norfolk Southern Shaffers Crossing Facility Roanoke VA

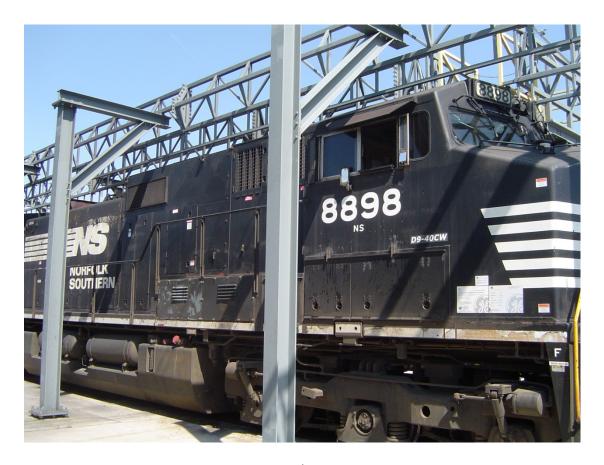
Locomotive under test NS 8898 GE Diesel Electric Locomotive Dash 9-40CW Figure 3

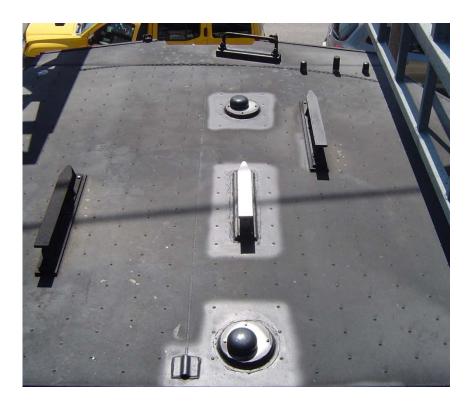
NS 8898 Rooftop View Front Facing

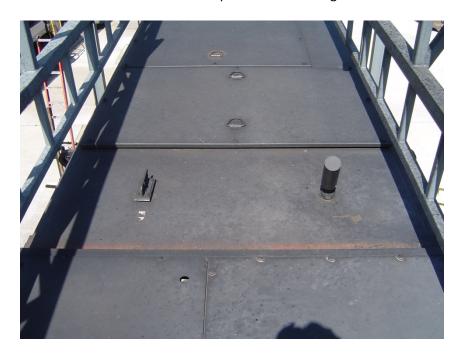
NS 8898 Rooftop View Rear Facing

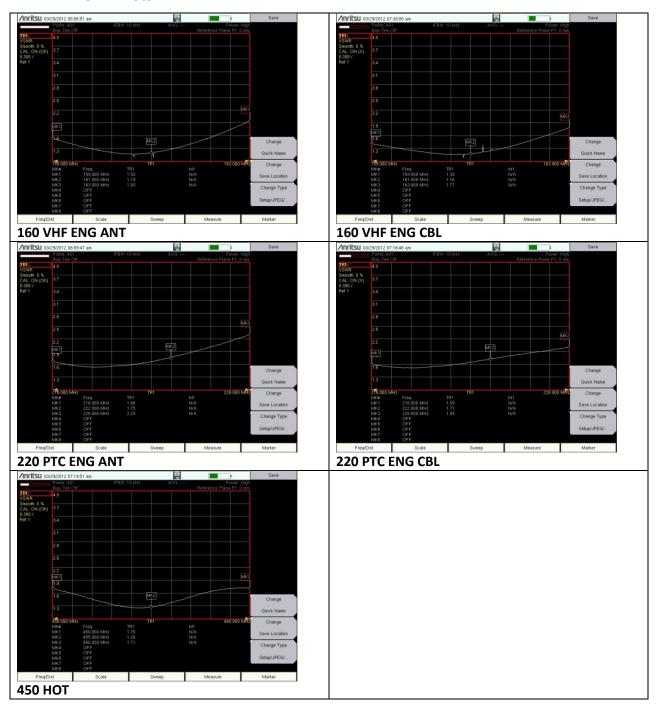
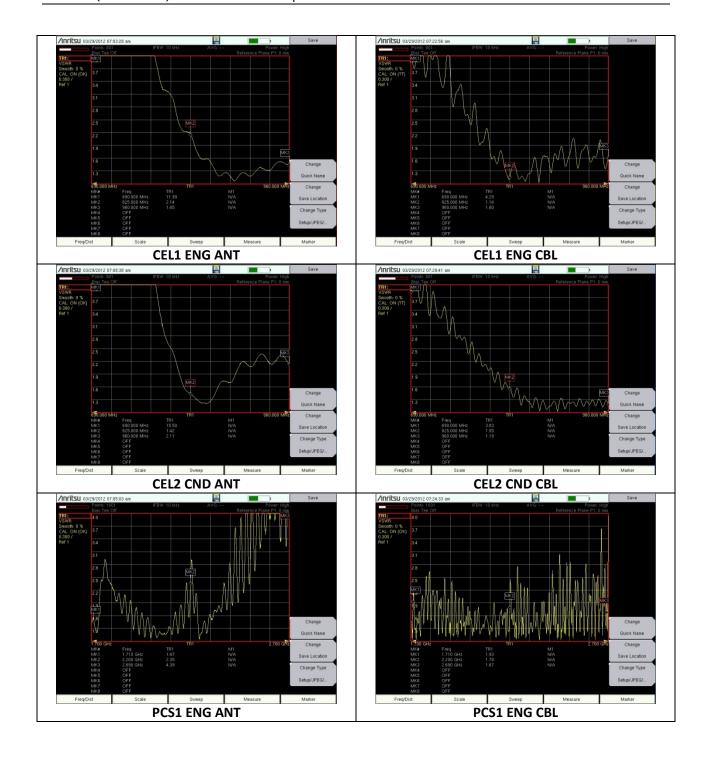
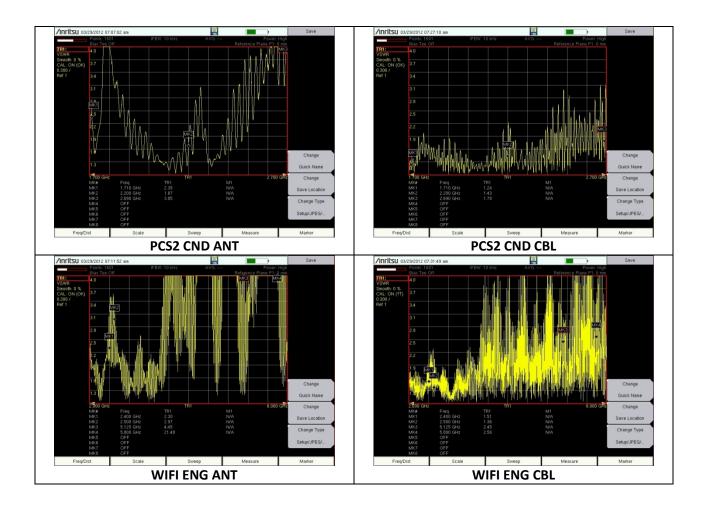
# **TABLE A VSWR Plots**

This test is designed to collect VSWR data in several formats for use in locomotive noise and intermodulation reporting. The test involved collecting voltage standing wave ratio and return loss data in the following formats; VSWR, S1P scatter parameters, comma separated values, and a portable network graphics. It is important to know if the antenna system is properly matched to the transceiver equipment as this can be a source of intermodulation and/or standing waves in the RF system. The first set of data was collected at the RF port located closest to each antenna element in the locomotive radio frequency system to give an accurate picture of antenna matching. A second set of data recorded the VSWR at the end of the transmission line cable that connects to the radio transceiver antenna connector, including any installed filtering to show what the full system response is that is presented to the transceiver. This measurement includes all system losses.

This test helps us to characterize the band pass parameters of the antenna. The information is useful in determining how much the antenna element contributes to filtering out of band energy as well as whether or not the antenna is functioning correctly. The results from the VSWR testing indicated all antennas and associated components were functioning properly. The full data from this testing has been presented in Appendix A. Typical data recorded from the locomotive is presented in Table A below.

#### VSWR:

The VSWR of the low profile Sinclair Technologies Inc. VHF antenna model number EXCAL221-8952446 was compliant with the manufacturers published specifications and no significant mismatch was noted. The 220 PTC antenna manufactured by Sinclair Technologies Inc. model number ST221-SF3SNF has a published frequency range of 217-223 MHz with a maximum specification of 1.5:1. Within this range the antenna was not compliant as tested at the end of the cable that would connector to the transceiver equipment. The vendor requirements for the ground plane of this antenna are a 36" by 36" metal plane. The surface area around the antenna is compliant. One possible reason for the mismatch may be the placement of the VHF antenna in the near field of the 220 MHz antenna (see figure 38). The spacing between the antennas is approximately 11 inches.

The VSWR reflection data on the Sinclair UHF antenna was taken after the unit was tightened down and indicated that the unit was functioning correctly.

The cellular antenna response for both cell antennas were in spec for a 820-960 MHz bandwidth <2:1. There were some variations in the response, but these may be attributed to the proximity of the fall protection and can be dis-regarded. These antennas were not rated for PCS band response but the data is presented in this report as a matter of reference.

The 802.11 antenna did not pass the manufacturer specification. After some investigation with the manufacturer it was determined that this antenna is in fact a cellular style MLPV-698 with a rated frequency range 806-960.

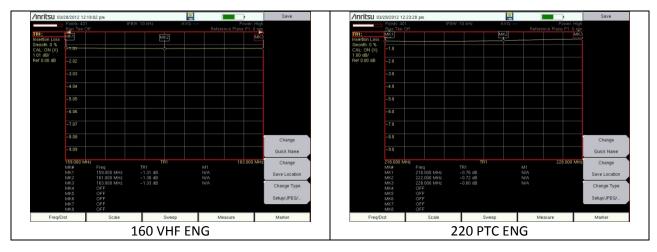
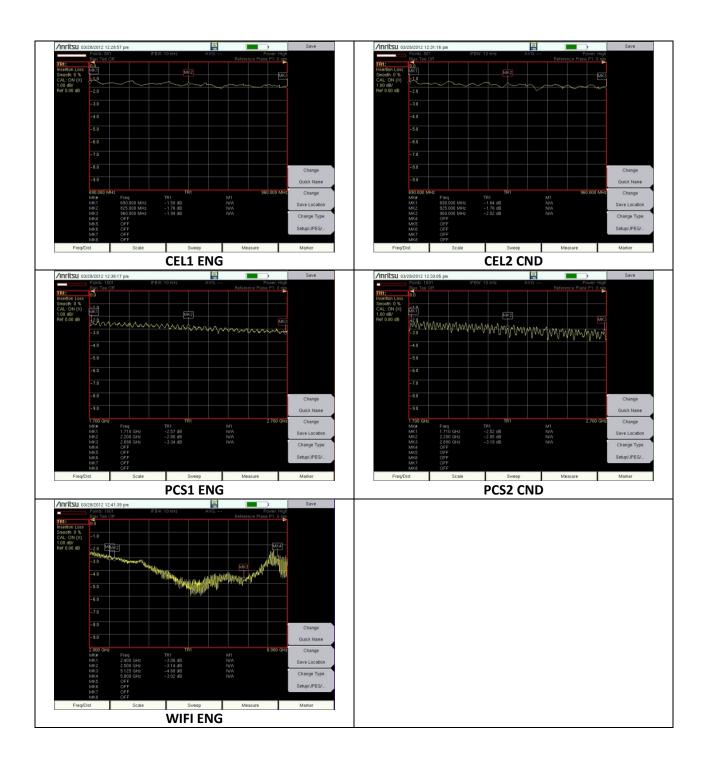
# **TABLE B Insertion Loss Plots**

This test is designed to collect insertion loss data in several formats for use in locomotive noise and intermodulation reporting. The test involved collecting insertion loss data in the following formats; insertion loss in dB, S1P scatter parameters, comma separated values, and a portable network graphics. It is important to know how much loss is experienced in the system in order to determine the impact on transmitted power and intermodulation effects. The test was performed on the transmission lines by measuring the loss from the antenna connection port to the equipment port. The test is frequency specific and each cable was measured based on the appropriate frequency range.

This report is useful for evaluating cable integrity and is representative of any losses that are present in the system. At the completion of this testing it was found that all on-board elements were in compliance as compared to planned values. A full report has been included in Appendix B.

While testing the insertion loss of the cables it was determined that one of the cellular cables was measuring a high loss in the band. Upon inspection a loose ground between the connector body and the cable shield was found near the equipment room end of the cable. The cable was repaired and testing resumed all data taken was after the repair was accomplished.

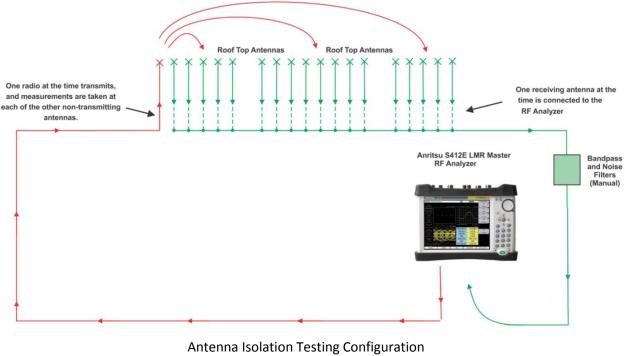
Figure 14

This test is designed to collect information on the amount of free space isolation between each antenna and each other antenna. This value in decibels and is used to calculate the amount of power from each radio impacting each other radio receiver front end during transmission. High signal levels impacting the receiver front end of a radio in receive mode will cause intermodulation products in proportion to the power received from the transmitting radio. The antenna isolation data is also used to determine the need for filtering in the system.

This test is frequency specific, each radio transmits at a certain level in the frequency it is configured to transmit, and the power of this transmitted signal is measured at each other radio antenna. The test was performed by measuring the loss from the transmitting radio antenna to each other antenna, and the data was recorded in decibel format. The information gathered from this test correlates to the amount on intermodulation that is present in the roof environment, and possible prevention methods.

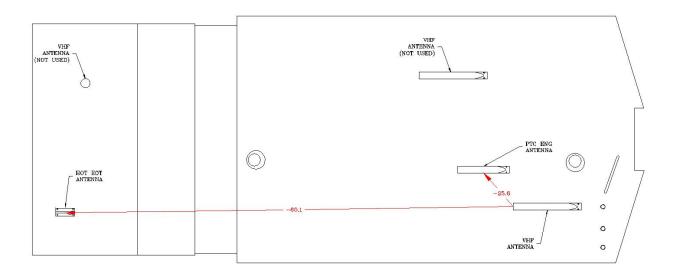
In the paired figures below, the "A" drawing shows the isolation data with no filtering and was mapped to show the relationship between antenna spacing and free space path loss. There are other factors to be considered such as the antenna element type and frequency response which will contribute to out of band rejection characteristics. In the cases where there is diversity or redundant antennas spaced across the locomotive, notice how the symmetry in the isolation numbers which tracks with the layout of the antenna elements. The "C "diagrams indicate what energy is seen by the primary element from different frequency bands non-filtered. The results here will correlate to the intermodulation data collected in later testing.

Note that measurements designated "<-60 dB" are actually below the noise floor of the instrument.

Figure 15 A XMIT

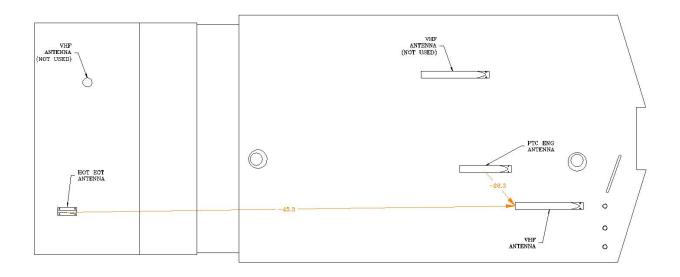
Figure 15 B RCV

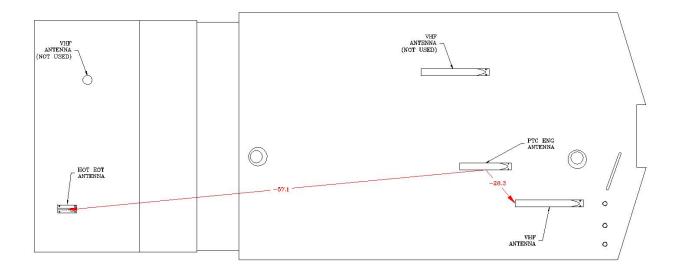
Figure 16 A XMIT

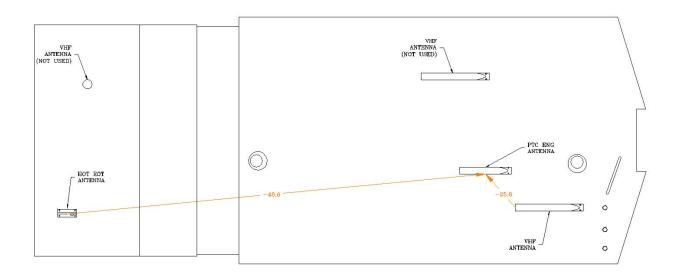
Figure 16 B RCV

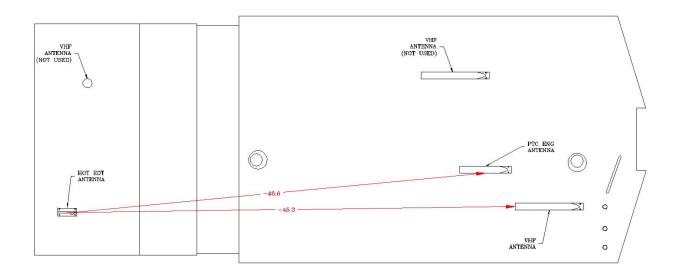
Figure 17 A Non-Filtered

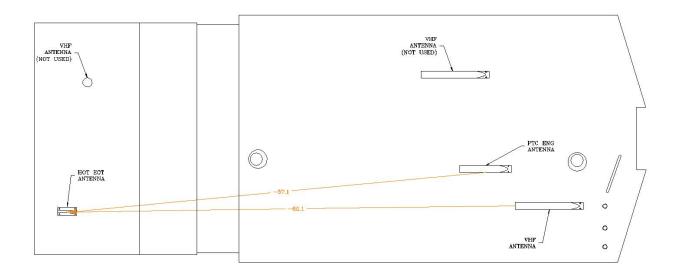
Figure 17 B RCV

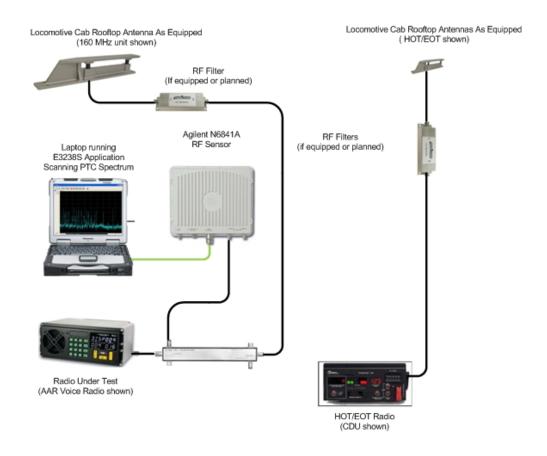
Each of the on board radios transmits at nominal power, and using a dual directional coupler the radio under test is measured for the amount of intermodulation products generated at the front end of the radio receiver and re-radiated back through the same antenna. Note that the radio under test is not transmitting.

A Dual Directional Coupler rated for a maximum power handling of 500 Watts was used to separately measure signals coming from the antenna to the radio receiver front end, and from the receiver front end travelling to the antenna and being transmitted as intermodulation products.

This Dual Directional Coupler has six ports, one for Antenna, one for Radio, two for 50 ohms loads, one to measure signals coming from the antenna to the radio transceiver, and one port to measure signals from the radio transceiver to the antenna.

In the IMD Test Apparatus diagram, the initial radio under test shown is the AAR Voice Radio, operating at ~ 160 MHz. Its Receiver is coupled directly to its existing transmission path, including Antenna (and Filter, if equipped or planned). The RF Sensor is coupled 20 dB down to the Receiver in the Radio under Test. The other radios of interest on the Locomotive (DPA, DPB, and HOT/EOT) are then keyed and RF energy from those radios pass through their respective existing transmission paths, including Antennas (and Filters, if equipped or planned). The RF energy then propagates into the Antenna of the Radio under Test, and then into the Receiver under test. Any IMD products in the 220 MHz spectrum generated in the Receiver that would be propagated via the Antenna system are measured by the RF Sensor.

Receive Intermodulation Testing Configuration Figure 18

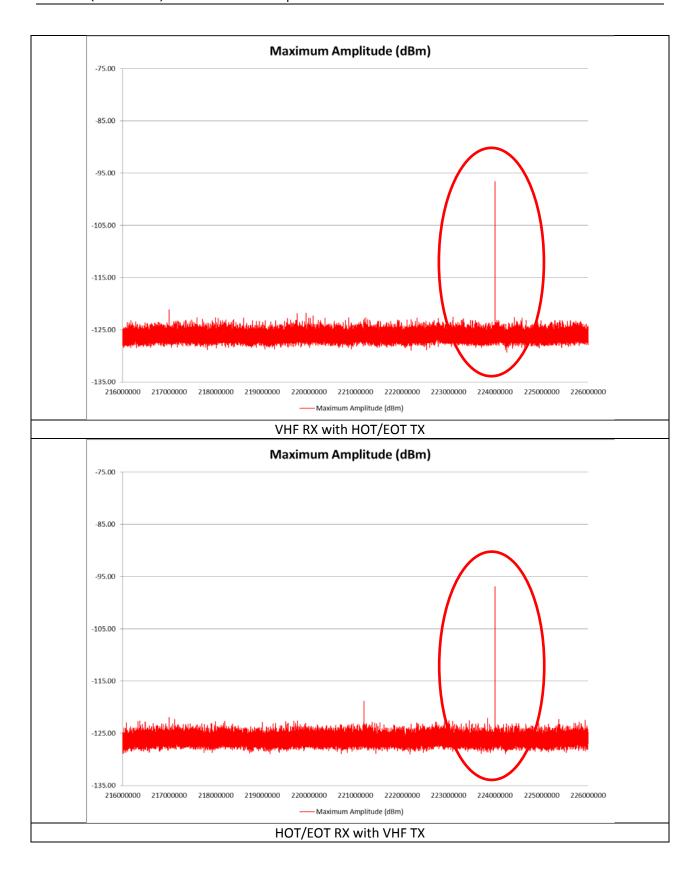
The energy detection at 224 MHz (highlighted with red circle) was present throughout our testing and is considered to be an artifact of the RF Sensor, and should be ignored. Note the small spur generated near 221 MHz in the HOT/EOT Receiver.

The receiver intermodulation test revealed a small spur near 221 MHz being generated in the HOT/EOT Receiver when the AAR VHF Voice Radio is keyed. Filtering of all significant contributor radios is emphatically recommended.

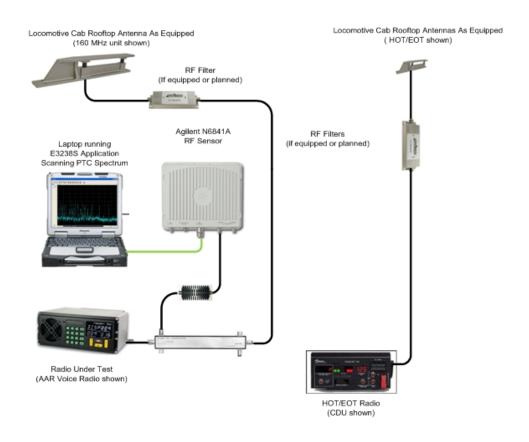
Two, three, four or more on-board radios combined in different groups transmit simultaneously. Each of the radios transmits at nominal power, and using a dual directional coupler each other non-transmitting radio is measured for the amount of signals received from the transmitting radios entering through the antenna, and for the amount of intermodulation products generated at the front end of the radio receiver and transmitted back through the same antenna.

A Dual Directional Coupler rated for a maximum power handling of 500 Watts is used to separately measure signals coming from the antenna to the radio receiver front end, and from the receiver front end travelling to the antenna and being transmitted as intermodulation products.

This Dual Directional Coupler has six ports, one for Antenna, one for Radio, two for 50 ohms loads, one to measure signals coming from the antenna to the radio transceiver, and one port to measure signals from the radio transceiver to the antenna.

In the IMD Test Apparatus diagram, the initial radio under test shown is the AAR Voice Radio, operating at ~ 160 MHz. Its Transmitter is coupled directly to its existing transmission path, including Antenna (and Filter, if equipped or planned). The RF Sensor is coupled 20 dB down (or more, as needed to protect the RF Sensor) to the Transmitter in the Radio under Test. The other radios of interest on the Locomotive (DPA, DPB, and HOT/EOT) are then keyed and RF energy from those radios pass through their respective existing transmission paths, including Antennas (and Filters, if equipped or planned). The RF energy then propagates into the Antenna of the Radio under Test, and then into the Transmitter under test. Any IMD products in the 220 MHz spectrum generated in the Transmitter that would be propagated via the Antenna system are measured by the RF Sensor.

Transmit Intermodulation Testing Configuration Figure 19

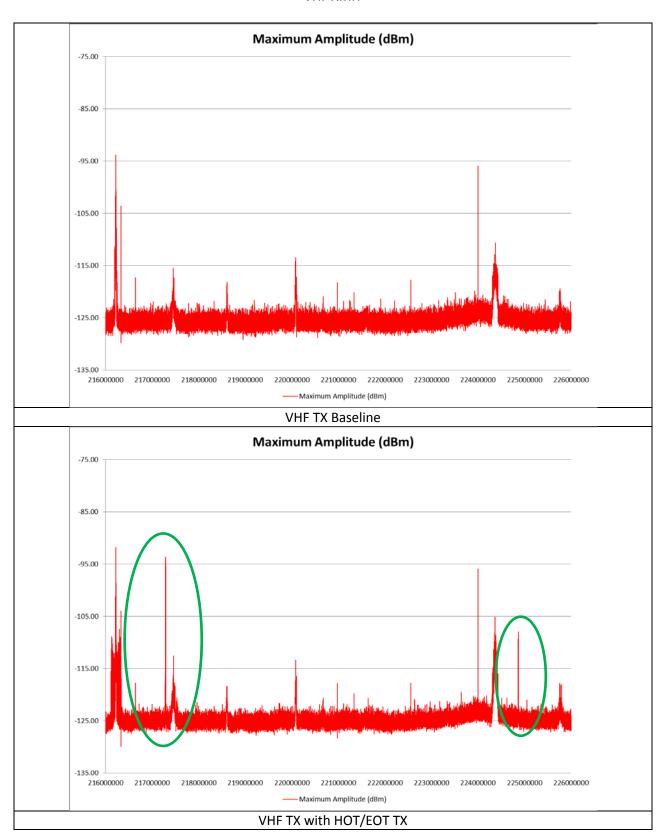
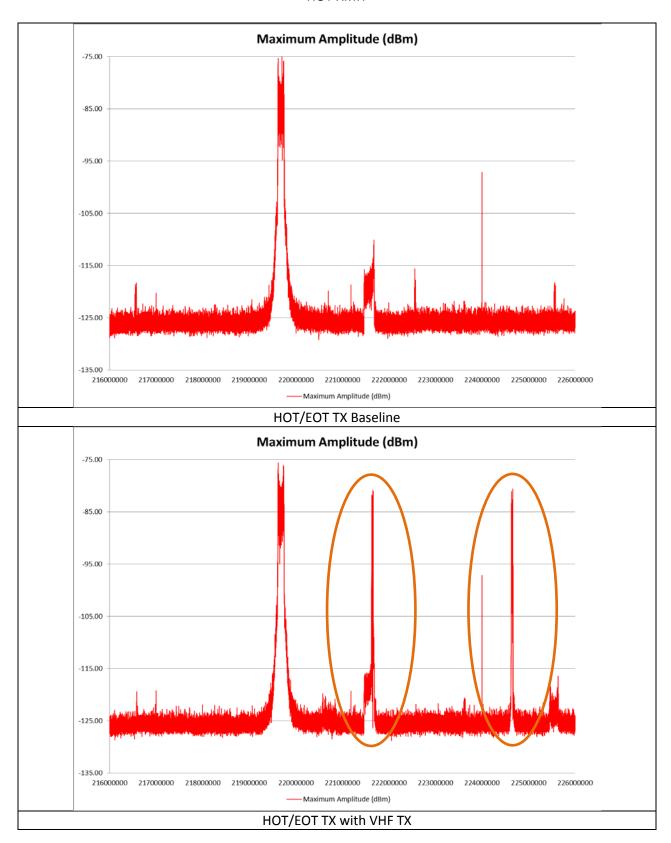
## **VHF XMIT**

In the VHF system the HOT transmit appears to cause some increased energy products in the PTC band (green circles). In the HOT system the VHF transmission causes some significant energy products (orange circles).

Several energy events were noted during the Transmit Intermodulation test with the HOT/EOT radio and the AAR VHF Voice Radio. Significant Intermodulation Products were generated by off-platform FM Broadcast signals mixing in the Power Amplifier stage of the AAR VHF Voice Radio. Mitigation will require deep FM Broadcast Rejection (notch filtering), probably on the order of 70 dB. More aggressive and controlled testing is recommended. Filtering of all significant contributor radios is emphatically recommended.

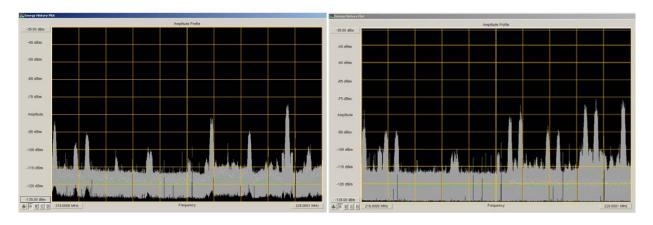
When transmitting on the AAR VHF Voice Radio, Significant RF Energy was measured in the 220 MHz Band. Testing on AAR Channel 13 (160.305MHz) and AAR Channel 26 produced multiple signals in the 220 MHz Band, 150 kHz to 200 kHz wide, at up to ~-77 dBm. Other signals were also present in the 220 MHz band varying in Amplitude from ~-105 dBm to ~-95 dBm. The Signals were Analog, and therefore could be demodulated, and were found to be carrying Broadcast Programming Audio. A scan of the FM Broadcast Band revealed signals with matching traffic for each of the 220 MHz signals demodulated. The plate on the left illustrates the 220 MHz Intermodulation Products when AAR Channel 26 is in use. The plate on the right illustrates the 220 MHz Intermodulation Products when AAR Channel 26 and AAR Channel 13 are in use. Careful perusal of the two plates reveals that the number of Intermodulation Product doubles. It is not uncommon for Railroad Yards to have several AAR Voice Channels in use.

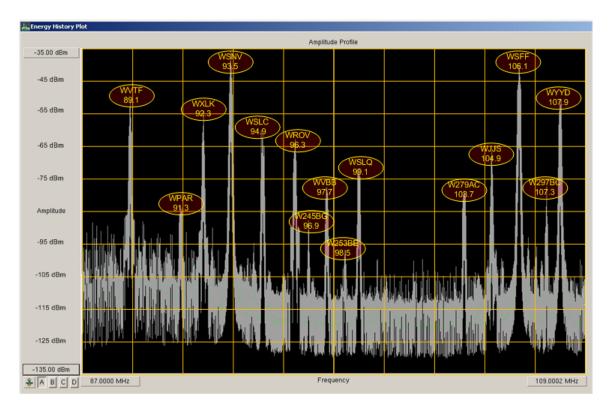
The next plate illustrates the FM Broadcast Band in Roanoke, Virginia, at the NS Shaffers Crossing Railroad Yard facilities. The signals have been identified.

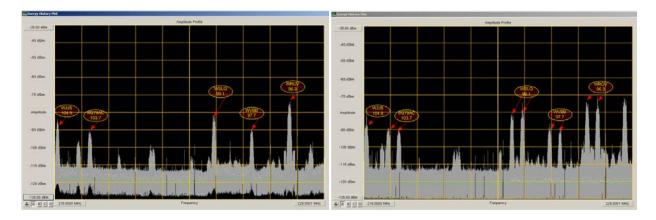
6/01/2012 © 2012 Meteorcomm LLC. All rights reserved. The next two plates illustrate how the Intermodulation Products are mapped back to the FM Broadcasters. The plate on the left, again illustrates the 220 MHz Intermodulation Products, with Identification, when AAR Channel 26 is in use. The plate on the right, again illustrates the 220 MHz Intermodulation Products, with Identification, when AAR Channel 26 and AAR Channel 13 are in use.

It is important to note that even though the FM Broadcasters' Audio Programming can be demodulated in the 220 MHz Intermodulation Products, the fault likely lies in the AAR VHF Voice Radio.

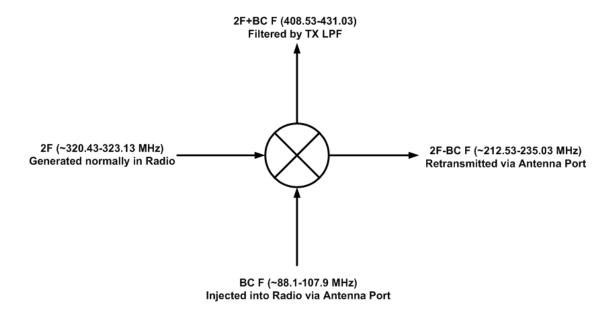
It is likely that the Intermodulation Products are being generated in the Power Amplifier stage of the AAR VHF Voice Radio. Most Land Mobile Radios employ a Low Pass Filter for FCC Compliance (to filter the 2<sup>nd</sup> and 3<sup>rd</sup> harmonics normally present in the Power Amplifier stage of any radio transmitter). A Band Pass Filter, with sharp cutoffs, would be a better choice than a Low Pass Filter, from a technical perspective, but economic concerns are involved in the decision to use a Low Pass Filter with a gradual cutoff (in order to control costs). Because of this, there is nothing in the radio's design to inhibit the FM Broadcast signals from entering the radio via the antenna port. Congruently, the lack of a steep cutoff in the Low Pass Filter allows 220 MHz products generated in the Power Amplifier stage to exit the radio via the antenna port, and are thus reradiated at a significant level. The diagram below is provided as a clarification.

6/01/2012 DCN 00002458-A If the FM Broadcast signal is strong enough, other entry points into the radio should be considered. Such entry points may be through induction along the DC Power leads, the Microphone/Handset leads, the Control leads, or even the cases of the Control Head and the RF Deck. Mitigation may include Ferrite Toroids, RF Chokes, or Bypass Capacitors, or some combination, such as a Pi Network. Finger Stock or Braid may be needed to treat the RF Deck or Control Head cases for RF integrity. Similar consideration for Base Stations, Control Stations and Mobiles (Hyrail Radios) is recommended, especially in locations where high-level FM Broadcast signals are present. Portables (hand-held radios) are also capable of significant contribution, especially if operated near the PTC 220 MHz Locomotive Antennas. However, treating Portables is not usually feasible due to physical limitations and operational realities. Further testing is recommended to capture the entire scope of what is happening.

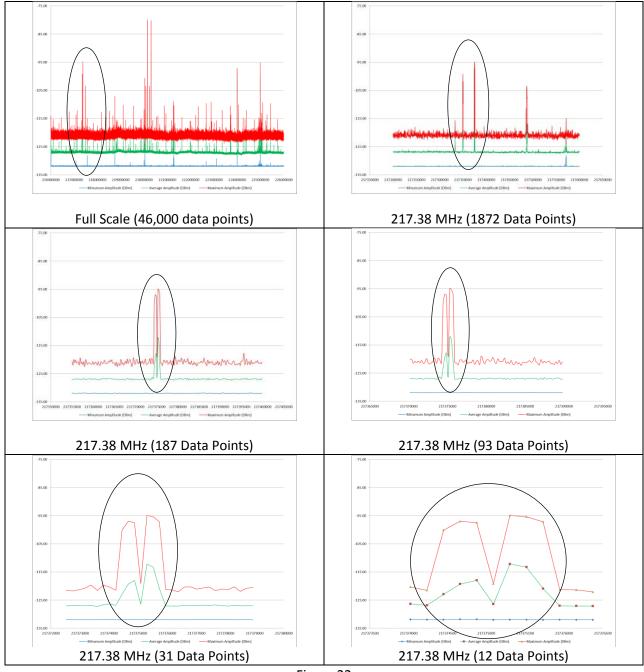
Figure 22

The following charts represent XY scatter chart with lines in EXCEL. Because of the amount of information shown in each chart the data might appear to be a spectrograph exported from a spectrum analyzer, rather than a record of the signal amplitude levels or duration information extracted and plotted from the energy history files that it actually represents. In Figure 25, three different resolutions of the information have been created to show the individual data points and how they are interconnected.

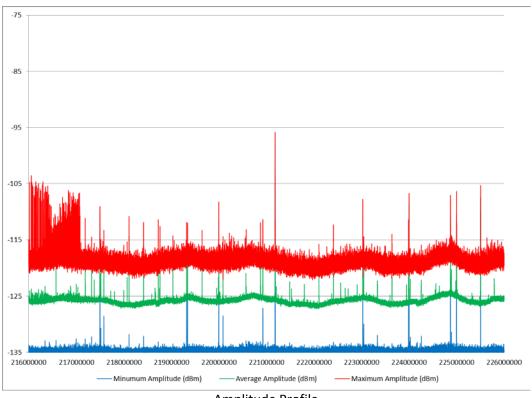
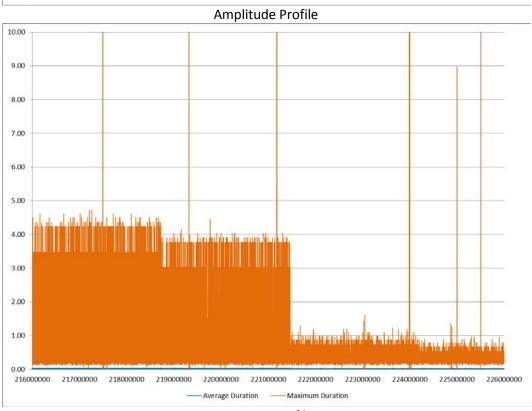
Duration Profile NS 8898 Engine Off State Figure 23

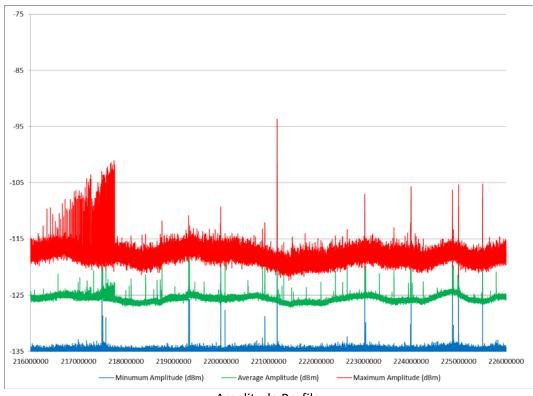
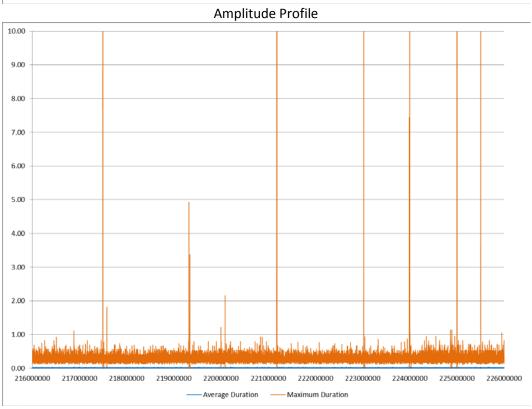
Duration Profile NS 8898 Startup Sequence Figure 24

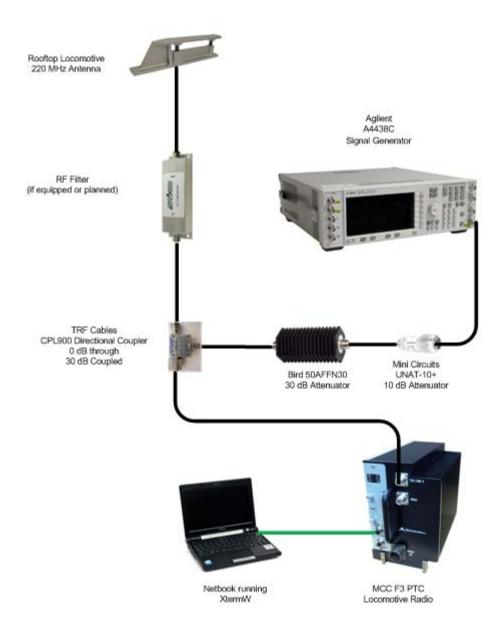
The purpose of this test is to determine the impact on receiving PTC transmissions in the locomotive noise environment, with the focus on capturing the minimum signal level needed for radio network planning. To accomplish this, a PTC Locomotive Radio (F3) was connected through a Directional Coupler to a Signal Generator equipped with an attenuator pad, and to the worse-case locomotive PTC Antenna. See Figure 35.

**BER Testing Configuration** Figure 35

To establish a baseline, the PTC Antenna was disconnected from the Directional Coupler port, and the port was terminated. This effectively isolated the radio from the noise environment. The Signal Generator was configured to send a Test Pattern, and the signal level was set so that a BER of E-4 was sustainable. In this configuration, the PTC Radio was able to report a BER of E-4 at -113 dBm. Note that this radio, under these test conditions, was performing slightly better than spec with a C/N of 10 decibels.

The PTC Antenna was then reconnected, and the test was repeated for each of ten Locomotive Operational States (Engine Off, Idle, and Notches 1 through 8). The limitations of the test do not permit reliable BER measurements for brief conditions such as Startup Sequence and Shutdown Sequence, so these two locomotive operational states were not tested.

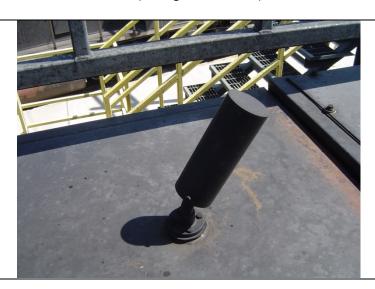
Some damage was noted on the antennas located on the rear section of the locomotive. The VHF antenna appeared to have been struck and bent at the base (see figure 36 below), this would not appear to affect operations in due to the fact that this antenna was not used with any active transmission system. The UHF antenna also in the rear roof section was loose on inspection and did not have sufficient electrical ground to be functional (see figure 37 below).

Damaged VHF antenna Figure 36

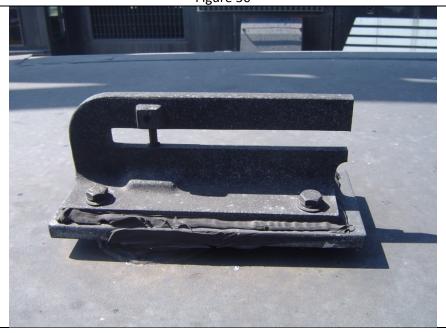
Loose UHF HOT Antenna Figure 37

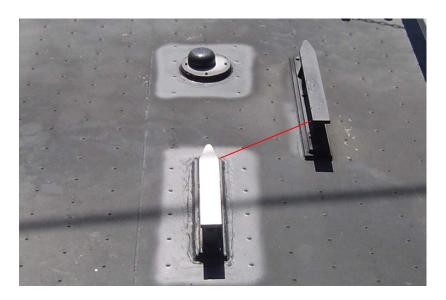
220 PTC Antenna and VHF Antenna Figure 38

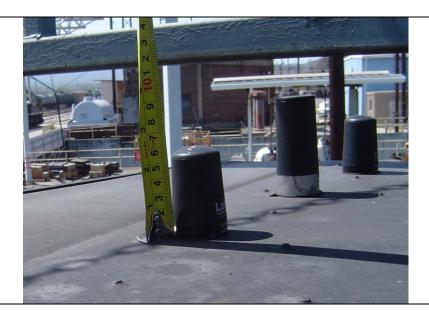
The antenna is connected to the OBN 802.11 W1 port. According to the manufacturer the radio in WMIC1 is an 802.11b radio and only supports the 2.4GHz range with allowed frequencies of:

Center antenna is designated as 802.11
According to physical height >3" it can only be in the cellular range MLPV-698
Figure 38

It is recommended that this antenna be replaced with the correct model PCTEL MLPV1700 (1700-2700 MHz 1000 MHz 4 dBi) or similar to improve performance.
