**Federal Railroad
Administration**

I am pleased to submit a report on the results of the study conducted by the Federal Railroad Administration (FRA) on the safety of push-pull and multiple-unit (MU) locomotive passenger rail operations, in response to the Committee's request in its report on the Departments of Transportation, Treasury, and Housing and Urban Development, The Judiciary, District of Columbia, and Independent Agencies Appropriations Bill, 2006 (H. Report No. 109-153; June 24, 2005).

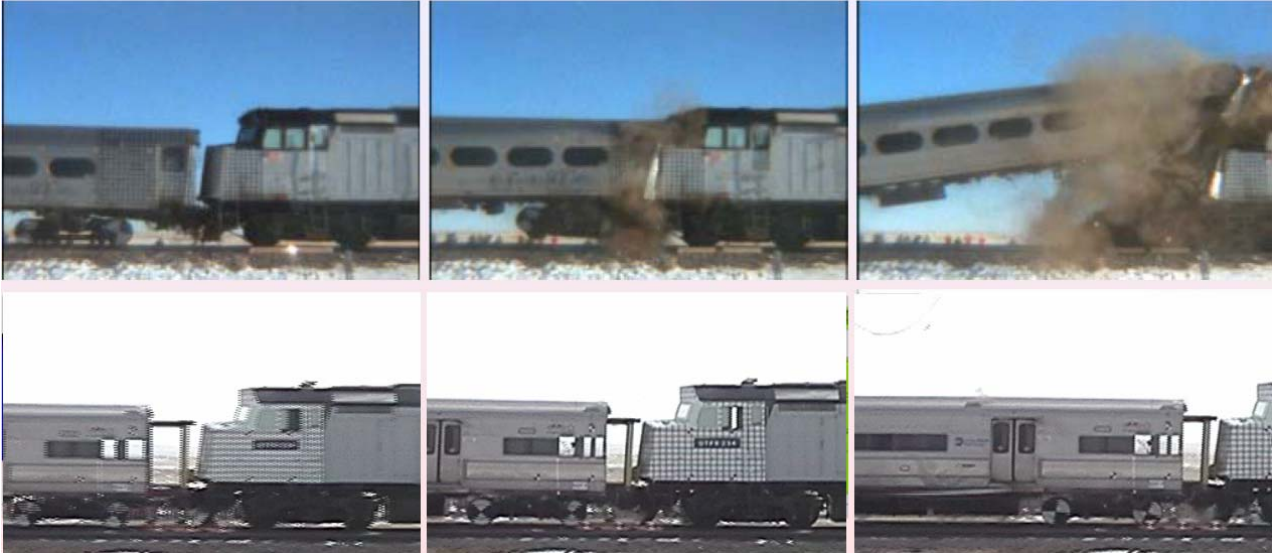
In the train-to-train test of existing equipment [32] at a closing speed of 30 mph, the colliding cab car crushed by approximately 22 feet. There was no crush imparted to any of the trailing equipment. Due to the crippling of the cab car structure, the cab car overrode the conventional locomotive. The space for the operator's seat and for approximately 47 passenger seats was lost. During the train-to-train test of CEM equipment, at a closing speed of 31 mph, the front of the cab car crushed by approximately 3 feet, and the crush propagated back to all of the unoccupied ends of the trailing passenger cars. The controlled deformation of the cab car prevented override. All of the crew and passenger space was preserved. Figure 5 includes frames from high-speed movies recorded at the train-to-train test of existing equipment and the train-to-train test of CEM equipment.

Figure 5. Frames from Train-to-Train Test Movies of CEM and Existing Equipment

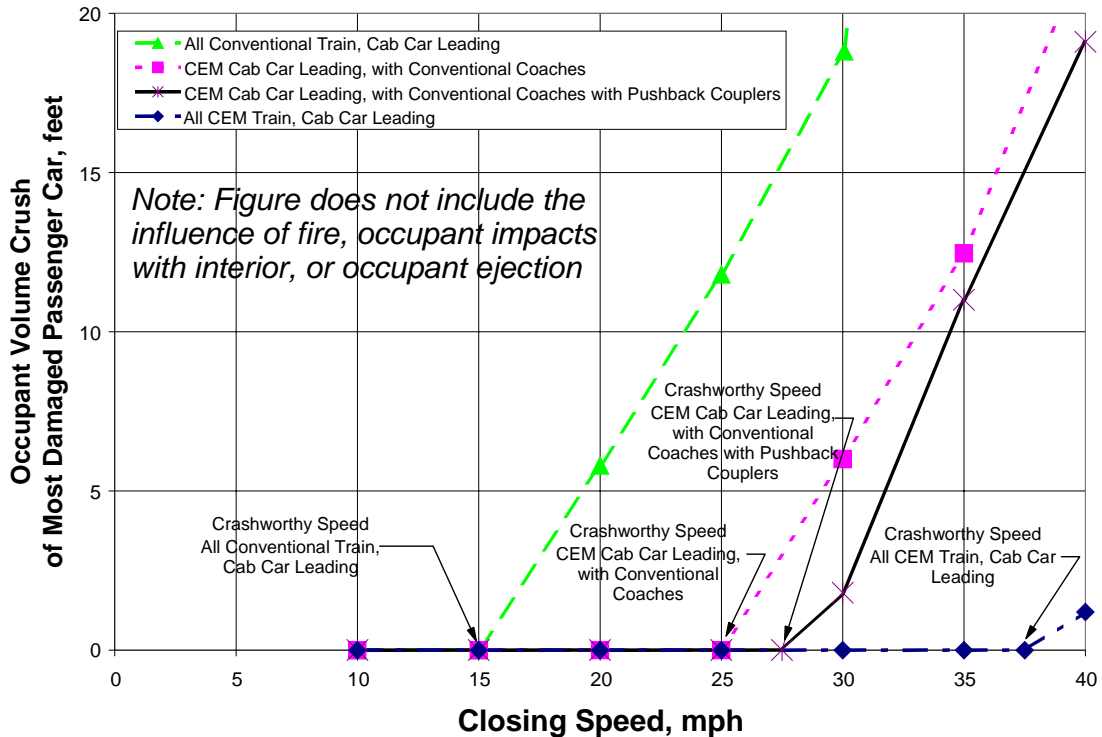
Figure 6 shows simulation results from a model developed as part of the full-scale test effort [33]. This figure shows the amount of occupant volume lost in the impact cab car for closing speeds up to 40 mph, for a cab car-led train collision with a conventional locomotive-led train of equal weight. Loss of occupant volume is the principal cause of fatality in cab car-led passenger train accidents. The plot does not address ejection, occupant impacts with the interior, or fire. The passenger equipment modeled is single level with end vestibules. This figure contains plots for an all-conventional train (i.e., a train comprised of existing equipment not utilizing a CEM design); a train with a CEM cab car and conventional coach cars; a train with a CEM cab car and conventional coaches modified with pushback couplers; and an all-CEM train. By changing only the cab car from an existing design to a CEM design, the crashworthy speed (the maximum speed for which no occupant volume crush exists) increases from 15 mph to 25 mph. A substantial increase in crashworthiness can be achieved by including crush zones on the first car in the train. By further changing the coach cars to have pushback couplers, but otherwise conventional structures, the crashworthy speed can be further increased to 28 mph. A pushback coupler allows for a relatively modest amount of energy absorption under collision conditions. This result suggests that a further increase in crashworthiness can be achieved by relatively minor modification to existing equipment. The fourth plot on the graph shows that an all-CEM train has a crashworthy speed of 38 mph.

Figure 6. Occupant Volume Crush Results for Varying Closing Speeds of Cab Car-Led Trains¹⁵

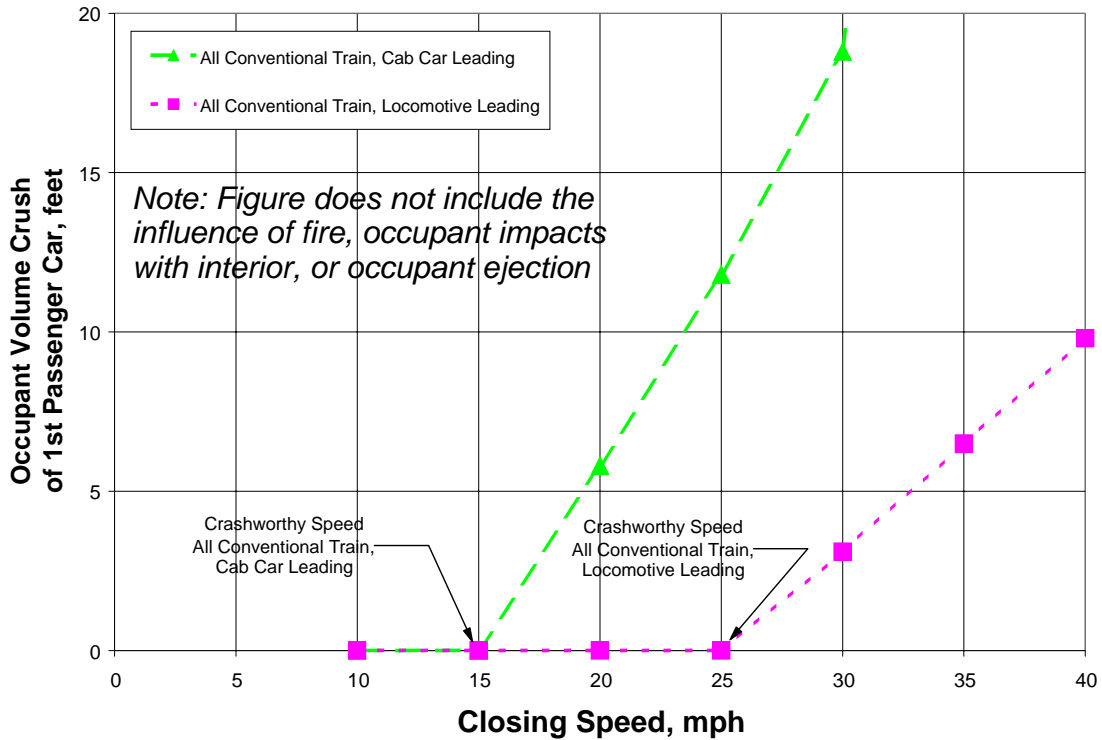
Figure 7 shows simulation results for the amount of occupant volume lost in the first passenger car (including a cab car) for conventional locomotive-led and cab car-led passenger trains not utilizing a CEM design in collisions with conventional locomotive-led trains. This figure focuses on the primary cause of fatality, which is loss of occupied volume; this figure does not address other causes of fatality, such as fire, ejection, and occupant impacts with the interior. As in Figure 6, the equipment modeled is single level with end vestibules. By substituting a conventional locomotive for the cab car, the crashworthy speed increases from 15 mph to 25 mph. For speeds above 25 mph, crush will occur in the first coach car. The conventional locomotive is stronger than the coach cars and hence absorbs little energy [2]. Figures 6 and 7 show that a CEM cab car provides the same crashworthy speed as substituting a conventional locomotive for single level equipment with end vestibules. An all-CEM train has a crashworthy speed that is greater than the crashworthy speed of a conventional locomotive-led train.

Figure 7. Occupant Volume Crush Results for Varying Closing Speeds

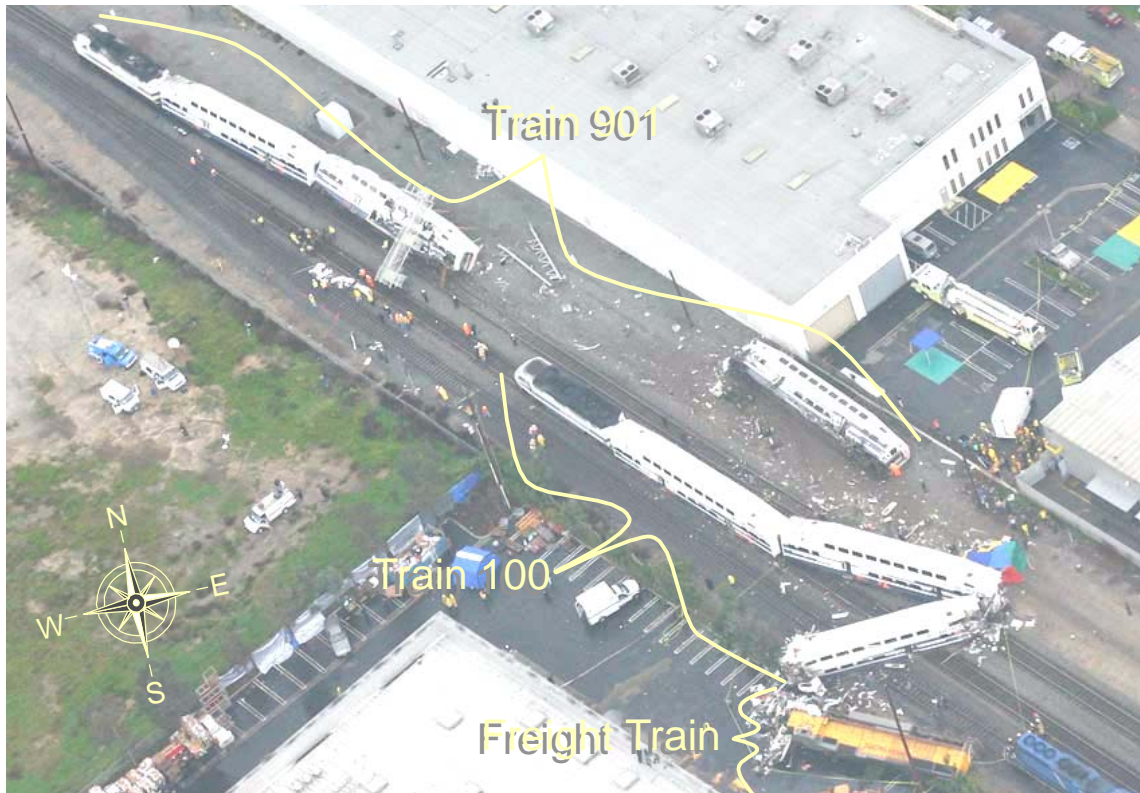
Figure 8 shows a photograph of the Glendale incident. Eight of the 11 fatalities occurred in train 100, the southbound cab car-led passenger train. Three of the fatalities occurred in train 901, the northbound conventional locomotive-led passenger train. The trailing cab car from train 901 is on its side, shown in the middle right side of the photograph. The passenger equipment is multi-level with quarter-point doors. This incident was investigated as part of FRA's ongoing field study of injury and fatality in passenger train accidents [23].

Figure 8. Aerial Photograph of Glendale Incident

Train 100, traveling south at 62 mph, collided with an SUV, which was situated perpendicular to the track with its front wheels between the rails. This impact occurred approximately 150 feet southeast of the grade crossing at Chevy Chase Drive. The SUV was lower than it would have been at a grade crossing, with the wheels of the SUV on the ties and ballast, below the running surface of the rails. This situation made it easier for some part of the SUV to get under the cab car and derail it. The Glendale incident involved three collisions:
