U.S. Department of
Transportation

Federal Railroad
Administration

Freeze-Thaw Performance Testing of Whole Concrete Railroad Ties

9. SPONSORING/MONITORING AGENCY NAME(S) AND ADDRESS(ES) U.S. Department of Transportation Federal Railroad Administration Office of Railroad Policy and Development Office of Research and Development Washington, DC 20590			10. SPONSORING/MONITORING AGENCY REPORT NUMBER DOT/FRA/ORD-13/39

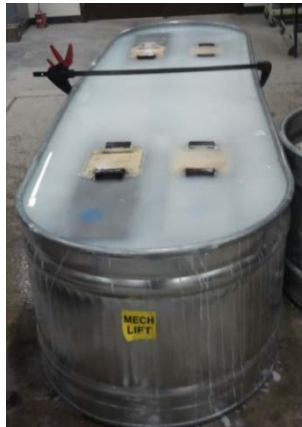
Figure 3: Railroad tie immersed in lime water in two Behlen galvanized round end tanks.

To begin the freeze-thaw testing, concrete railroad ties were soaked in saturated limewater. The railroad ties were immersed at 73.4 ± 3 °F (23 ± 1.7 °C) for 48 hours. The ties were immersed in two large water tanks, with up to four ties stacked two deep per tank, as shown in Figure 3.

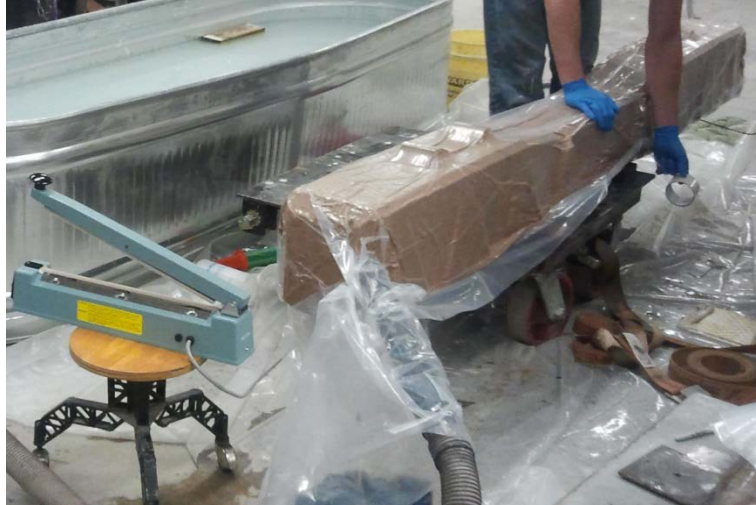
Figure 4: Railroad tie vacuum sealed and wrapped with packing tape.

After the soaking period, the ties were removed from the lime water tanks and wrapped with wet burlap sheets. The wet burlap was placed around the tie to ensure that free water was present all around the tie for the duration of the test, instead of simply collecting underneath the tie. The wrapped ties were covered with plastic tubing with one end of the tubing sealed. A wet and dry vacuum was used to remove air from the tubing through the open end, as shown in Figure 4. After removing the air, the open end of the tube was sealed and the tie was wrapped with packing tape to ensure that the plastic tubing was held tightly around the tie. Wrapping the burlap and plastic close to the tie surface was intended to limit the insulating effects of the burlap and tubing.

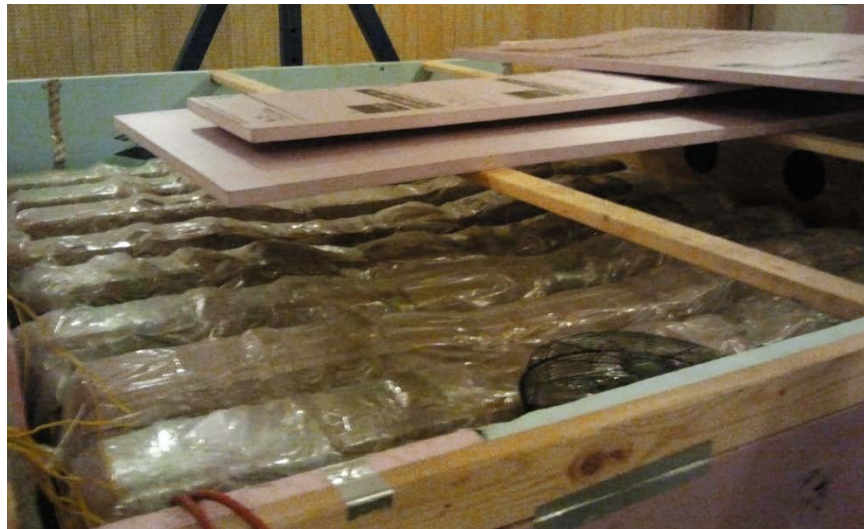
Figure 6: Railroad ties in the testing chamber.

Figure 6 shows the ties in the assembled chamber. Locations of the ties in the chamber were rotated each time measurements were taken to prevent bias from tie location.

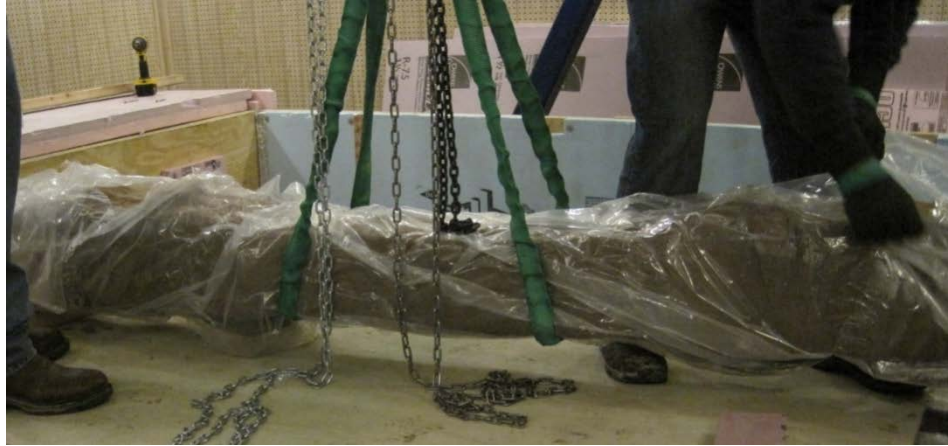
Figure 8: Railroad ties unwrapping.

After placing the ties in the chamber, initial readings of the tie weight, distance between Whittemore points, and resonant frequency were taken after the ties reached 40 °F (4 °C) and before commencing the freeze-thaw cycles. Once the cycling commenced, length change, weight, and resonant frequency measurements were taken every 20 to 36 cycles. ASTM C666 specifies that measurements should be taken at least every 36 cycles, but more frequent measurements are permitted to accommodate standard Monday through Friday work schedules. To perform the testing, tubes were unsealed, as shown in Figure 8, and burlap was collected in separate bags to gather concrete particles stuck to the fabric in order to measure mass loss. After measurements were completed, the ties were wrapped in wet burlap and sealed in plastic for additional freeze-thaw cycling.

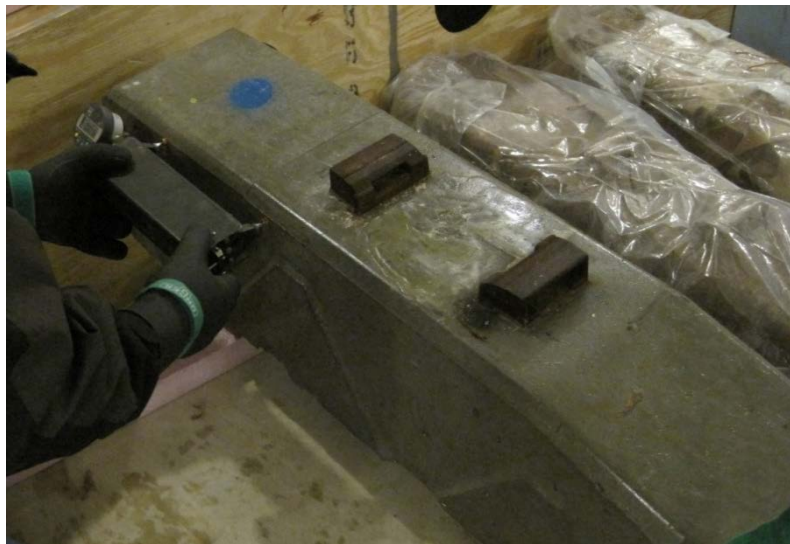
Figure 9: Whittemore point length measurements.

The ties were weighed using a 1,000-pound (454 kg) crane scale with a resolution of 0.1 lb (0.05 kg). The crane scale was attached to a 2-ton gantry crane with a 14.5-foot (4.4 m) span. During the testing period, the ties were kept wet using a sponge. The concrete expansion was measured using a Whittemore mechanical strain gauge at four locations on the tie, as shown in Figure 9.

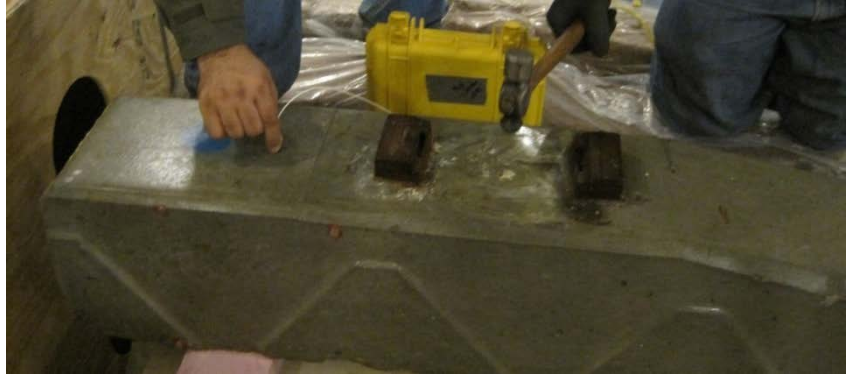
Figure 10: Resonant frequency measurements.

Concrete resonant frequency is measured to detect concrete deterioration from freezing and thawing cycles. Cracking and other forms of damage will slow down waves that travel through the concrete. These internal damages will not show up in visual observations but can be indicated by a decrease in the concrete resonant frequency. In this test program, the resonant frequency change in ties was measured using the impact resonance method shown in Figure 10. With this method, the concrete at one location is impacted with a light hammer. The waves transmitted through the concrete from the impact are detected using an accelerometer at another location. The resonant frequency of the concrete is then calculated from the measured waves. This was repeated for the points shown in Figures 11 and 12. Values equivalent to the relative

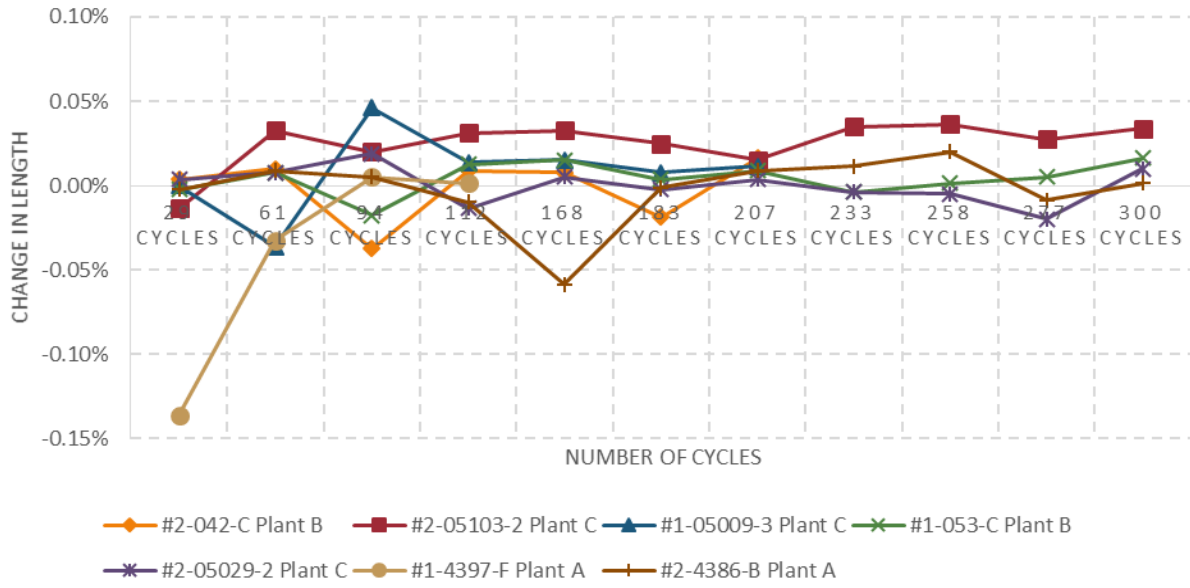
Figure 14: Length change in diagonal direction at the nonID side.

Concrete that deteriorates during freezing and thawing cycles typically expands from the growth of internal micro-cracking. The concrete tie length change showed similar trends regardless of location. Figure 14 shows fluctuations of the percentage length change for all ties; however, the length change did not consistently increase beyond ± 0.05 percent throughout the testing period. This is significantly less than the commonly used failure criteria of 0.1 percent. Some brass points popped off the surface of the ties, possibly due to weakening of the epoxy-concrete bond caused by freezing and thawing cycles and different coefficients of thermal expansion for the epoxy and the concrete. Length change measurements from the other gauge locations are shown in Appendix A. The observed length changes remained below the 0.1 percent limit specified in ASTM C666 for the entire 300 cycles. This consistency indicates that the concrete ties did not experience significant amounts of internal cracking.

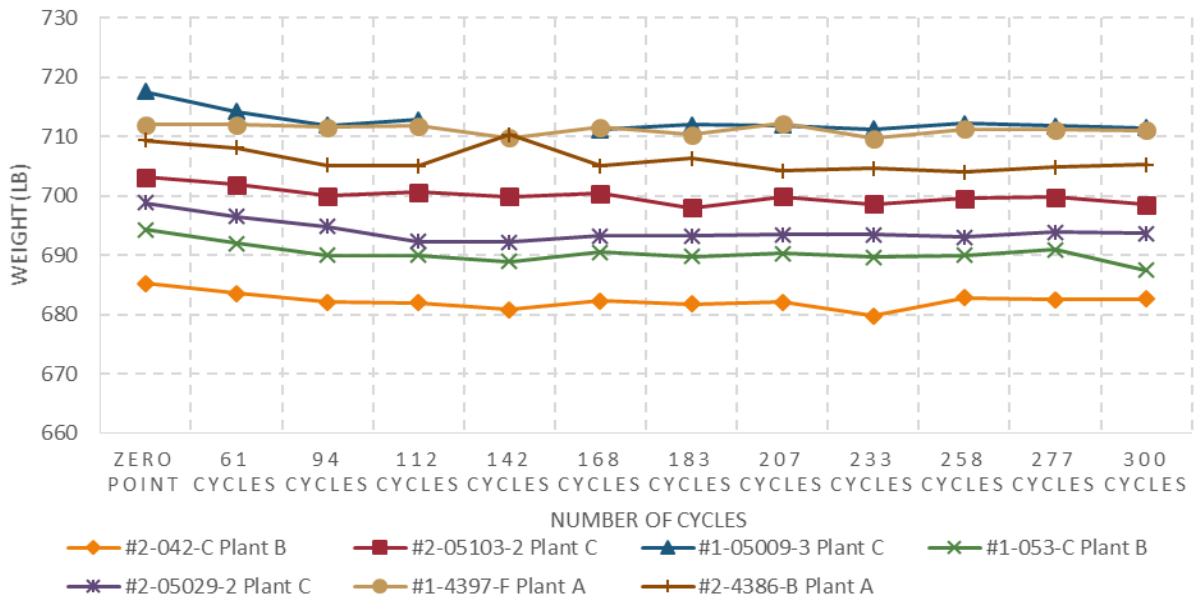
Figure 15: Concrete tie weight.

Concrete weight loss from scaling, pop-outs, or crumbling is a common result of freeze-thaw damage. There is no commonly accepted limit for weight loss since a lack of weight loss does not necessarily equal good performance. (The concrete can develop internal micro-cracking without losing any weight.). A large amount of weight loss, however, is an indicator of damage. Measurements of concrete weight throughout the testing period showed that concrete ties did not lose a significant amount of weight from freeze-thaw testing, as shown in Figure 15. Small fluctuations in weight values could be attributed to slight changes in water content on the surface of the specimens.

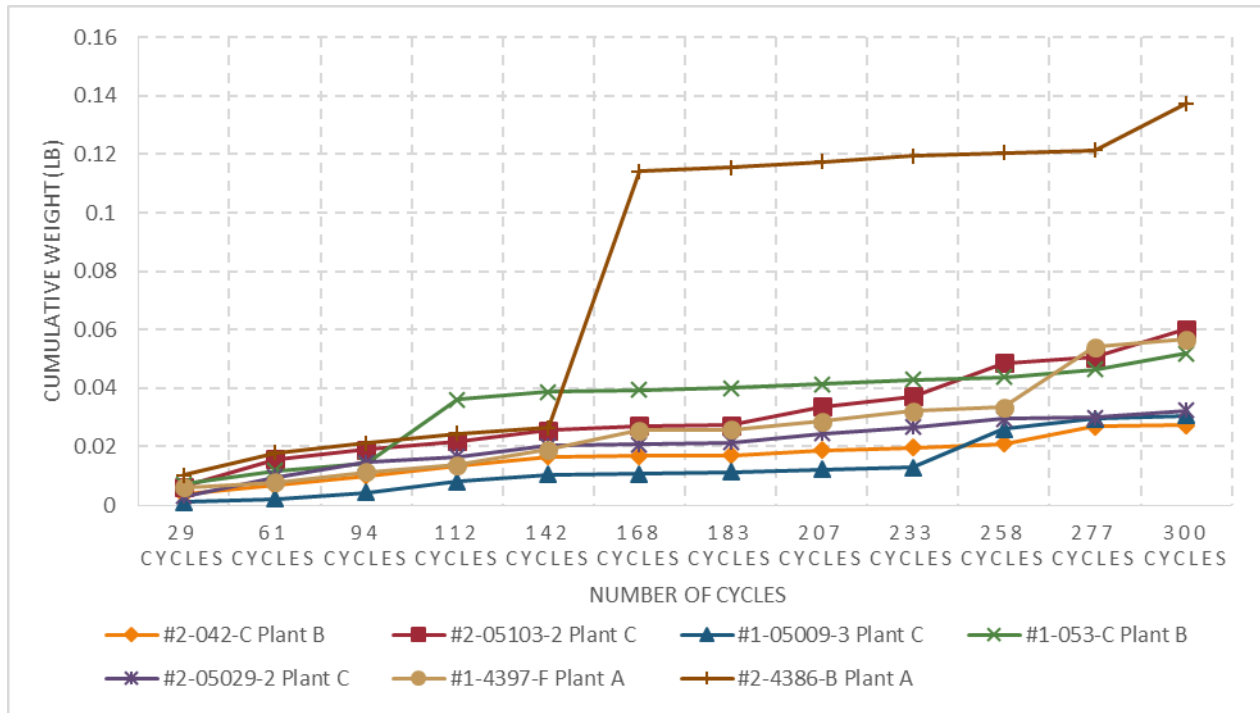
Figure 16: Concrete ties cumulative mass loss.

Measurements of the weights of scaled-off particles show a small amount of weight loss, although less than 0.1 percent. Most weight loss was caused by surface pop-outs or slight scaling. Figure 16 shows that the cumulative weight of scaled-off particles did not exceed 25 gm for most ties even after 300 cycles of freezing and thawing. Tie #2-4386-B experienced mass loss from a piece of concrete that came off one of its bottom corners (about 1.4 oz (40 gm)) after 168 cycles of freezing and thawing. Tie #1-4397-F developed some cracking between cycles 258 and 277 which developed into a section loss of 0.3 oz (9 gm). This small weight loss is considered minor. Surface problems would only be expected to cause problems if the entire region at the rail seat deteriorated, which was not seen in testing.

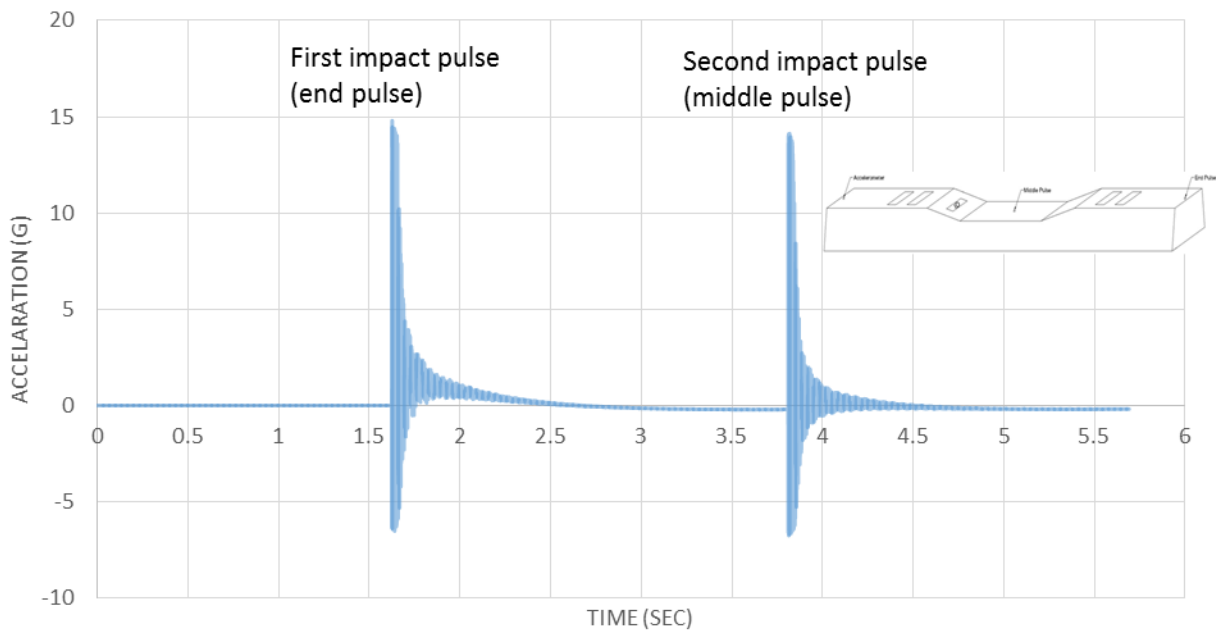
Figure 17: Pulse vibration for tie #2-05103-2 Plant C at the 258th cycle.

The whole tie resonant frequency measurements gave consistent impact pulse measurements. Figure 17 shows time series data obtained from the accelerometer for one of the ties at the 258th cycle. The first impact pulse is the end pulse and the second one is for a pulse delivered in the middle of the tie. The frequency domain of the two pulses for the same tie is shown in Figure 18. The two pulses produced peaks at almost the same frequency. Figures 19 through 21 show the end pulse frequency domain at the 258th cycle for Plant A, Plant B, and Plant C ties plotted against the end pulse frequency for their corresponding control ties. Similar graphs for the 277th and 300th cycles are shown in the appendix. The range for the first resonant frequency of all ties was 105–120 Hz, indicating that the ties had similar internal states. Table 4 shows the first resonant frequency for the ties at the 258th, 277th, and 300th cycles. Since this test was not conducted at the 0 cycle, the control for this case was taken to be the companion ties not subjected to freeze- thaw damage. Differences seen in the whole tie resonant frequency testing were within expected experimental error. The nearly constant whole tie resonant frequency values indicate that the ties did not incur any internal structural damage during freezing and thawing cycles.

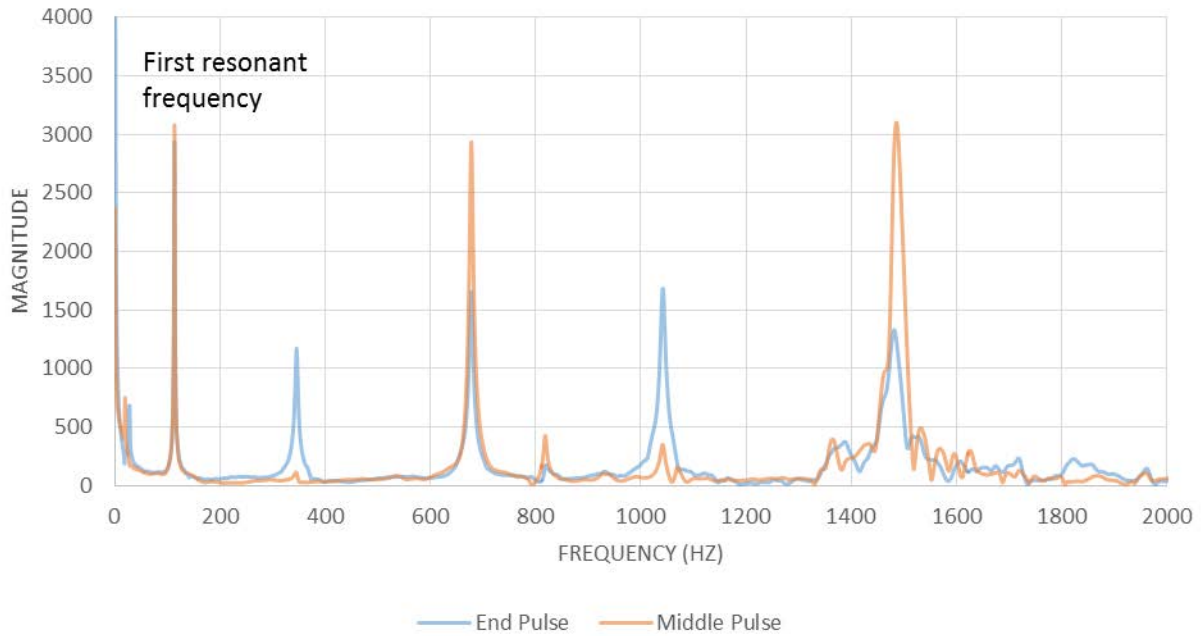
Figure 18: Frequency domain for tie #2-05103-2 Plant C at the 258th cycle.

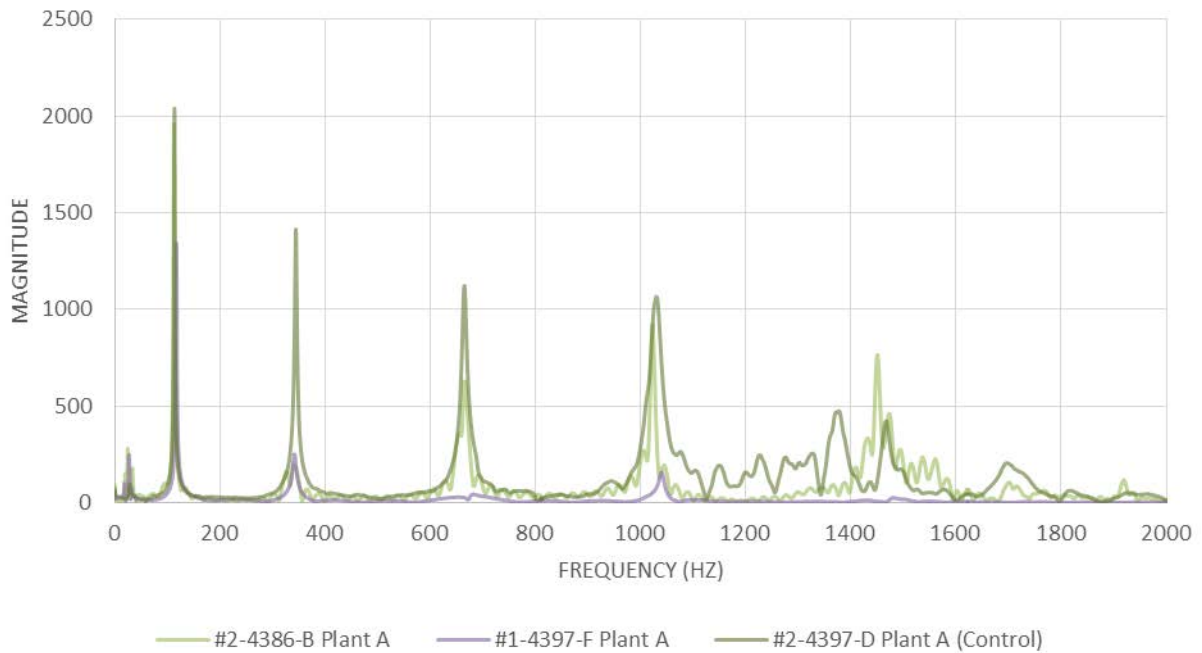
Figure 19: End impact frequency domain for Plant A ties at the 258th cycle.

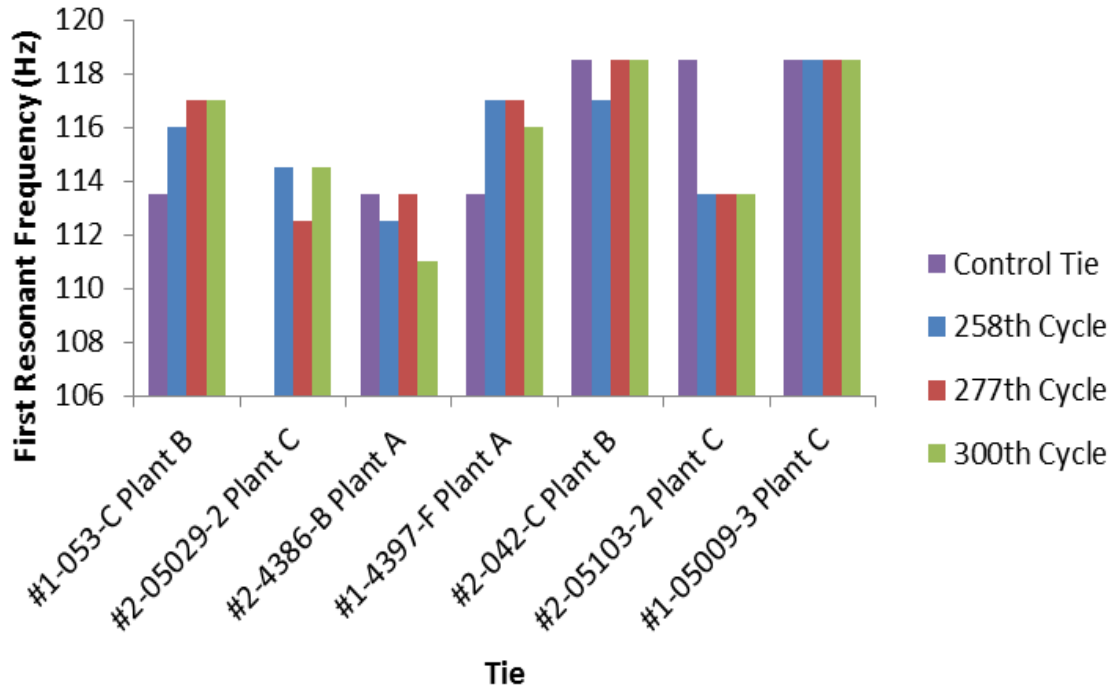
Figure 22: Overall resonant frequency for all ties tested at different cycles.

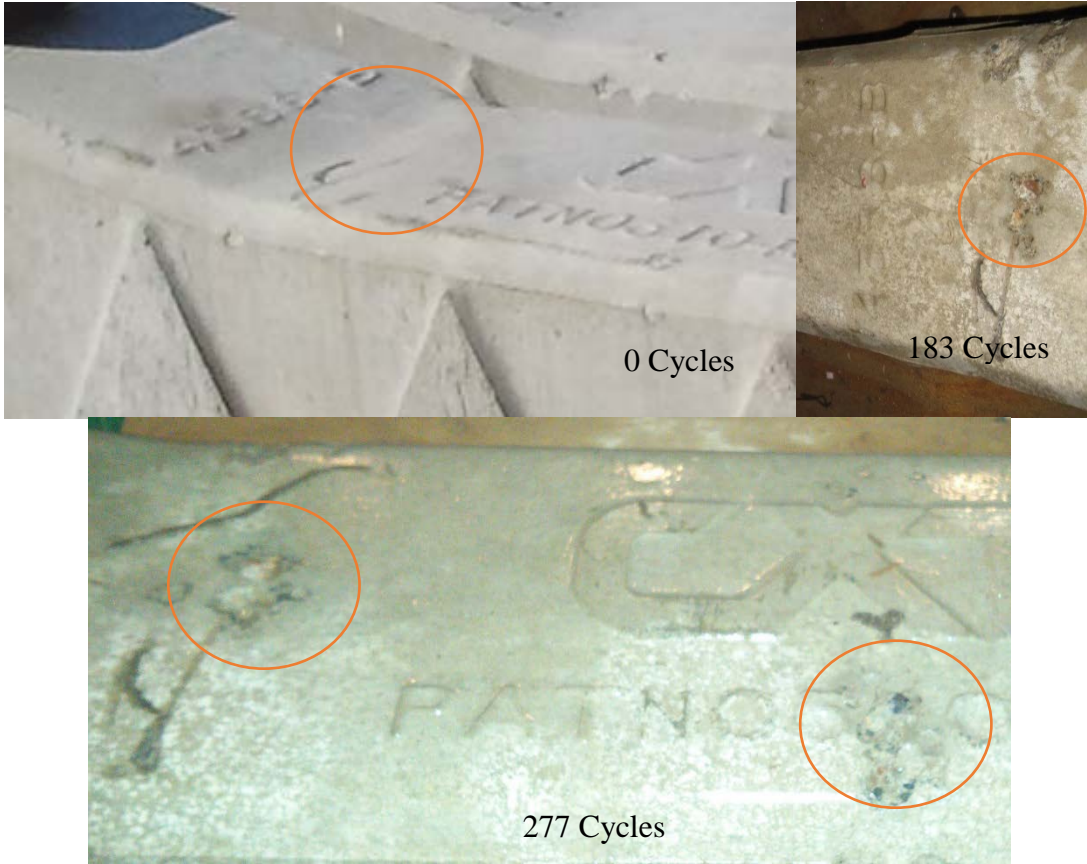
Figure 23: Tie #2-4386-B pop-outs and surface scaling.

The ties suffered some surface damage represented by pop-outs and small, shallow surface cracking, resulting, in some cases, in pop-outs. This shallow surface damage was typically not deeper than 0.25 in (6 mm) and did not affect the strength capacity of the ties. Tie #2-4386-B, which came from Plant A, suffered pop-outs and the loss of a piece of a corner weighing approximately 1.4 oz (40 gm), as shown in Figure 23 and Figure 24.

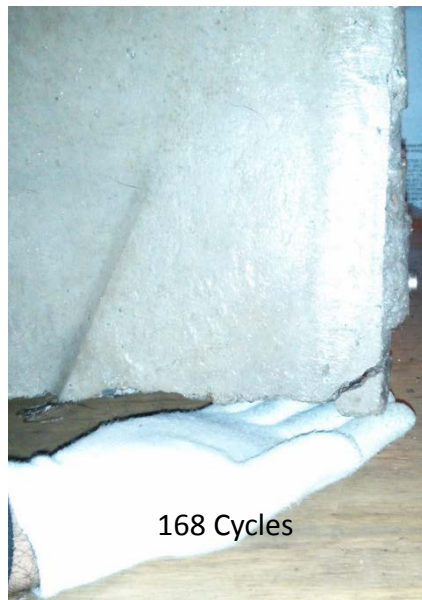
Figure 24: Tie #2-4386-B corner piece after fracture.

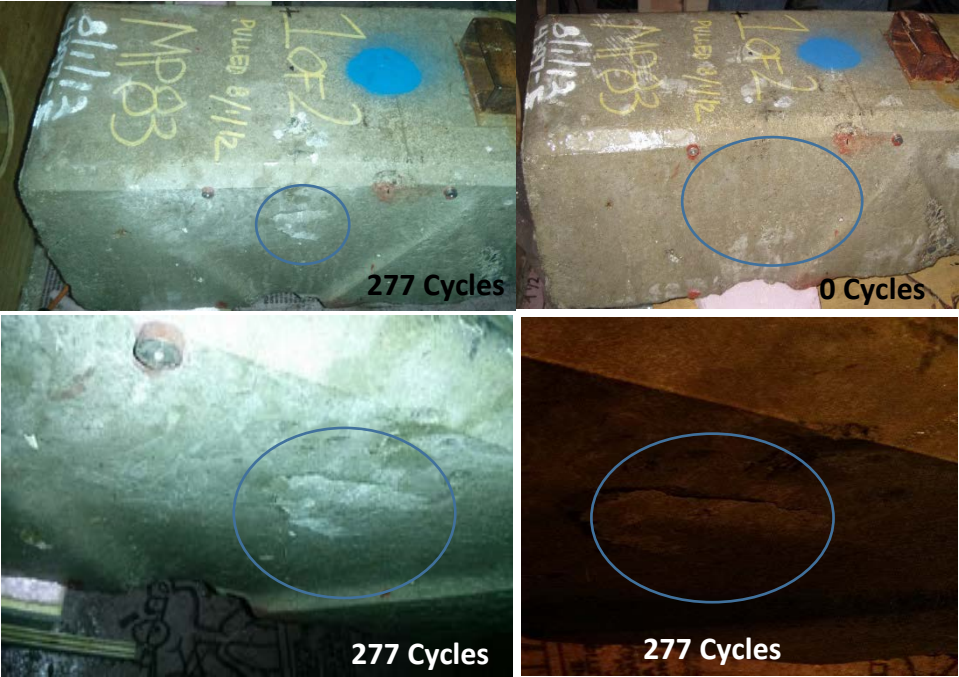
Figure 25: Tie #1-4397-F shallow cracking.

Tie #1-4397-F experienced a shallow crack several inches in length between cycles 258 and 277. Figure 25 shows this crack that likely will eventually result in a pop-out. A smaller pop-out on top of the same tie is shown in Figure 26.

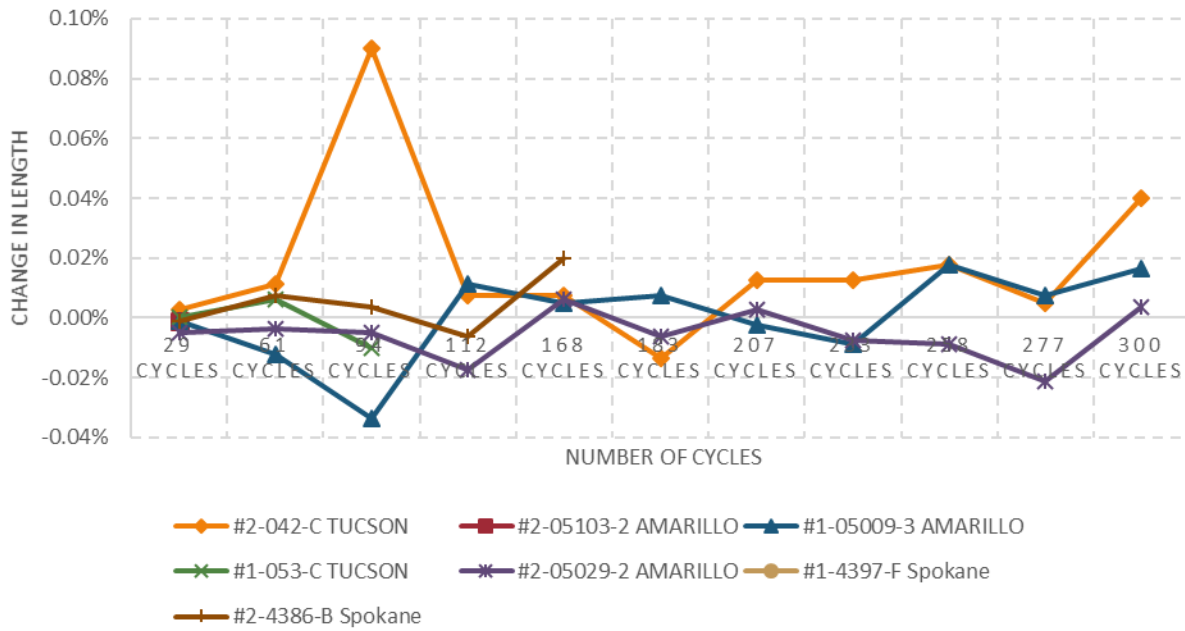
Figure A-1: Length change in diagonal direction at the ID side.

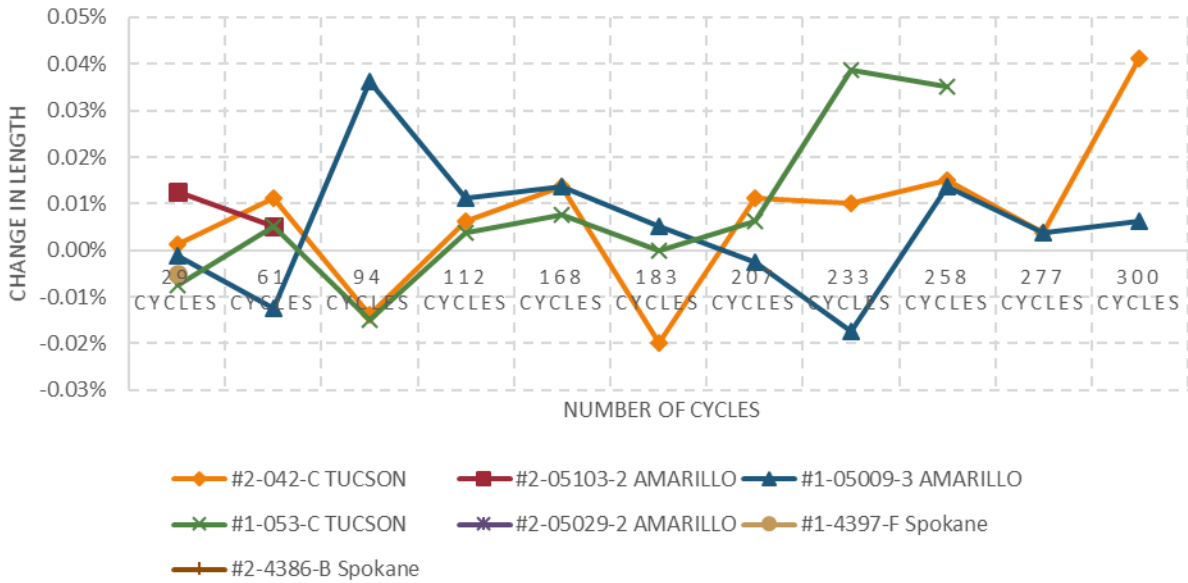
Figure A-2: Length change in vertical direction at the ID side.

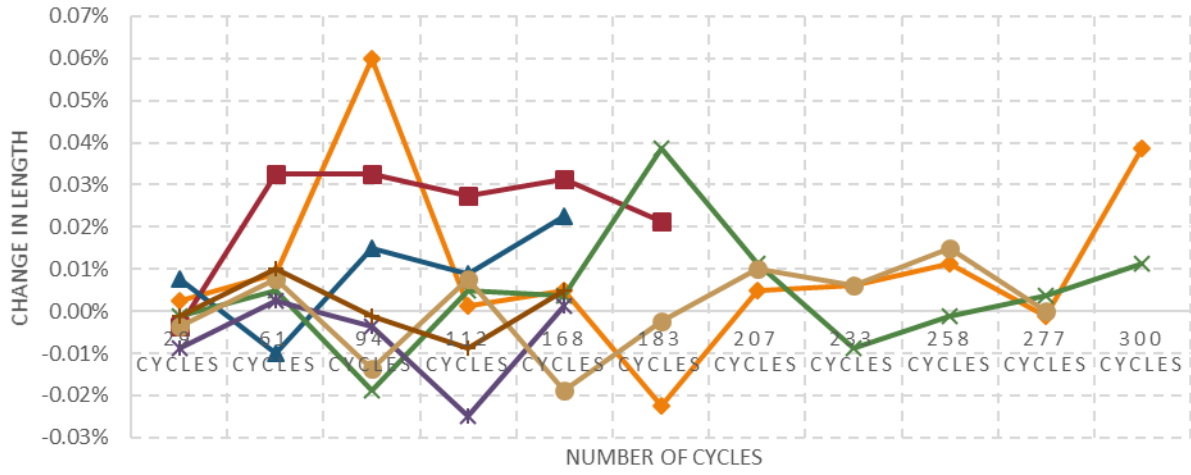
Figure A-3: Length change in horizontal direction at the ID side.

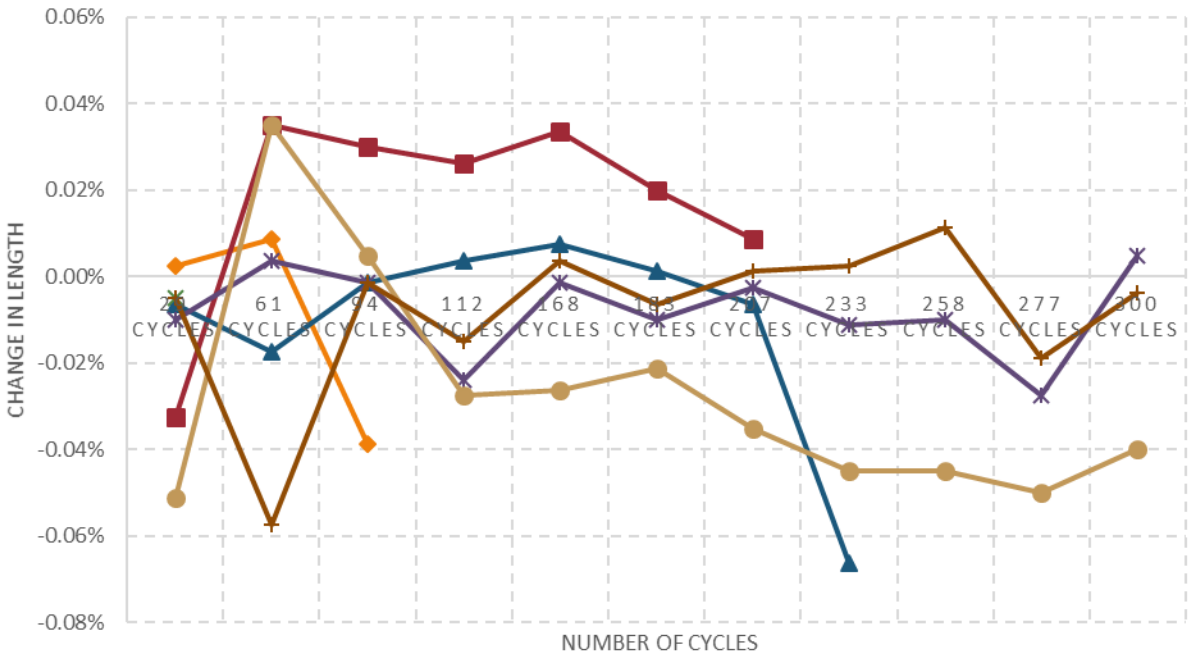
Figure A-4: Length change in horizontal direction at the opposite side to ID.

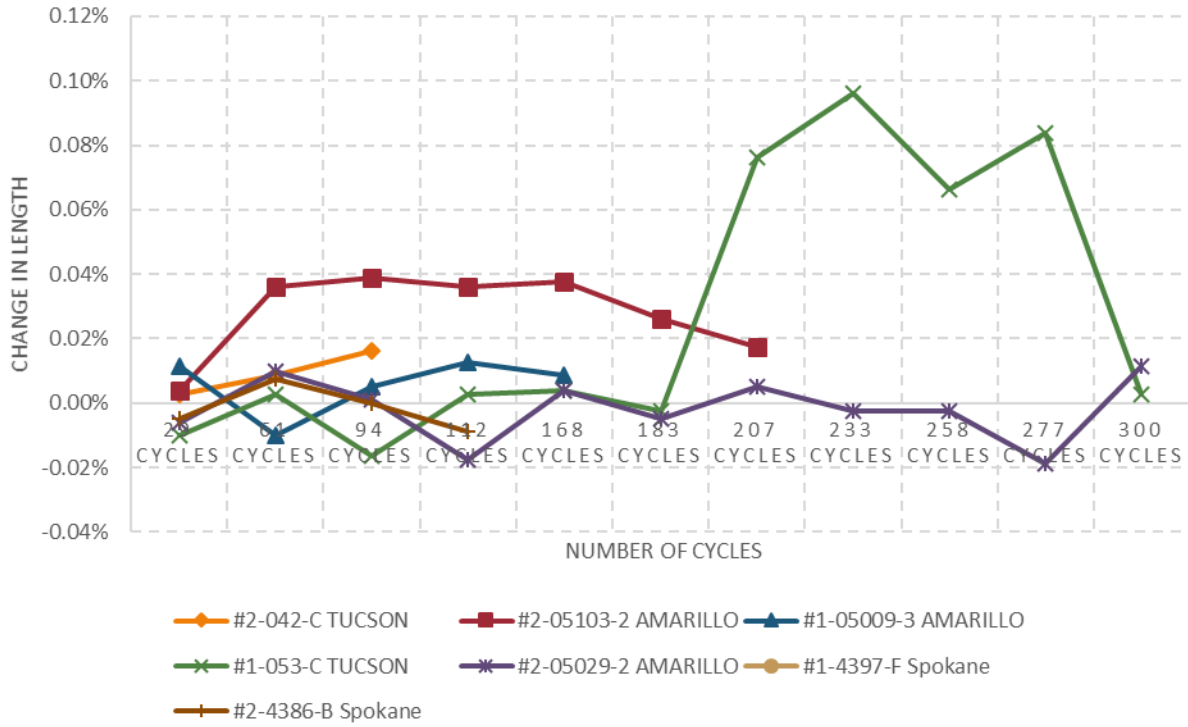
Figure A-5: Length change in vertical direction at the opposite side to ID.

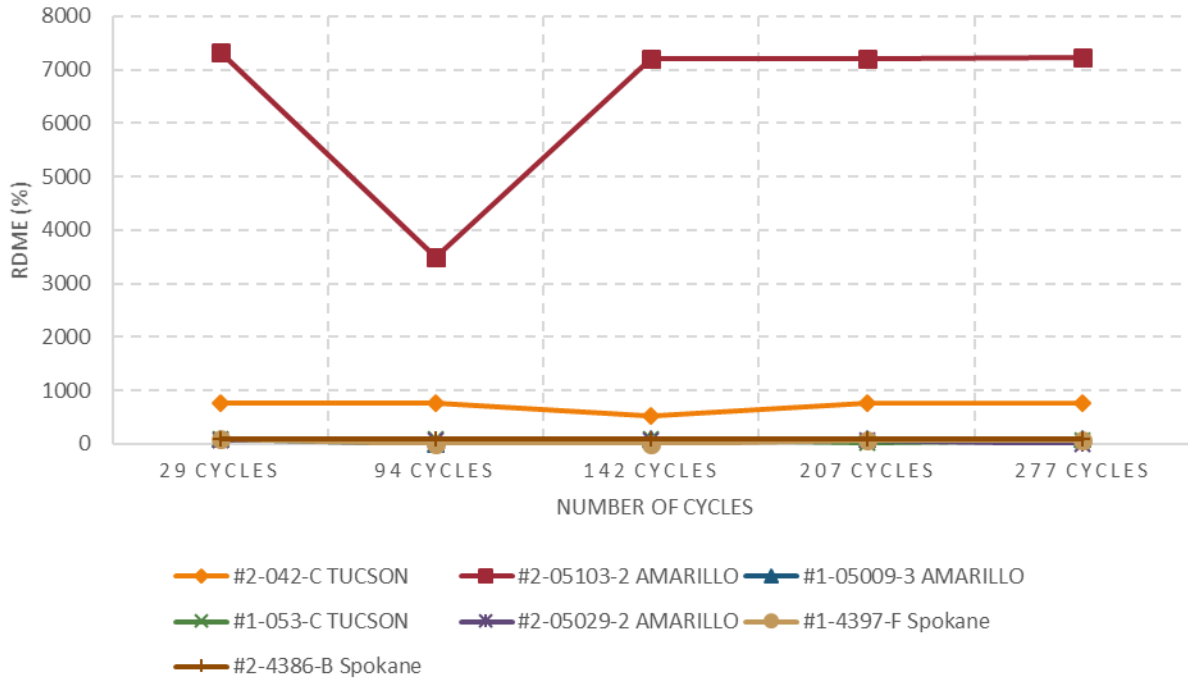
Figure A-7: RDME values at the ID side for the short top longitudinal direction of the tie.

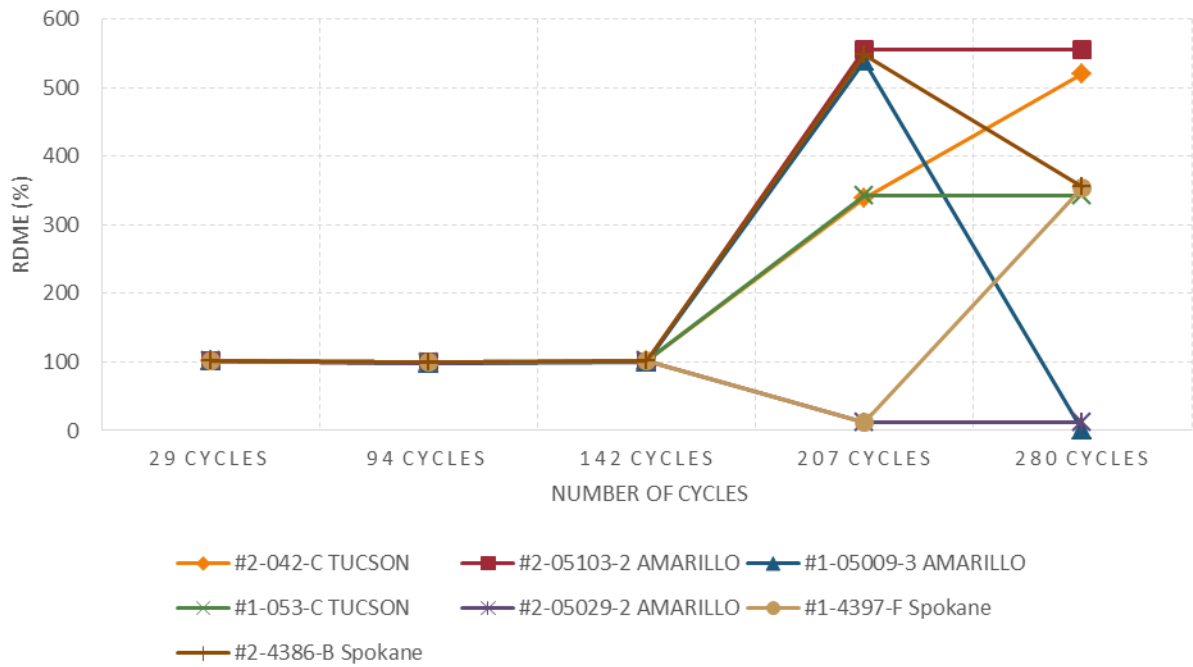
Figure A-8: RDME values at the ID side for the long top longitudinal direction of the tie.

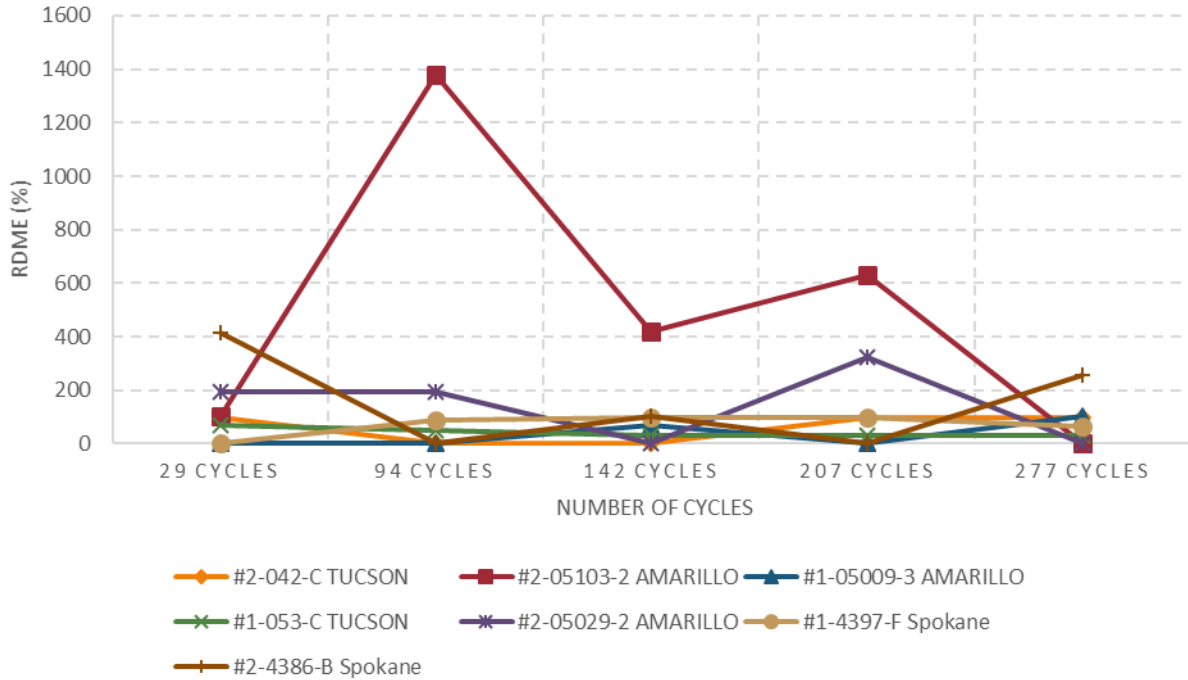
Figure A-9: RDME values at the ID side for the side transverse direction of the tie.

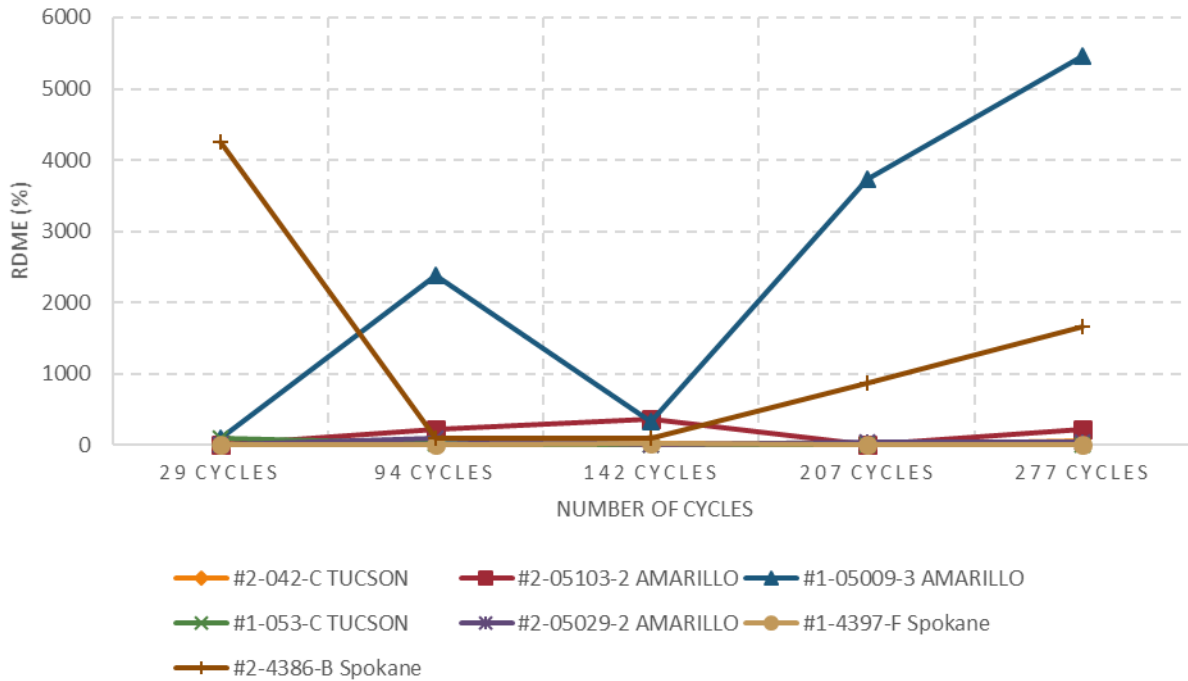
Figure A-10: RDME values at the ID side for the side longitudinal direction of the tie.

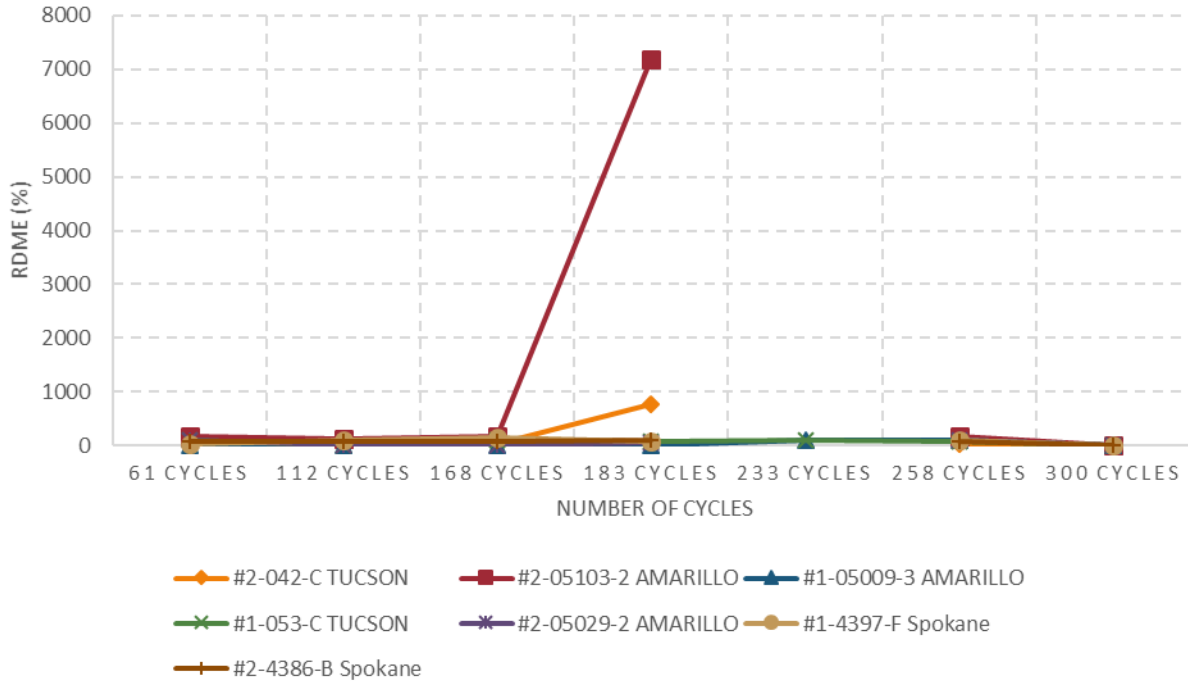
Figure A-11: RDME values at the other side for the short top longitudinal direction of the tie.

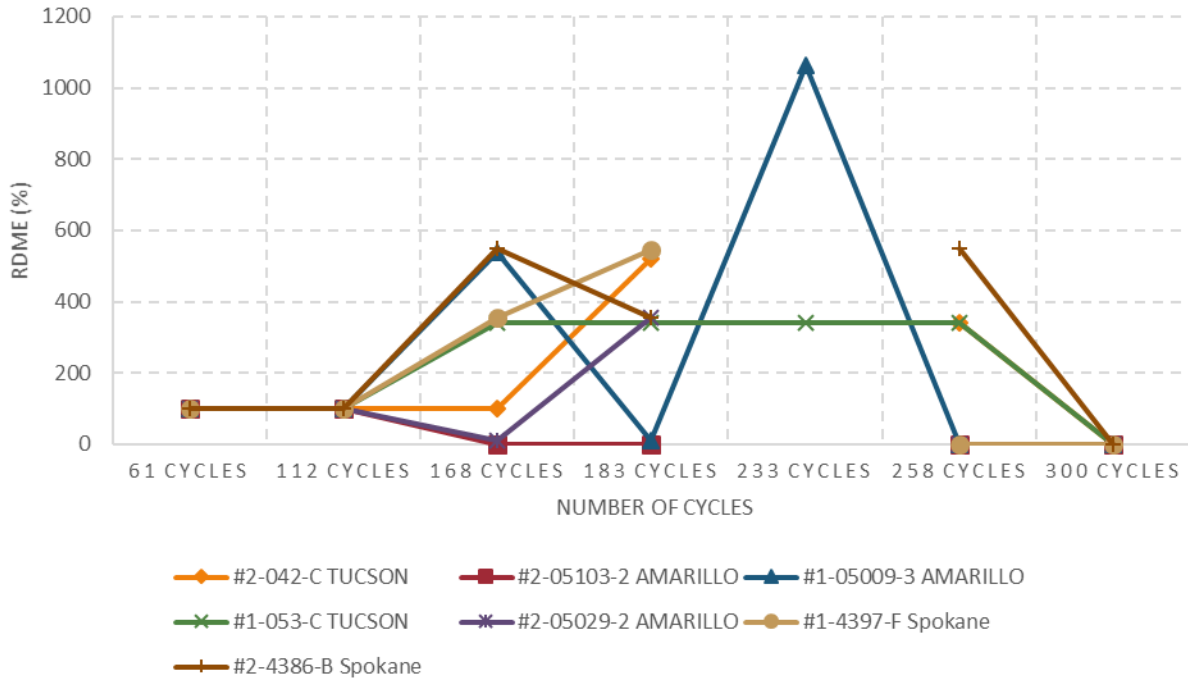
Figure A-12: RDME values at the other side for the long top longitudinal direction of the tie.

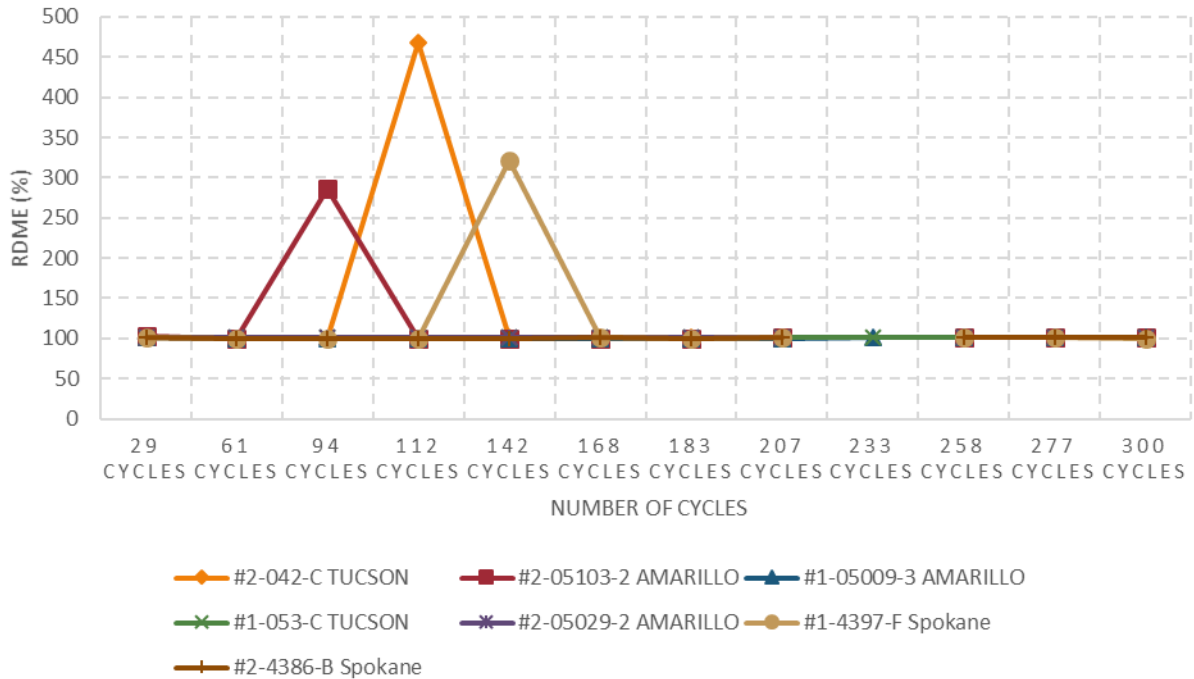
Figure A-18: RDME values at the middle for the side longitudinal direction of the tie.

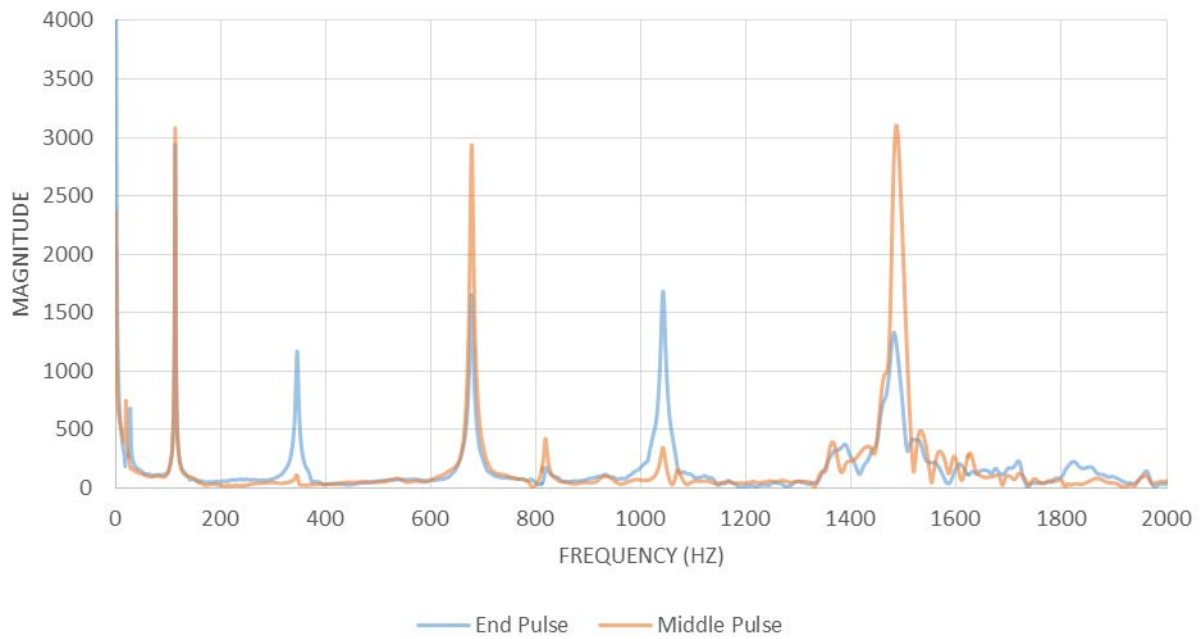
Figure A-20: Frequency domain for tie #2-05103-2 Plant C at the 258th cycle after impact.
