U.S. Department of
Transportation

Federal Railroad
Administration

Freeze-Thaw Performance Testing of Whole Concrete Railroad Ties

9. SPONSORING/MONITORING AGENCY NAME(S) AND ADDRESS(ES) U.S. Department of Transportation Federal Railroad Administration Office of Railroad Policy and Development Office of Research and Development Washington, DC 20590			10. SPONSORING/MONITORING AGENCY REPORT NUMBER DOT/FRA/ORD-13/39

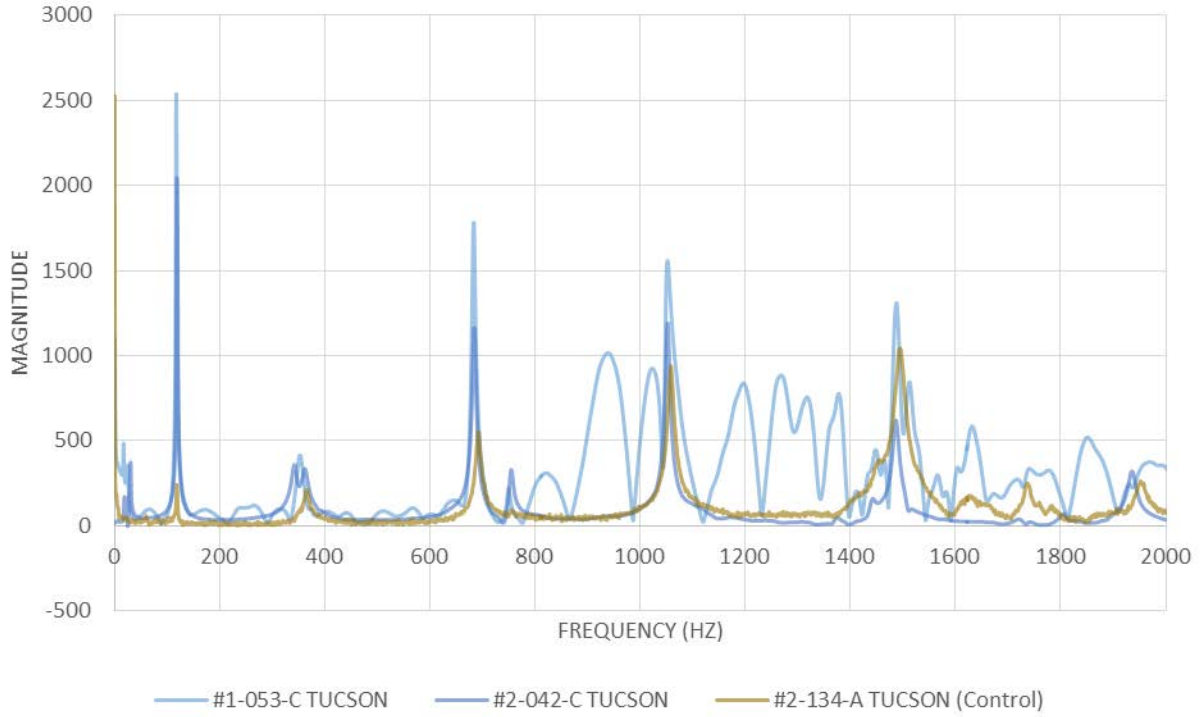
Figure A-21: Tie end frequency domain for Plant B ties after the 277th cycle after impact.

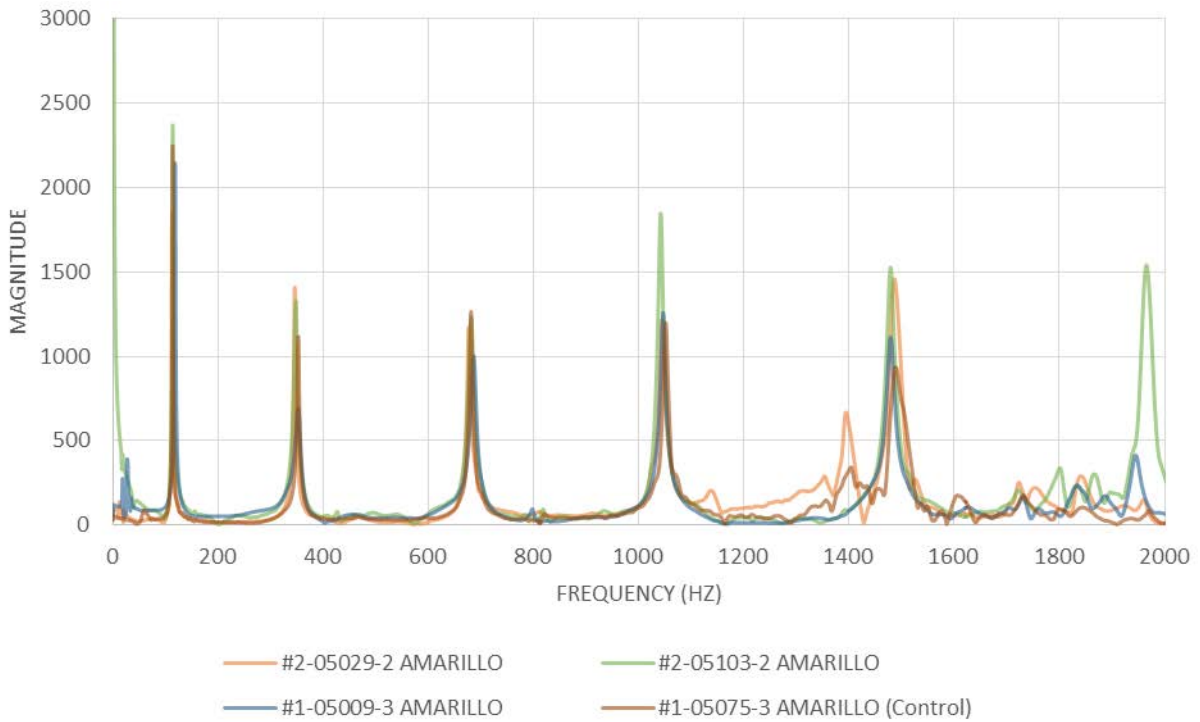
Figure A-22: Tie end frequency domain for Plant C after the 277th cycle after impact.

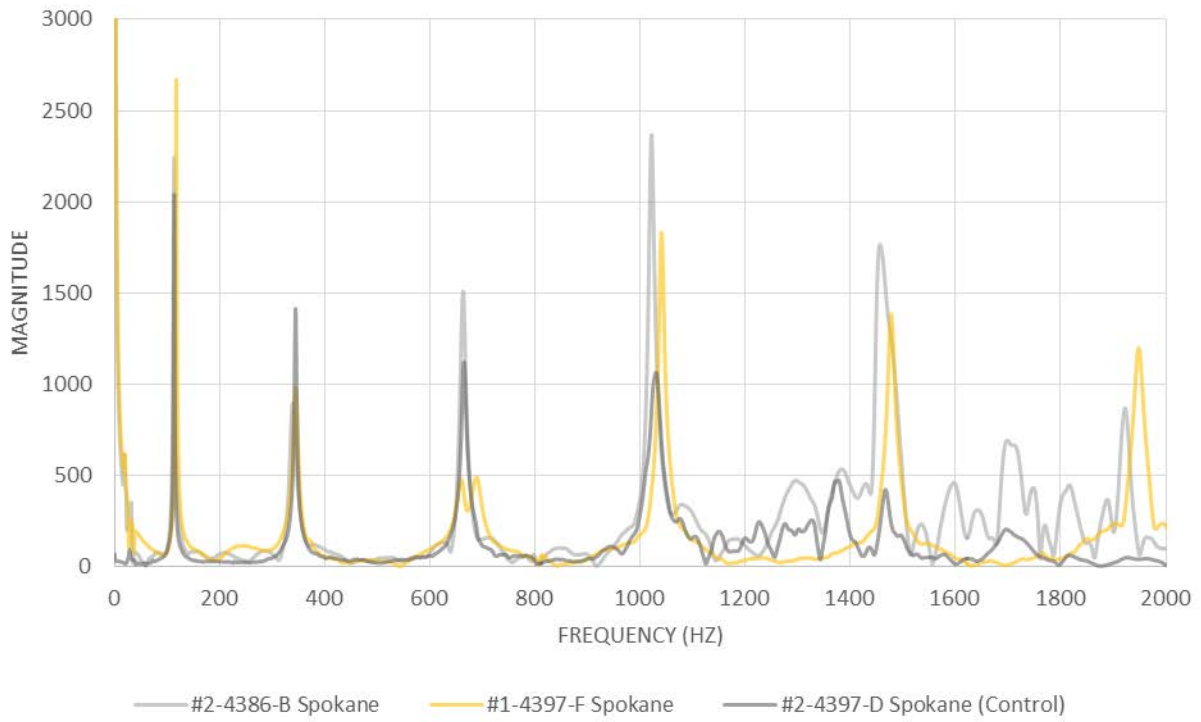
Figure A-23: Tie end frequency domain for Plant A at the 277th cycle after impact.

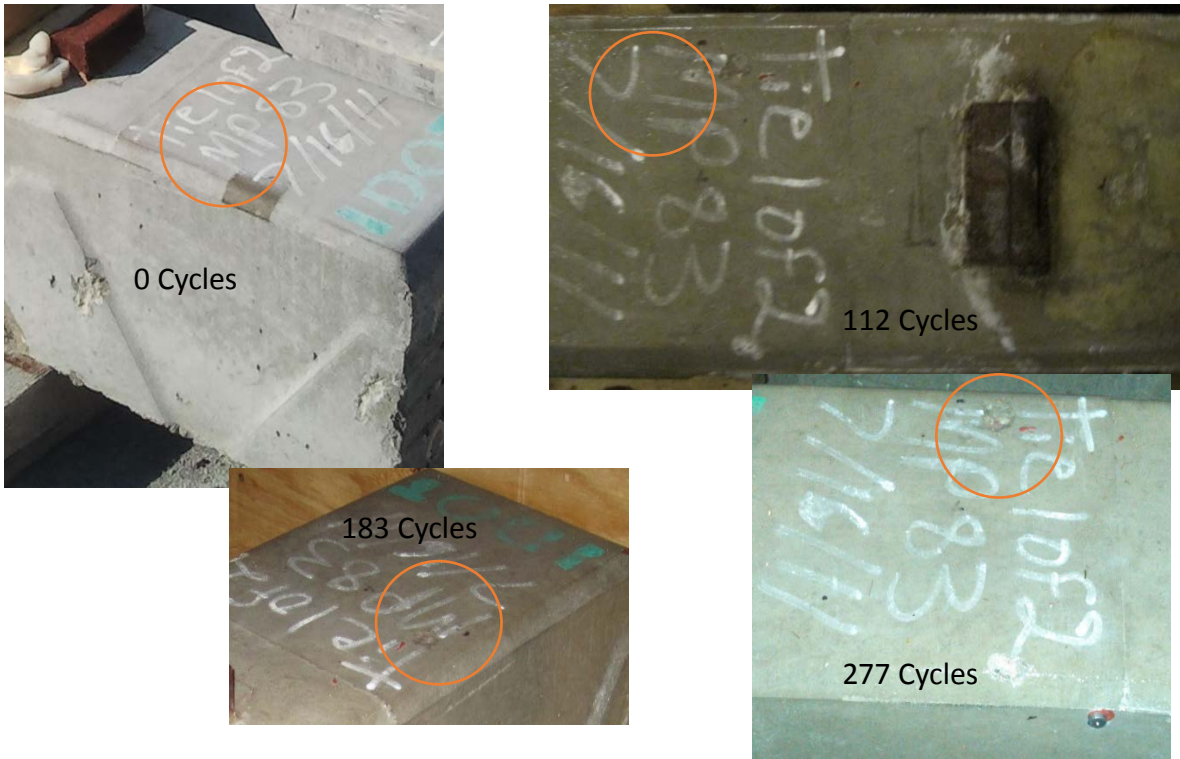
Figure A-25: Tie #1-05009-3 Plant C visual observations.
