NBSIR 84-2858

REPORT NO. 11
OBSERVATIONS OF THE APRIL 8, 1979
RAILROAD ACCIDENT AT CRESTVIEW,
FLORIDA

April 1984

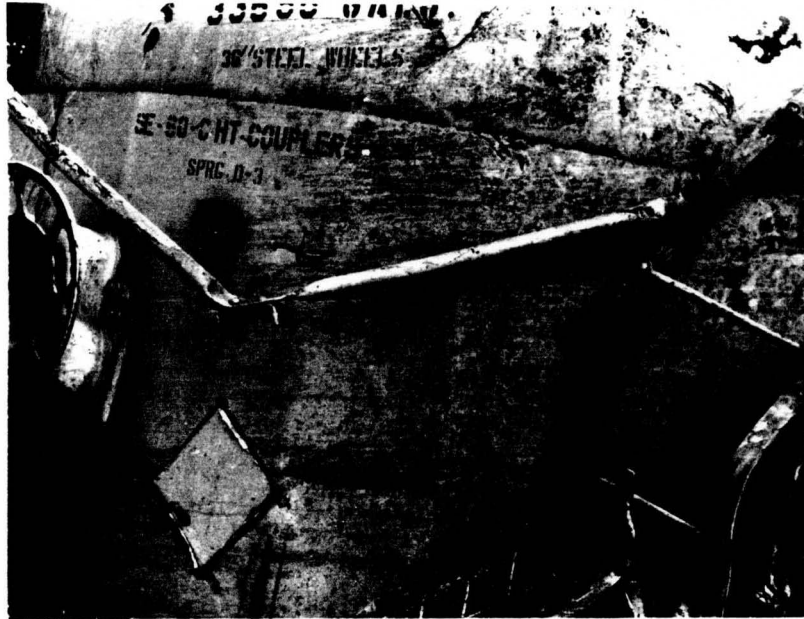
Sill, Coupler, Wheel, other parts (in that order) Head shield support pad (see 2-2) and head shield (2-3 and 2-4). Head shield was hit from one side with a gentle crushing force. Damage is shown in photos.

Photo 2-3: B head showing the head-shield of tank-car GATX 93444.

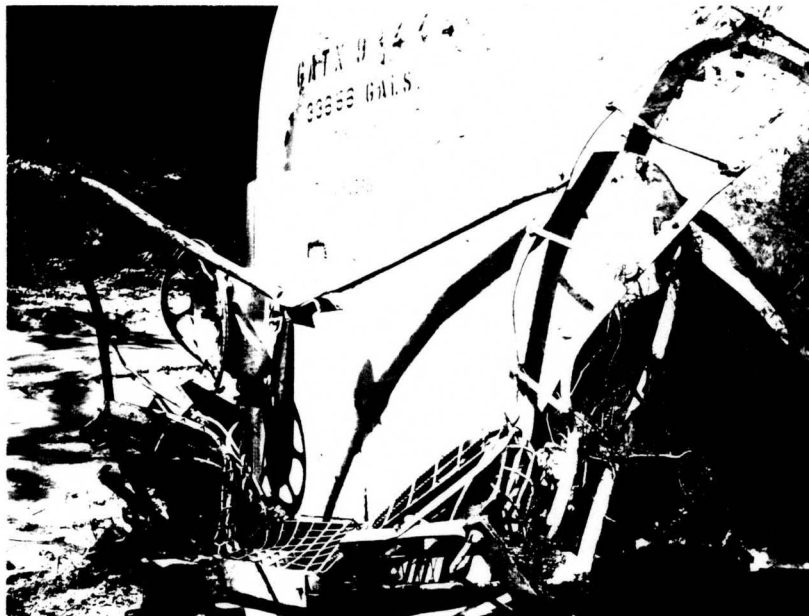
Photo C1-9: B head showing the head-shield of tank-car GATX 93444.

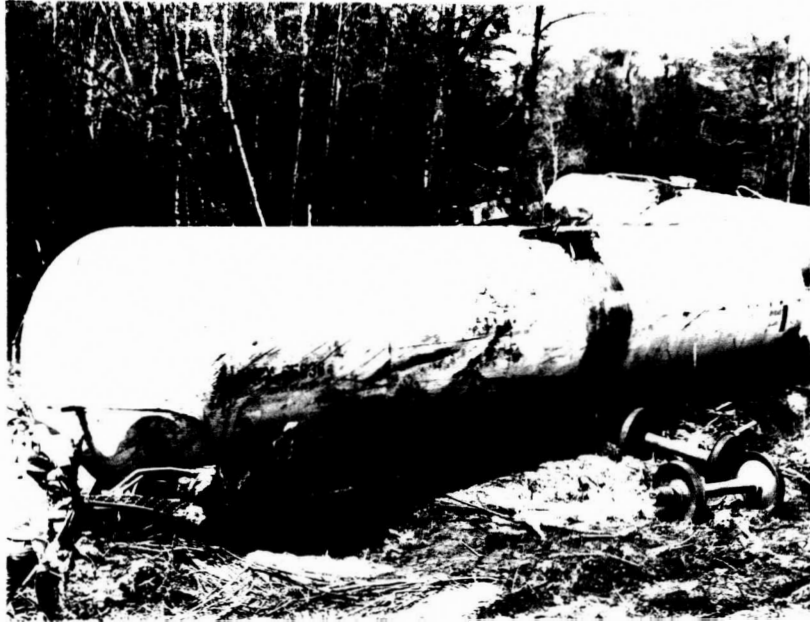
Jacket: No Jacket _____ or Describe: Scraped enough to remove paint and to scratch metal jacket, but was not rumped. No significant damage to jacket on either A or B-heads.

Photo 1-4: B-end of tank-car GATX 55836.

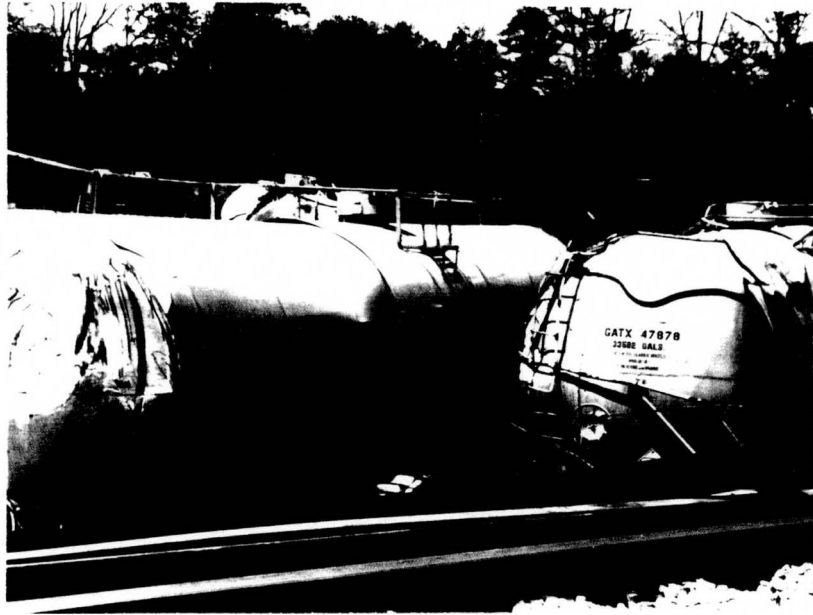
Photo 1-6: Tank-cars GATX 47872 (left) and GATX 47878 (right).

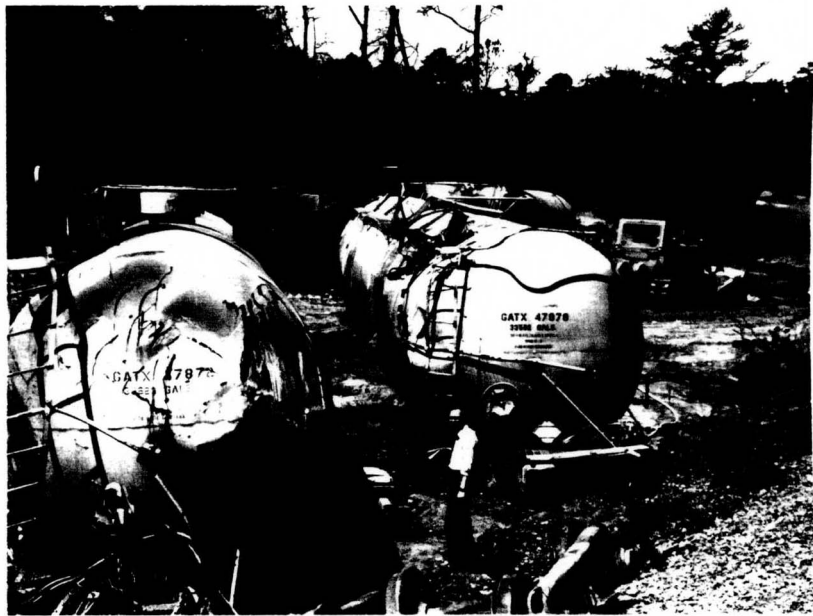
Photo 1-8: Tank-cars GATX 47872 (left) and GATX 47878 (right).

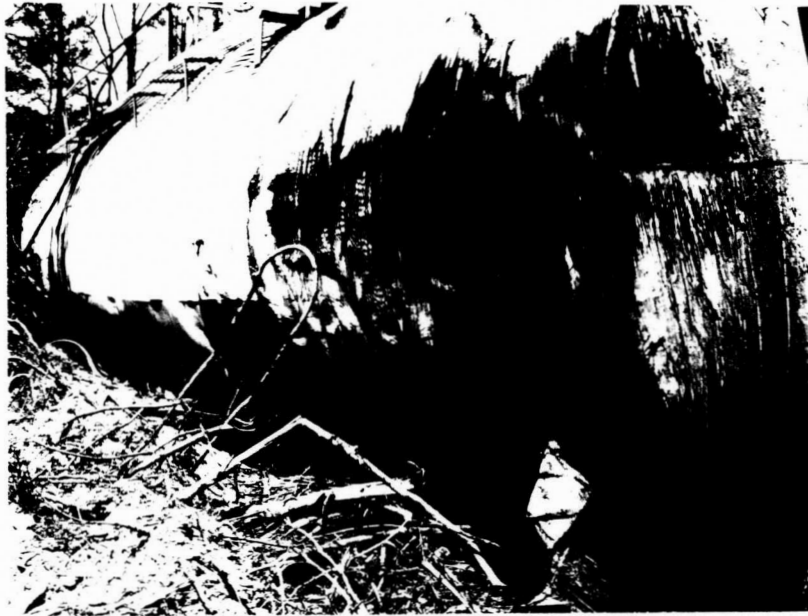
Photo Cl-10: B-end of tank-car GATX 47872.

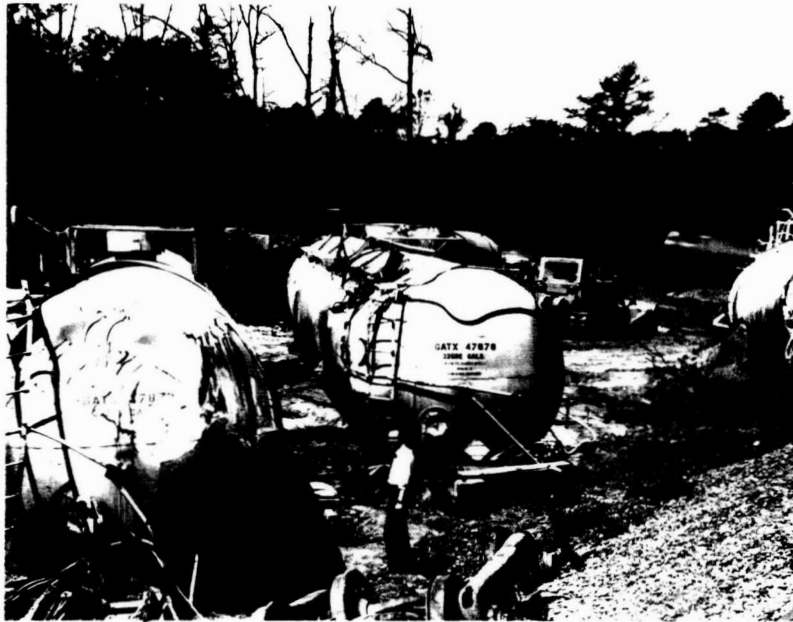
Jacket: No Jacket _____ or Describe: Dented and scratched, and ruptured (see 1-8 and 1-8B) in head (small) and shell area (larger).

Photo 1-8: Tank-cars GATX 47878 (right) and GATX 47872 (left).

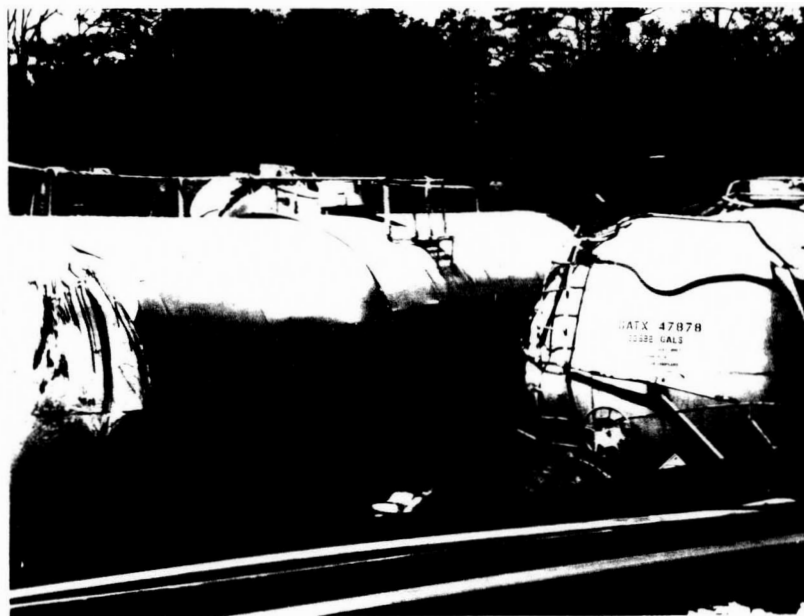
Photo 1-6: Tank-cars GATX 47878 (right) and GATX 47872 (left).

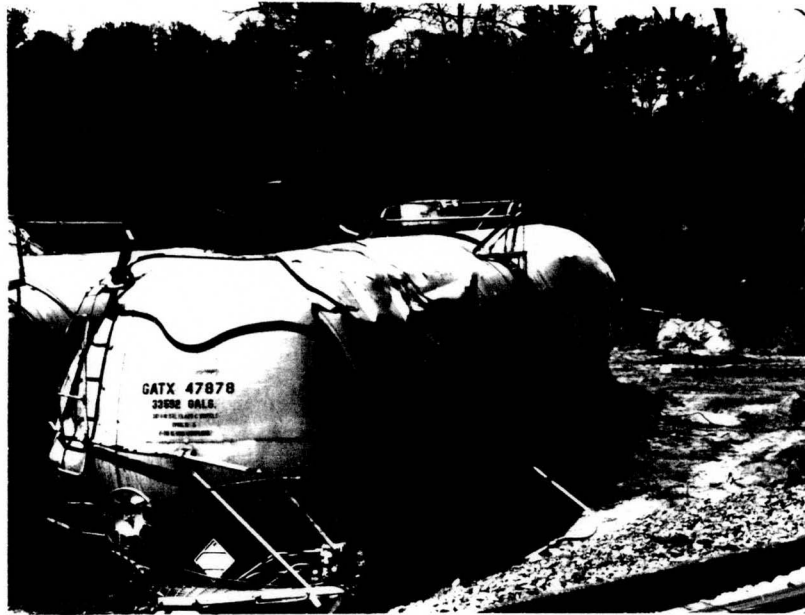
Photo 1-7: Tank-car GATX 47878.

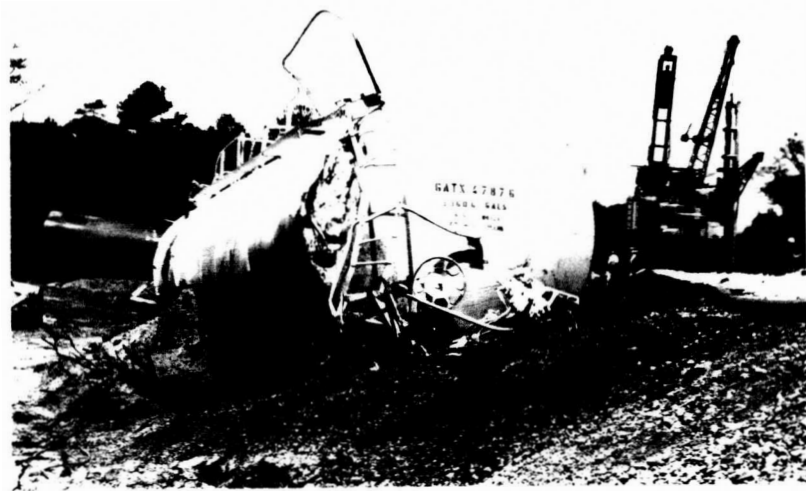
Jacket: No Jacket _____ or Describe: Damaged at one end. Both A and B-heads jackets have dents at edge.

Photo 1-9: B head of tank-car GATX 47876.

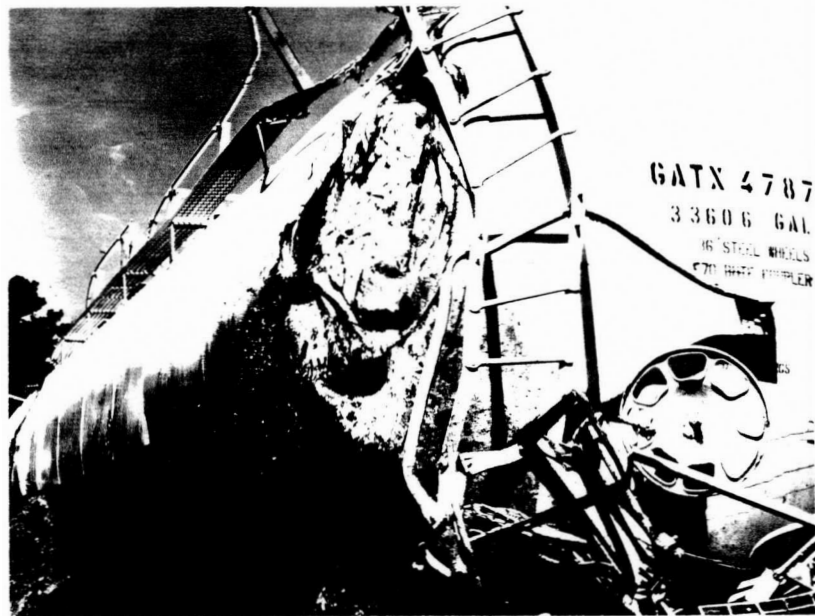
Photo C1-13. Closer view of the B head of tank-car GATX 47876.

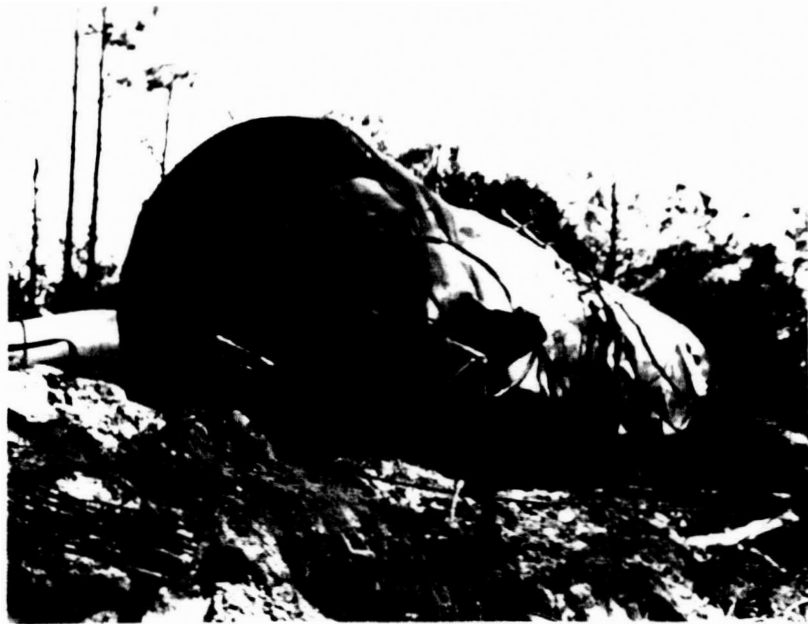
Jacket: No Jacket _____ or Describe: Badly damaged. Severe dents in both A and B-heads.

Photo 1-10: A-head of tank-car GATX 92097.

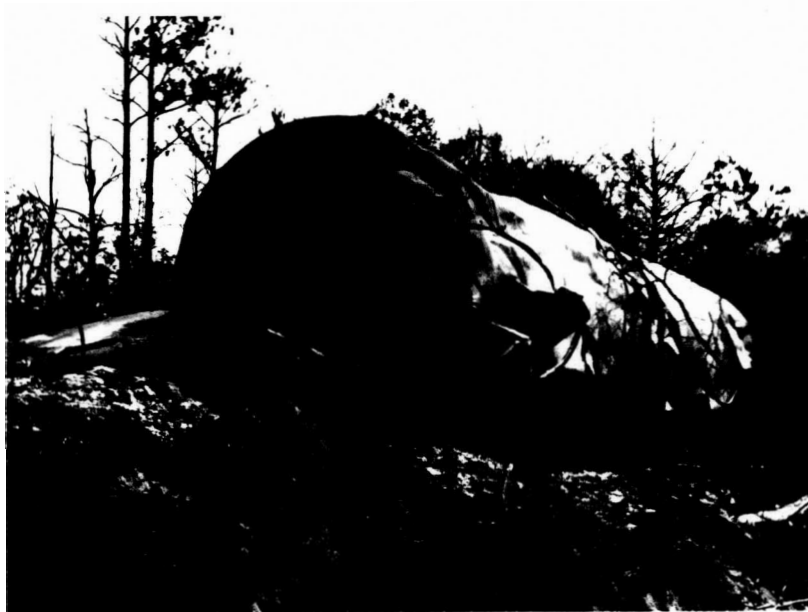
Photo 1-11: A-head of tank-car GATX 92097.

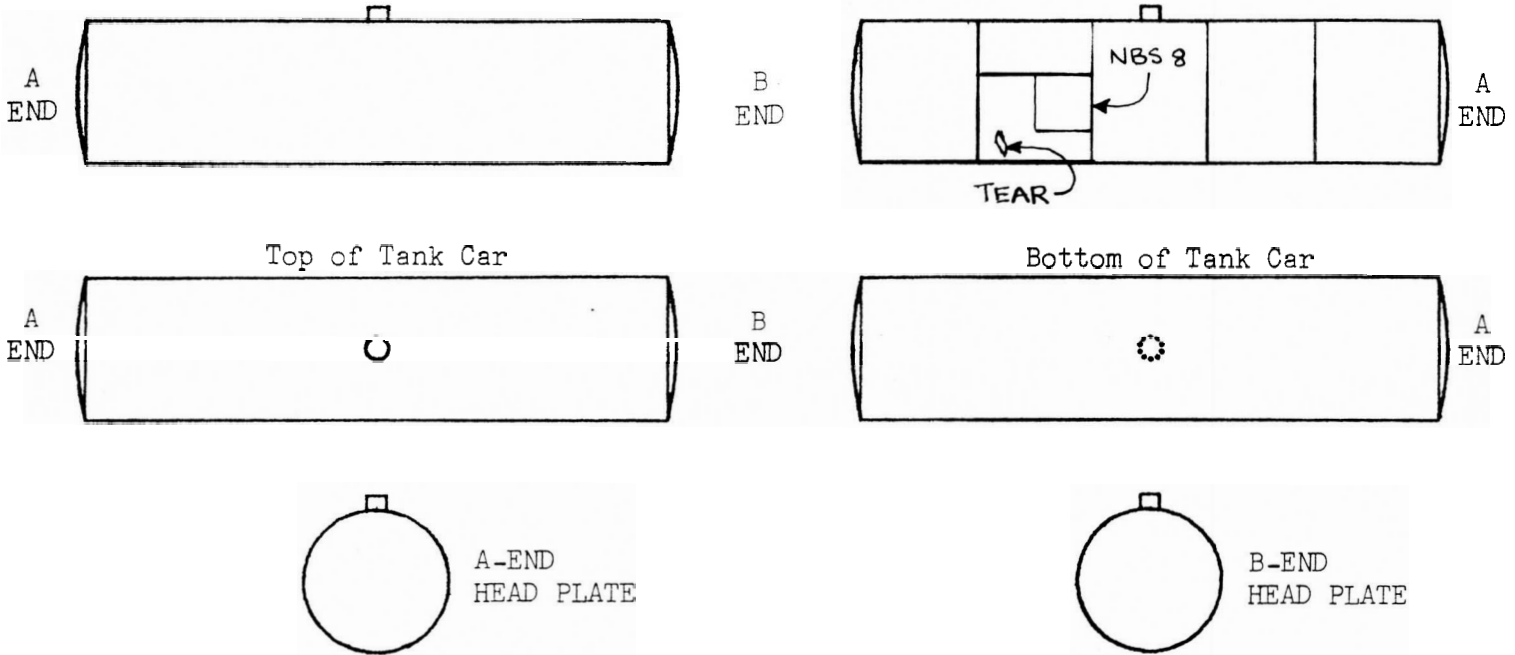
LOCATIONS OF SHELL COURSES, FRACTURES AND SAMPLES

Shell and Head Plates: This very badly damaged car had only one fracture (in course 4). It was 17" long in a shell plate at a region of very high strain. NBS 8 contains course 4 and the weld to 3. The A-head contained a dent at the edge. (cont. on Attachment _____)

SAMPLE IDENTIFICATION NUMBER	OTHER SAMPLE IDENTIFICATION MARKINGS	LOCATION OF SAMPLE ON CAR
NBS 8		Shell course 4.

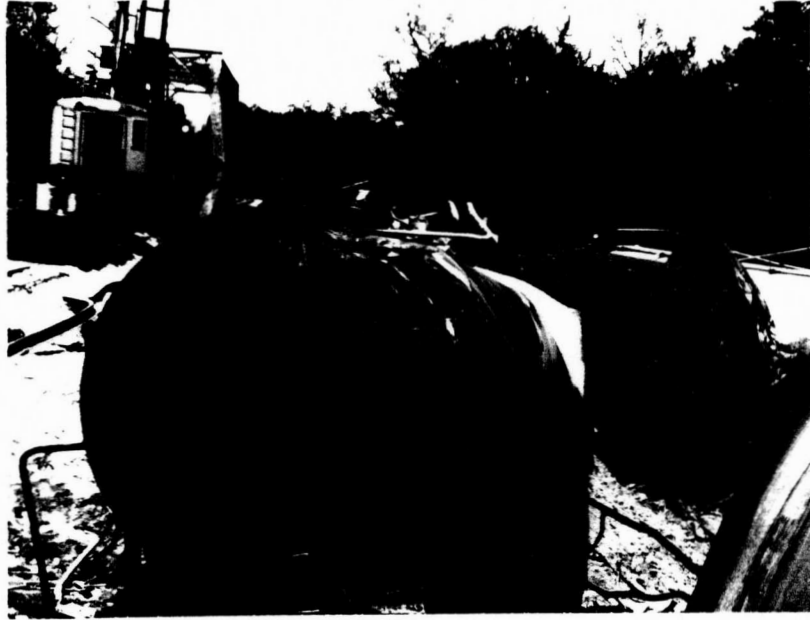
Photo 1-22: A-head of tank-car GATX 44019.

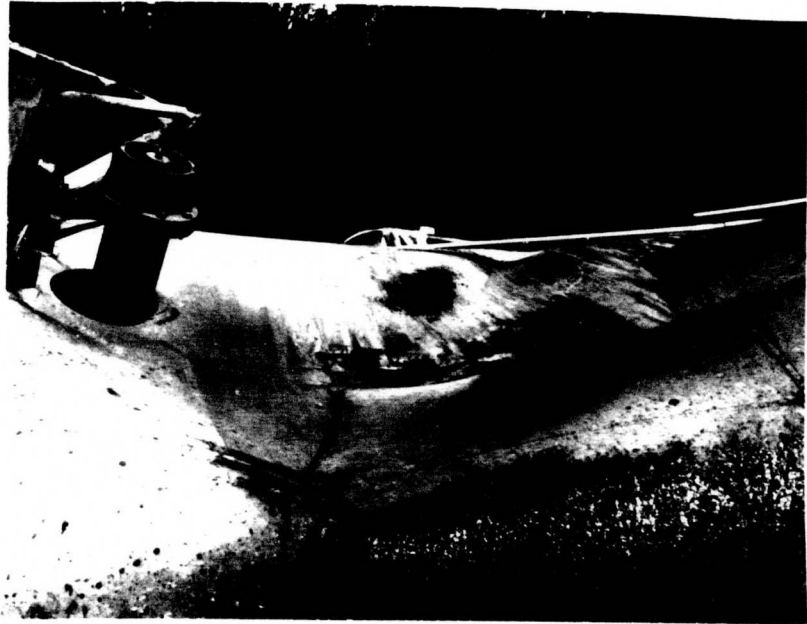
Photo 1-20: Large dent in the top of tank-car
GATX 44019.

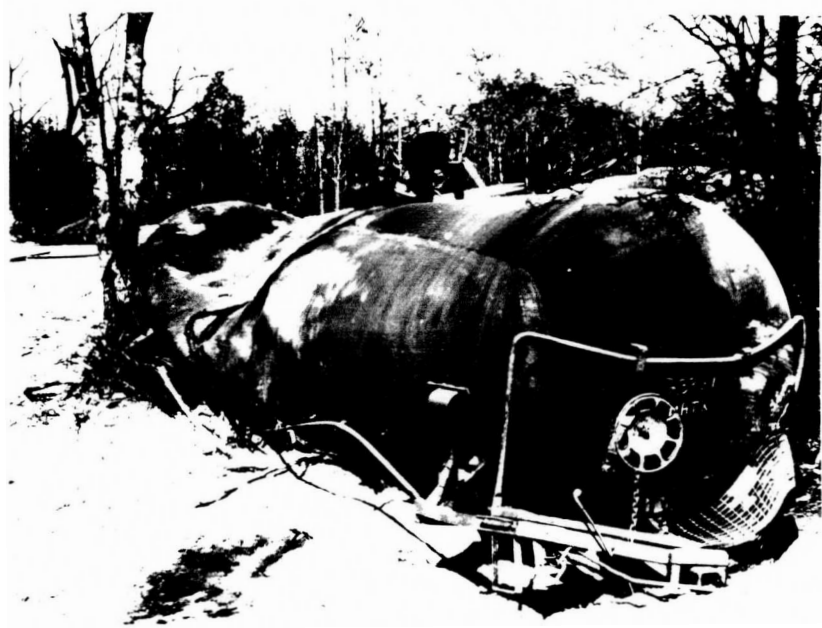
Photo C3-11: B-end of tank-car NATX 23367.

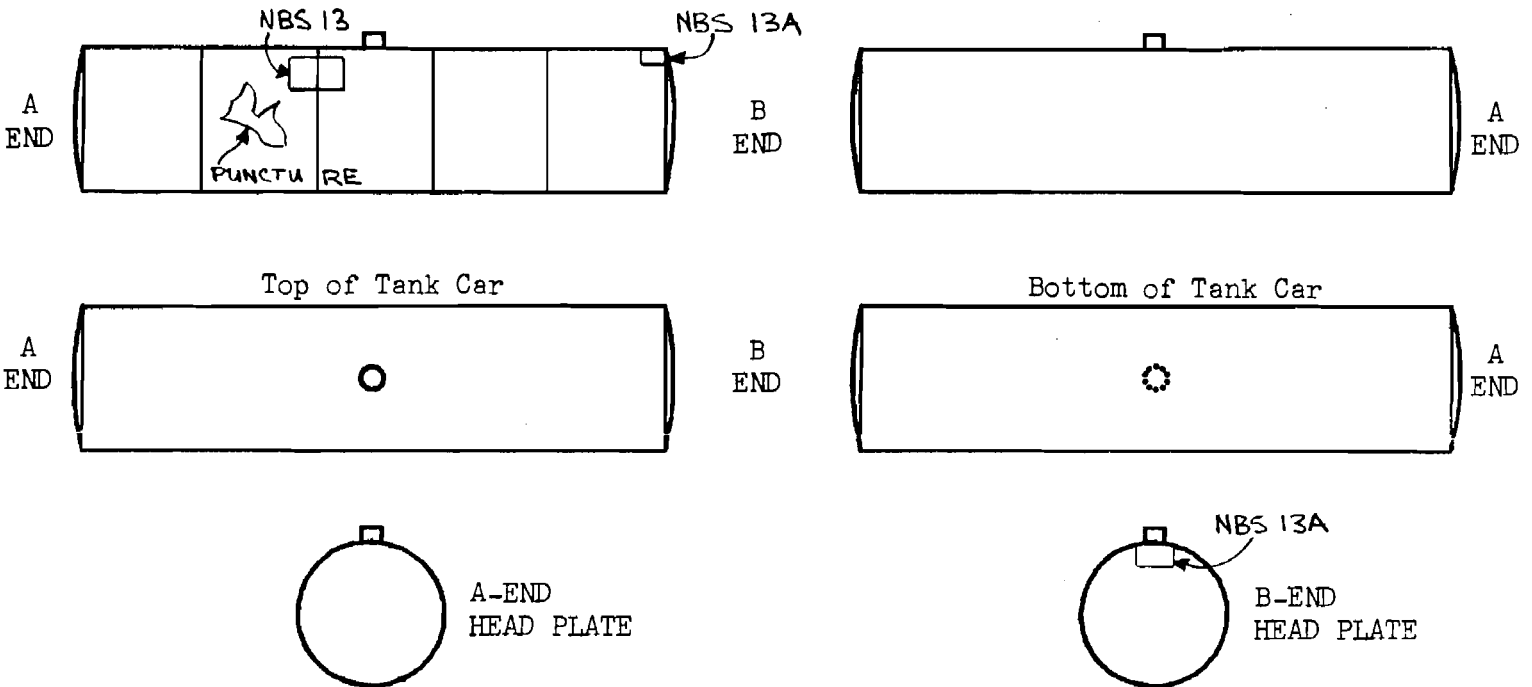
LOCATIONS OF SHELL COURSES, FRACTURES AND SAMPLES

Shell and Head Plates: Car leaked its contents from fractures. Fractures
were observed on top and on bottom where a 2-ft. long fracture (see 2-15)
exists in the course that contains the relief (cont. on Attachment A)

valve (course 3). On top of 63" fracture is largest flaw.

The tank has a banana shape. The 63" rupture is generally lying in the girth weld direction away from the girth weld.

NBS 13 is located in two shell courses (one contains 63" rupture); NBS 13A is located in the severely dented head plate, but it is in a relatively undeformed part of this head plate.

SAMPLE IDENTIFICATION NUMBER	OTHER SAMPLE IDENTIFICATION MARKINGS	LOCATION OF SAMPLE ON CAR
NBS 13		Shell courses 2 & 3, near puncture.
NBS 13A		Shell course 5 & B-head plate.

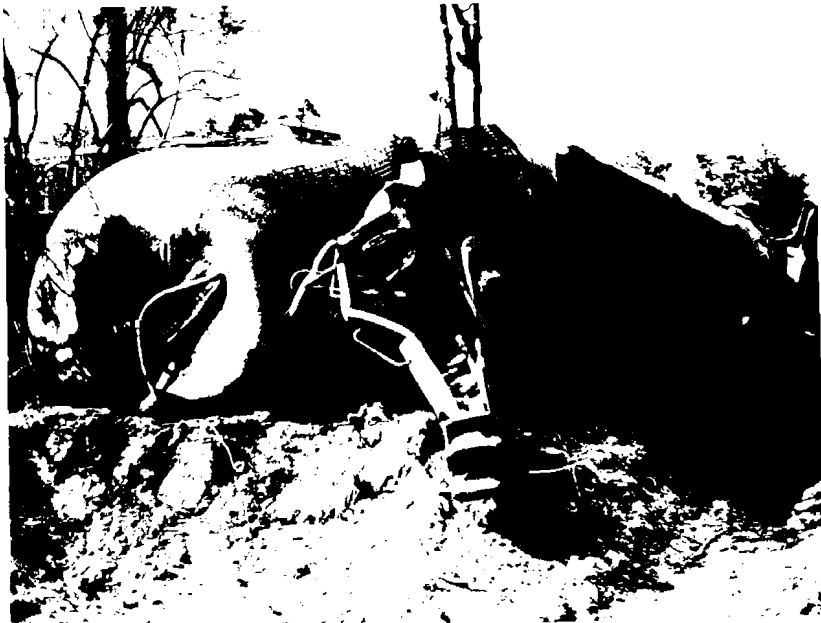
Photo C3-14: Tank-car ACFX 81395.

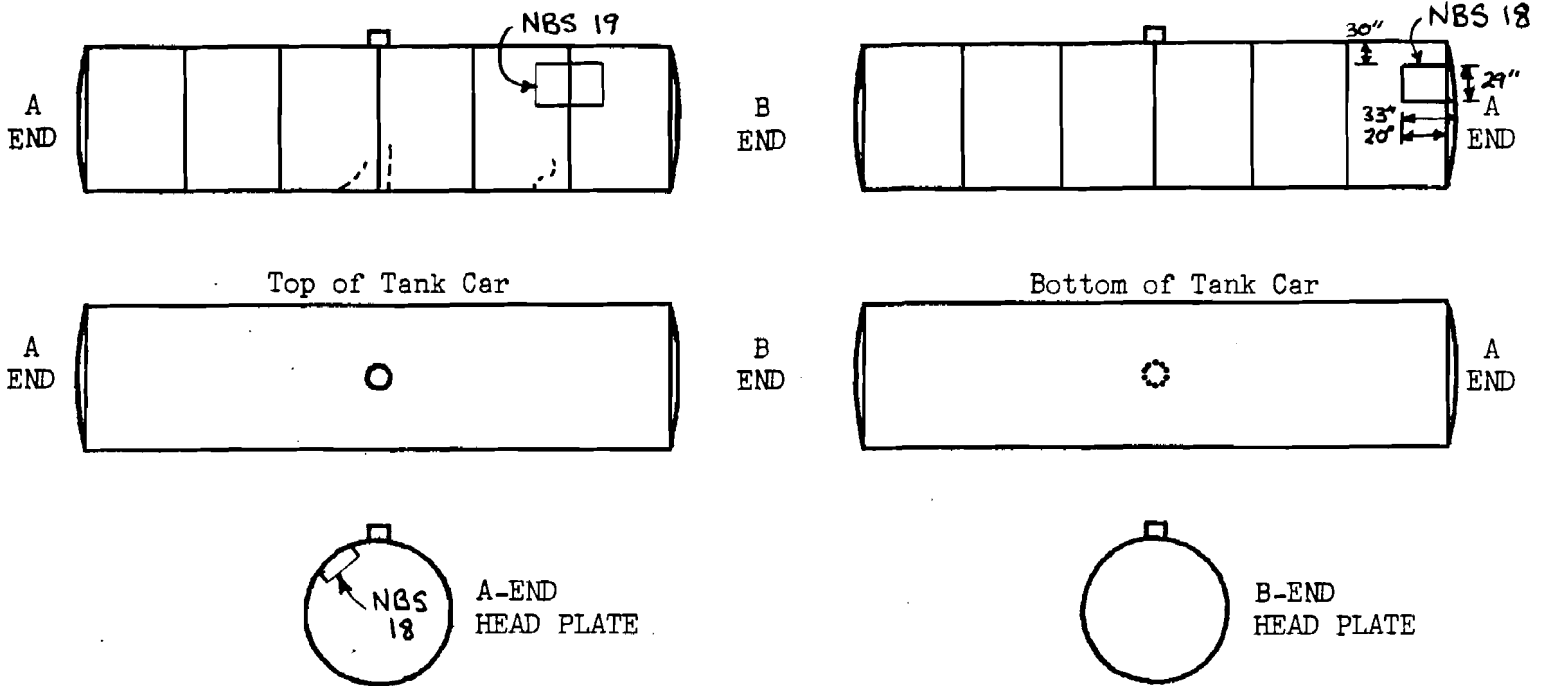
LOCATIONS OF SHELL COURSES, FRACTURES AND SAMPLES

Shell and Head Plates: A most badly damaged and crushed car that did contain stable fractures (see photo 2-26). Sample NBS 18 was taken (see photo 2-30) in an unaffected (not deformed) (cont. on Attachment A) Sill, Coupler, Wheel, other parts (in that order) _____

SAMPLE IDENTIFICATION NUMBER	OTHER SAMPLE IDENTIFICATION MARKINGS	LOCATION OF SAMPLE ON CAR
NBS 18		Shell course 1 and A-head plate.
NBS 19		Shell courses 5 & 6.

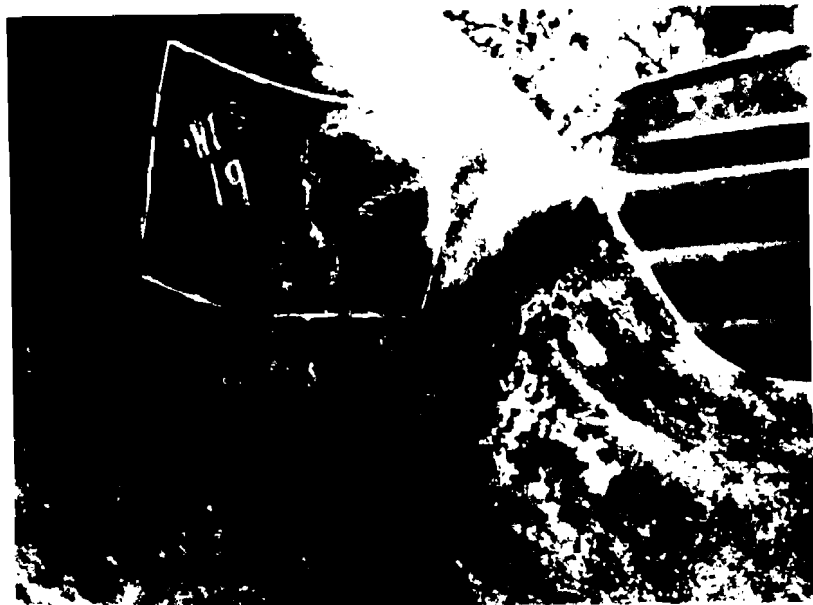
Photo C4-22: B-end of tank-car ACFX 82959 showing sample NBS 19.

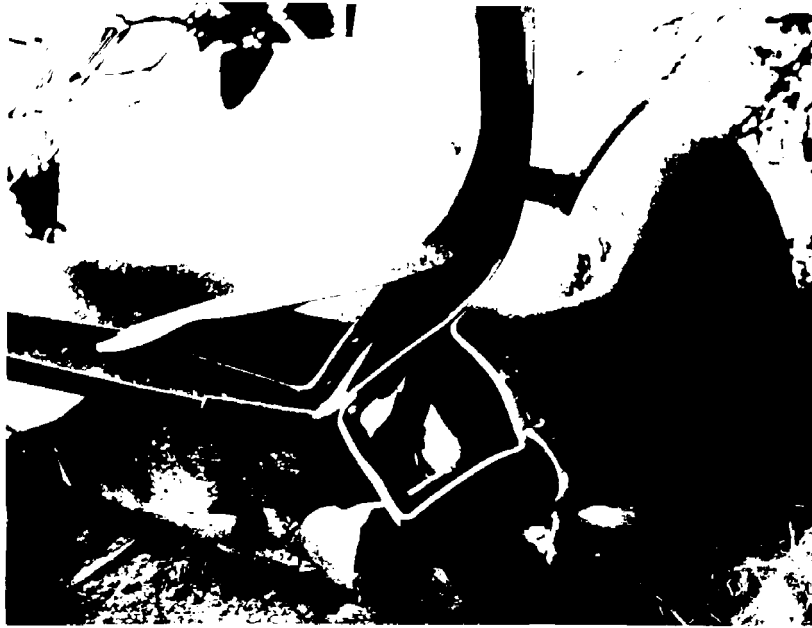
Photo C3-19: B-end of tank-car ACFX 82959 showing a large hole at the end of the car.

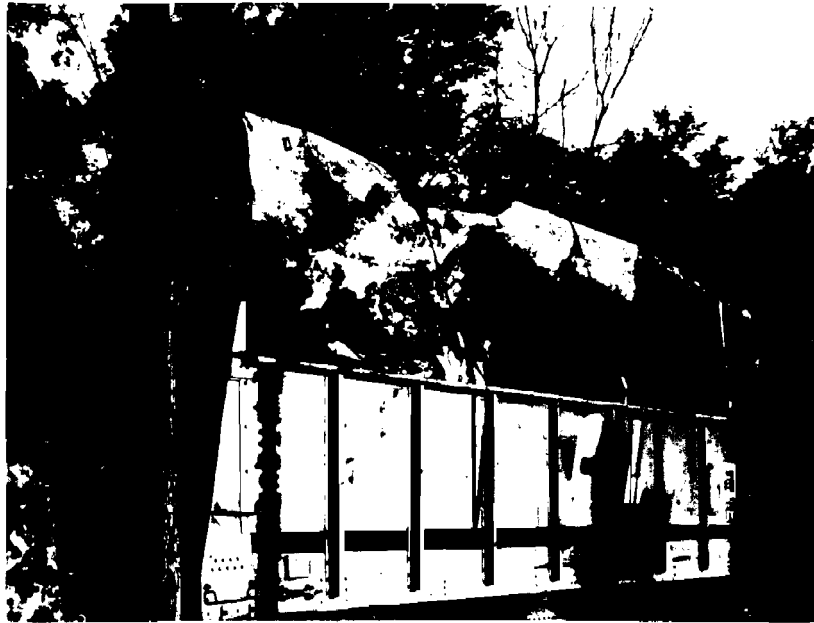
Photo C4-14: A-end tub of tank-car ACFX 89990 being carried in a gondola car.

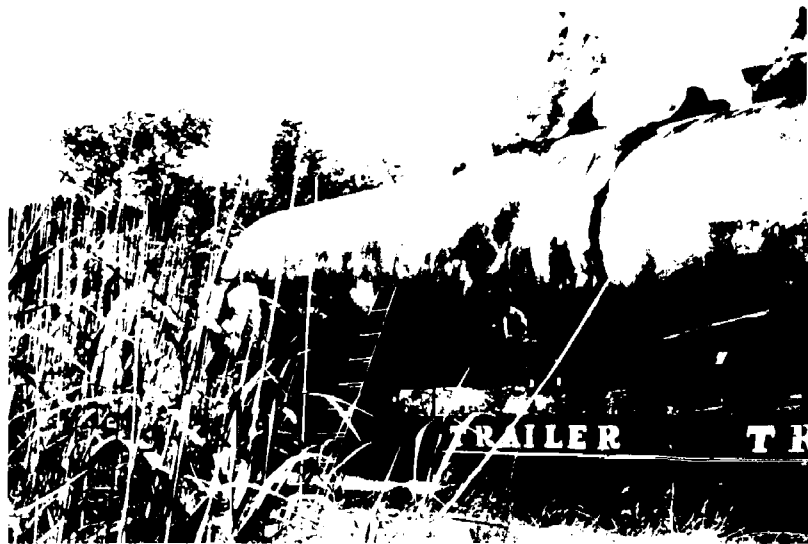
Shell and Head Plates: The leaking shell course had a hole punched in it just below the middle of the shell course.

Photo C4-19: Tank-car UILX 28727 showing a hole in the center shell course.

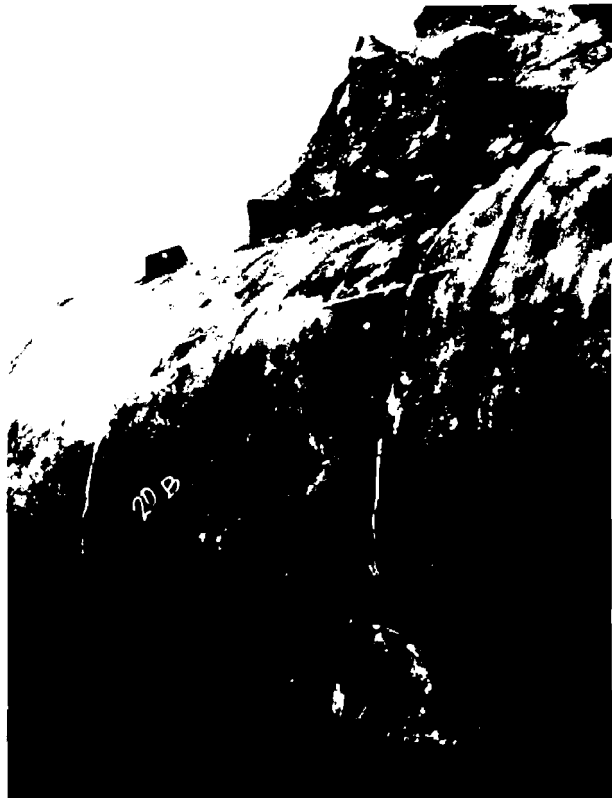
Photo C4-20: Close-up of tank-car UILX 28727 showing a hole in the center shell course and samples NBS 20A and NBS 20B.

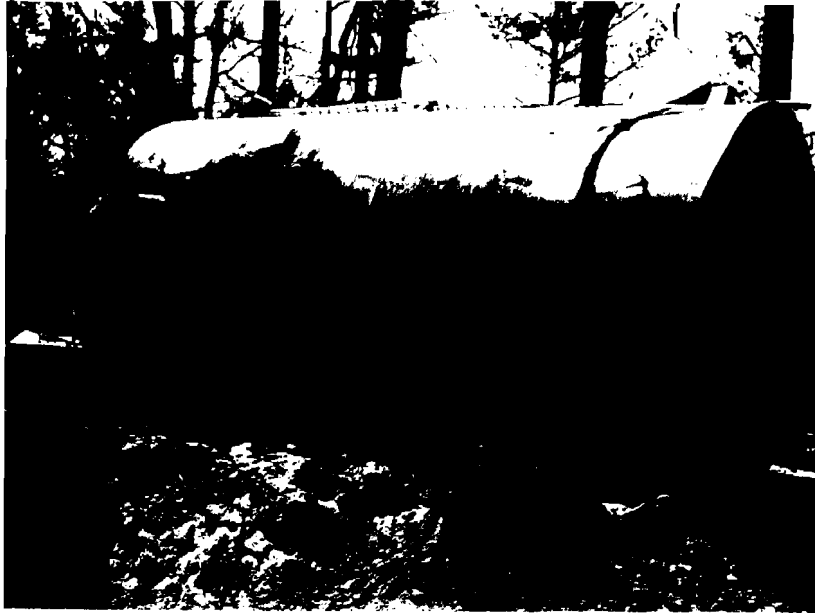
Photo 1-12: South side tub (A-end) of tank car
IMCX 2513.

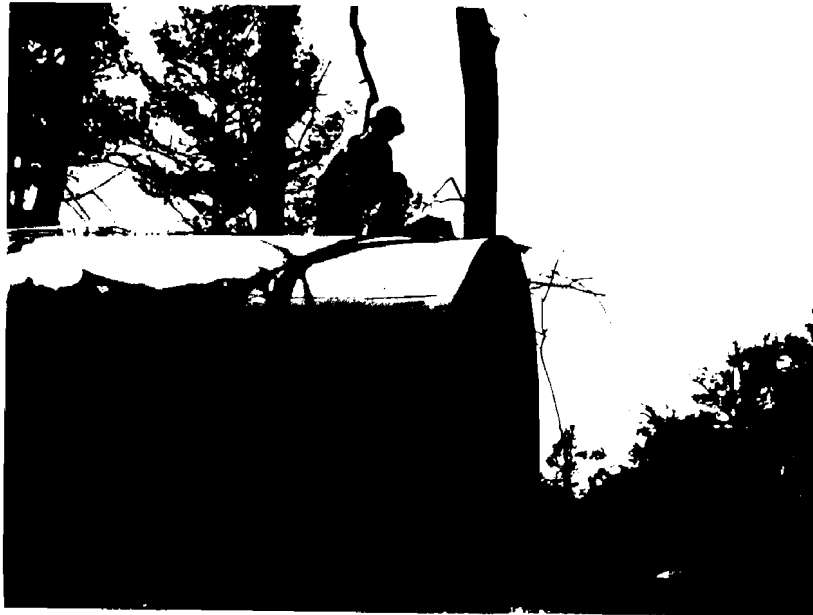
Photo 1-15: South side tub (A-end) of tank-car
IMCX 2513.

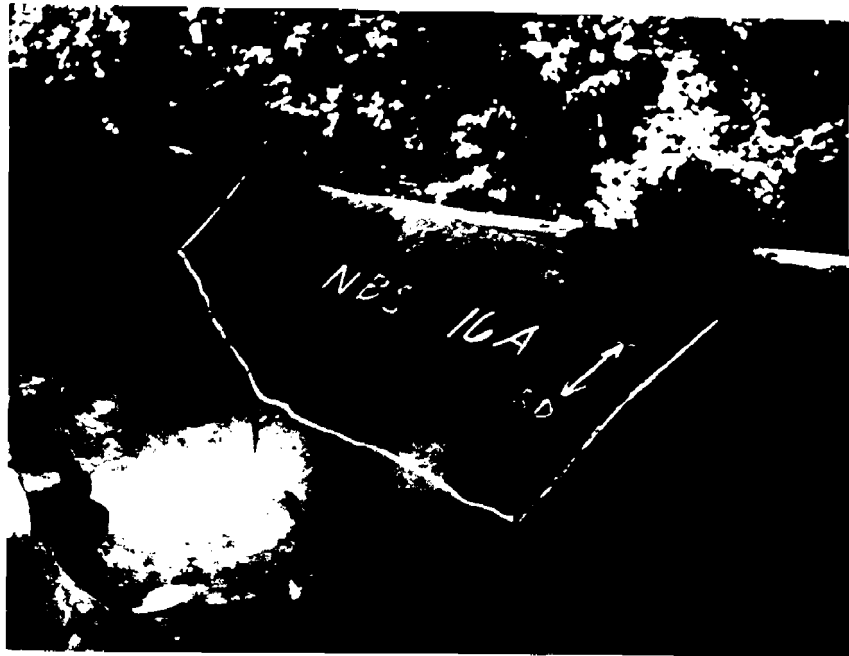
Photo C4-11: Center section of tank-car IMCX 2513 showing sample NBS 16A.

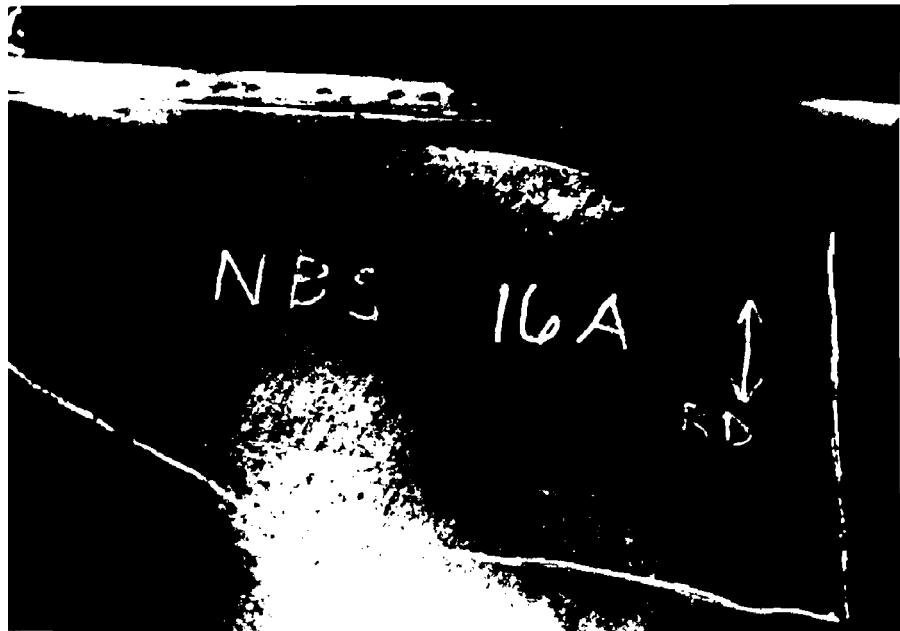
Photo C4-12: Close-up of sample NBS 16A marked on the center section of tank-car IMCX 2513.

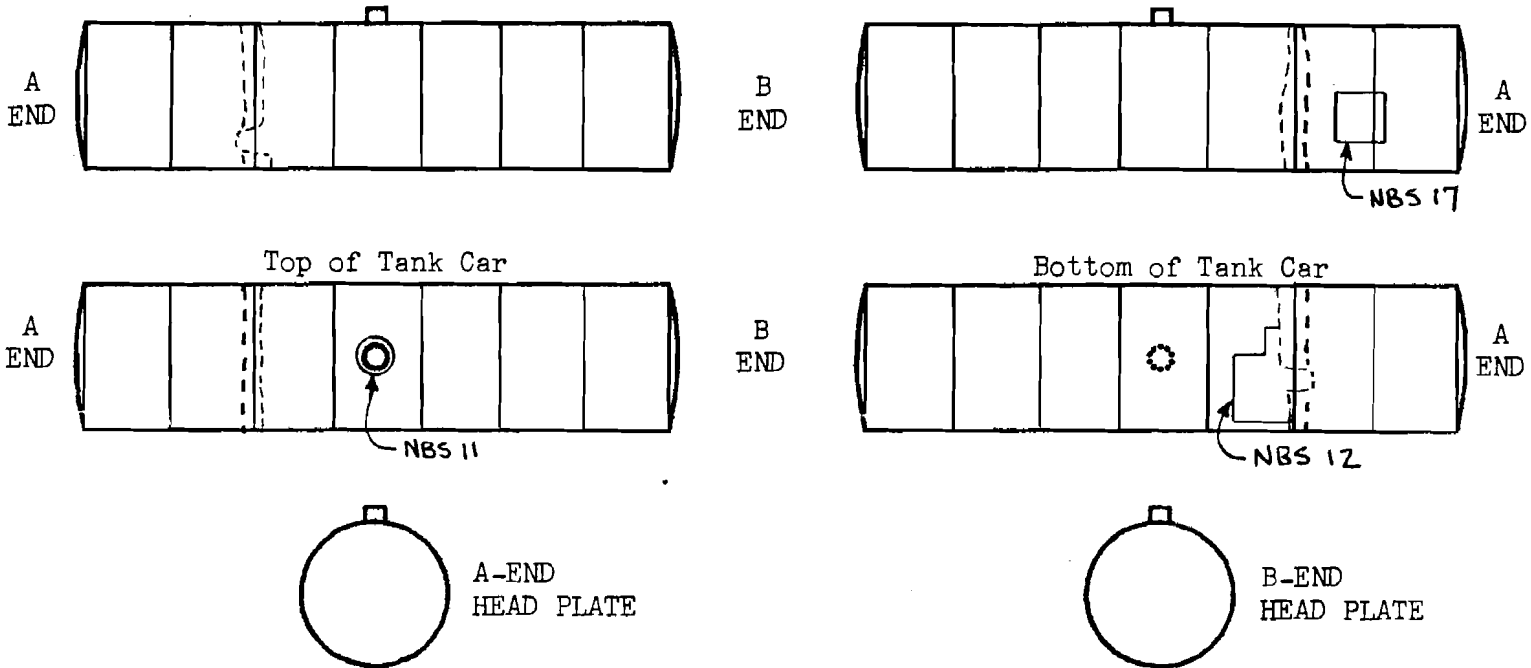
LOCATIONS OF SHELL COURSES, FRACTURES AND SAMPLES

SAMPLE IDENTIFICATION NUMBER	OTHER SAMPLE IDENTIFICATION MARKINGS	LOCATION OF SAMPLE ON CAR
NBS 11		Valve.
NBS 12		Shell courses 2 & 3, along fracture.
NBS 17		Shell courses 1 & 2.
