REPORT NO. UMTA-IN-06-0009-83-3

COLD WEATHER TRANSIT TECHNOLOGY PROGRAM

VOLUME 3 - INVESTIGATION OF THE HIGH INCIDENCE OF RAIL PULL APARTS ON CONTINUOUS WELDED RAIL

May 1983

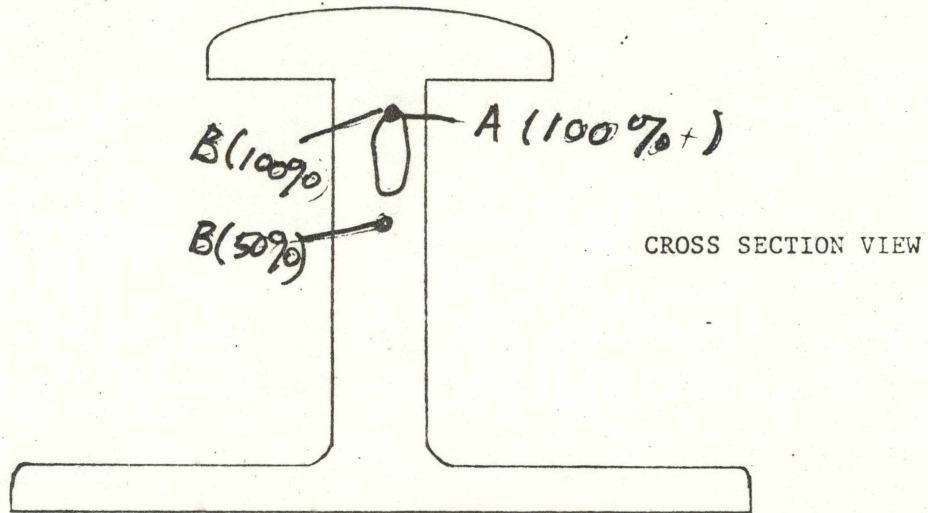
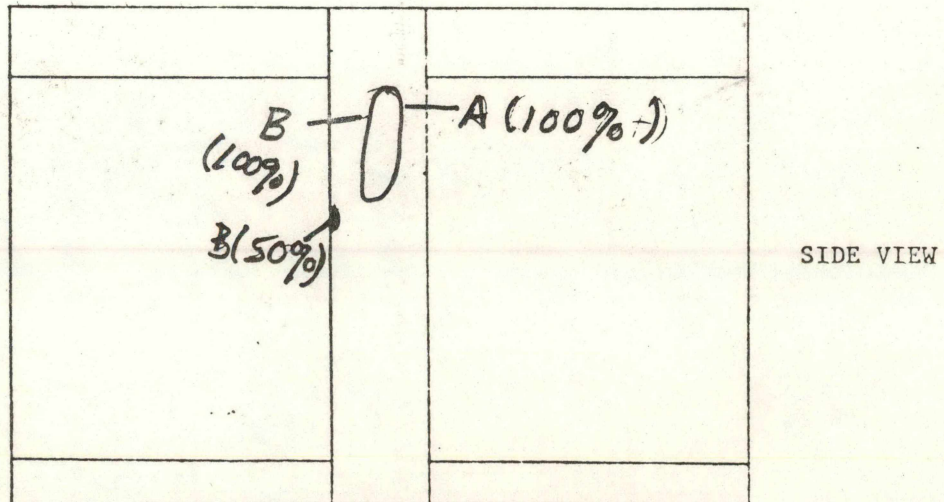
INDICATION SIZE: A - 1" (100%+)
