Seismic Damage Assessment of Rail Structures in Japan after the January 1995 Kobe Earthquake

**Parsons Brinckerhoff Quade & Douglas, Inc.
San Francisco, California**

April 1995

**U.S. Department of Transportation
Federal Railroad Administration
Office of Research and Development
Washington, DC 20590**

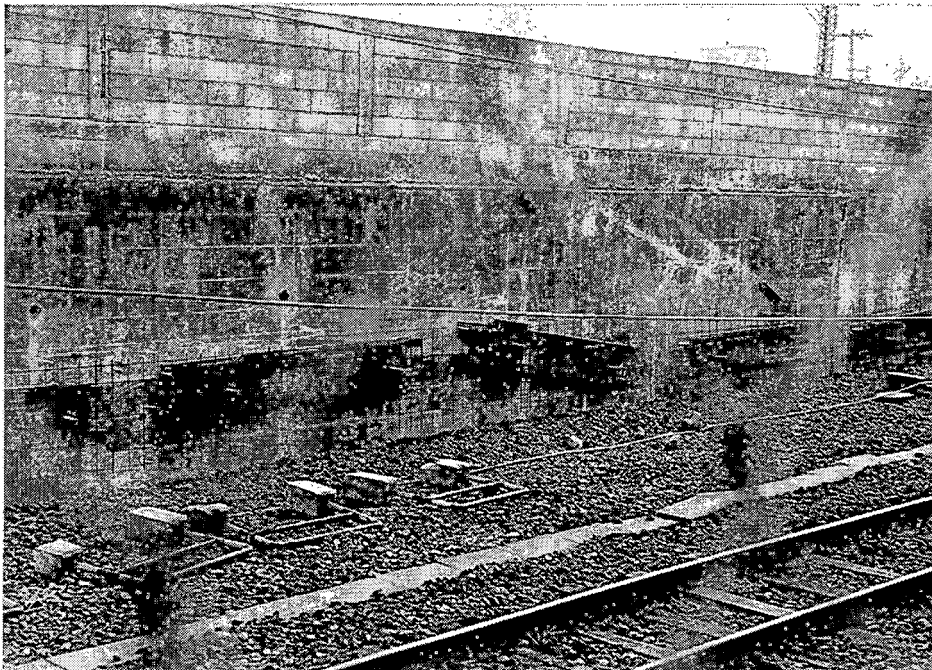
JRT-4. Retaining embankment through bolts as seen from the back face of the wall.

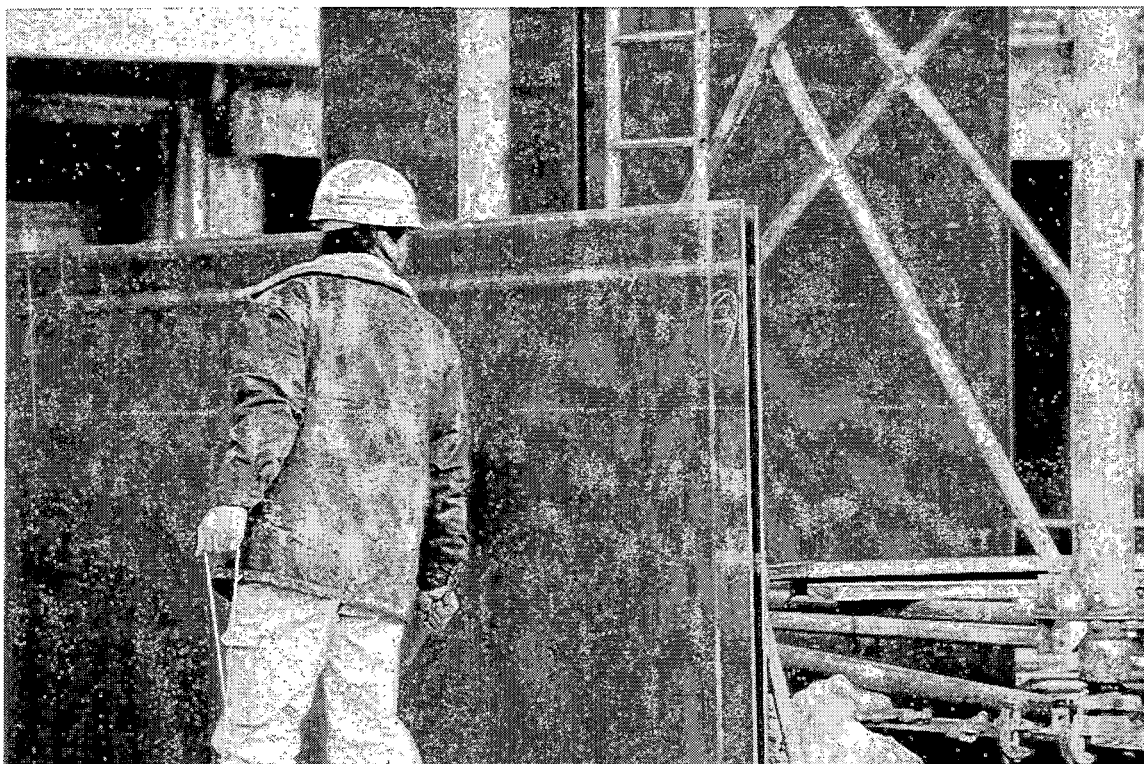
JRS-17. This construction worker is standing on a steel jacket. The jacket is nearly 1.5 meters on a side and only 9 mm thick.

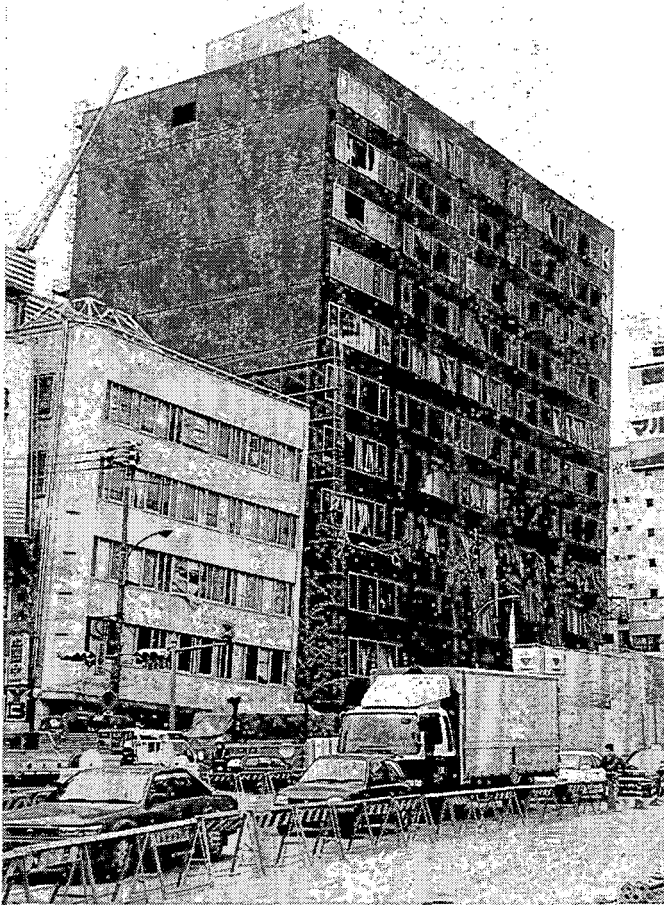
SS-7 & SS-8. These buildings next to Sannomiya Station were also heavily damaged. The one to the left is leaning. The darker building sheared about 2 meters at the fourth floor and appears quite dangerous.

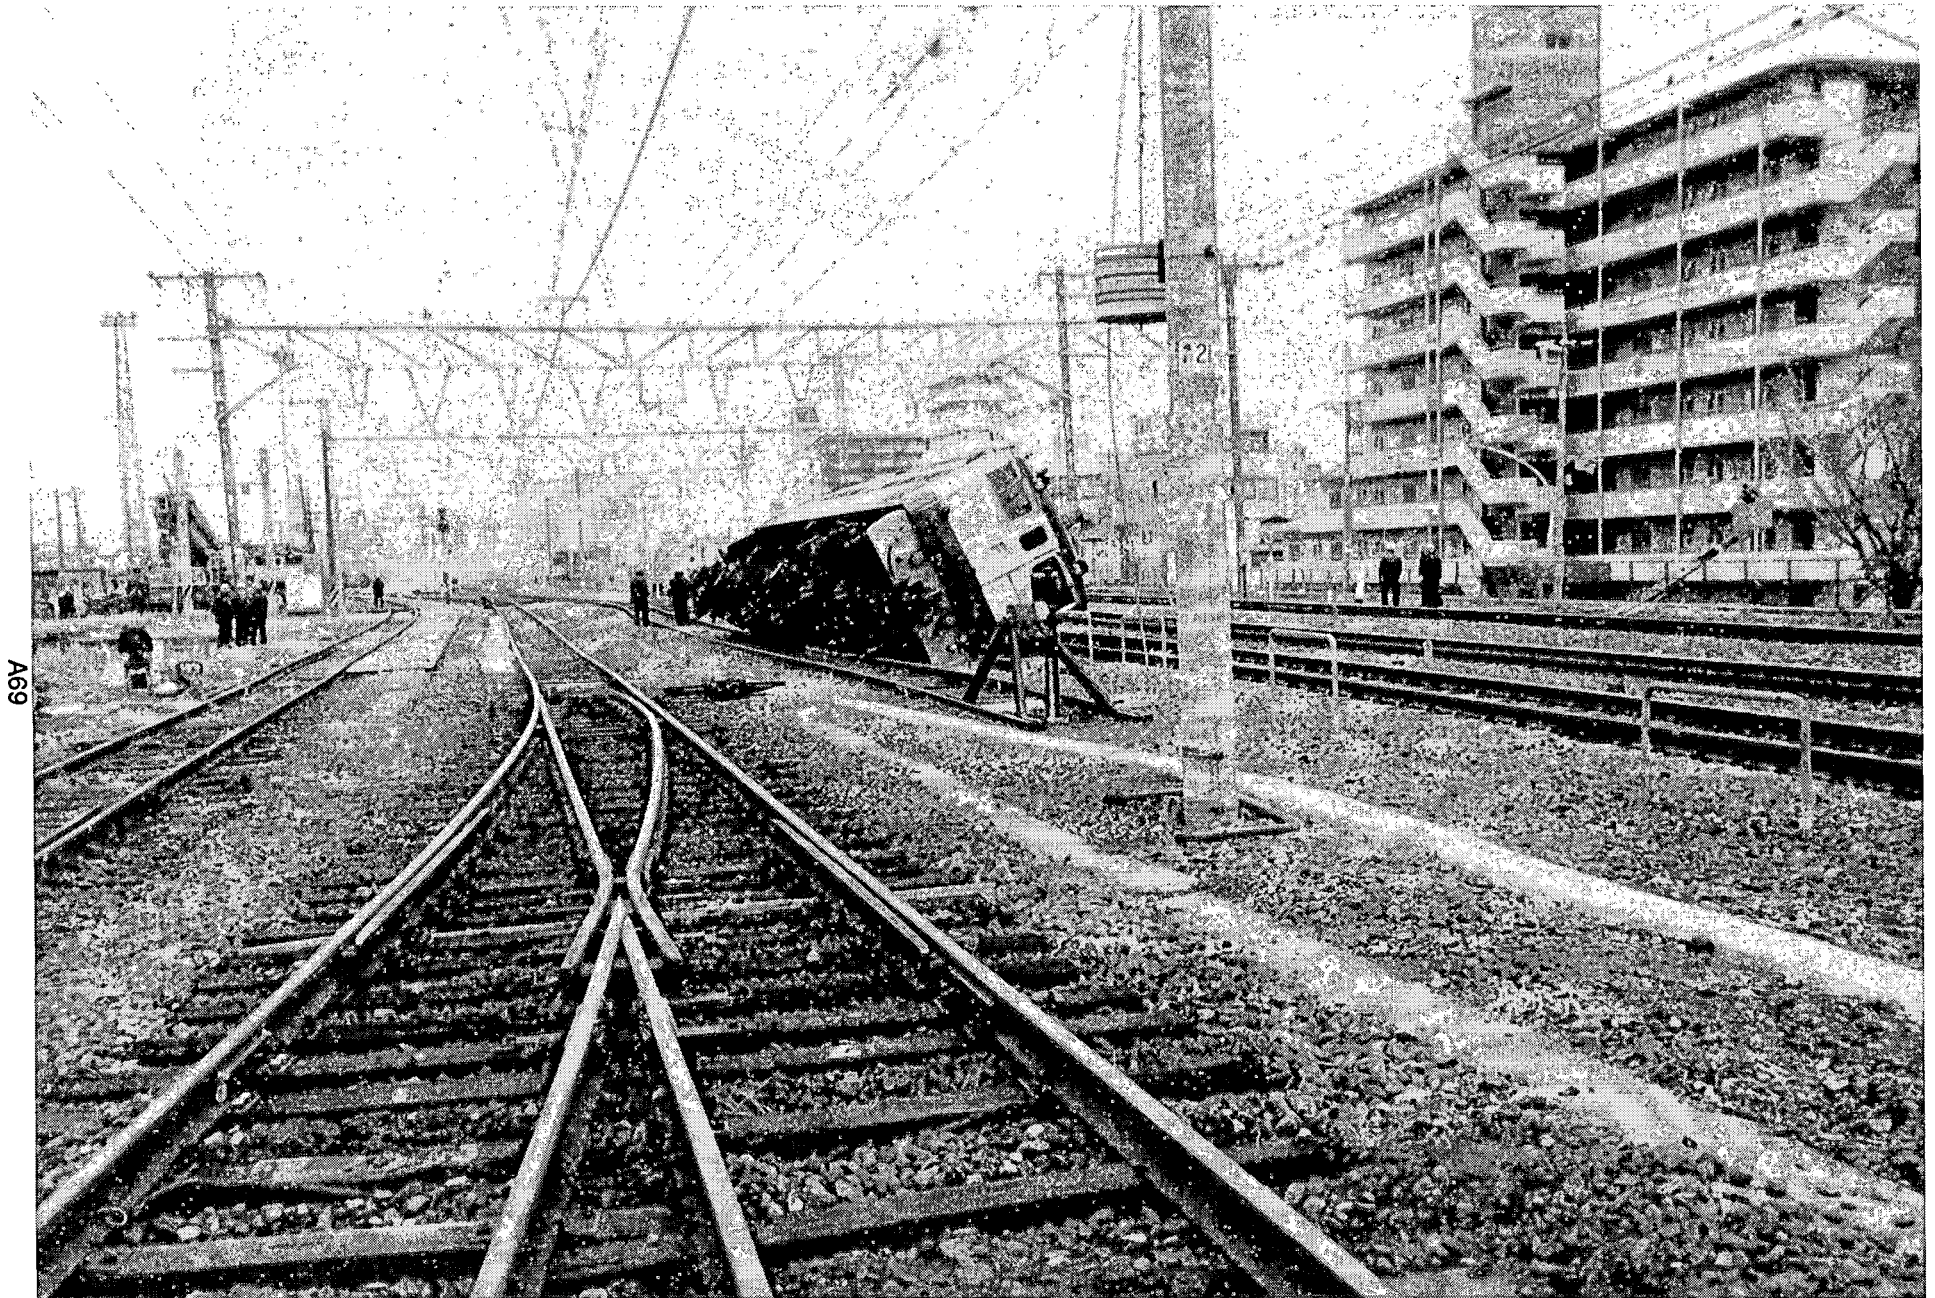
HC-3. Hankyu Corporation passenger car derailed from its out-of-service siding. Notice the buildings appear undamaged. (photo courtesy of M. Yashinsky)

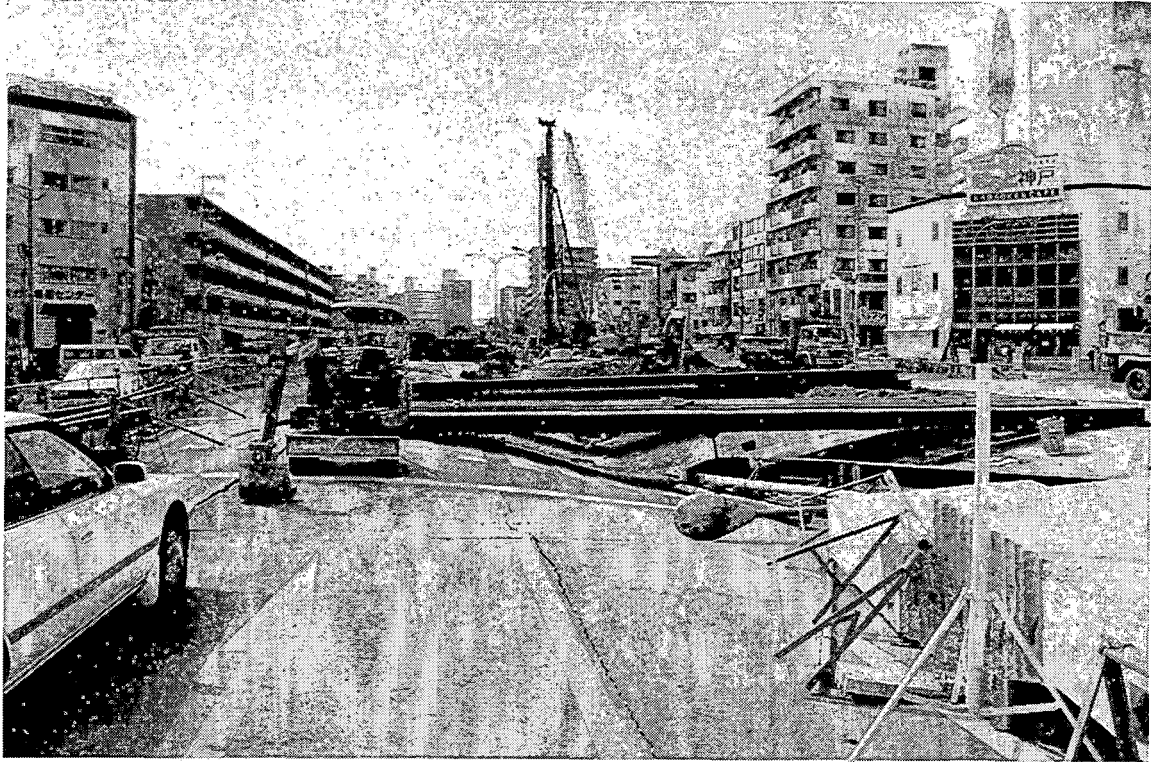
KMS-1. Depression in the street is above the Daikai-dori Station.

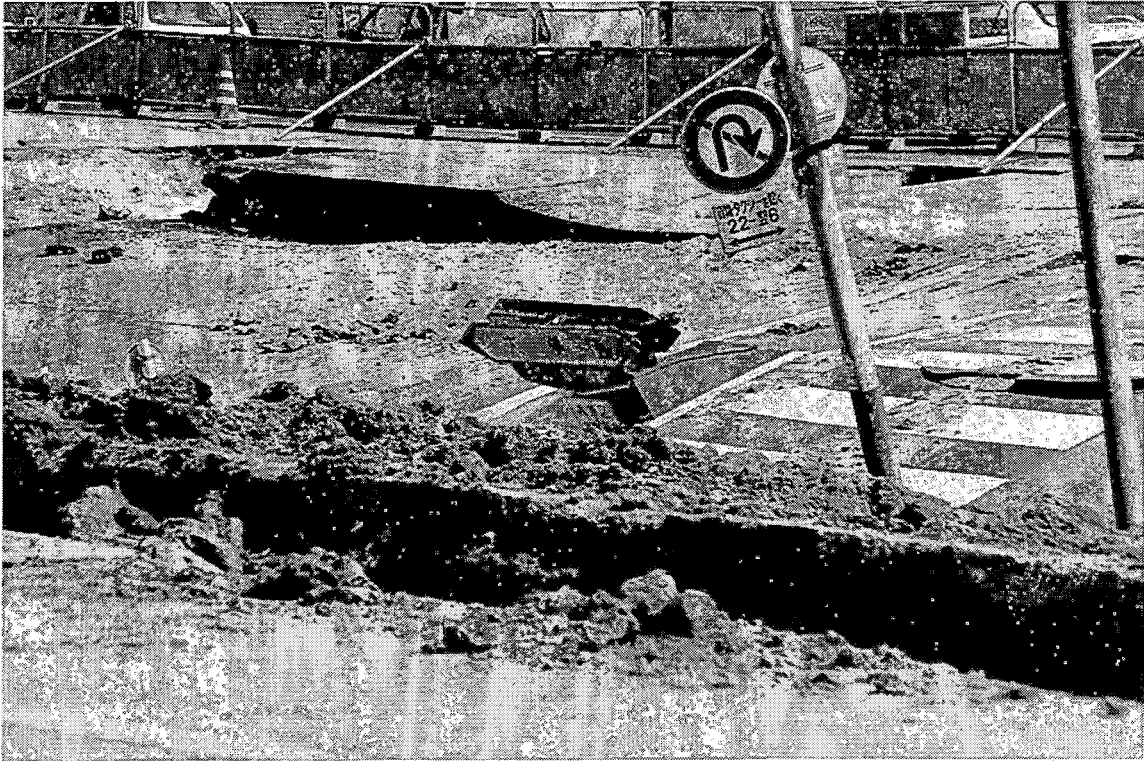
KMS-3. A street sign marks the intersection at Daikai-dori.
